Site Condition Report for Surrender Application EPR/XP3131VK/V002

Deeside Power Station

Deeside Power (UK) Limited

Report No. CRM 343 004 PE R 003

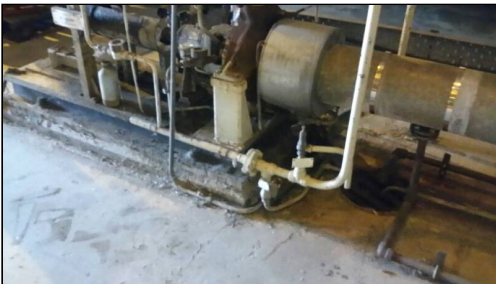
Survey Date:	Lead Surveyor	Survey Type	Floor	Analysis
	18 Feb 2021 to 23 Feb 2021	Adam Yates	Demolition Survey	Ground Floor	No Asbestos Detected
	Building	Room	Item	Quantity	
	Zone 5 - HRSG Building	HRSG building G/01	gasket to pipework flange to HRSG MP pump pipework	5no.	
	Sample No (S,SP,P,As)	Product Type	Surface Treatment	Condition	Accessibility
	JW004072 (S)	N/A	N/A	N/A	N/A
Material Risk Score					
N/A					
Recommended action		No further action required			
Surveyor comments		N/A

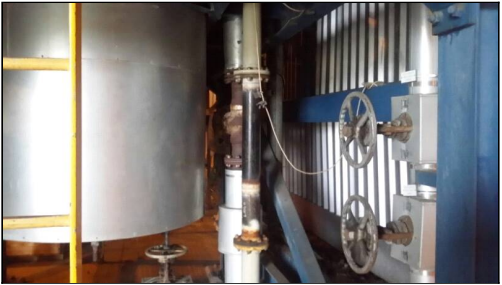
Survey Date:	Lead Surveyor	Survey Type	Floor	Analysis
	18 Feb 2021 to 23 Feb 2021	Adam Yates	Demolition Survey	Ground Floor	No Asbestos Detected
	Building	Room	Item	Quantity	
	Zone 5 - HRSG Building	HRSG building G/01	gasket to pipework flange to HRSG 1 tank pipework	4no.	
	Sample No (S,SP,P,As)	Product Type	Surface Treatment	Condition	Accessibility
	JW004073 (S)	N/A	N/A	N/A	N/A
Material Risk Score					
N/A					
Recommended action					
No further action required					
Surveyor comments					
N/A

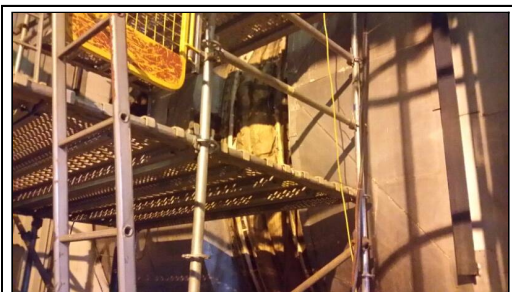
Survey Date:	Lead Surveyor	Survey Type	Floor	Analysis
	18 Feb 2021 to 23 Feb 2021	Adam Yates	Demolition Survey	Ground Floor	No Asbestos Detected
	Building	Room	Item	Quantity	
	Zone 5 - HRSG Building	HRSG building G/01	woven expansion to HRSG 1	10m ²	
	Sample No (S,SP,P,As)	Product Type	Surface Treatment	Condition	Accessibility
	JW004074 (S)	N/A	N/A	N/A	N/A
	Material Risk Score				
Recommended action		No further action required			
Surveyor comments		N/A

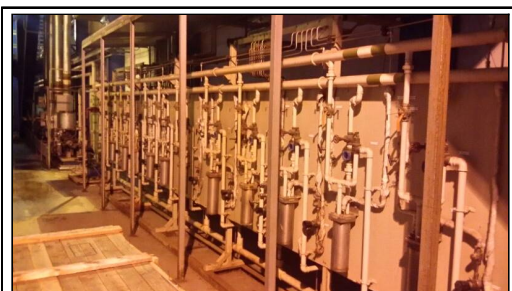
Survey Date:	Lead Surveyor	Survey Type	Floor	Analysis
	18 Feb 2021 to 23 Feb 2021	Adam Yates	Demolition Survey	Ground Floor	No Asbestos Detected
	Building	Room	Item	Quantity	
	Zone 5 - HRSG Building	HRSG building G/01	woven wrap to cooling water pipework	20lm	
	Sample No (S,SP,P,As)	Product Type	Surface Treatment	Condition	Accessibility
	As JW004074 (SP)	N/A	N/A	N/A	N/A
	Material Risk Score				
Recommended action		No further action required			
Surveyor comments		N/A

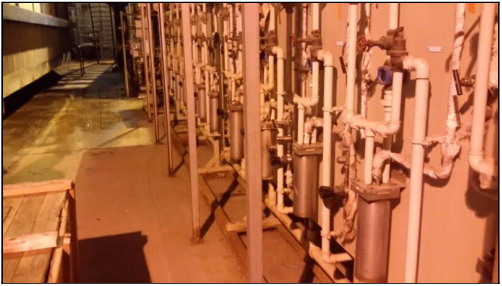
Survey Date:	Lead Surveyor	Survey Type	Floor	Analysis
	18 Feb 2021 to 23 Feb 2021	Adam Yates	Demolition Survey	Ground Floor	No Asbestos Detected
	Building	Room	Item	Quantity	
	Zone 5 - HRSG Building	HRSG building G/01	gasket to cooling water compressor	12no.	
	Sample No (S,SP,P,As)	Product Type	Surface Treatment	Condition	Accessibility
	JW004075 (S)	N/A	N/A	N/A	N/A
	Material Risk Score				
Recommended action		No further action required			
Surveyor comments		N/A

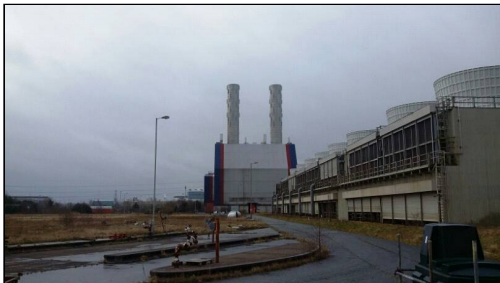
Survey Date:	Lead Surveyor	Survey Type	Floor	Analysis
	18 Feb 2021 to 23 Feb 2021	Adam Yates	Demolition Survey	External	N/A
	Building	Room	Item	Quantity	
	Zone 5 - HRSG Building	Externals E/01	limited access to high level roof features	N/A	
	Sample No (S,SP,P,As)	Product Type	Surface Treatment	Condition	Accessibility
	Visual (P)	N/A	N/A	N/A	N/A
	Material Risk Score				
N/A					
Recommended action	Inspection Required				
Surveyor comments	Scaffolding required to fully access roof

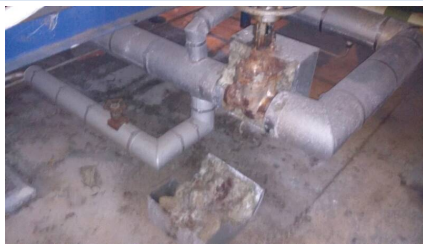
Inspection of pipework flange

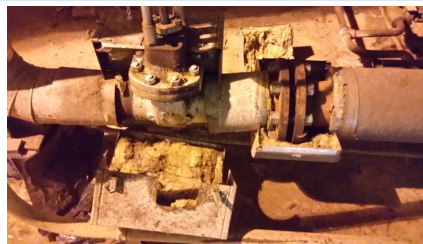
Inspection of pipework flanges

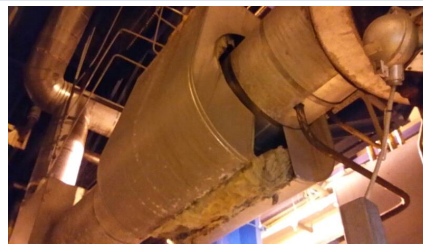
Inspection of pipework flange

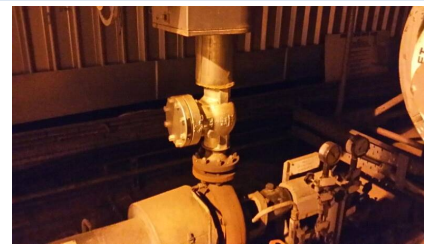
Inspection of pipework flange

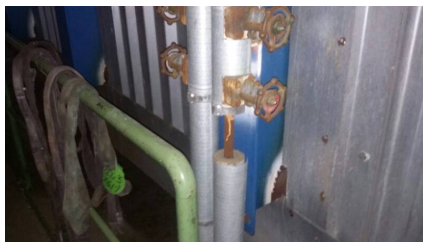
Intrusion into pipework

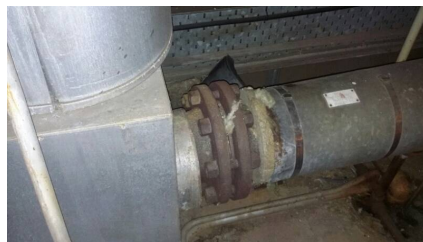
Inspection of gasket

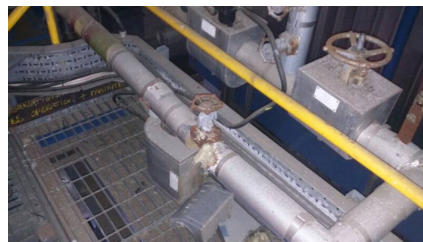
Inspection of valve

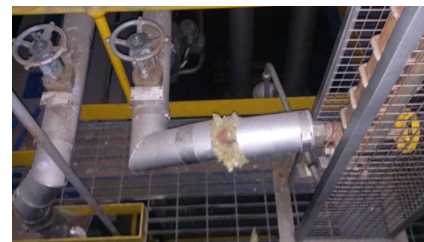
Intrusion into pipework insulation

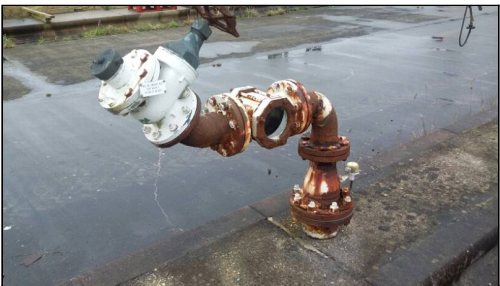
Survey Date:	Lead Surveyor	Survey Type	Floor	Analysis
	19 Feb 2021 to 23 Feb 2021	Adam Yates	Demolition Survey	External	No Asbestos Detected
	Building	Room	Item	Quantity	
	Zone 6 - Fuel Oil Pumphouse	Externals E/01	gasket to pipework flange to fuel oil unload pipework	18no.	
	Sample No (S,SP,P,As)	Product Type	Surface Treatment	Condition	Accessibility
	JW004077 (S)	N/A	N/A	N/A	N/A
Material Risk Score					
N/A					
Recommended action					
No further action required					
Surveyor comments					
N/A

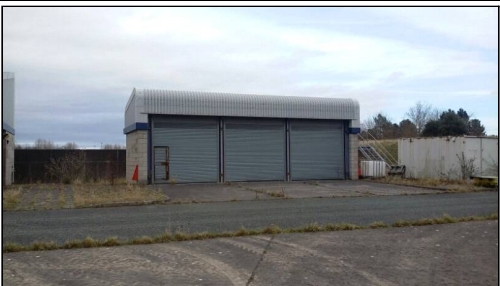
Survey Date:	Lead Surveyor	Survey Type	Floor	Analysis
	19 Feb 2021 to 23 Feb 2021	Adam Yates	Demolition Survey	Ground Floor	N/A
	Building	Room	Item	Quantity	
	Zone 6 - Fuel Oil Store	Fuel oil store G/01	No suspect materials found within fuel oil store	N/A	
	Sample No (S,SP,P,As)	Product Type	Surface Treatment	Condition	Accessibility
	Visual (P)	N/A	N/A	N/A	N/A
Material Risk Score					
N/A					
Recommended action					
No further action required					
Surveyor comments					
N/A

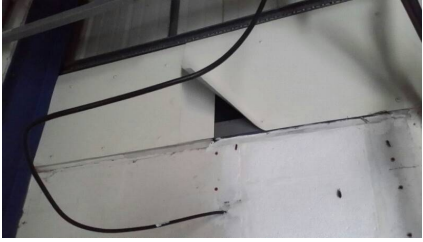
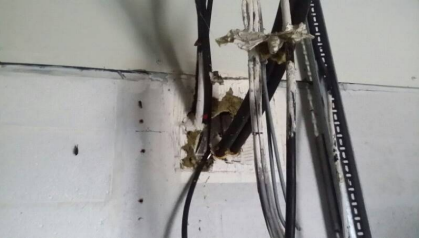
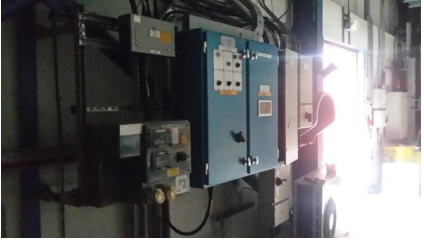
Intrusion into boxing	Intrusion into packing	Modern electrics & switchgear

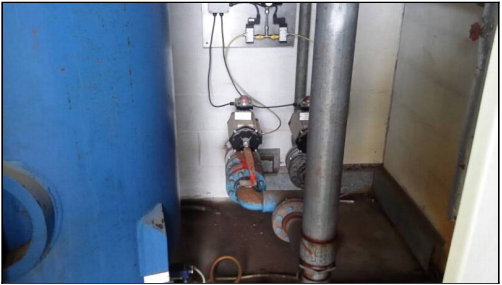
Survey Date:	Lead Surveyor	Survey Type	Floor	Analysis
	22 Feb 2021 to 23 Feb 2021	Adam Yates	Demolition Survey	Ground Floor	No Asbestos Detected
	Building	Room	Item	Quantity	
	Zone 7 - Intake & Outfall System	Compressor room G/02	gasket to pipework flange to tank pipework	5no.	
	Sample No (S,SP,P,As)	Product Type	Surface Treatment	Condition	Accessibility
	JW004089 (S)	N/A	N/A	N/A	N/A
	Material Risk Score				
Recommended action		No further action required			
Surveyor comments		N/A

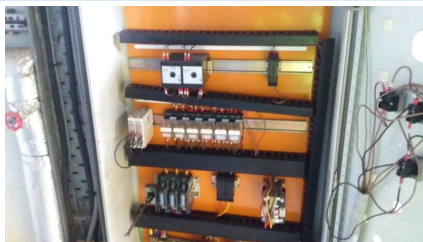
Inspection within electrics

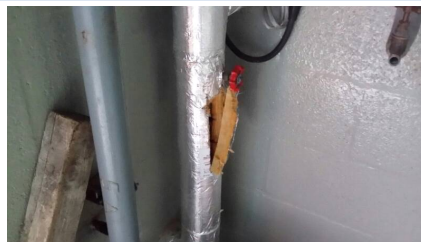
Intrusion into pipework insulation
