BUILDING SURVEY REPORT

Former Mabey Bridge Facility, Newhouse Farm
Industrial Estate, Chepstow

May 2016

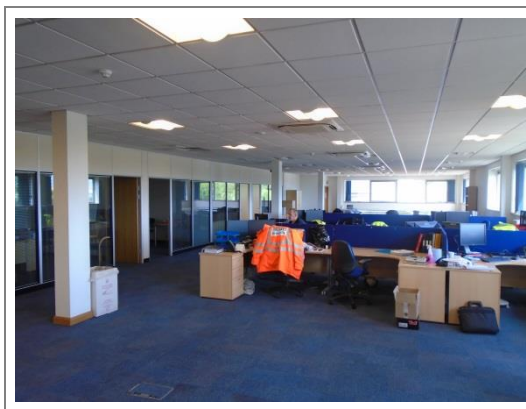
We did not observe any defects suggesting fundamental inadequacies to the structure of the building.
