**SOUTH SIDE
QUEENSWAY WASTE
MANAGEMENT SITE,
LLANWERN STEELWORKS**

**2020 Annual Review of
Environmental
Monitoring**

Report Number 2116r2v1d0221

February 2021

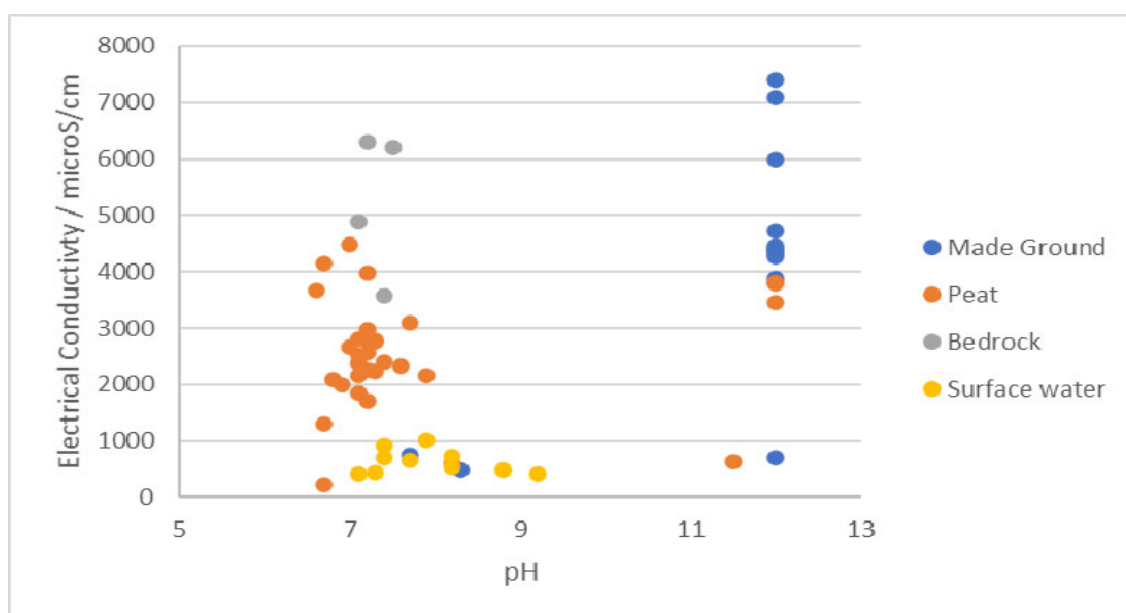
Plate 5-1 Differences in pH and Electrical Conductivity during 2020

The data indicates that groundwater within the shallow made ground is distinct and characterised by elevated pH (typically > pH 11). This is principally because some of the made ground comprises steel slag that leaches lime with a strong alkaline pH. In comparison, the groundwater in the peat is circumneutral (pH 6 – 8) although there is potential evidence of potential interconnection between the made ground and peat at BH202, as the pH is persistently elevated at this point. Groundwater chemistry tends to become more dilute from north to south.

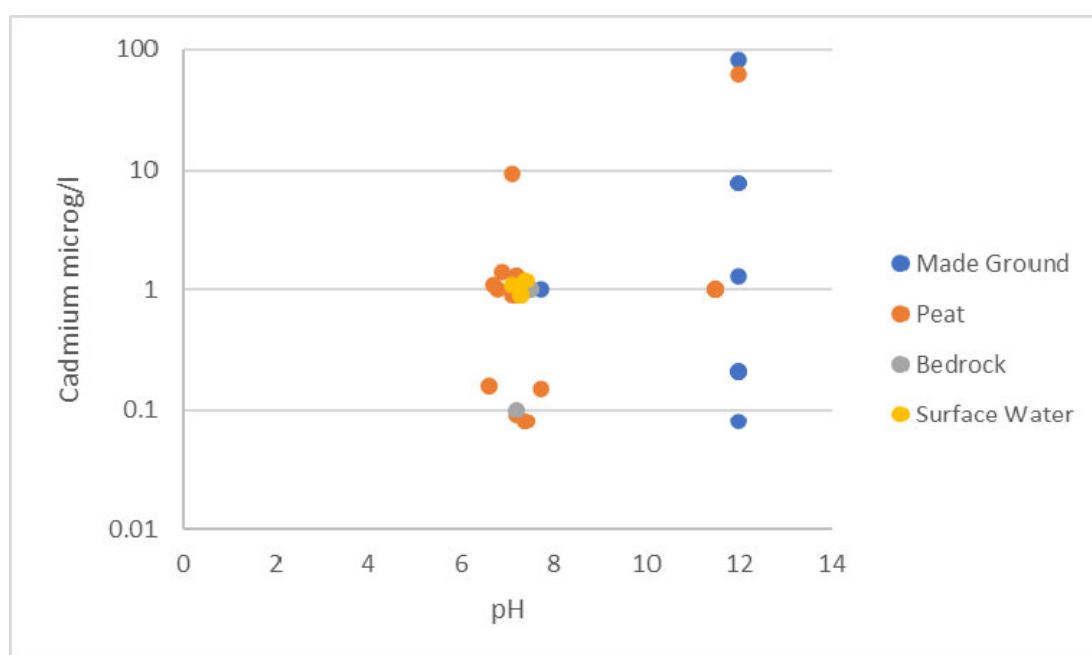
Plate 5-3 Differences in cadmium concentration during 2020

Because of the highly alkaline pH, many non-hazardous and hazardous substances are sometimes below detection limits or at low concentrations in the groundwater recovered from the made ground. In recent years, hazardous substance cadmium has been detected on several occasions, and sometimes at elevated concentration. Chromium, copper, lead (and other metals) have also been found above their freshwater Environmental Quality Standards (EQS). In 2019, cadmium was only detected once, within the peat at BH18D, at 0.001 mg/l. In 2020, Cadmium was detected on several occasions, including within the made ground and peat groundwater, as illustrated in Plate 5-3. Some of the levels detected were above freshwater Environmental Quality Standards (EQS), as summarised in Table 5-2. Mercury was not detected in 2020 but lead and nickel, also hazardous substances were detected above their respective EQSs.

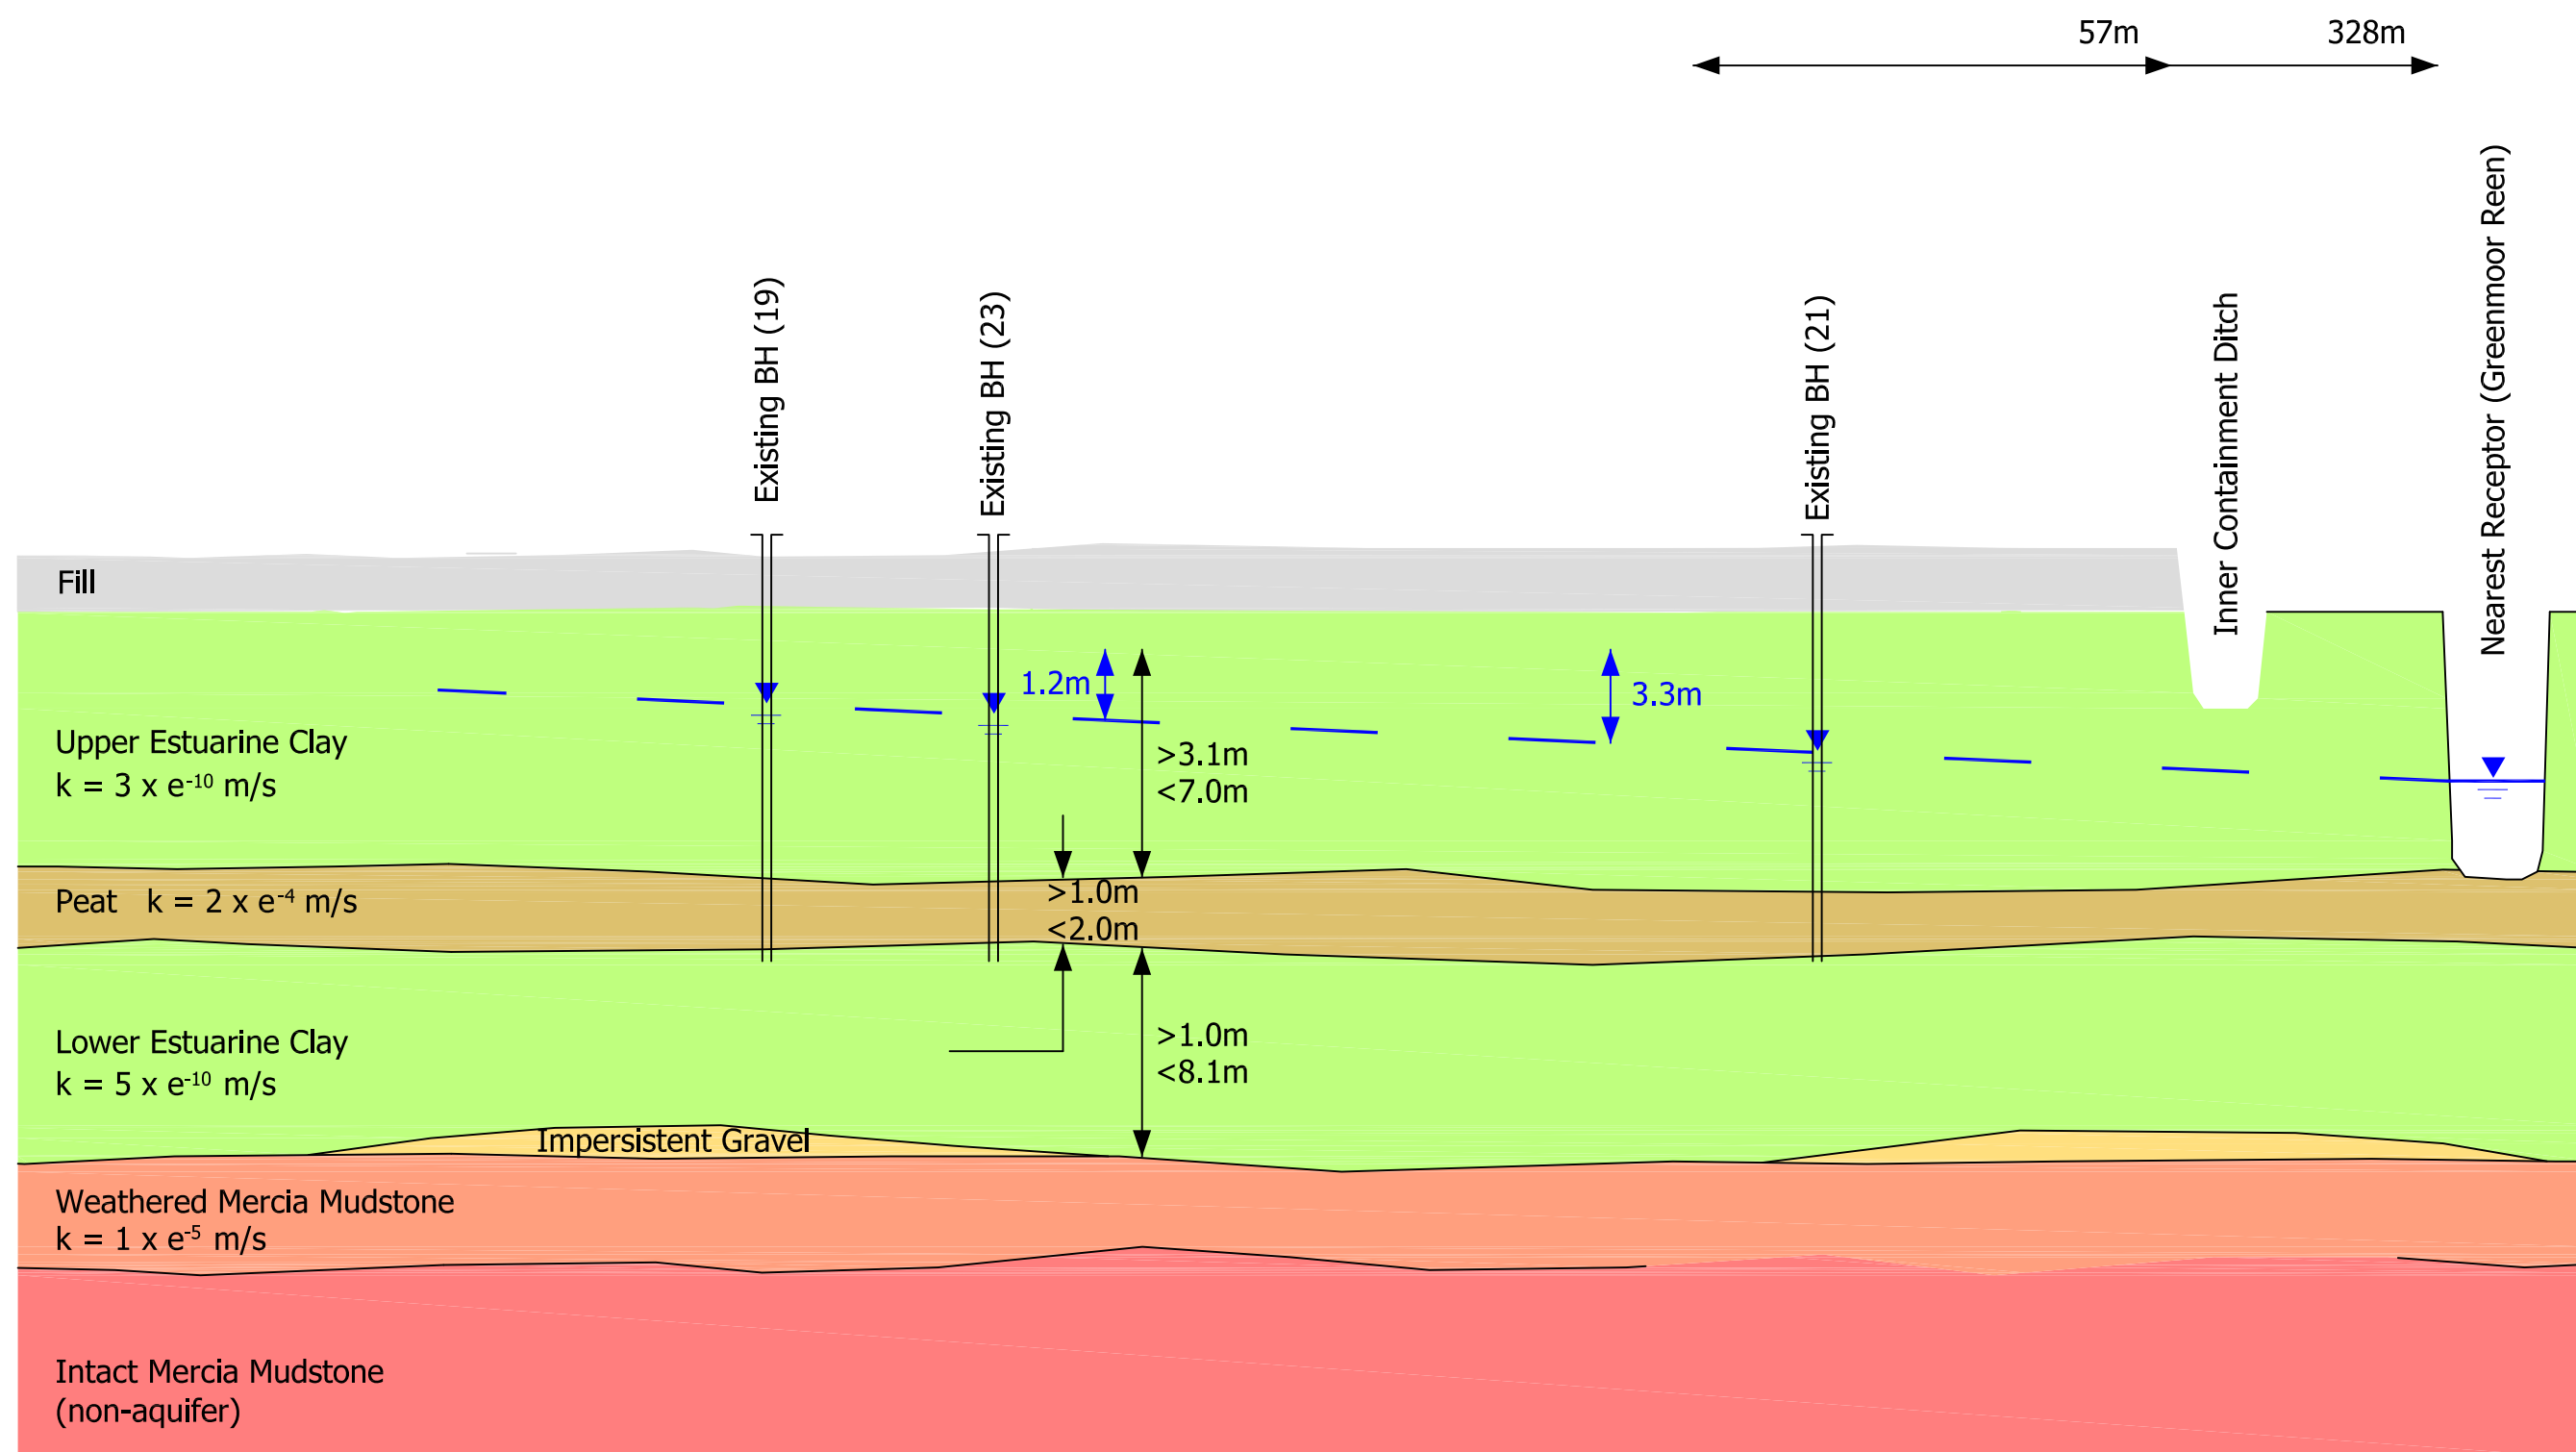
Figure 4 Conceptual Site Model

To enable the risks posed to groundwater and surface water to be evaluated, a conceptual hydrogeological model was developed as part of the closure process. The diagrammatic representation of the model is provided in Figure 4.
