**MORFA NON-  
HAZARDOUS LANDFILL,  
PORT TALBOT**

**PERMIT BV7311IE**

**2022 Annual Review of  
Environmental  
Monitoring**

*Report Number 2295r1v1d0223*

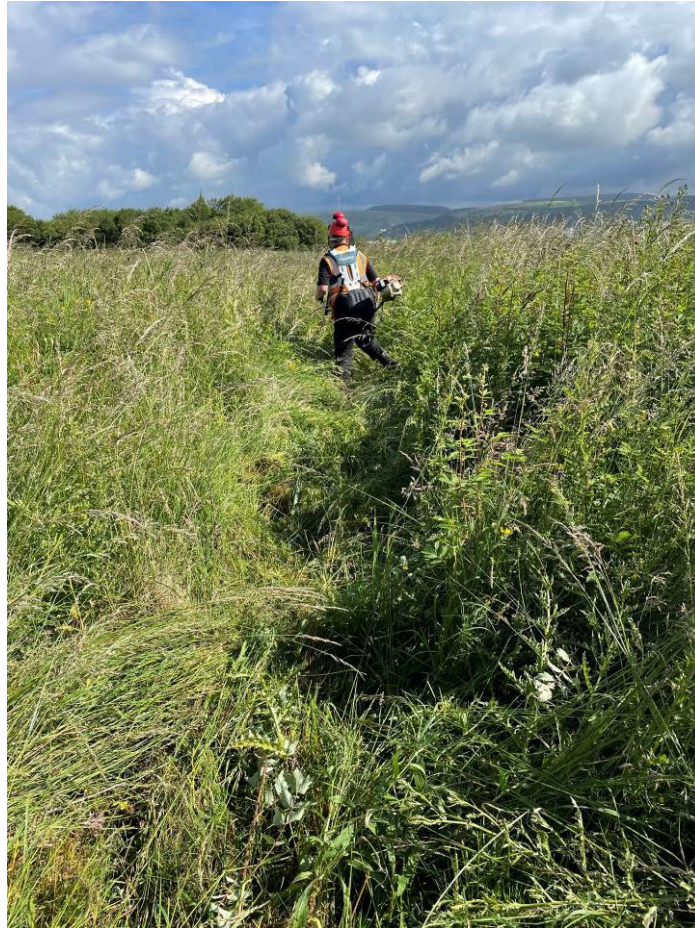
**Plate 3-1 Head height vegetation growth along access route to Margam Moors from MNHL**

As shown by the grass height in Plate 3-1, routine vegetation clearance during the growing season is critical to ensuring that all monitoring points remain safely accessible.

- Vegetation near several sampling points requires routine clearance to enable continual safe access.
- Undertake survey of methane emissions at permanently capped landfill.
- Install permanent settlement markers on surface of Biocell A and B to allow annual assessment of settlement.

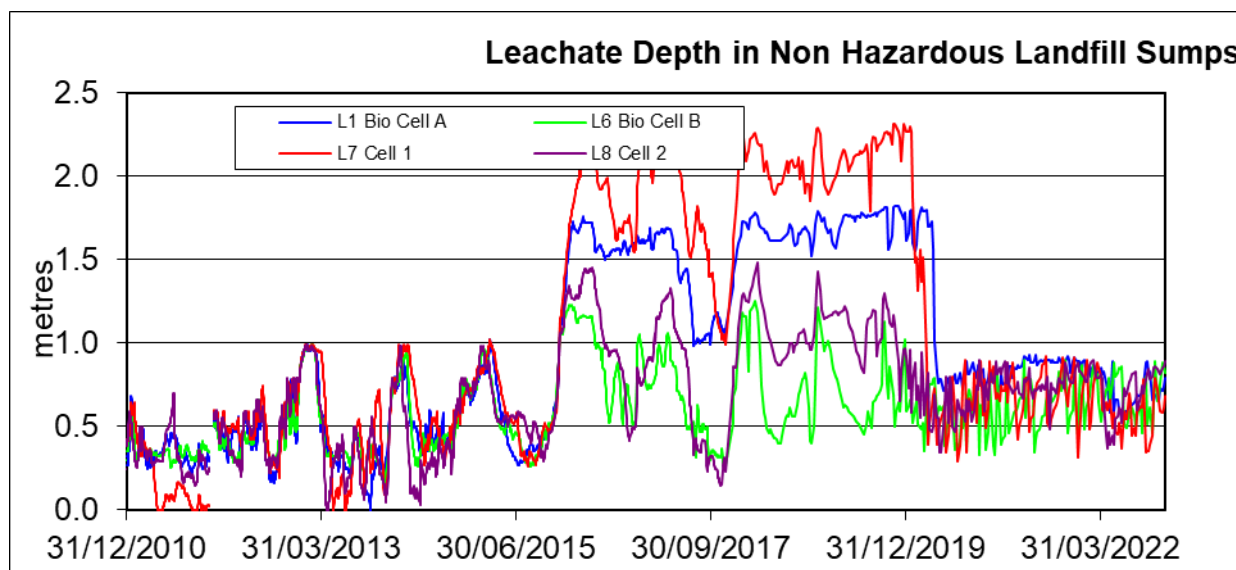
**Chart 6-1 Leachate levels**

Based on the monitoring results provided by the landfill operator, the variation of leachate levels above the base of the sump is fully illustrated in Appendix 2 and summarised in Chart 6-1. The monitoring reveals that leachate levels exceeded 0.75m above the concrete slab in the winter periods of 2013, 2014 and 2015. Between 2016 and winter 2019, the leachate levels regularly breached the compliance 1.0m level which means that this aspect was not in accordance with the Permit requirements.

Since 2019, the new leachate management system has had a dramatic influence on leachate levels with significant leachate level reductions in all cells. This step change is a direct consequence of the new system enabling the volume of leachate extracted to be significantly increased. This has enabled the landfill to be compliant with the 1.0m leachate level compliance limit set in the Permit.

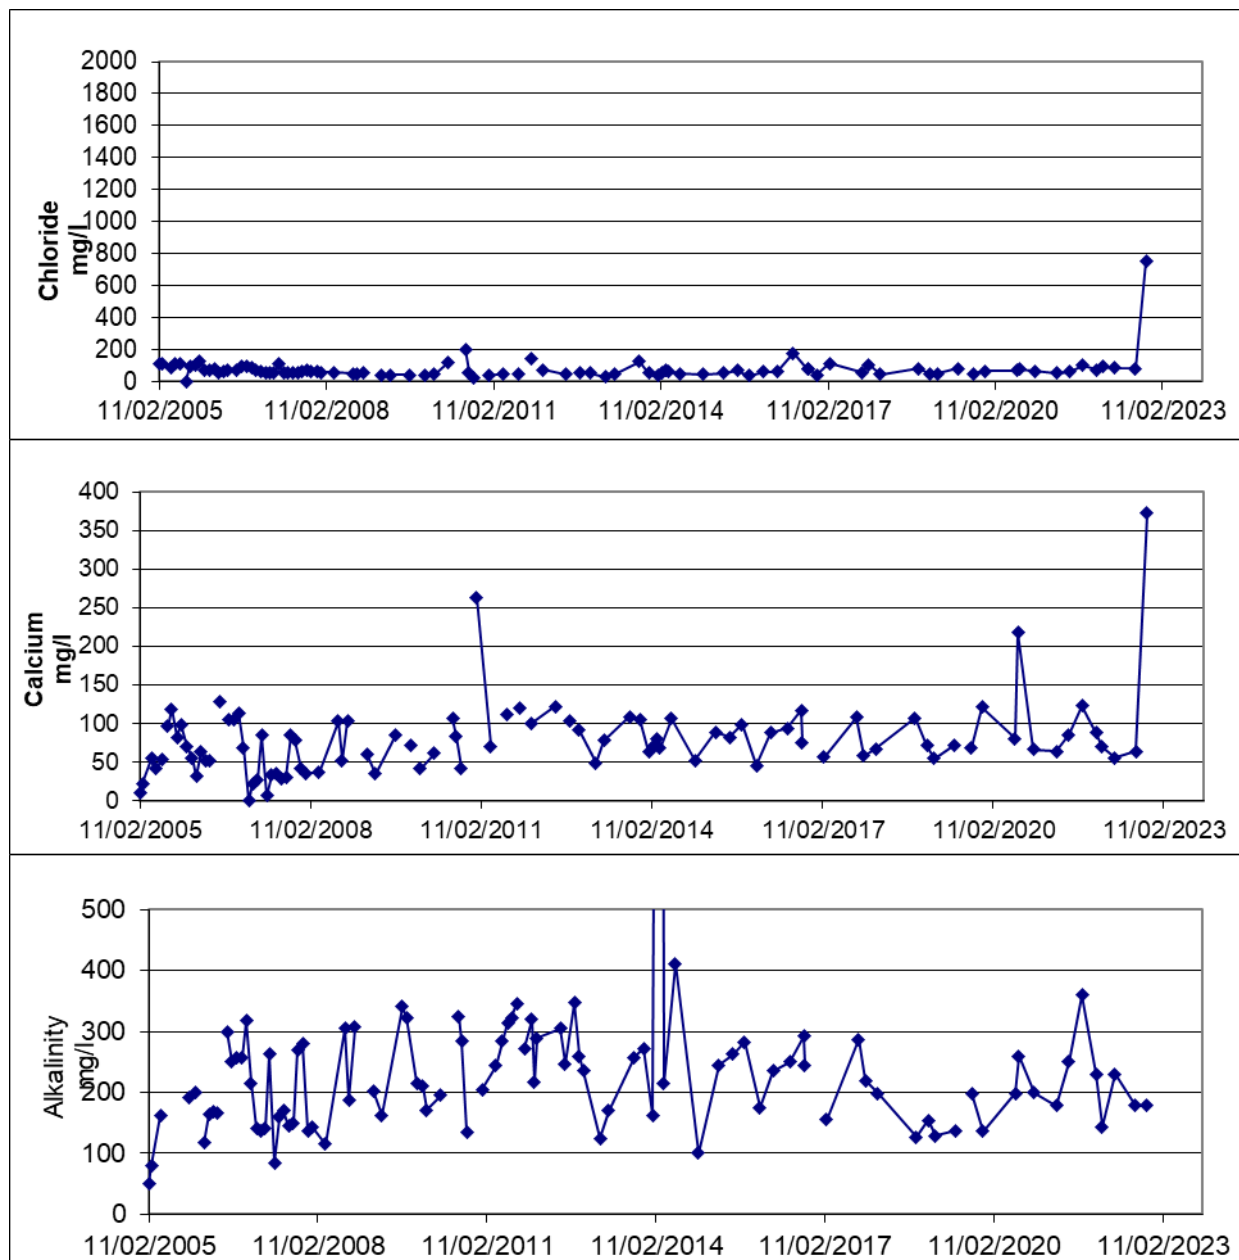
**Plate 8-1 Chloride, Calcium and Alkalinity at SW4**

Due to the low risk that MNHL directly poses to surface water under active management control and the historical impact of seepage from MCL, there are no Permit Compliance Limits for surface water. Instead, there are two assessment levels (AL1 and AL2). An evaluation of the 2022 dataset against these levels is presented in Table 8-1. This analysis reveals no persistent breaches since 2020 although chloride was elevated in October 2022, as well as Calcium, as shown in Plate 8-1.

Surface water immediately northeast of MHL on Margam Moors is already known to be significantly impacted by seepage from MCL, as there is a well-developed highly alkaline springline.
