# NETWORK RAIL

## Bridge Detailed Examination Report

| Structure Name: BONT FURNACE STREAM | | Type: BU | | Exam ID: 14462980 | |
| Route: Betws-y-Coed Branch | | | | Complete Exam: No | |

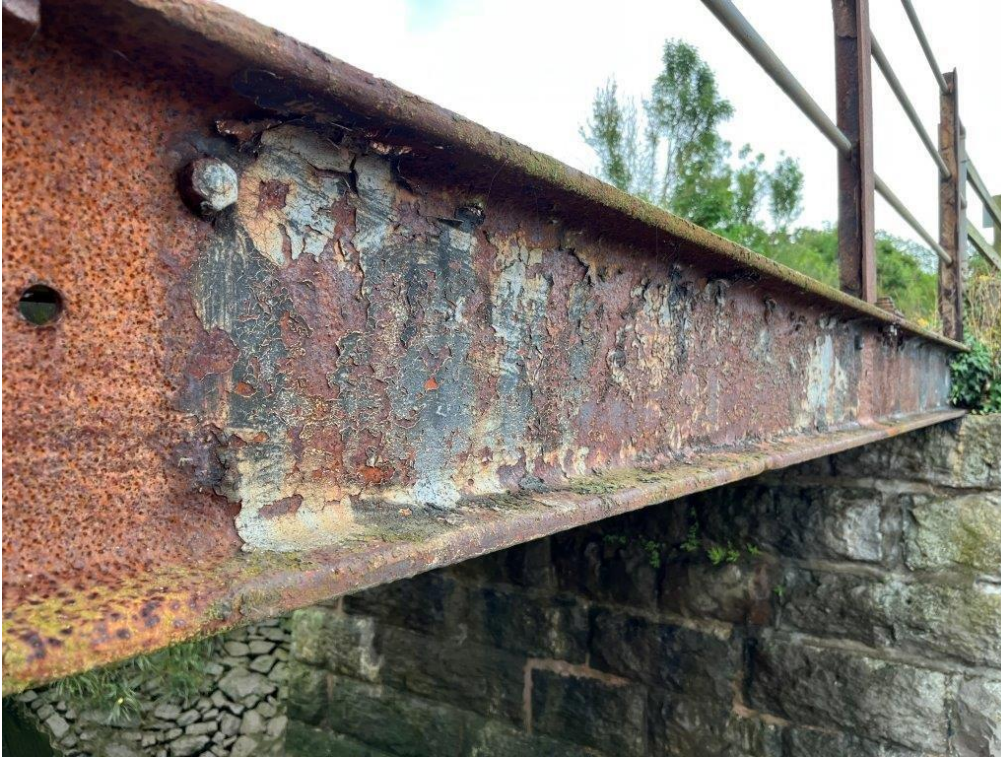
Photo 11: Upside Walkway Support Girder, mid-point towards HM (02/08/22)

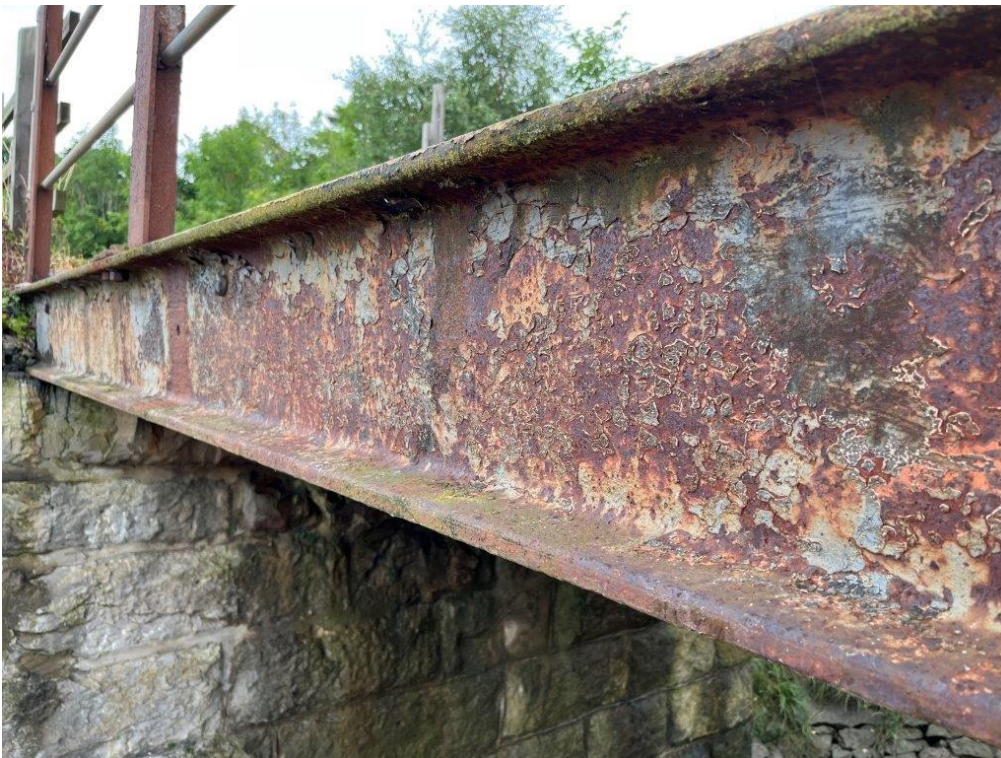
Photo 12: Upside Walkway Support Girder, mid-point towards LM (02/08/22)

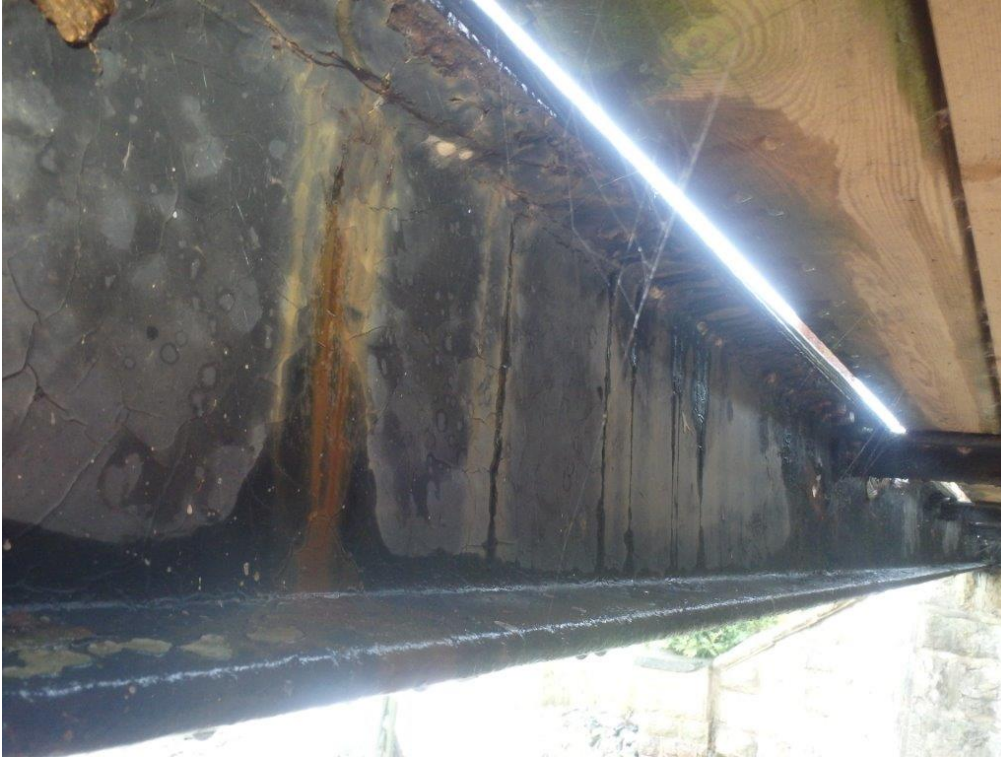
Photo 13: Inner Face of US Walkway Support Girder (02/08/22)

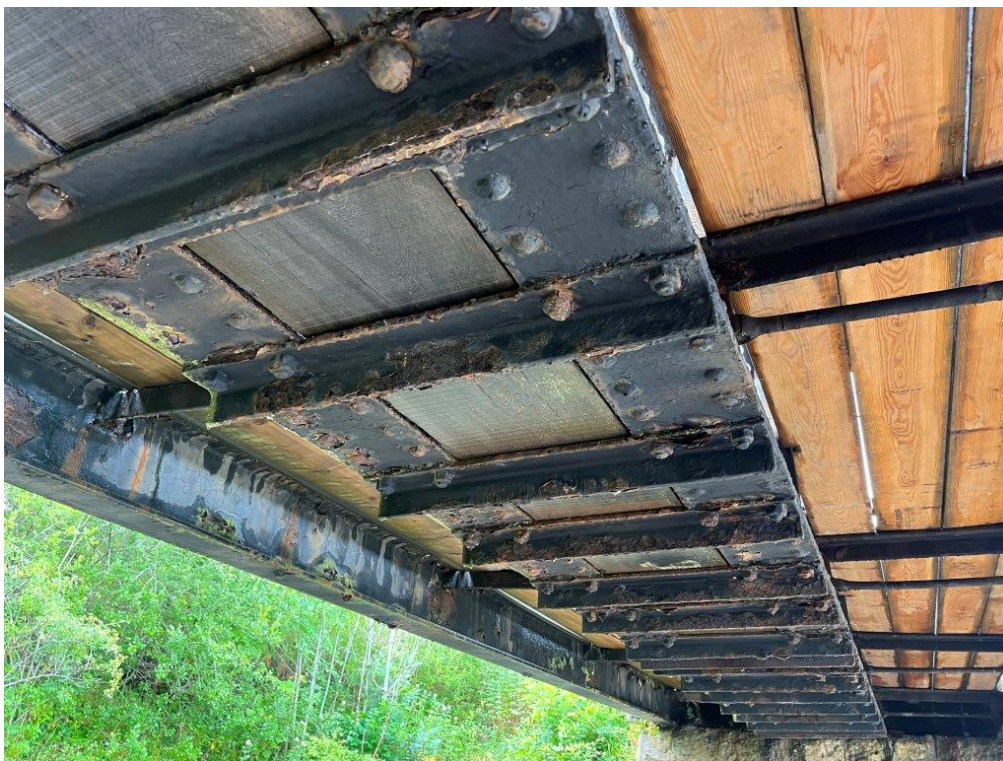
BOTTOM FLANGE: Isolated areas of flaking paintwork over approx. 20%, where lost corrosion loss 1-3mm deep increasing to 5mm at connections. Lamination present scattered throughout, unable to remove due to watercourse below.

Photo 19: Soffit of DS Main Girder (02/08/22)

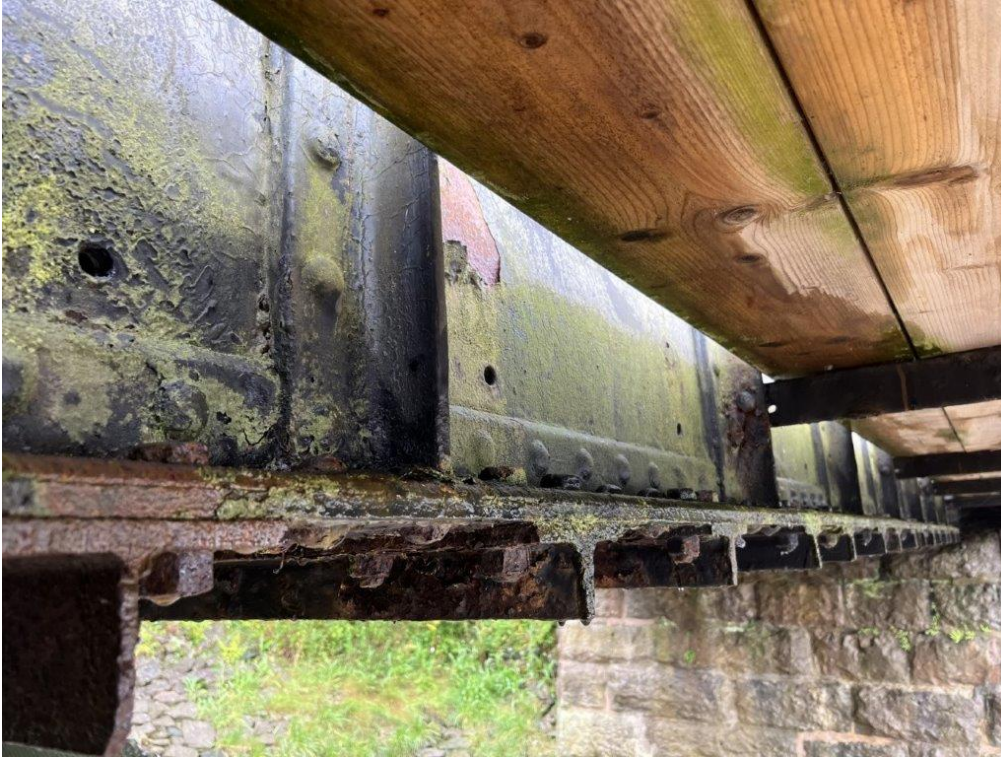
Photo 21: Upside Main Girder, US Face (02/08/22)

Generally in same condition as MGE1, but showing further patches of paint loss to the outer faces of the webs <10% with surface corrosion and pitting to 1mm where lost, and some minor loss paint to the stiffeners where the deck timbers meet the girders, again with surface corrosion and pitting to 1mm where lost.

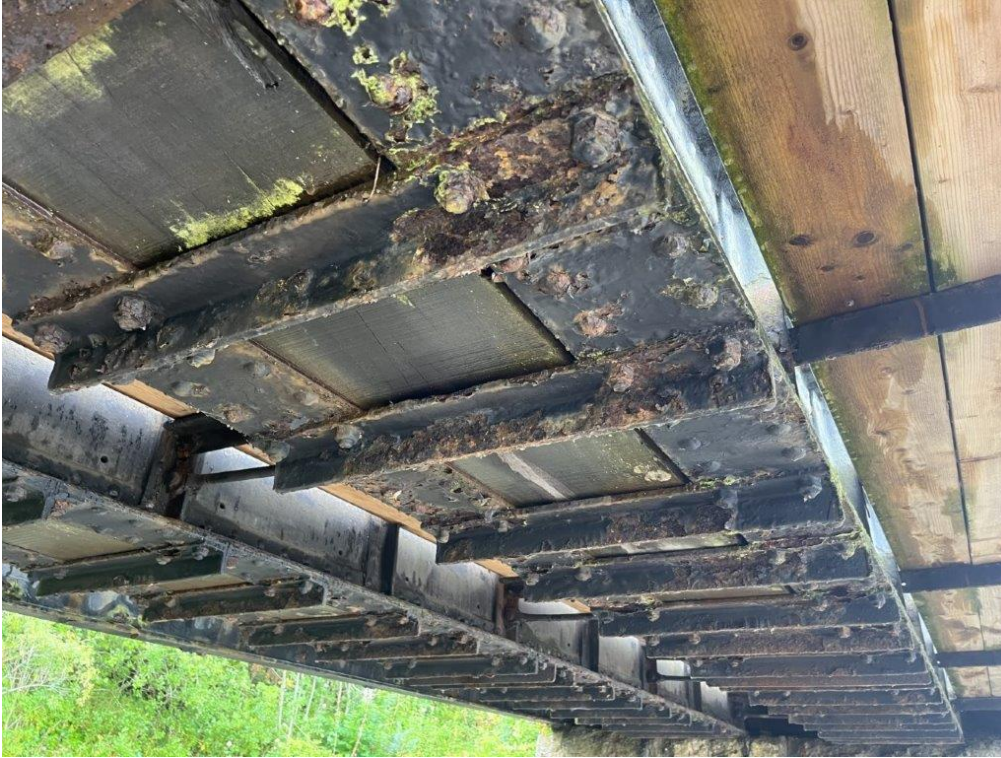
**Photo 23: Soffit of US Main Girder (02/08/22)**

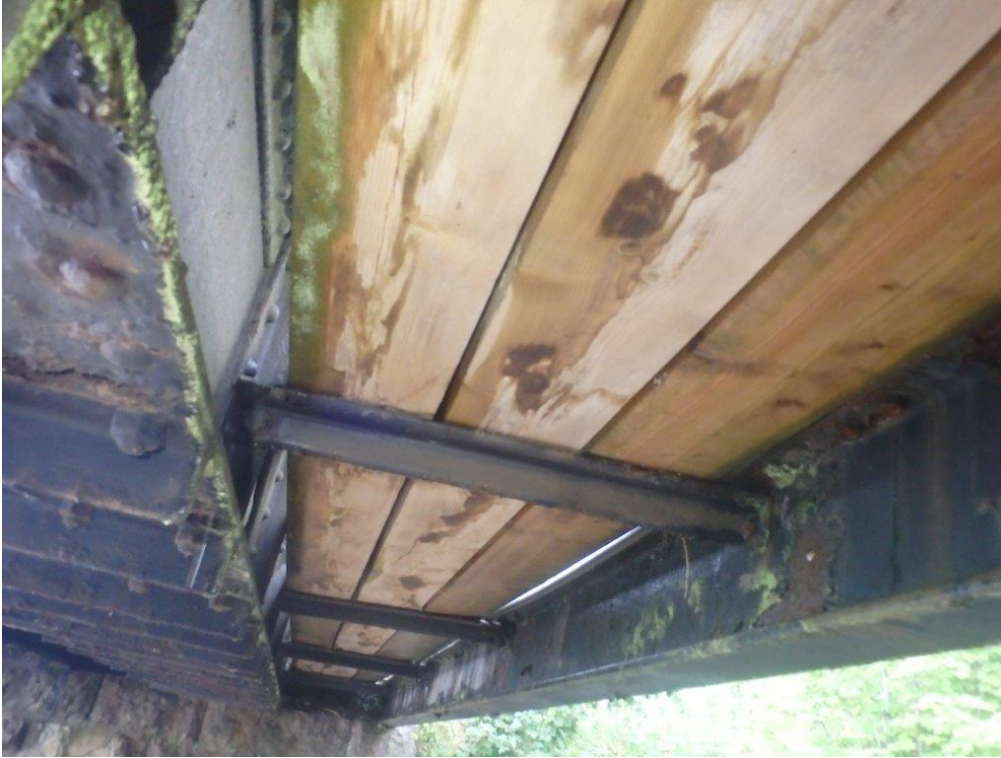
Downside Walkway slightly loose in same area, possibly just anti-slip (new).

Photo 27: Downside Walkway / DCK (02/08/22)

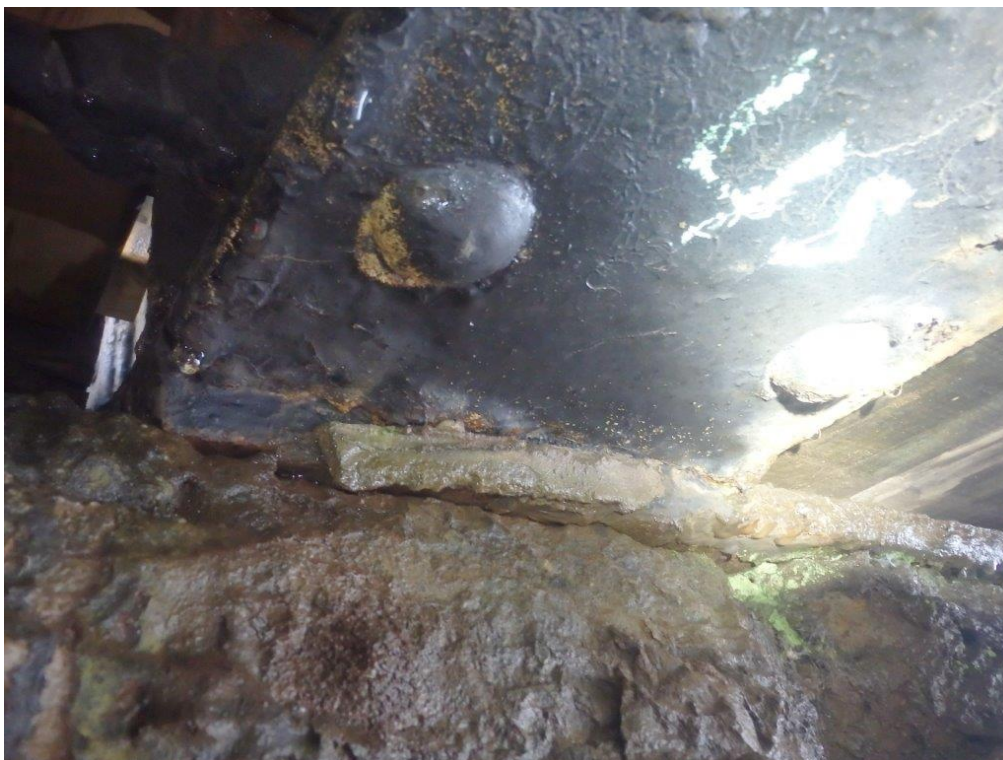
Photo 56: Mortar to outer edge of bearings (02/08/22)

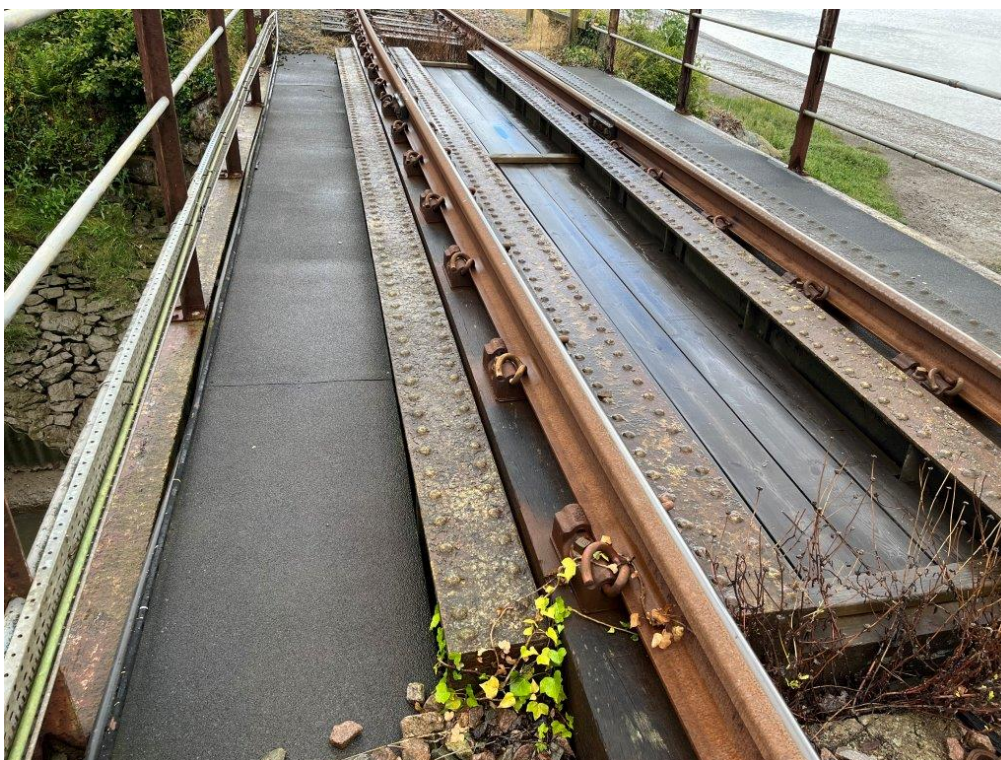
Photo 60: Typical view of Longitudinal Timbers (02/08/22)

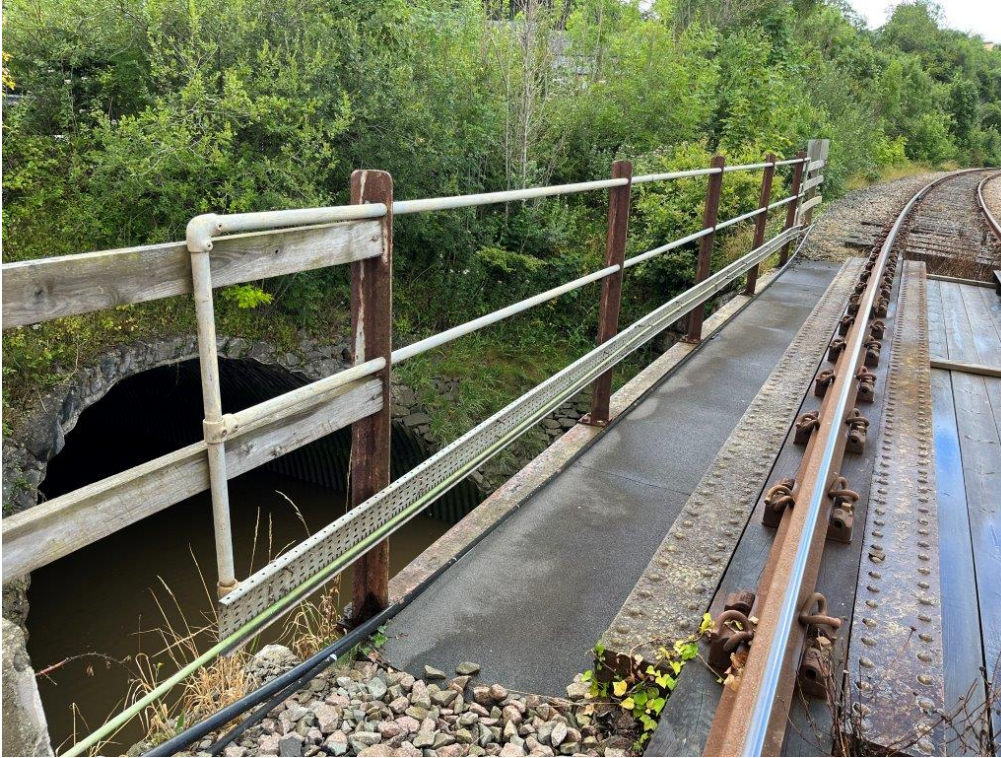
Photo 61: General view of Handrails (02/08/22)
