Location Plan:	<b>Afonwen Sea Wall</b> Assessment Date: 16/03/2022	
<p>Contains Ordnance Survey data © Crown copyright and database right 2015</p>	CARRS Exam ID:	<b>14468740</b>
	Exam Type:	<b>Detailed</b>
	Complete Survey:	Yes
	Network Rail ELR:	<b>DJP</b>
	Structure Reference:	<b>127 41</b>
	Mileage:	<b>127m 798yds 36chs</b>
	OS Ref:	245630 , 337300
	Operational Area:	Cambrian
NOTE: This document has been prepared as an Asset Condition Survey Report for Network Rail. JBA Consulting accepts no responsibility or liability for any use that is made of this document other than by the Client for the purposes for which it was originally commissioned and prepared.	Governing SMP2:	Coastal Snowdonia
	SMP2 Policy Unit:	12.24
	SMP2 Policy:	2025 = hold the line; 2055 = managed realignment; 2105 = managed realignment.

Afonwen Sea Wall is located between Afonwen and Llanystumdwy. The defence is split into two sections, Afonwen Sea Wall A and B, corresponding to a change in major element type at 245068, 337218 (between Sections A and B):

# COASTAL ASSET CONDITION SURVEY REPORT

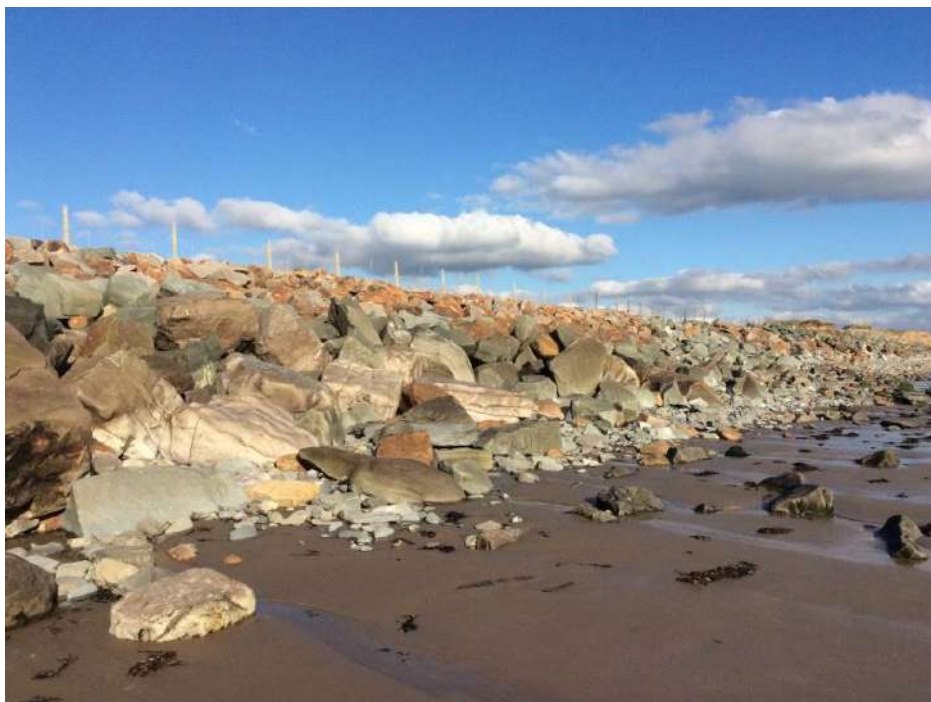
**Section A  
Embankment  
Armour  
Photo number: 18**

Minor Elements	Photo No.	Attributes and General Notes	Condition Grade	Weighting (1-9)	Overall (CG x W)
Embankment Armour	18, 23	Rock (unstable upper rocks, poor interlocking, steep armourstone face, expelled rock units, exposed geotextile, unprotected cliff face, cliff erosion).	3	7	21
Sum (W)				7	
Sum (CG x W)					21
<b>Overall Asset Grade</b>	<b>Sum of (Weight x Condition Grades) divided by sum of weightings. Unless weighting of 9 for any element, then condition grade is used.</b>		<b>3</b>

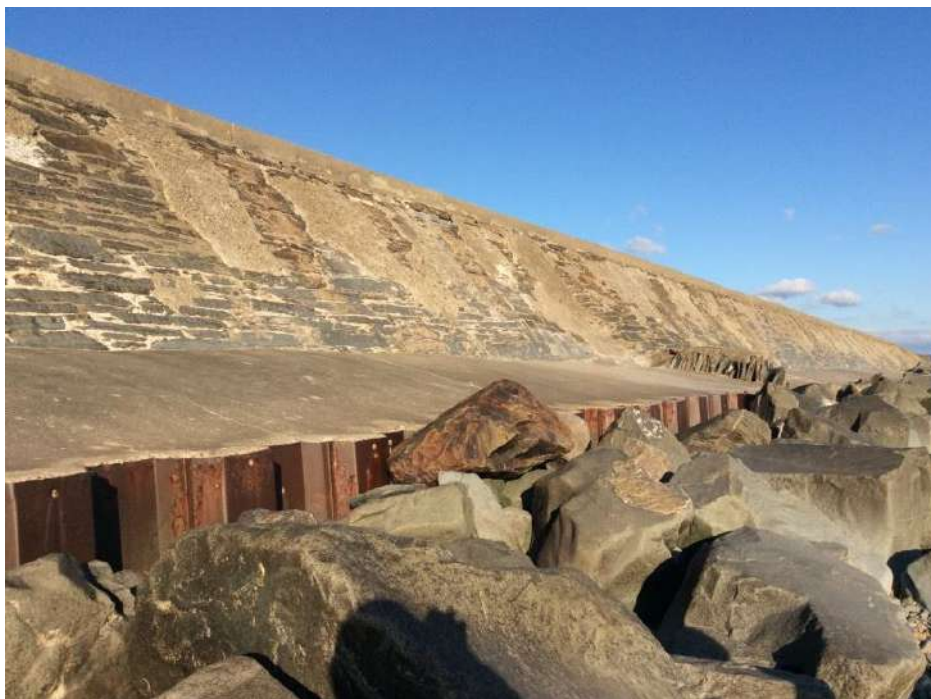
**Section B**  
**Wall section**  
**Photo number: 20**

Minor Elements	Photo No.	Attributes and General Notes	Condition Grade	Weighting (1-9)	Overall (CG x W)
Wall section	20	Masonry (stone masonry open joints, missing blockworks, loss of mortar, longitudinal cracks).	3	7	21
Wall Apron	22	Concrete (undermining, voids behind steel sheet piles).	3	7	21
Wall Toe	19	Concrete (concrete spalling, undermining, scour, expelled rock units, corroded sheet pile).	4	5	20
Parapet/Capping	21	(Wall drainage).	4	7	28
Sum (W)				26	
Sum (CG x W)					90
<b>Overall Asset Grade</b>	<b>Sum of (Weight x Condition Grades) divided by sum of weightings. Unless weighting of 9 for any element, then condition grade is used.</b>		<b>3</b>

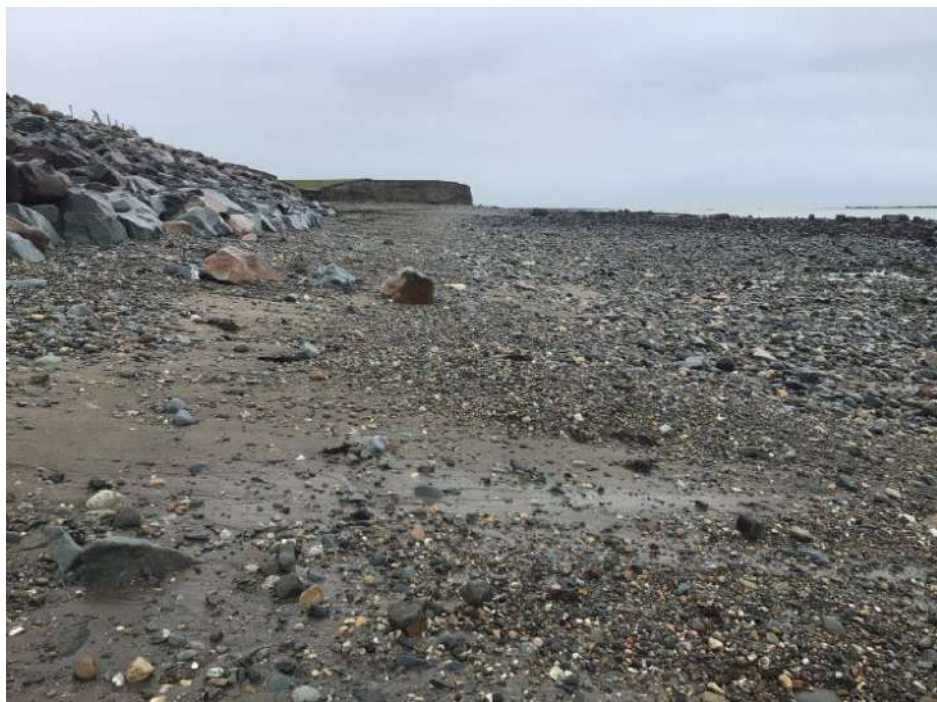
**Defect Ref: D1**

Defect Ref No.	Defect Location (NGR)	Major Element	Minor Element	Photo Ref	Severity	Probability	Risk Score	Below MHW	Defect Group	Defect Description	Recommendations	Defect Priority
D1	245547, 337285 DJP 127.095	Embankment	Embankment Armour	43, 143	2	3	6	True	Loss/damage of rock-armour	Expelled rock from profile. No change between 2021-2022 examinations.	Monitor the asset and if expulsion of rock armour continues consider re-profiling the embankment (possibly by replacing smaller rocks with larger rocks and with a slope no steeper than 1:2).	13
D2	245551, 337289 DJP 127.095	Embankment	Embankment Armour	44, 145	1	3	3	True	Loss/damage of rock-armour	Uncovered and ripped geotextile. Shingle coverage has predominantly been removed, leaving only sand covering the geotextile. No change between 2021-2022 examinations.	Monitor for signs of subsidence.	19

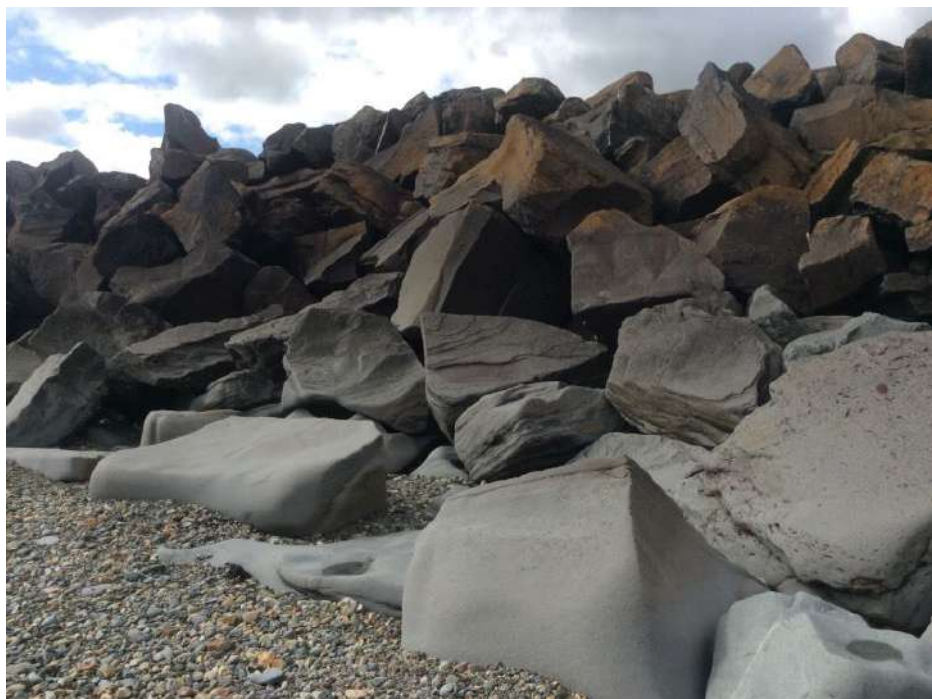
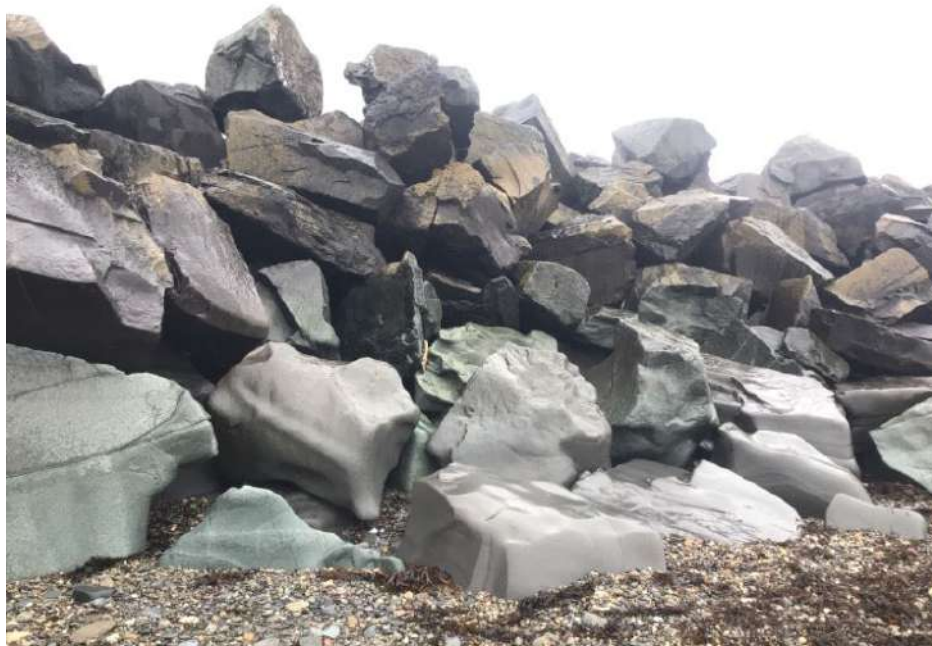
**Defect Ref: D7**

Defect Ref No.	Defect Location (NGR)	Major Element	Minor Element	Photo Ref	Severity	Probability	Risk Score	Below MHW	Defect Group	Defect Description	Recommendations	Defect Priority
D7	245170, 337237 DJP 127.136	Embankment	Embankment Armour	52, 131	3	2	6	True	Loss/damage of rock-armour	Dissolved armour stone, loss of interlock between units. No change to the dissolved rock face during the 2022 examination. There is concern regarding the lack of interlock and the resultant potential for collapse.	Monitor the asset and consider replacing severely degraded units if re-profiling will be required.	17
D8	245069, 337217 DJP 127.148	Wall	Parapet/Capping	54, 124	4	3	12	True	Scour/undermining	Poor overall condition of the outfall pipe. During the 2022 examinations, heavy water flows through dilapidated outfall, corrosion, and leaky pipes.	Investigate the function of the outfall and monitor possible scour caused by the drainage water. Remove failed sections of outfall pipe as causing health and safety hazard on foreshore.	3

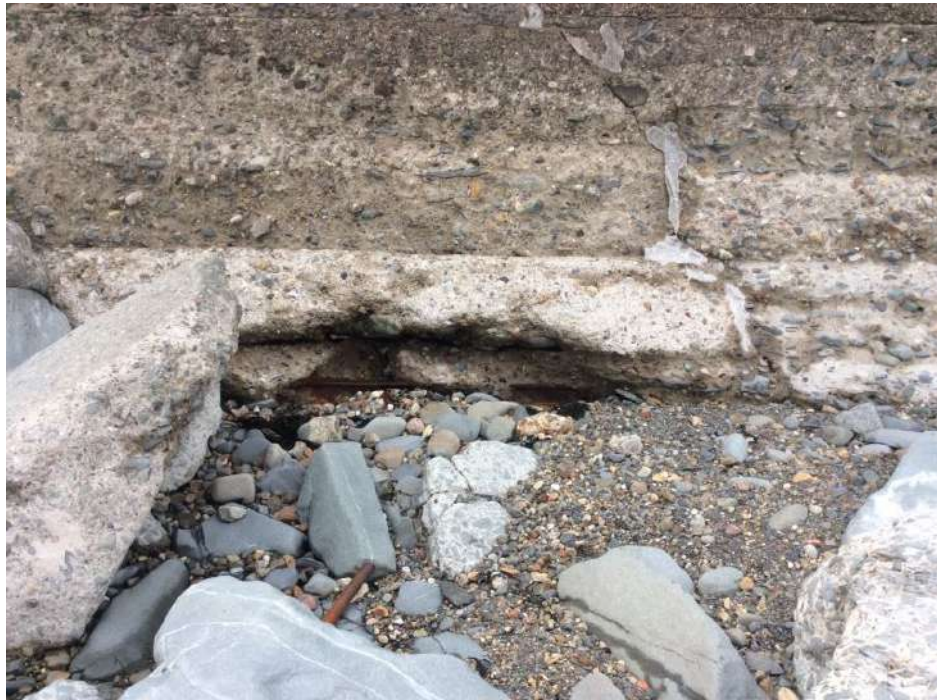
**Defect Ref: D11**

Concrete spalling, undermining at the toe, and loss of material. The defect worsened slightly, and the undermining has been covered up by an increase in beach level between the 2021 and 2022 examinations

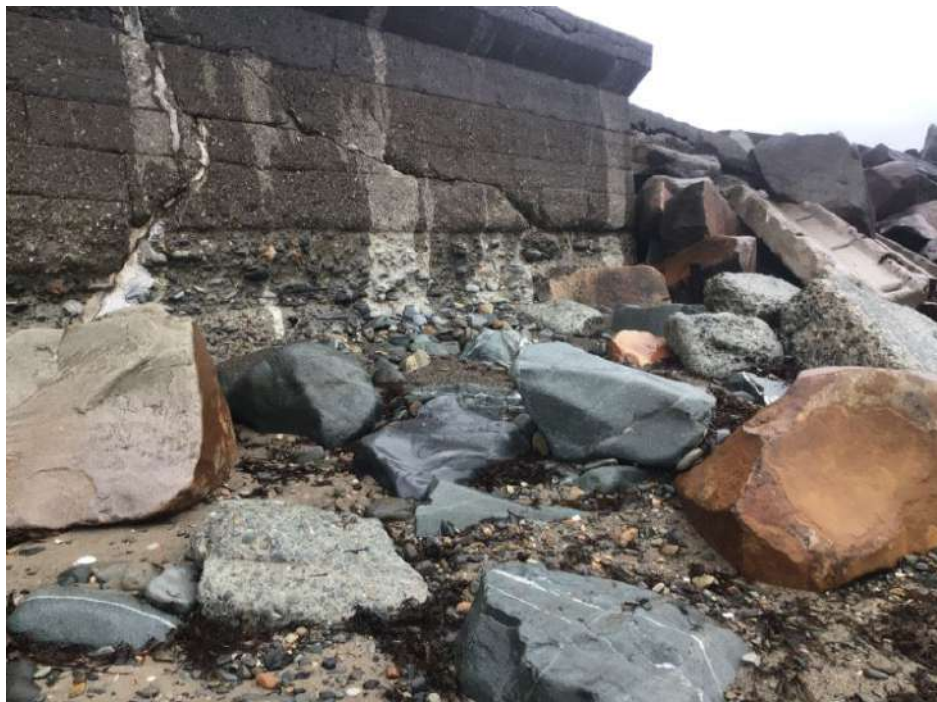
**Defect Ref: D11**

Concrete spalling, undermining at the toe, and loss of material. The defect worsened slightly, and the undermining has been covered up by an increase in beach level between the 2021 and 2022 examinations

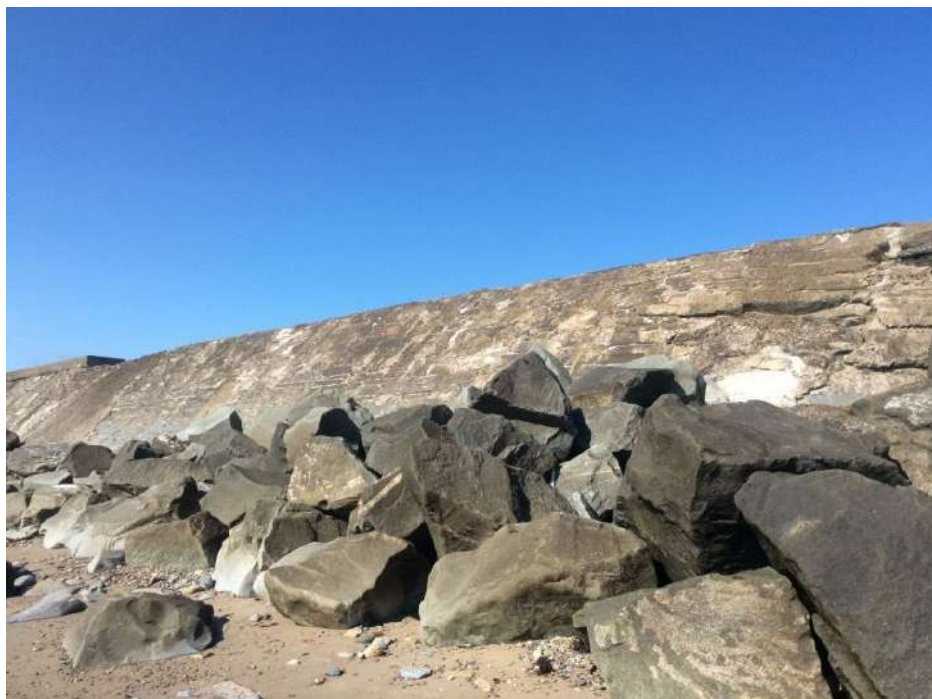
**Defect Ref: D12**

**Description:** Open joints, poor connections, and loss of mortar. This defect has been previously repaired but the poor quality of repairs were noted in the 2021 examination. No change between 2021-2022 examinations.

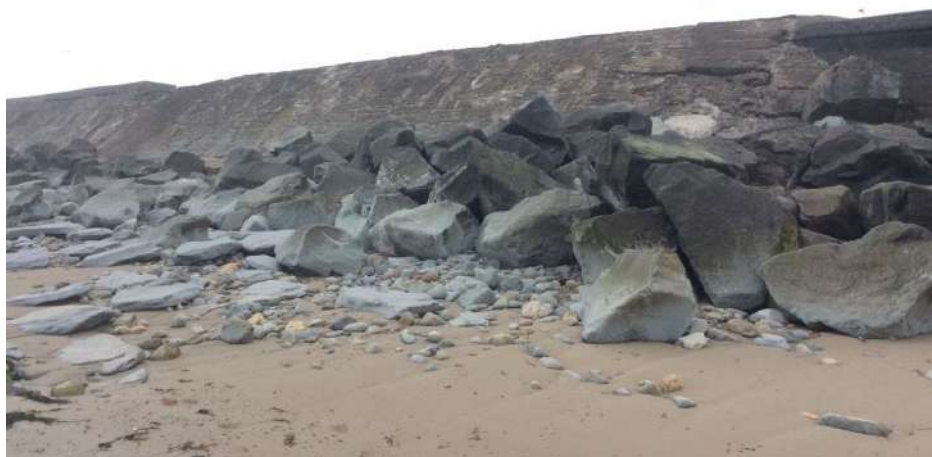
**Defect Ref: D12**

**Description:** Open joints, poor connections, and loss of mortar. This defect has been previously repaired but the poor quality of repairs were noted in the 2021 examination. No change between 2021-2022 examinations.

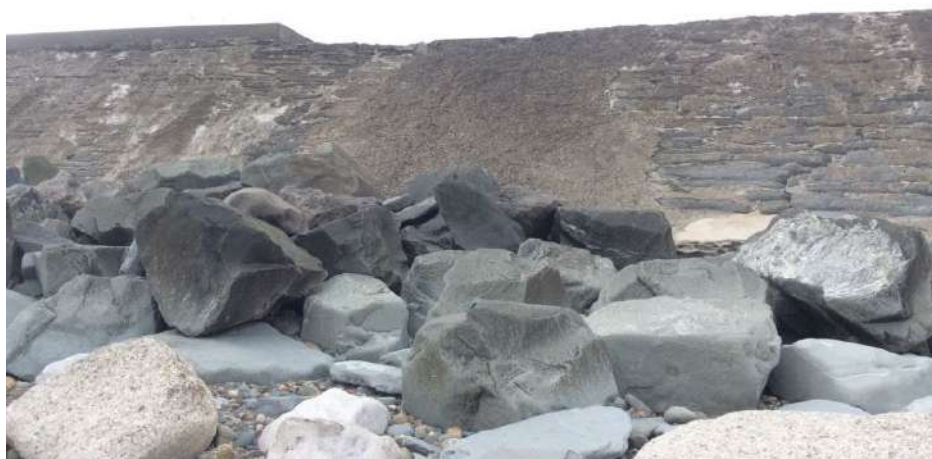
**Defect Ref: D13**

**Description:** Poor concrete patch repair and delamination from the wall section with exposed rebar. Heavy spalling to patch repair has been discovered from 2022, with possible additional rock placement.

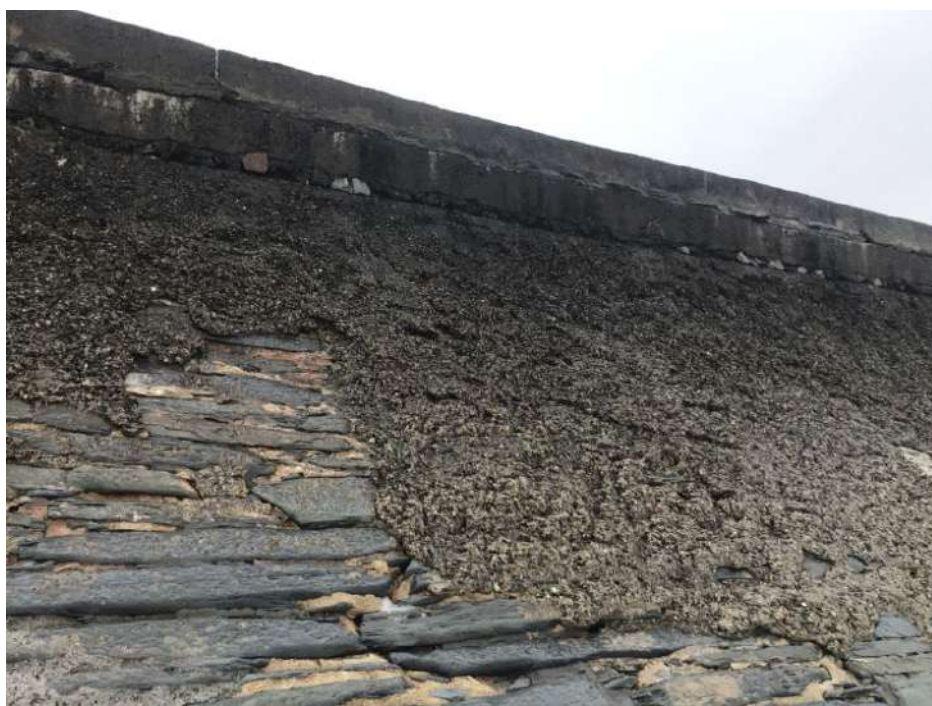
**Defect Ref: D13**

**Description:** Poor concrete patch repair and delamination from the wall section with exposed rebar. Heavy spalling to patch repair has been discovered from 2022, with possible additional rock placement.

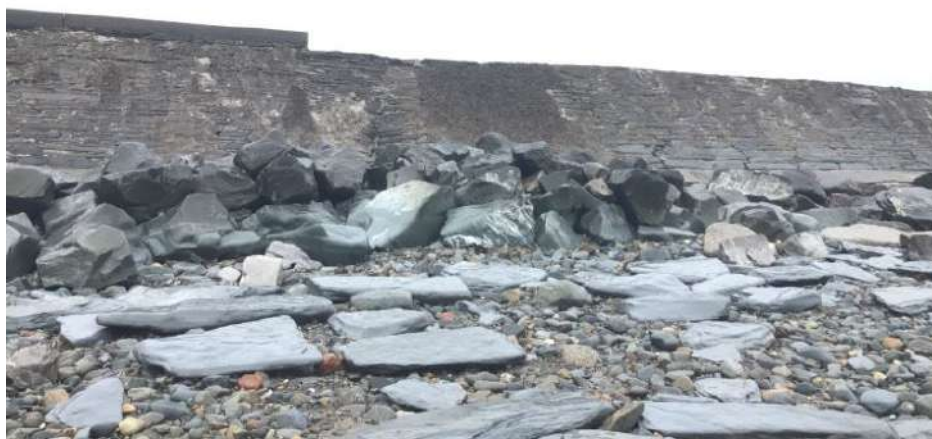
**Defect Ref: D13**

**Description:** Poor concrete patch repair and delamination from the wall section with exposed rebar. Heavy spalling to patch repair has been discovered from 2022, with possible additional rock placement.

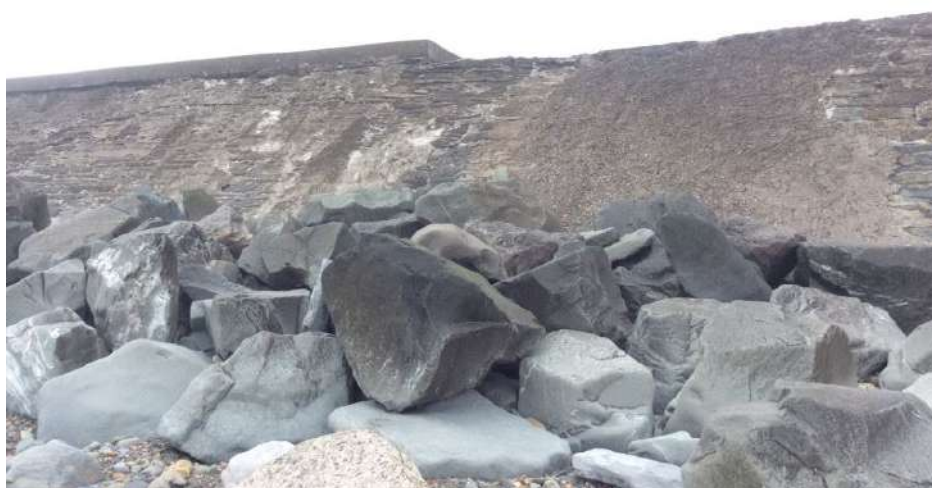
**Defect Ref: D14**

**Description:** Missing capping beam. There was no change between the 2021-2022 examinations.

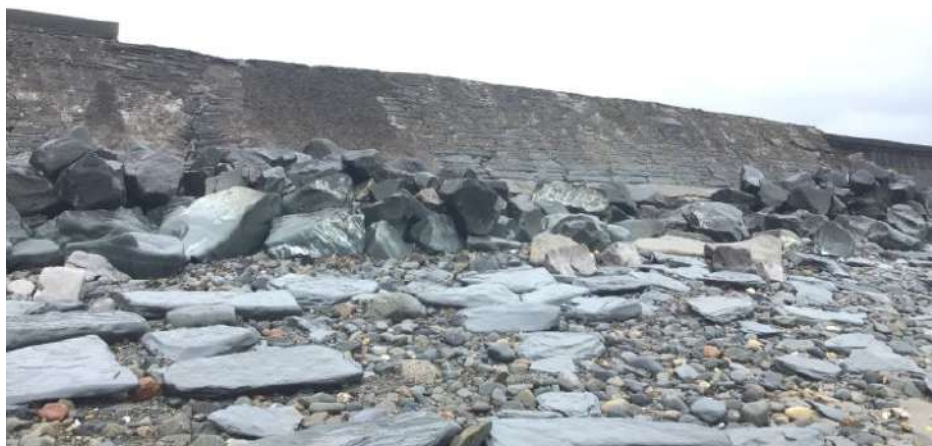
**Defect Ref: D14**

**Description:** Missing capping beam. There was no change between the 2021-2022 examinations.

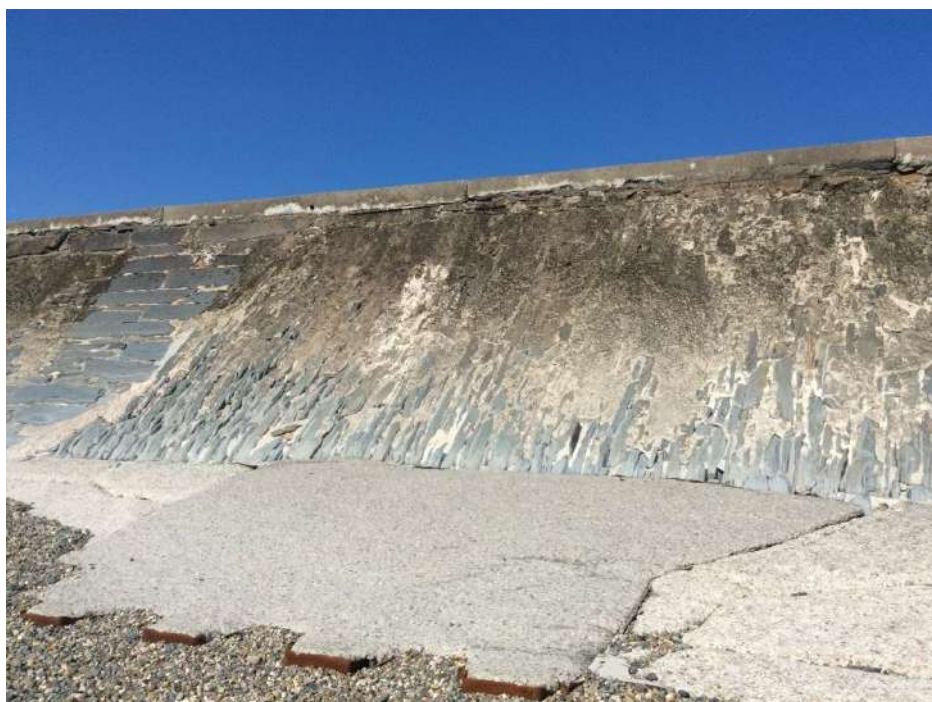
**Defect Ref: D15**

**Description:** Poor connection, open joints, loss of mortar. This defect has been previously repaired in 2020. There was no change between 2021-2022 examinations.

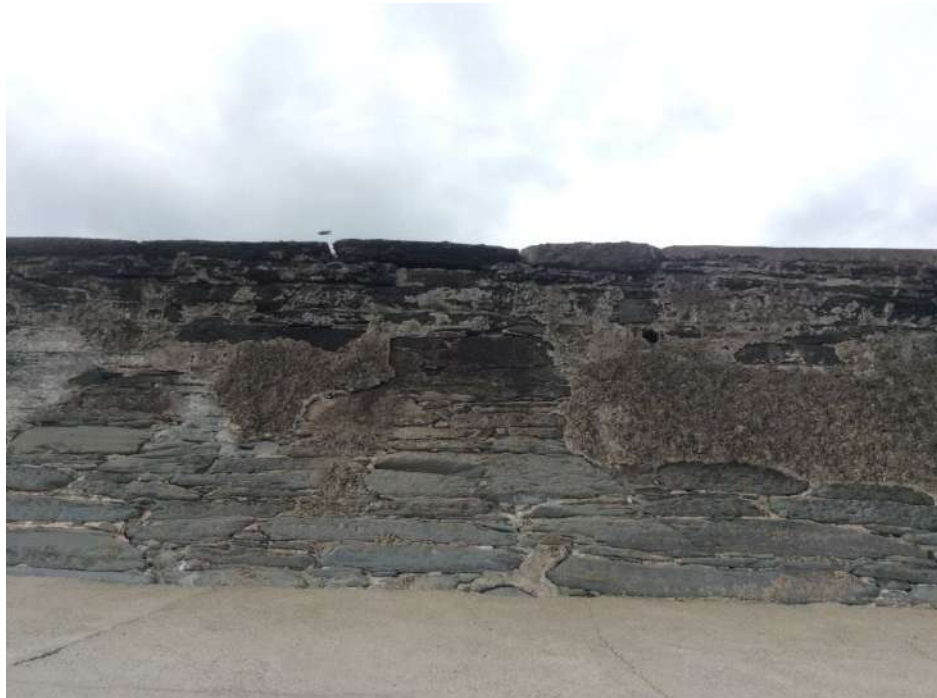
#### Defect Ref: D15

**Description:** Poor connection, open joints, loss of mortar. This defect has been previously repaired in 2020. There was no change between 2021-2022 examinations.

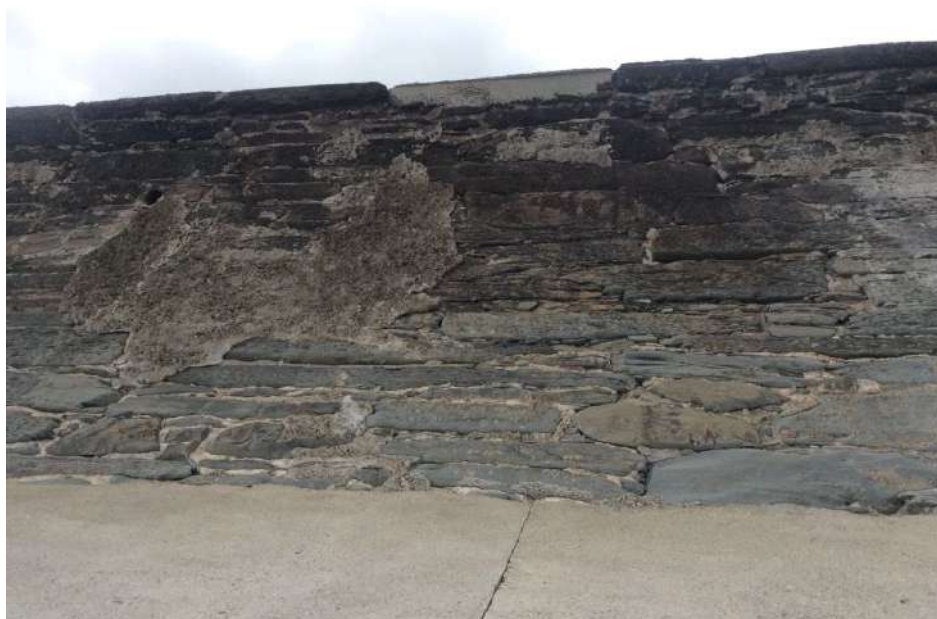
#### Defect Ref: D16

**Description:** Open joints, loss of mortar. This defect has been previously repaired in 2020. During the 2022 examination, heavily spalled concrete repairs, delamination and open joints were observed.

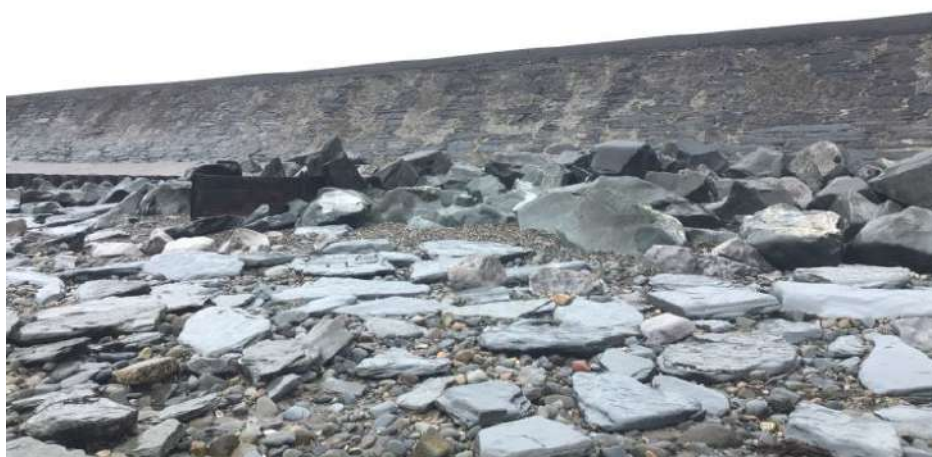
#### Defect Ref: D16

**Description:** Open joints, loss of mortar. This defect has been previously repaired in 2020. During the 2022 examination, heavily spalled concrete repairs, delamination and open joints were observed.

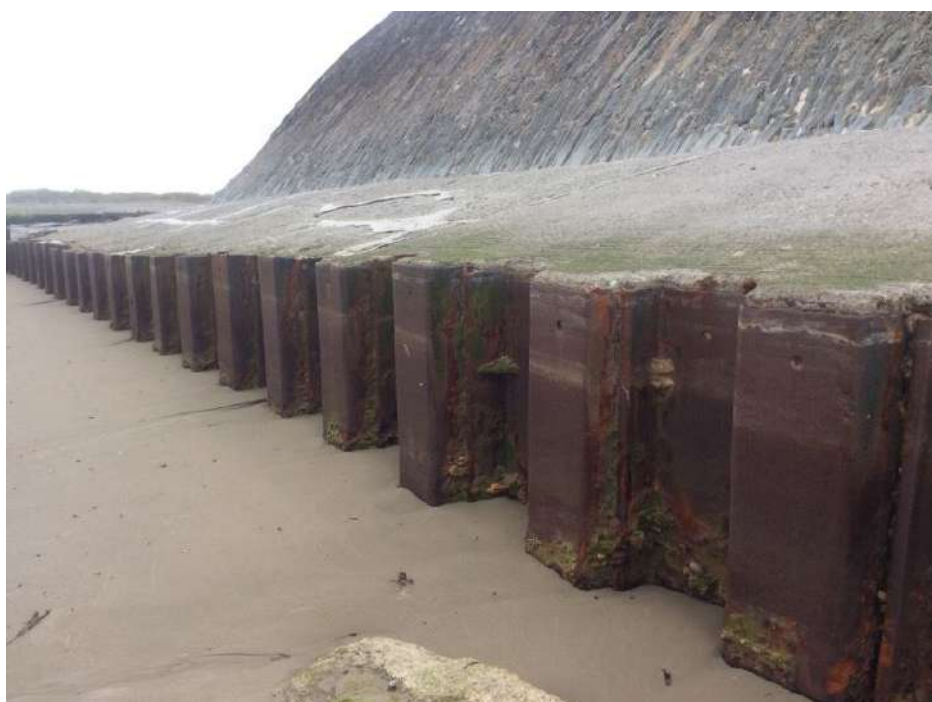
#### Defect Ref: D17

**Description:** Corrosion at the top of the steel sheet piles. This is a general defect along the length of the element. Between 2021 and 2022 the defect worsened.

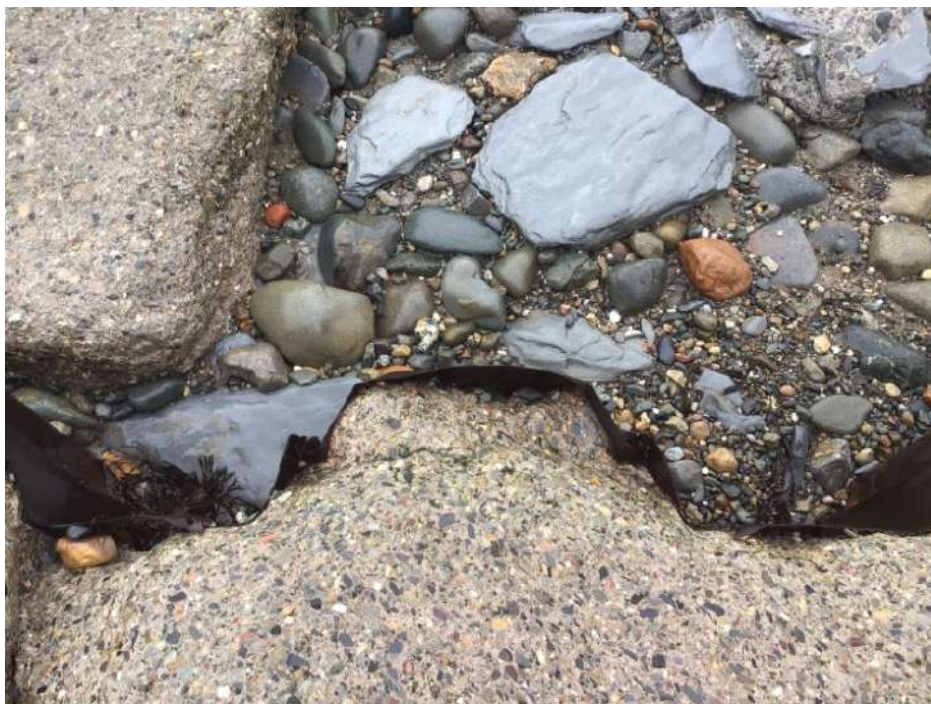
**Defect Ref: D17**

Corrosion at the top of the steel sheet piles. This is a general defect along the length of the element. Between 2021 and 2022 the defect worsened.

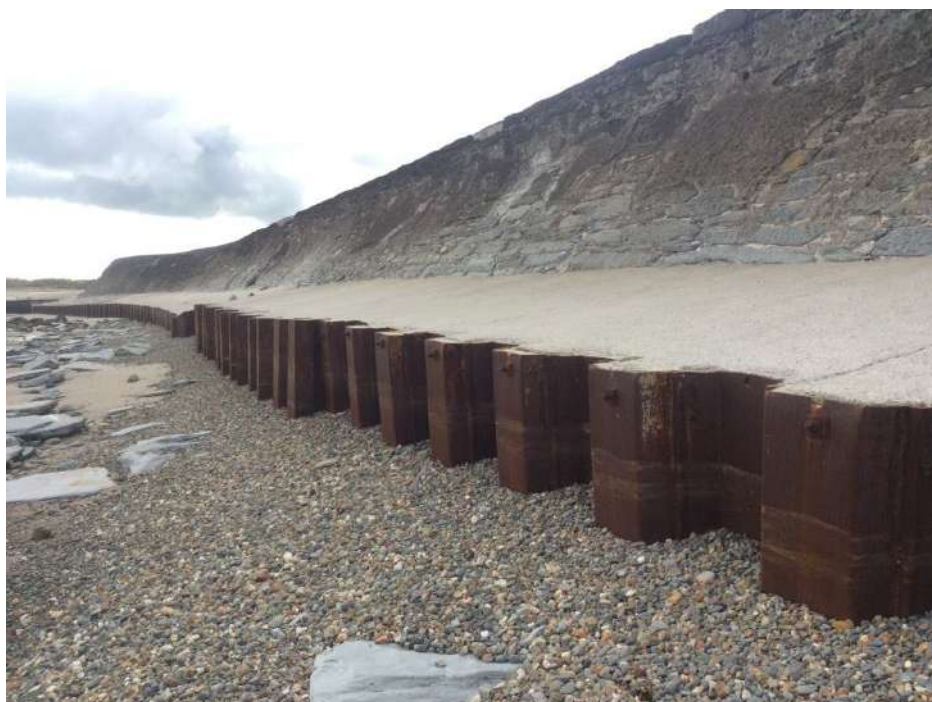
**Defect Ref: D19**

Expelled sheet piling. This defect has been previously repaired. Possible separation has occurred between the 2021 and 2022 examinations.

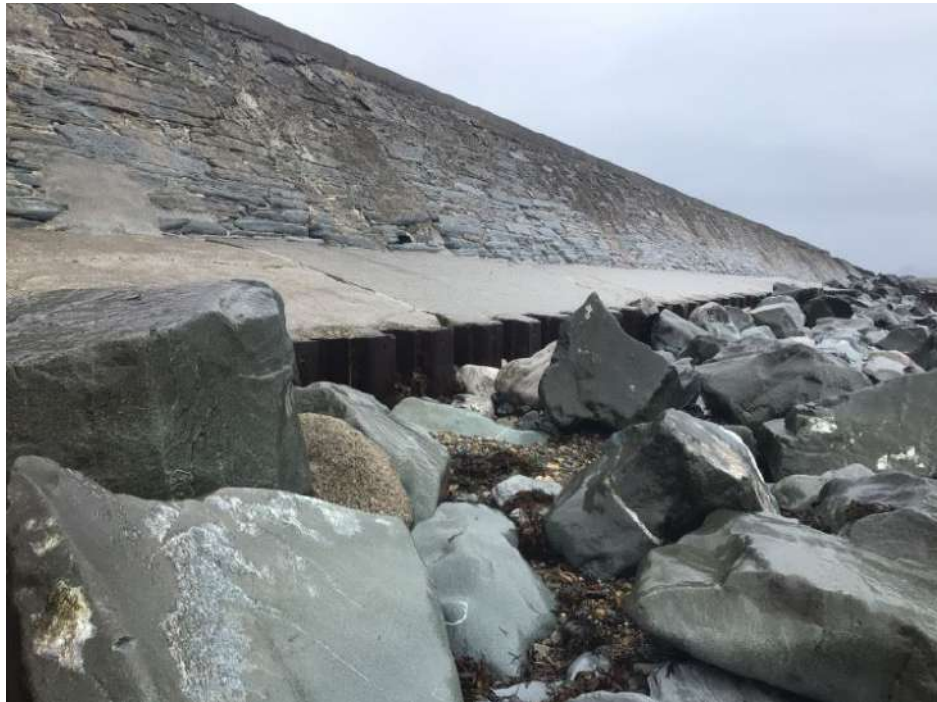
**Defect Ref: D19**

Expelled sheet piling.  
This defect has been previously repaired.  
Possible separation has occurred between the 2021 and 2022 examinations.

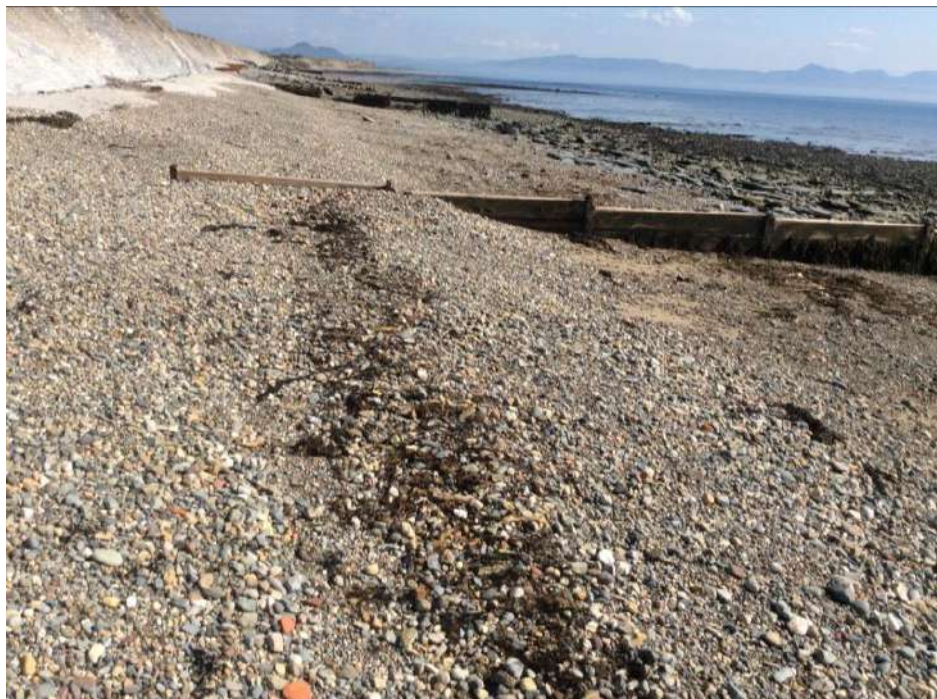
**Defect Ref: D20**

Undermining under the apron, hollow section. This defect has been previously repaired in 2020.  
There was no change between the 2021-2022 examinations.

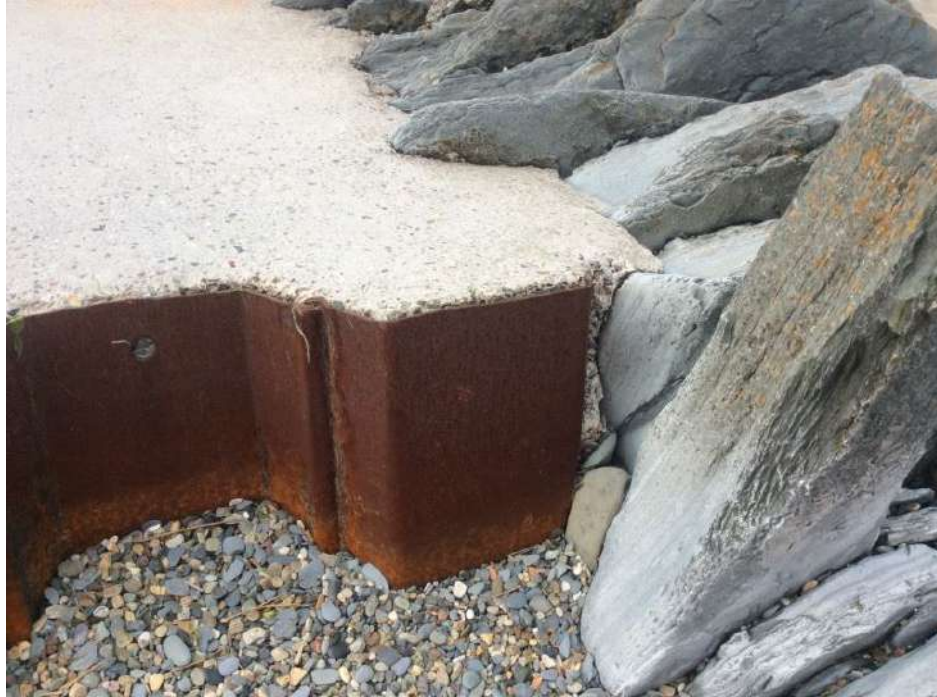
**Defect Ref: D20**

Undermining under the apron, hollow section. This defect has been previously repaired in 2020. There was no change between the 2021-2022 examinations.

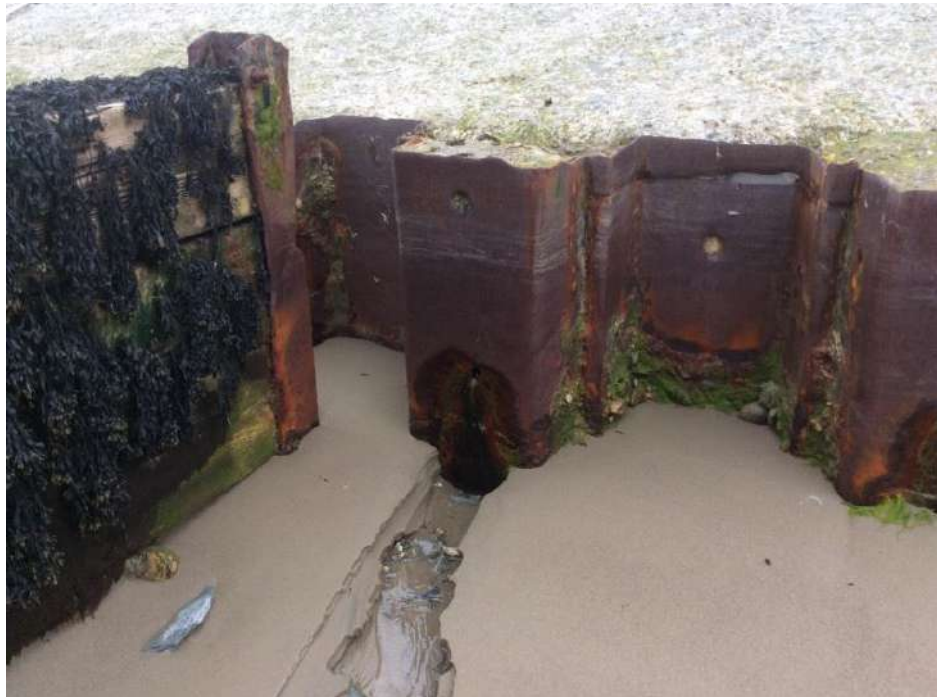
**Defect Ref: D21**

Water seepage through eyelets in the sheet piling indicates a large pressure head behind the wall. The source of the build-up of water could be from a large water body north of the wall which may be draining through the structure. This mechanism could explain one of the factors behind the pile failure in D19. Reduced water seepage was observed during the 2022 examination. It is noted this could be due to seasonal variations in rainfall.

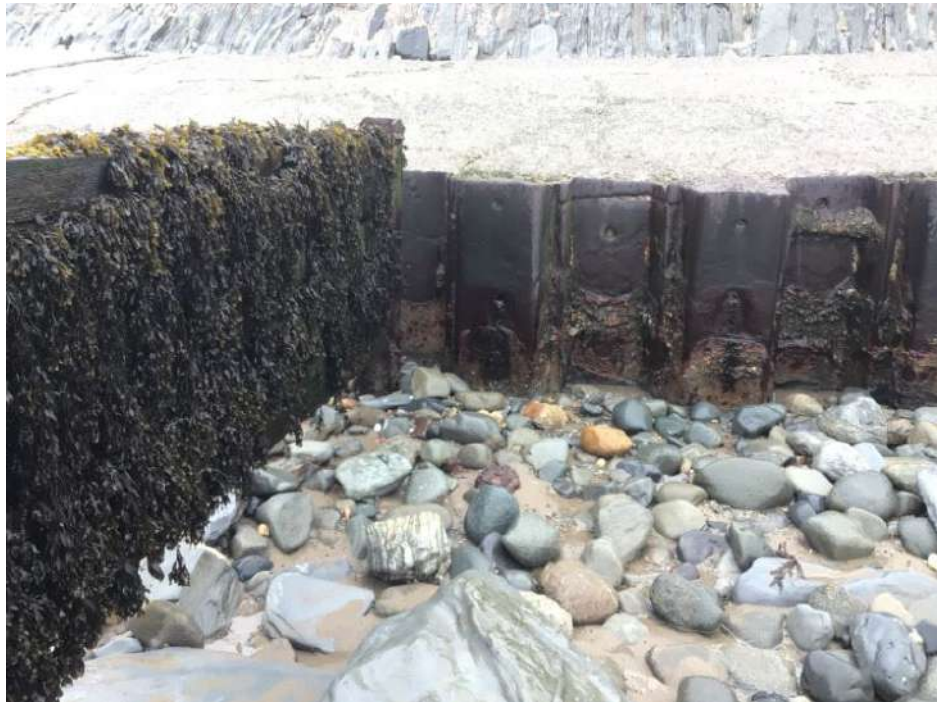
#### Defect Ref: D21

**Description:** Water seepage through eyelets in the sheet piling indicates a large pressure head behind the wall. The source of the build-up of water could be from a large water body north of the wall which may be draining through the structure. This mechanism could explain one of the factors behind the pile failure in D19. Reduced water seepage was observed during the 2022 examination. It is noted this could be due to seasonal variations in rainfall.

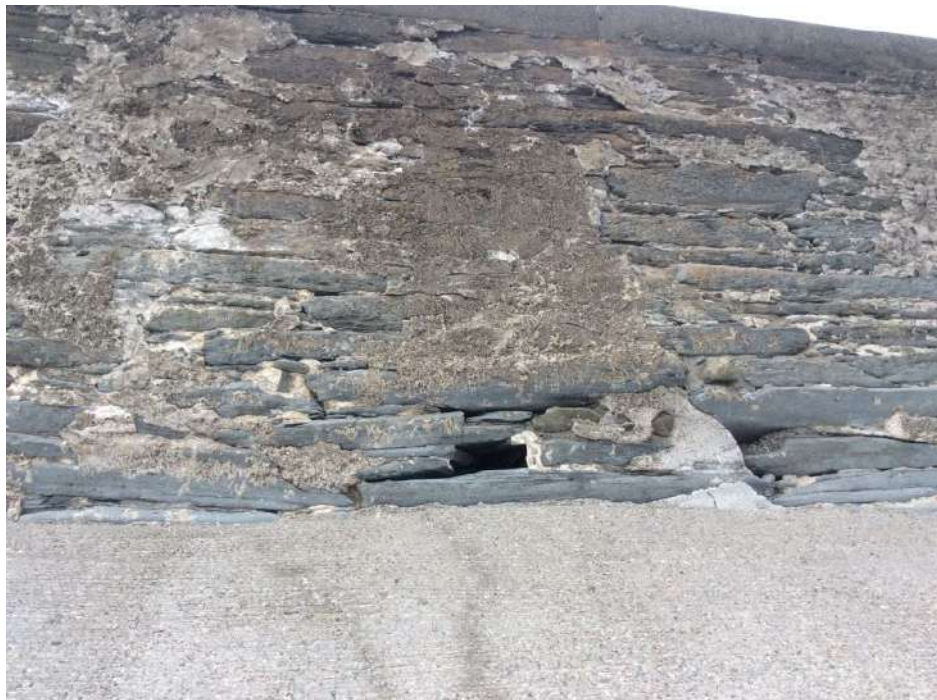
#### Defect Ref: D22

**Description:** Missing stone from masonry wall. Void behind the wall. This defect has been previously repaired but additional missing units were noted during the 2021 examination. There is voiding behind patch repair. There was no change between the 2021 and 2022 examinations.

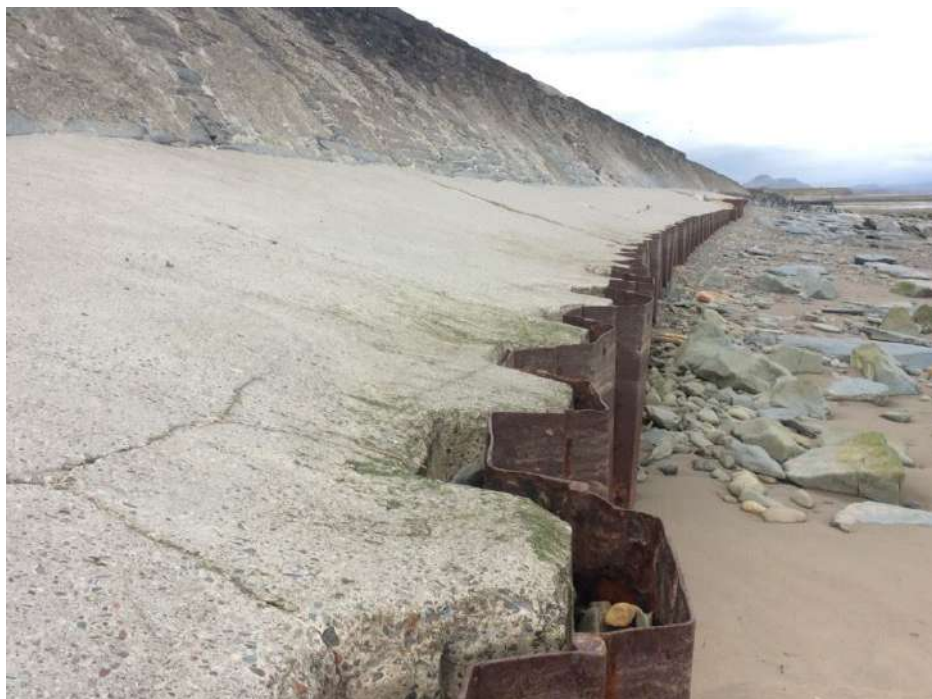
**Defect Ref: D32**

Movement in pile with separation from concrete (about 0.5 - 0.10 m of gap) for a wall extent of approx. 15 m. Significant movement in the piling was observed in 2022 (approx. 0.75m of separation).

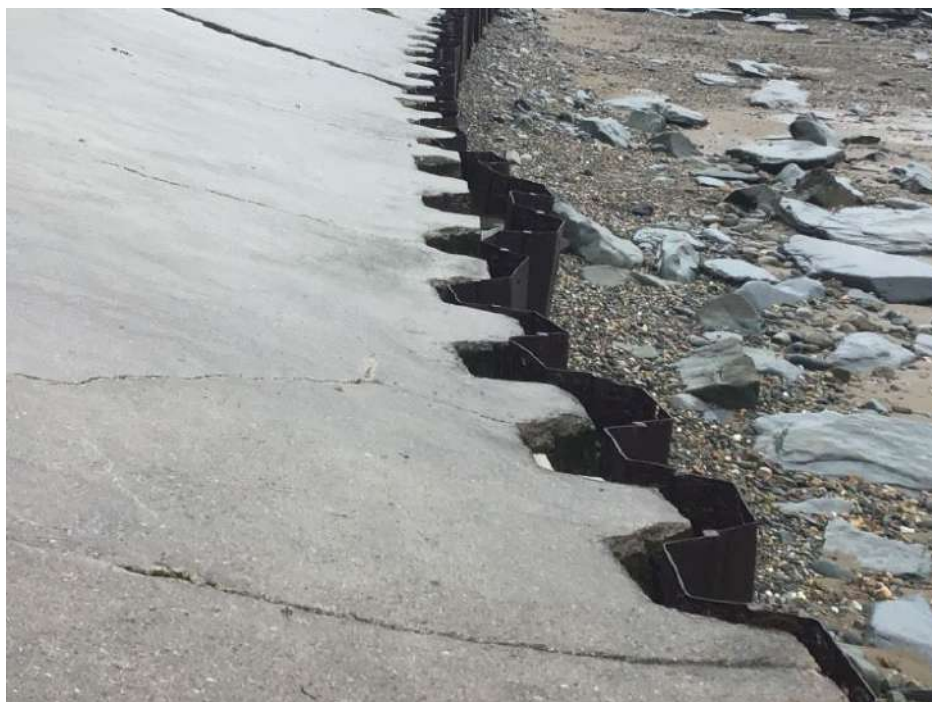
**Defect Ref: D32**

Movement in pile with separation from concrete (about 0.5 - 0.10 m of gap) for a wall extent of approx. 15 m. Significant movement in the piling was observed in 2022 (approx. 0.75m of separation).

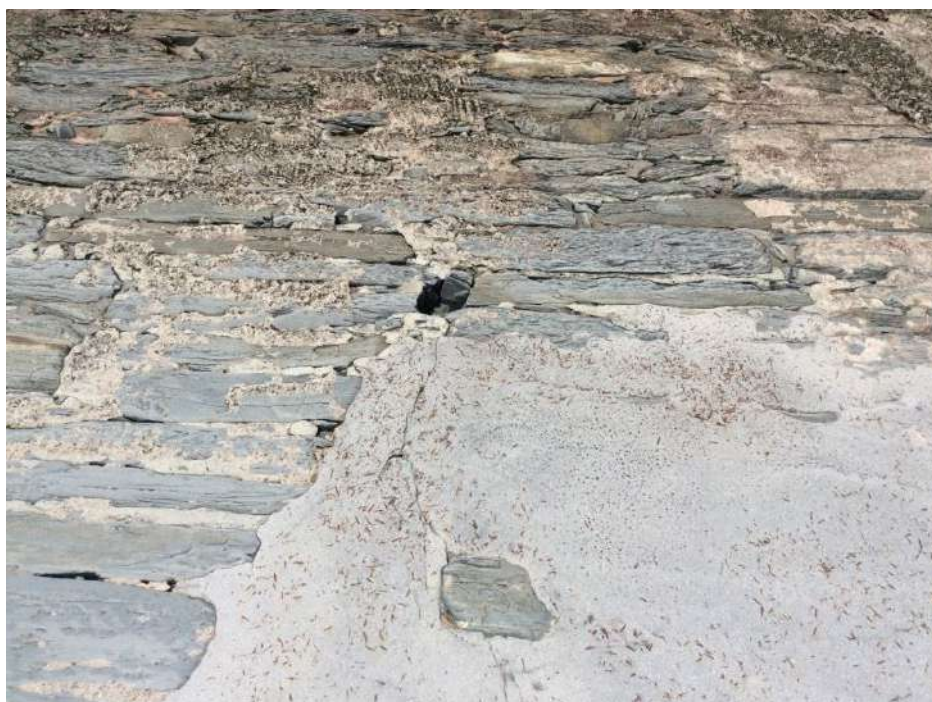
**Defect Ref: D34**

**Description:** Missing blockwork. See photo in D22. There are multiple missing units in the wall section. No change between the 2021 and 2022 examinations.

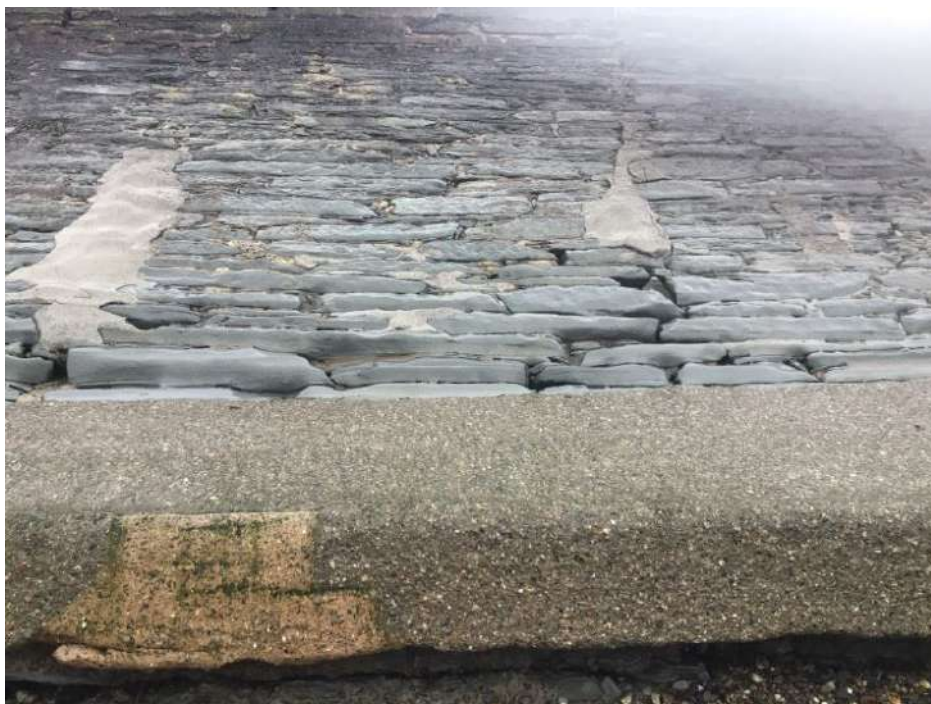
#### Defect Ref: D34

**Description:** Missing blockwork. See photo in D22. There are multiple missing units in the wall section. No change between the 2021 and 2022 examinations.

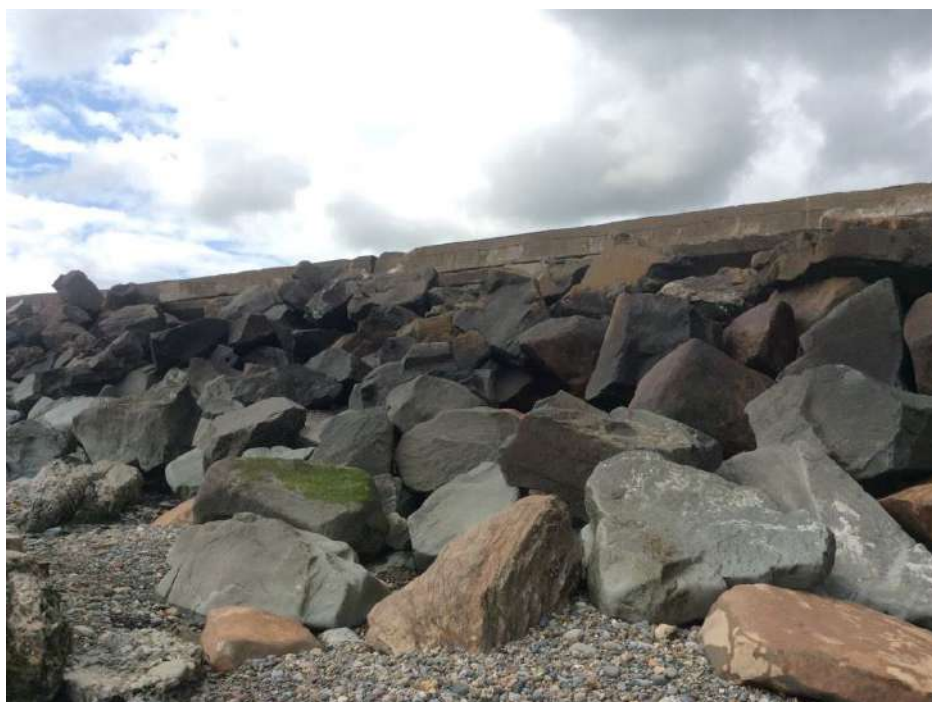
**Defect Ref: D40**

Cracking and spalling  
in wall section. To be  
moved to Section A  
due to updated  
location. There was  
no change between  
the 2021 and 2022  
examinations

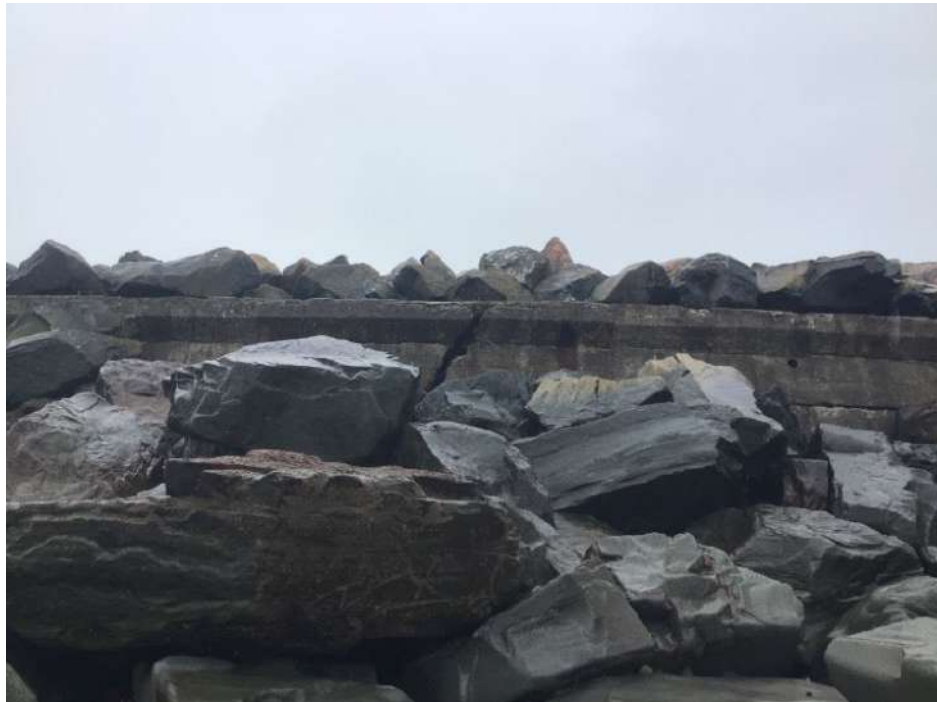
**Defect Ref: D40**

Cracking and spalling in wall section. To be moved to Section A due to updated location. There was no change between the 2021 and 2022 examinations
