Location Plan:	<b>Afonwen Sea Wall</b> Assessment Date: 16/03/2022	
<p>Contains Ordnance Survey data © Crown copyright and database right 2015</p>	CARRS Exam ID:	<b>14468740</b>
	Exam Type:	<b>Detailed</b>
	Complete Survey:	Yes
	Network Rail ELR:	<b>DJP</b>
	Structure Reference:	<b>127 41</b>
	Mileage:	<b>127m 798yds 36chs</b>
	OS Ref:	245630 , 337300
	Operational Area:	Cambrian
NOTE: This document has been prepared as an Asset Condition Survey Report for Network Rail. JBA Consulting accepts no responsibility or liability for any use that is made of this document other than by the Client for the purposes for which it was originally commissioned and prepared.	Governing SMP2:	Coastal Snowdonia
	SMP2 Policy Unit:	12.24
	SMP2 Policy:	2025 = hold the line; 2055 = managed realignment; 2105 = managed realignment.

Afonwen Sea Wall is located between Afonwen and Llanystumdwy. The defence is split into two sections, Afonwen Sea Wall A and B, corresponding to a change in major element type at 245068, 337218 (between Sections A and B):

# COASTAL ASSET CONDITION SURVEY REPORT

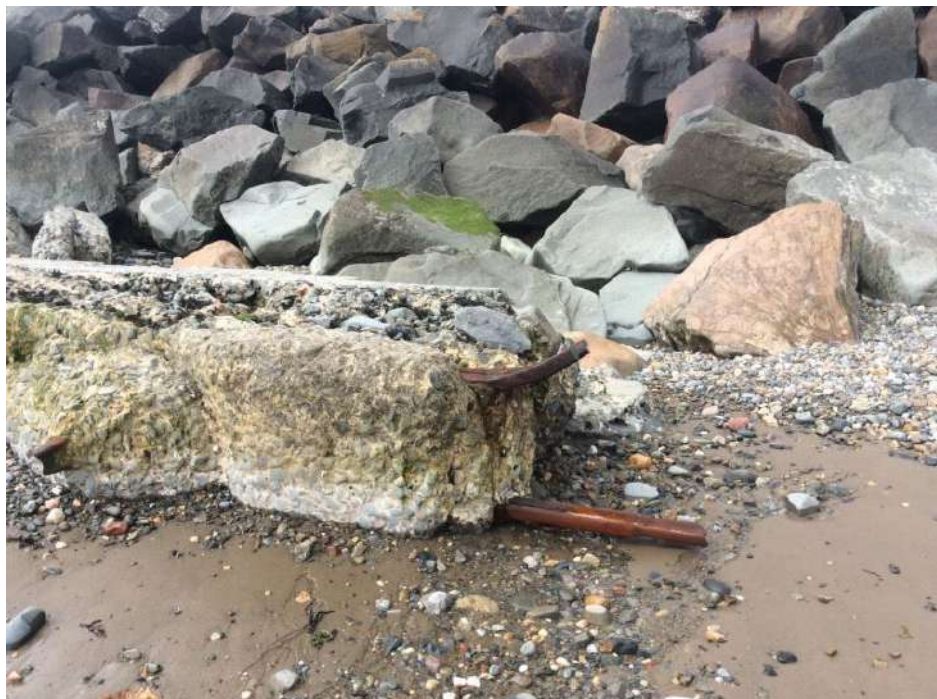
**Defect Ref: D41**

Remove exposed rebar (safety hazard). To be moved to Section A due to updated location. There was no change between the 2021 and 2022 inspections

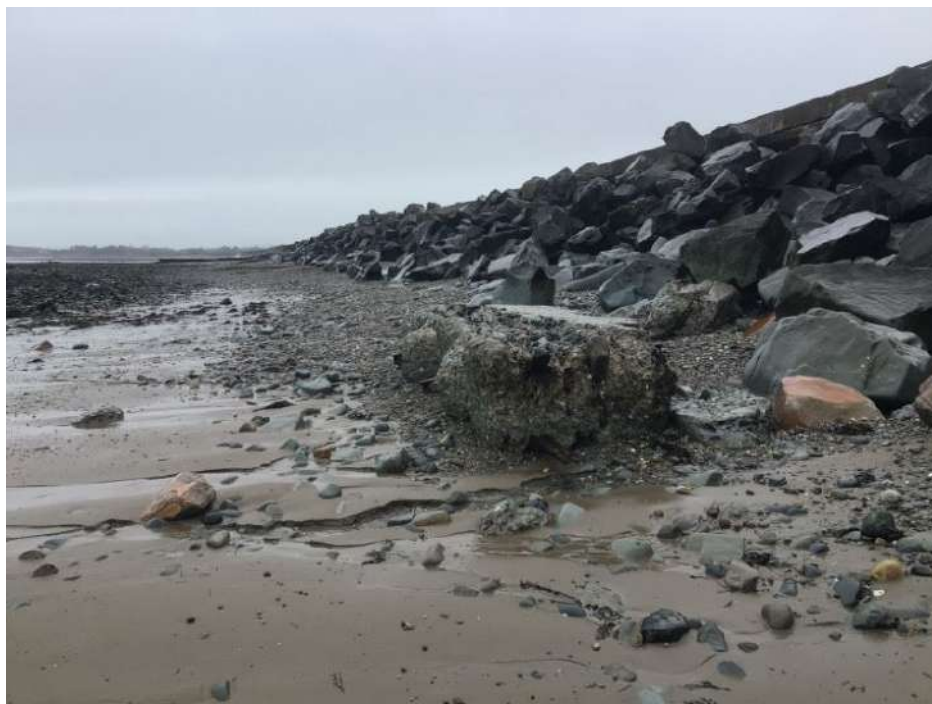
**Defect Ref: D41**

Remove exposed rebar (safety hazard).  
To be moved to  
Section A due to  
updated location.

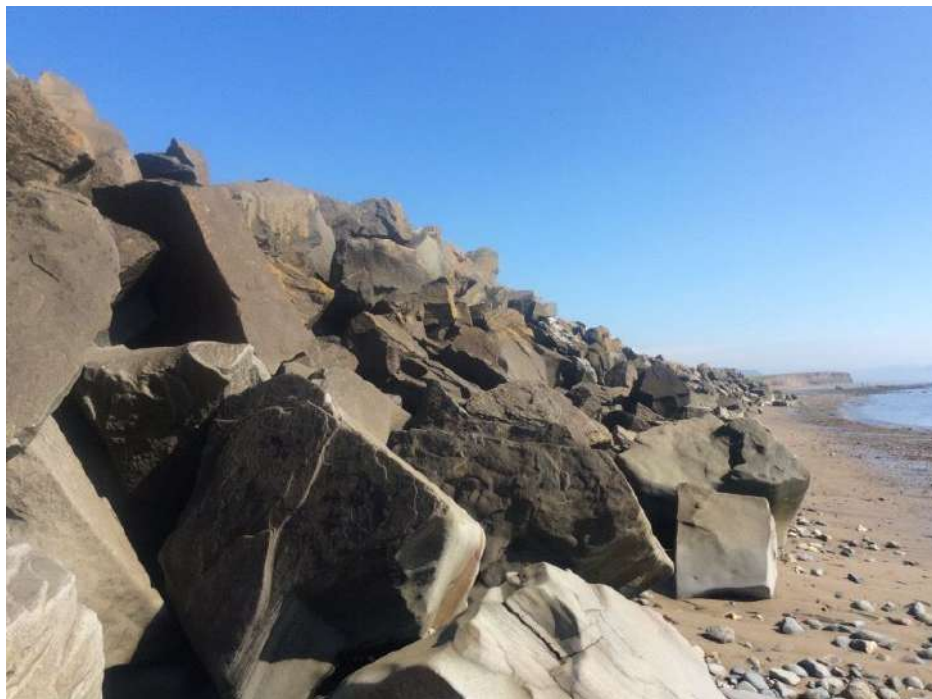
**Defect Ref: D42**

Very  
steep rock armour.  
During the 2022  
examination, areas of  
very steep rock  
armour were  
observed with  
potentially unstable  
units and other split  
units

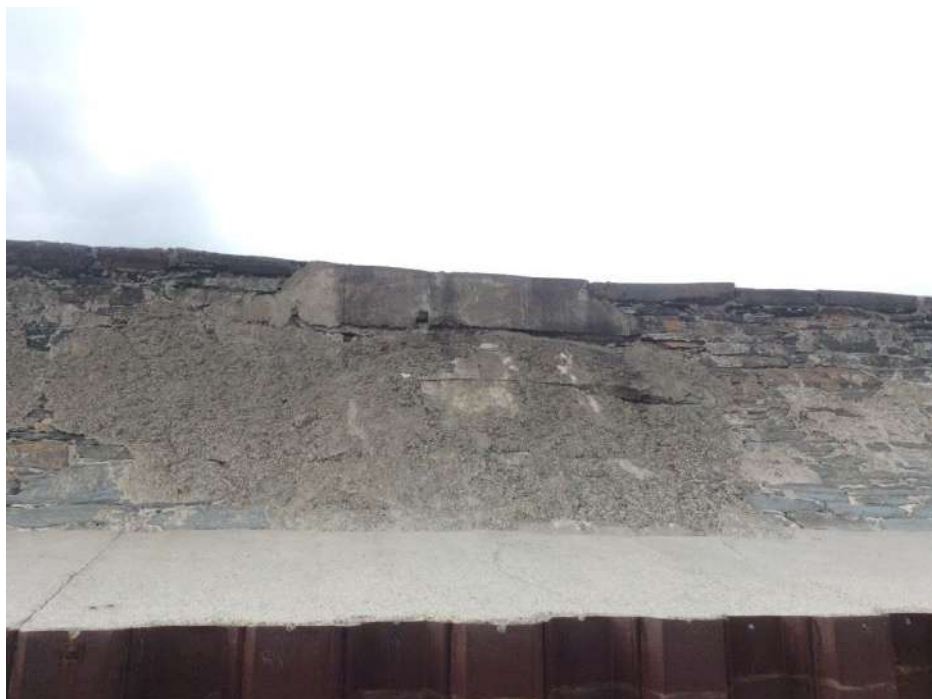
**Defect Ref: D44**

**Description:** Mortar washout in crest at concrete repair. There was no change between the 2021 and 2022 examinations.

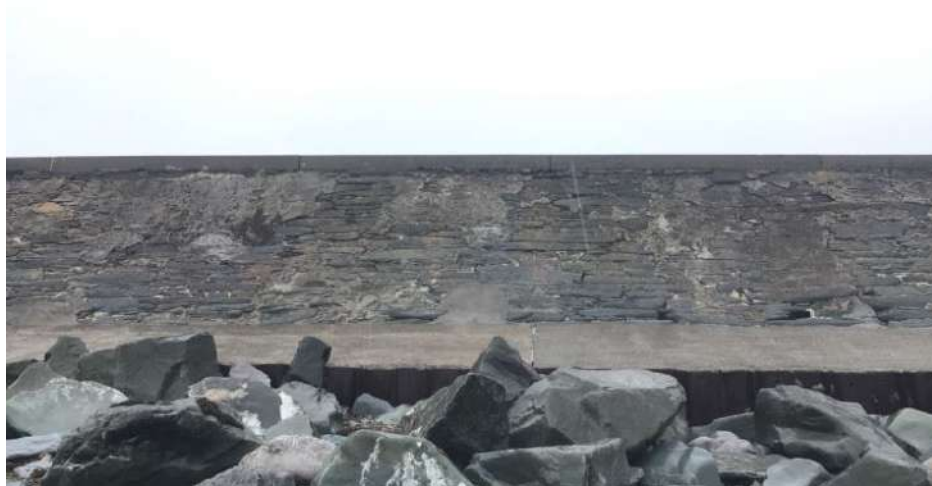
**Defect Ref: D44**

**Description:** Mortar washout in crest at concrete repair. There was no change between the 2021 and 2022 examinations.

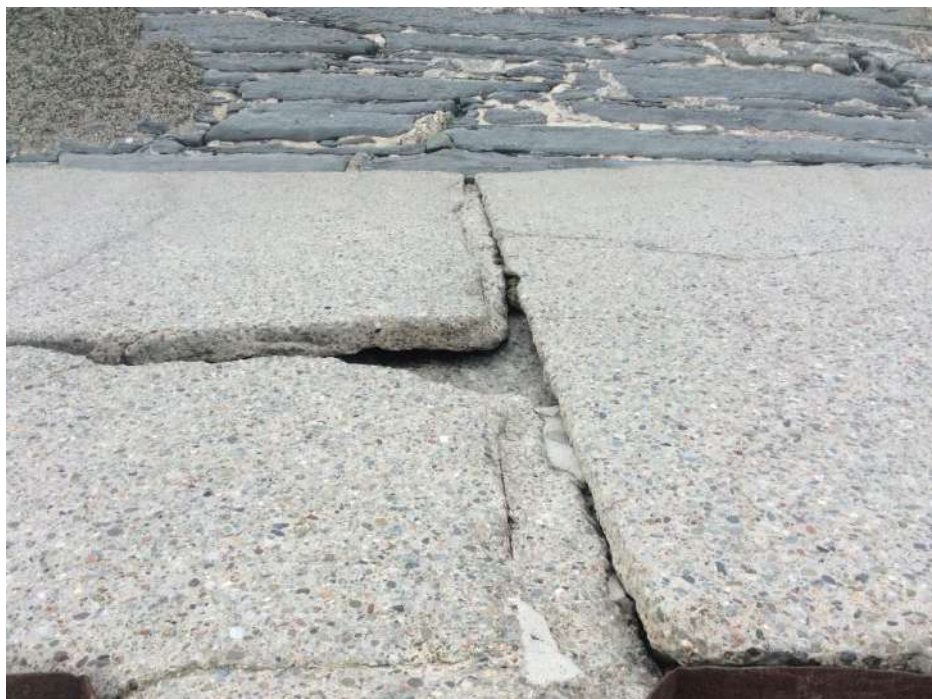
**Defect Ref: D46**

Damaged concrete with a void in the concrete apron. To be moved to Wall Apron element due to updated location. Between the 2021 and 2022 examinations, the defect has worsened, now beginning to undercut the adjacent slab. Concern over potential for expulsion of concrete slab.

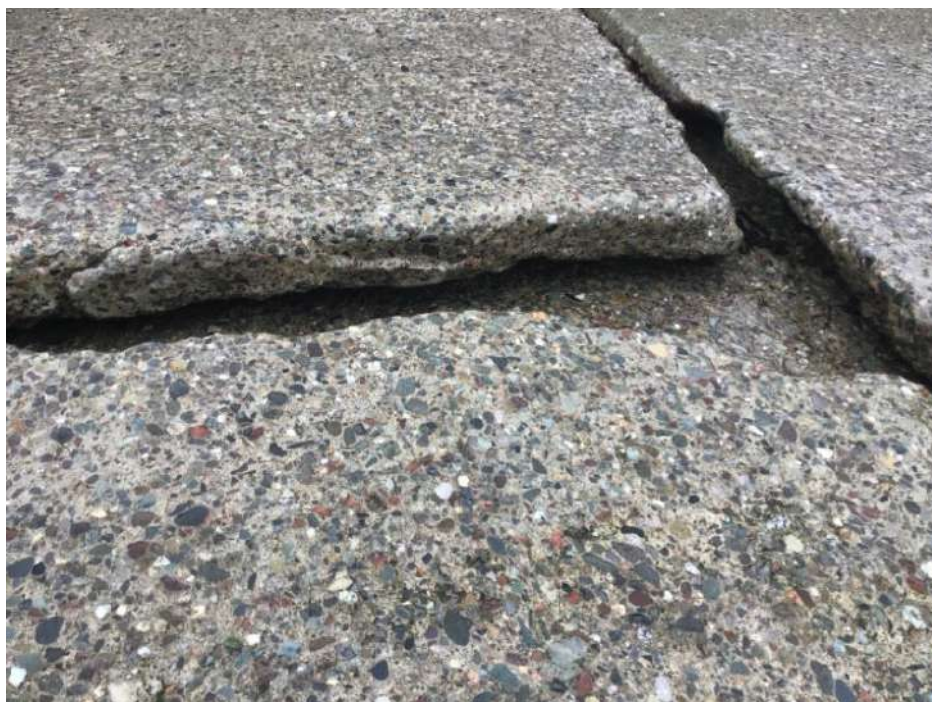
**Defect Ref: D46**

Damaged concrete with a void in the concrete apron. To be moved to Wall Apron element due to updated location. Between the 2021 and 2022 examinations, the defect has worsened, now beginning to undercut the adjacent slab. Concern over potential for expulsion of concrete slab.

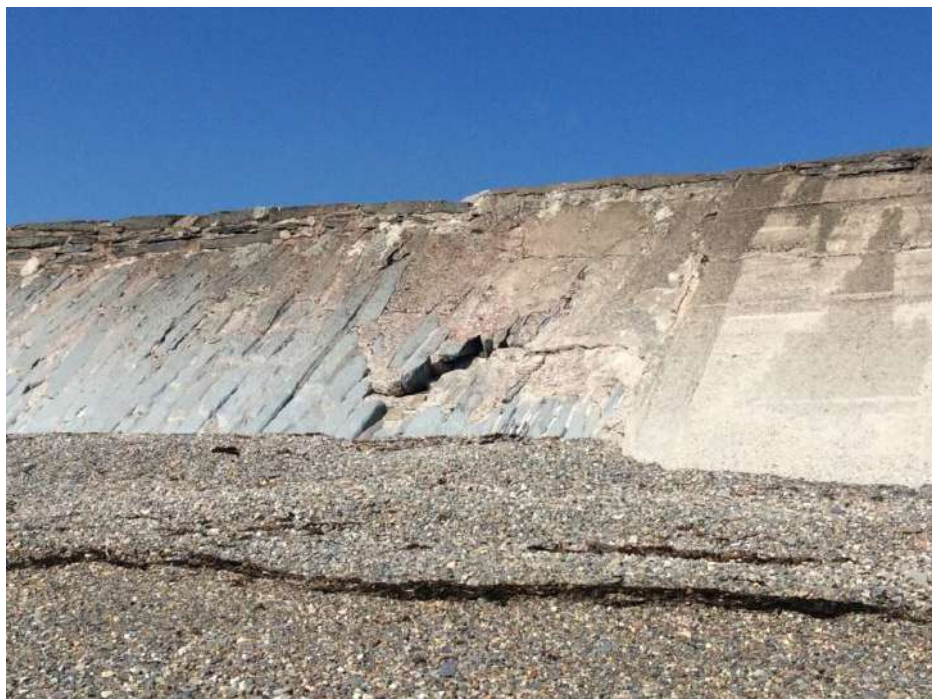
#### Defect Ref: D47

**Description:** Missing blockwork in the wall. Between the 2021 and 2022 examinations, there is possible worsening of concrete patch repair adjacent to missing blockwork. Beach level was observed to be visibly lower.

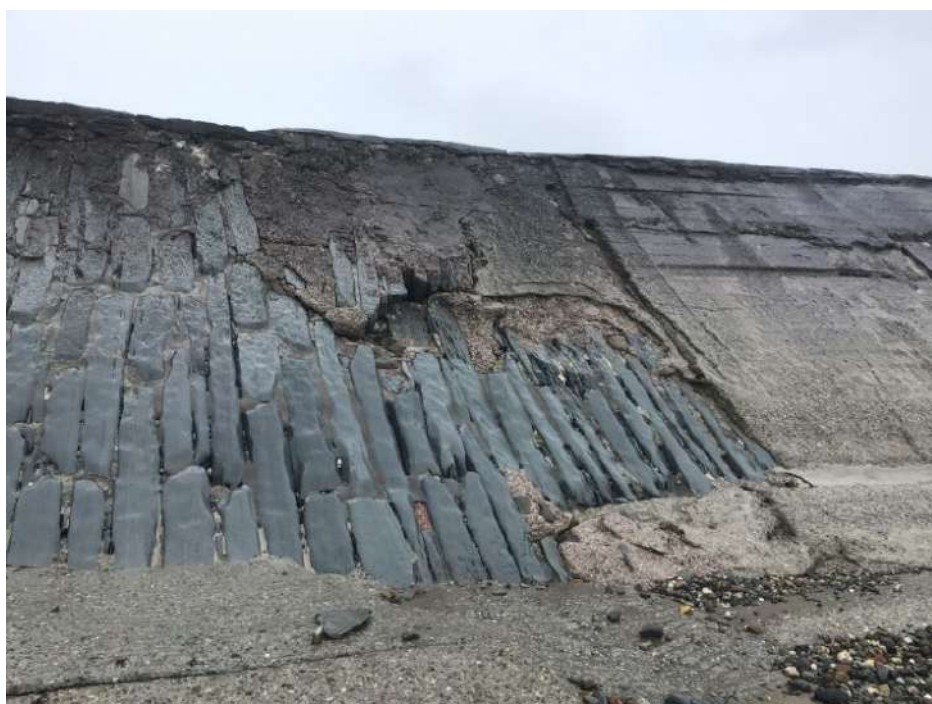
#### Defect Ref: D47

**Description:** Missing blockwork in the wall. Between the 2021 and 2022 examinations, there is possible worsening of concrete patch repair adjacent to missing blockwork. Beach level was observed to be visibly lower.

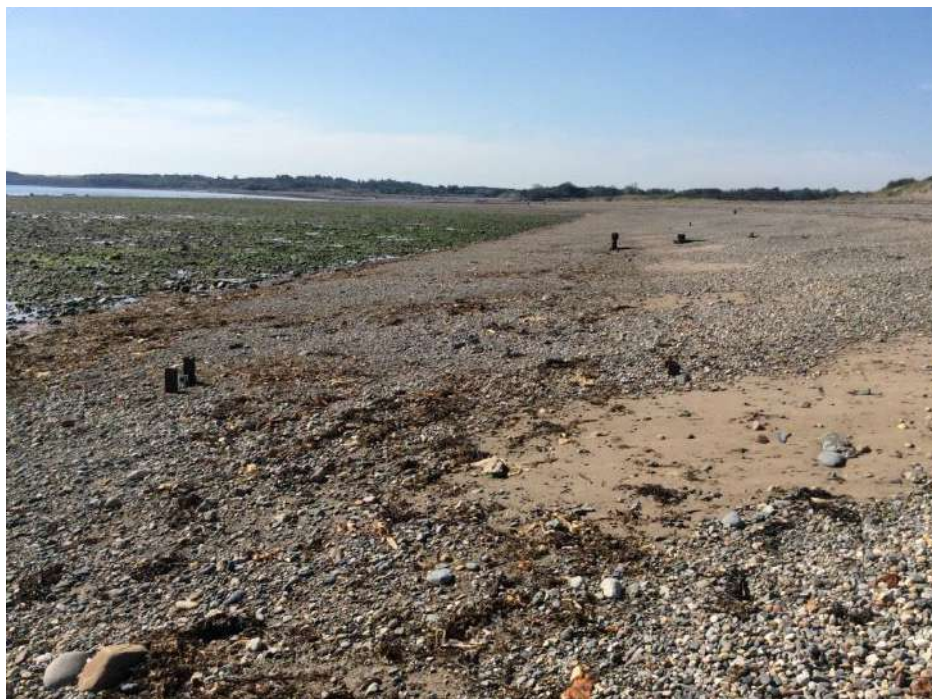
**Defect Ref: D48**

Dilapidated groynes.  
This defect is noted  
as a duplicate of D24  
and is recommended  
for closure.

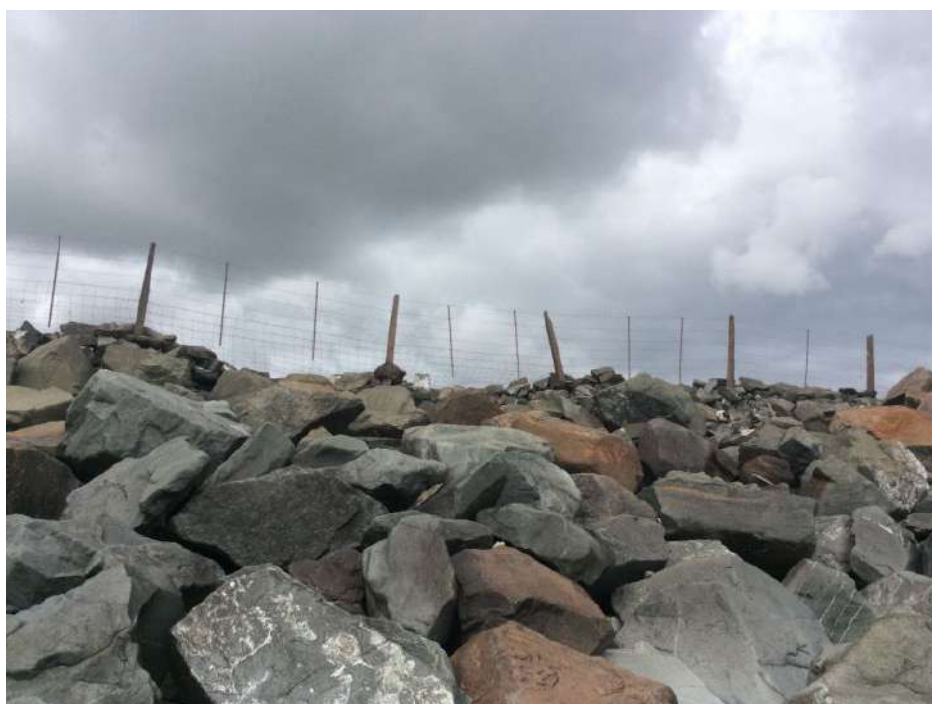
**Defect Ref: D49**

**Description:** An  
unstable concrete  
fence post creating  
potential health and  
safety hazard should  
the post or fence fail.  
There has been no  
change between the  
2021 and 2022  
examinations.

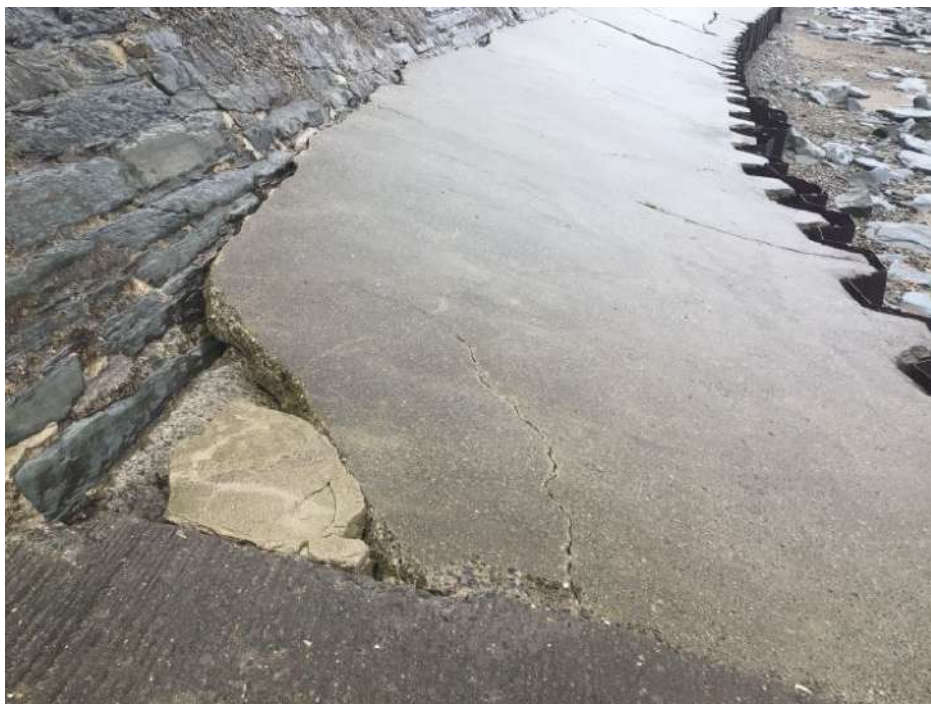
#### Defect Ref: D51

**Description:** Cracks in the concrete apron. During the 2022 examination, multiple large cracks and removed material creating voids were observed throughout the large concrete slabs.
