**SOUTH SIDE  
QUEENSWAY WASTE  
MANAGEMENT SITE,  
LLANWERN STEELWORKS**

**2018 Annual Review of  
Environmental  
Monitoring**

*Report Number 1785r2v1d0219*

**February 2019**

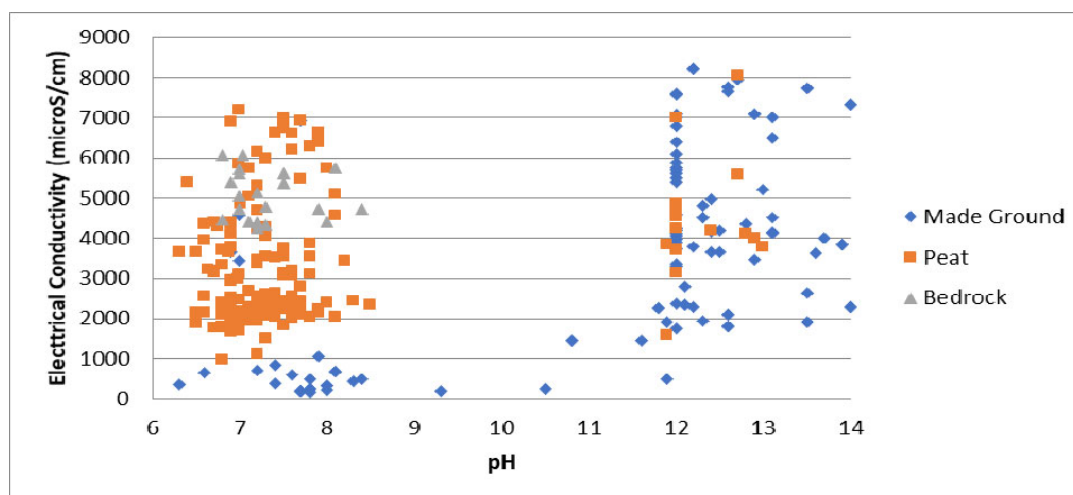
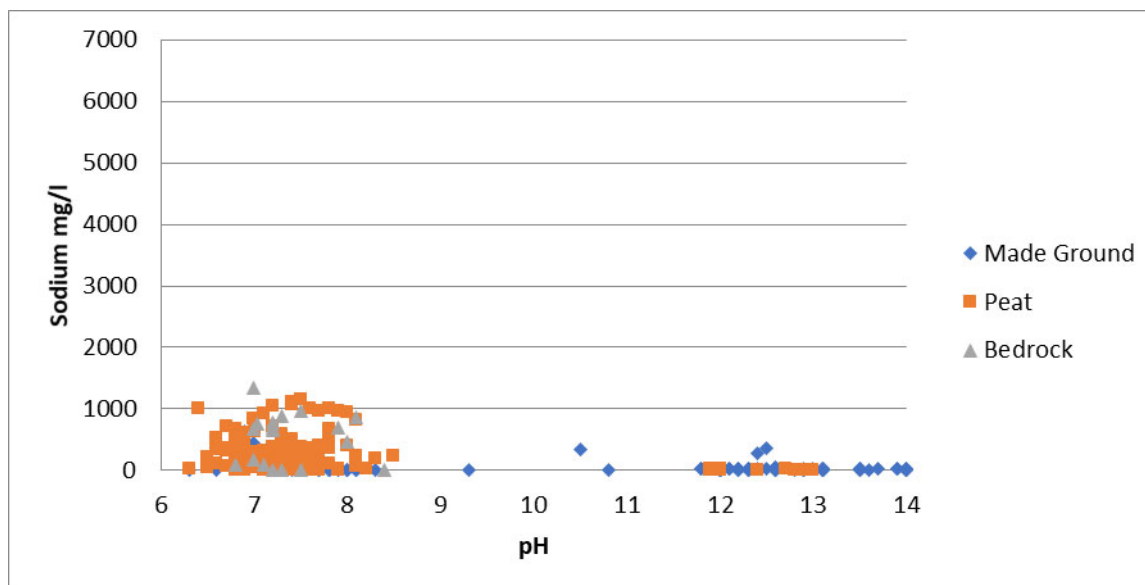
The data indicate that groundwater within the shallow made ground is distinct and characterised by elevated pH (typically > pH 11). This is principally because the made ground comprises steel slag that leaches lime. In comparison, the groundwater in the peat is circumneutral (pH 6 – 8) although there is potential evidence of some interconnection between the made ground and peat at BH202, as the pH is elevated at this point. Groundwater chemistry tends to become more dilute from north to south.

Because of the highly alkaline pH, most non-hazardous and hazardous substances are either below detection limits or at low concentrations in the groundwater recovered from the made ground. In recent years, hazardous substance cadmium has been detected on several occasions and sometimes at elevated concentration (e.g. upto 324 microg/l in the shallow made ground at BH18S in 2015 and upto 377 microg/l in 2016 in the peat at BH19). In 2017, cadmium at all positions was not detected above 7 microg/l with the highest value detected at BH203S. The same sample also contained the highest lead detected during 2017 (29.26 microg/l in December). In 2018, cadmium was only detected in December from groundwater sampled from wells with screened intervals in the peat (BH13D, BH17, BH203D and BH205D). The maximum concentration detected was 1.3 microg/l. Mercury was also detected in 2018, at BH205D in September at 51 microg/l.

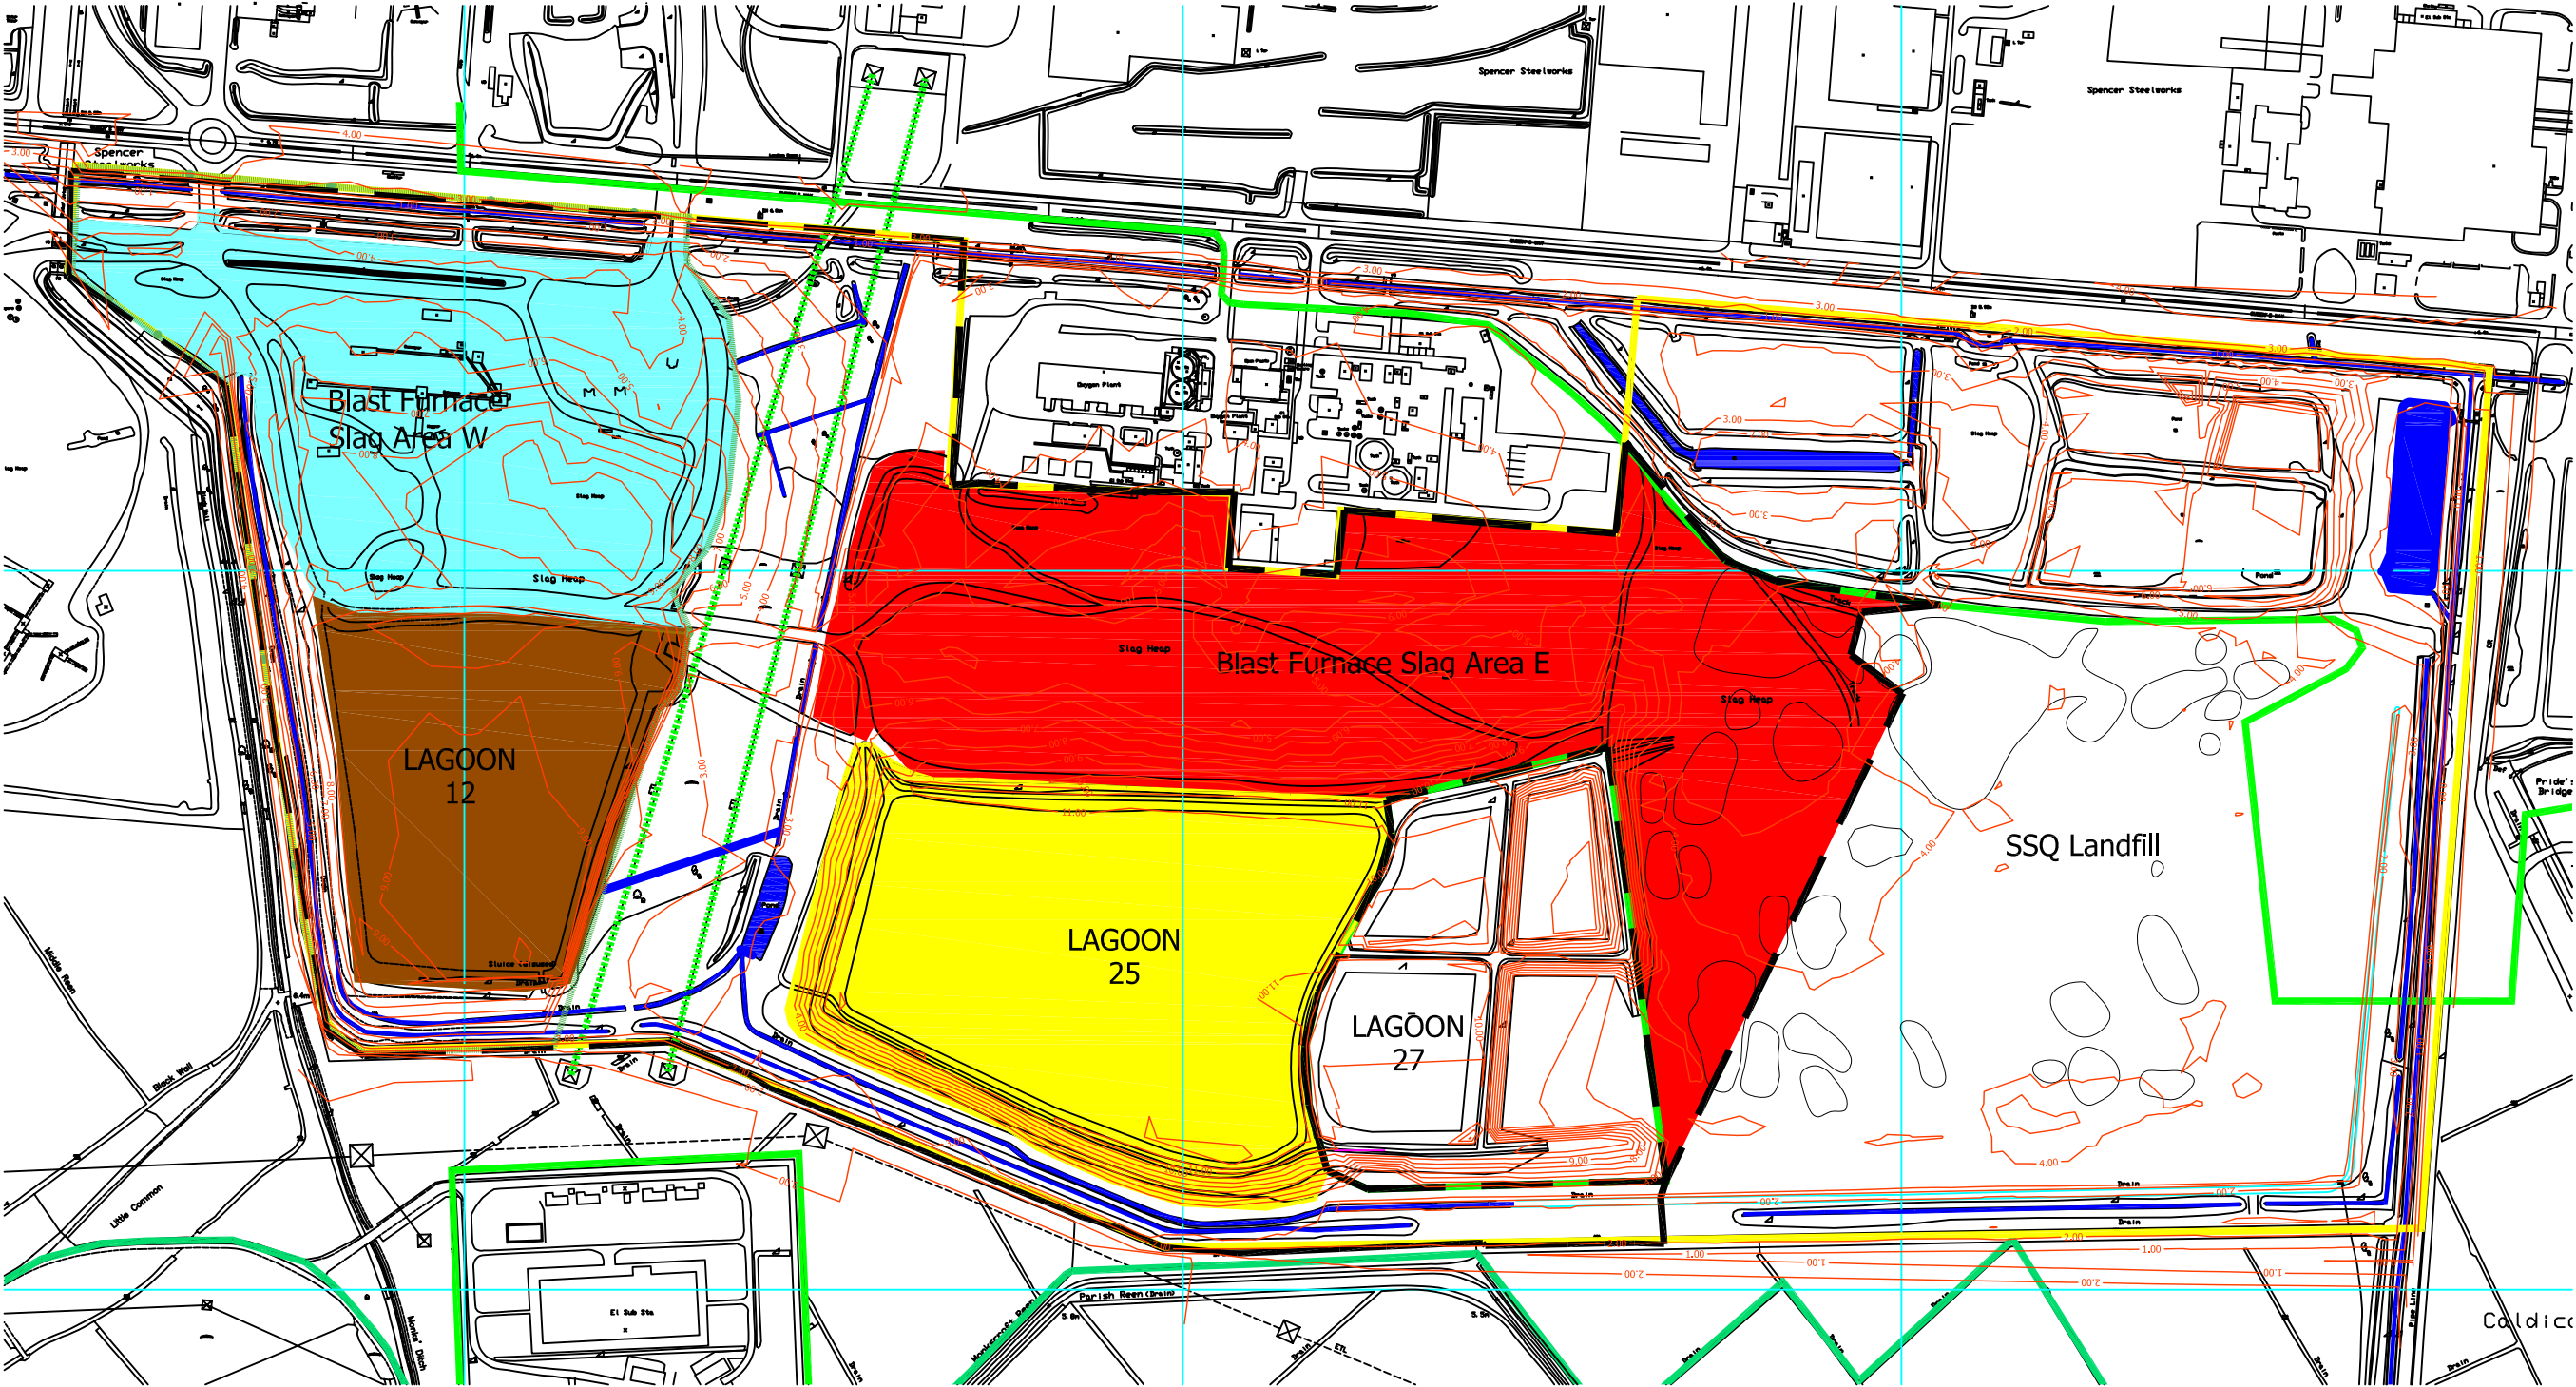
Figure 3 Areas of Site Included in Closure Plan

In the context of the areas of SSQ which have now been definitively closed and which are of most relevance to this report, these are distinguished from the other site areas as coloured blocks on Figure 3. On Figure 3, the area which has been definitively closed is outlined with a black dashed line with key sub-areas shaded. The closure plan, therefore, only referred to the areas within the dashed closure boundary and no other areas. The areas bound by the closure plan are:

Throughout the duration of disposal activities, steel and iron slag was deposited to the north and east of Lagoons 12 and 25. Deposits of coarse granular slag of up to 7m thickness covered the areas indicated on Figure 3 as Slag Area W, Slag Area E and the SSQ Non-Hazardous Landfill. Since its deposition, both steel slag and blast furnace slag have become commercially viable for a variety of applications and most of the deposit has now been removed. The entire area now occupied by SSQ Non-Hazardous Landfill has, therefore, been reduced to a 1m thick slag stabilising layer.

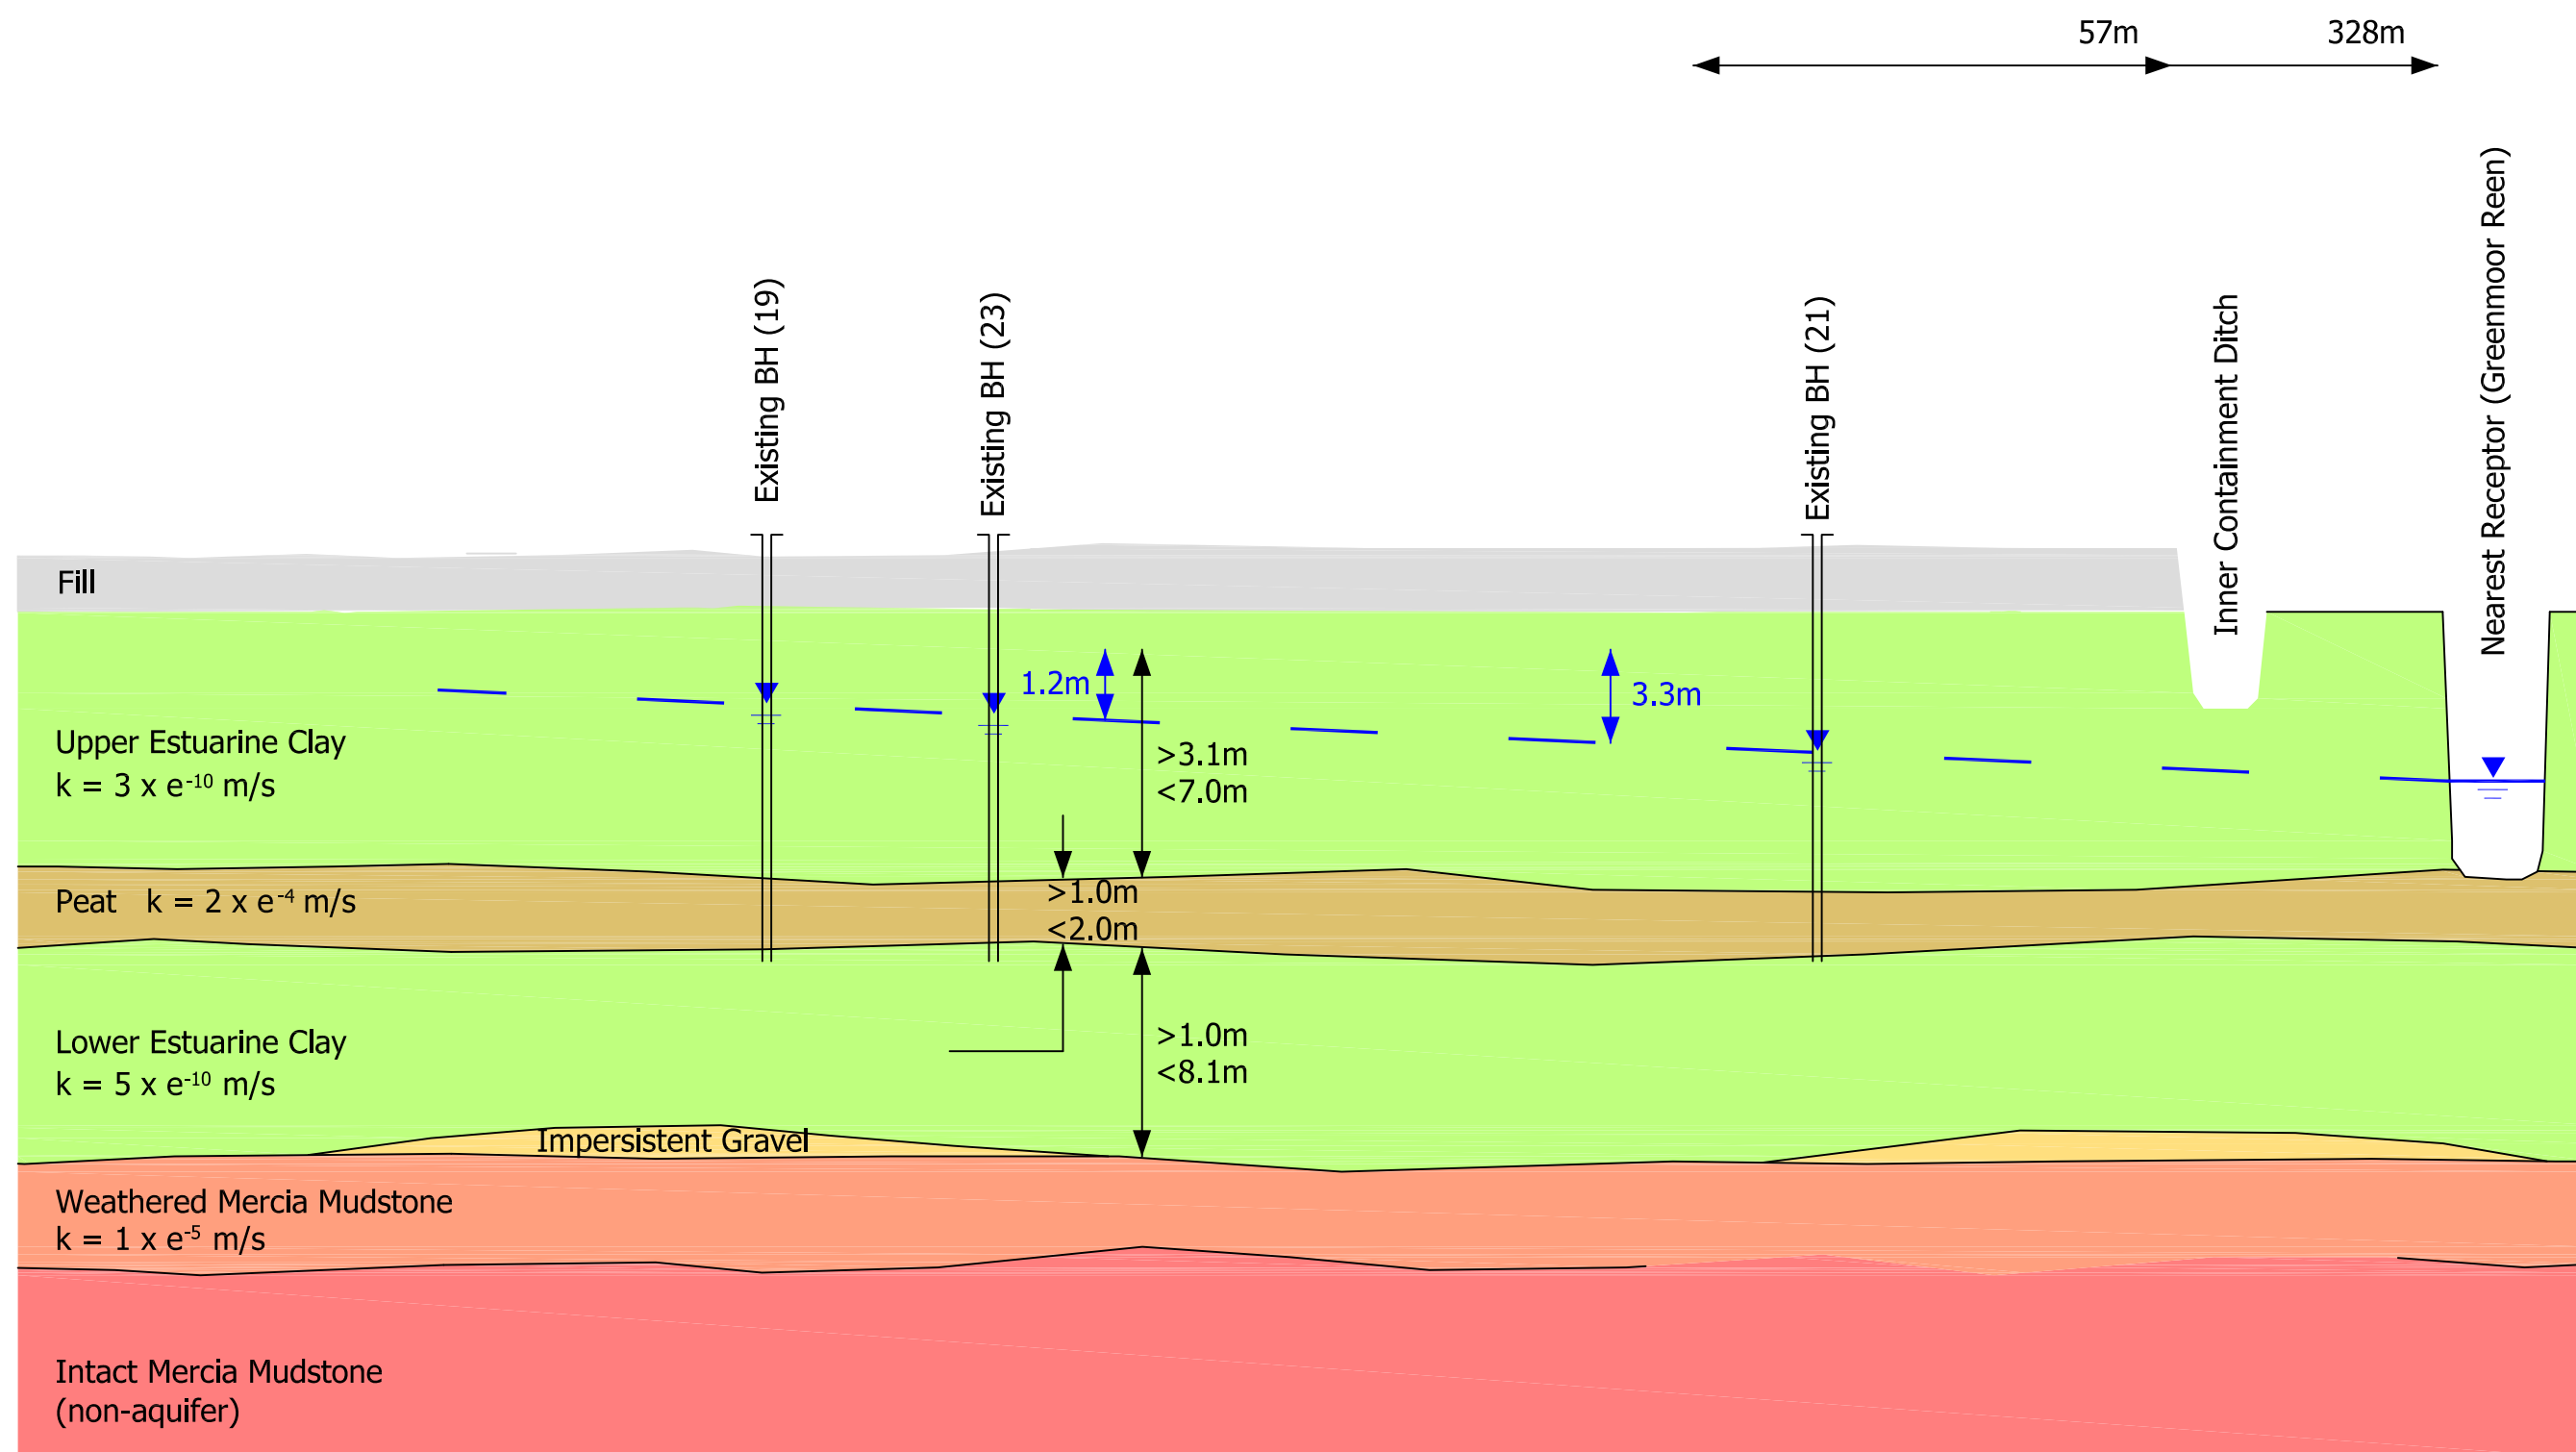
Figure 4 Conceptual Site Model

To enable the risks posed to groundwater and surface water to be evaluated, a conceptual hydrogeological model was developed as part of the closure process. The diagrammatic representation of the model is provided in Figure 4.

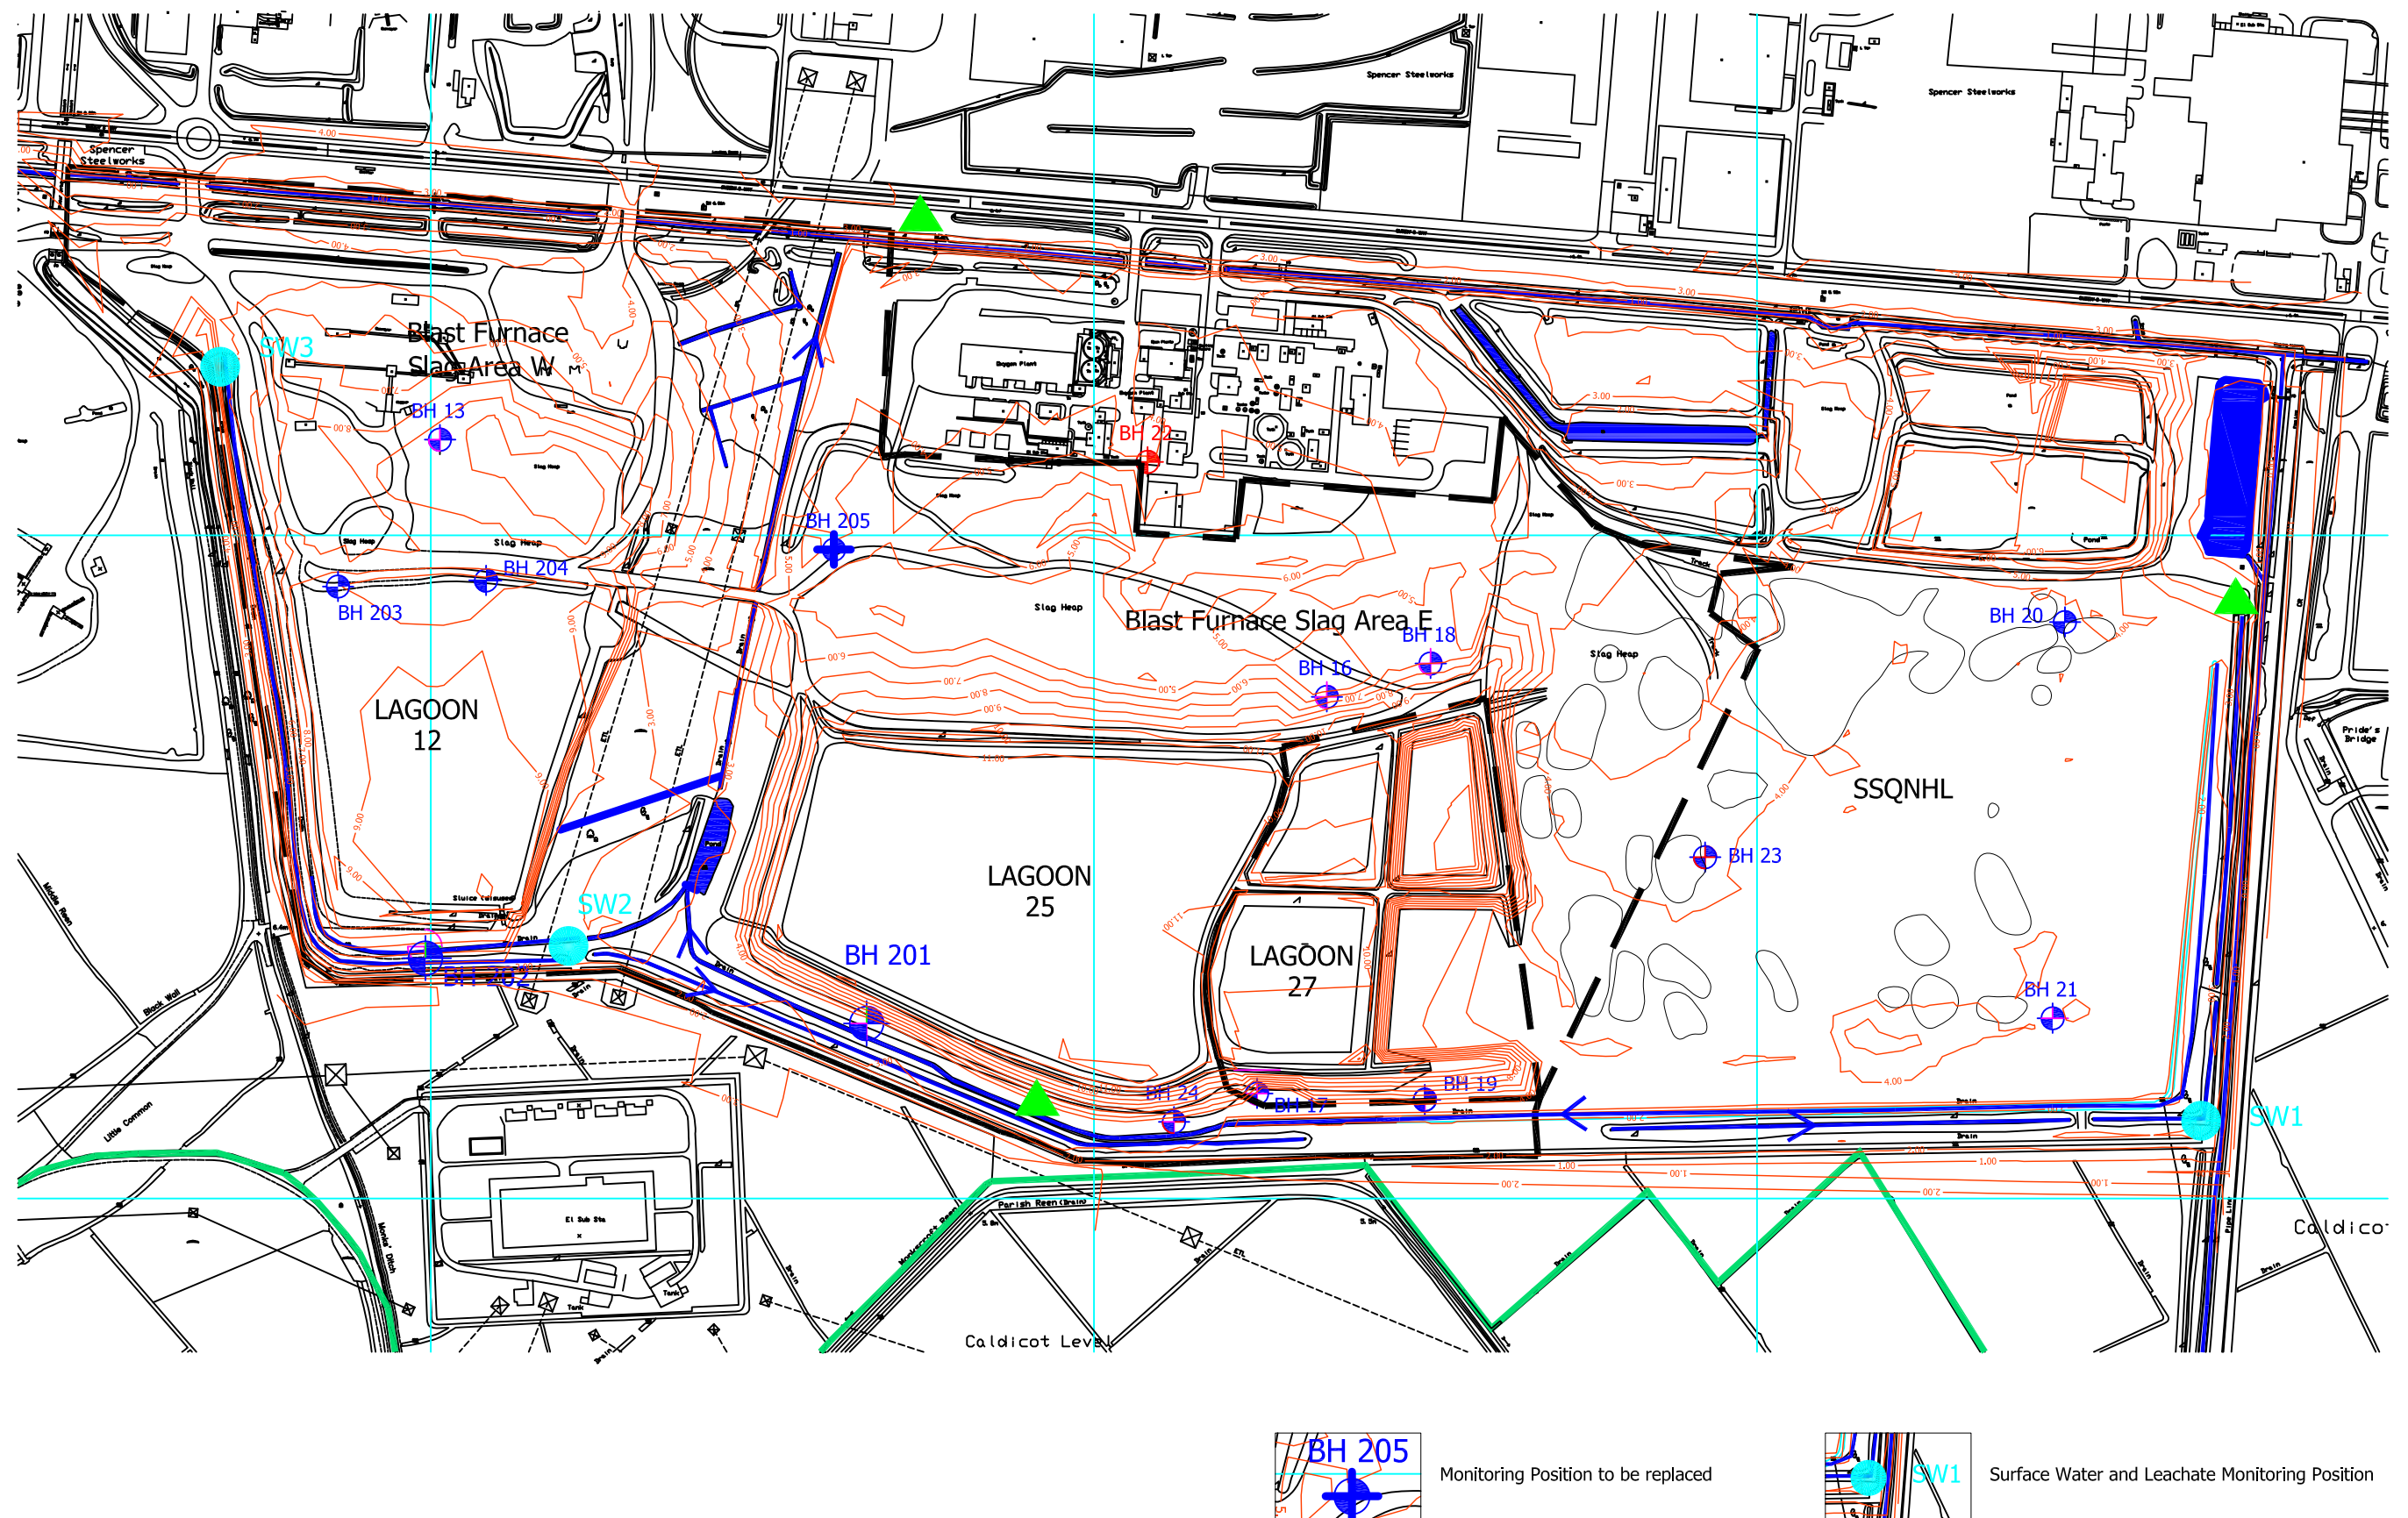
Figure 5 Available Monitoring Network

The current available monitoring network is illustrated in Figure 5.

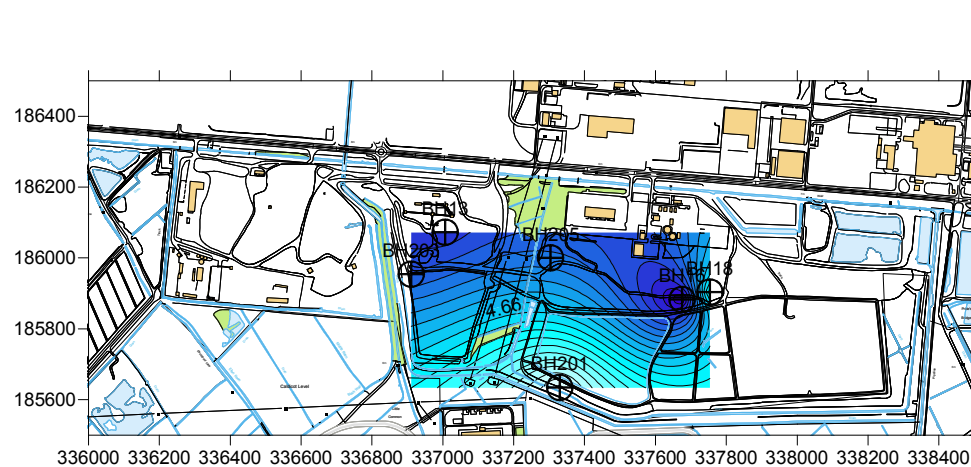
**April 2016 Shallow**

Figure 6 presents groundwater levels encountered in the shallow made ground and peat layer during 2017. These plans have been developed from measurements of water level at the piezometers summarised in Table 5-1.
