**EAST WASTE  
MANAGEMENT SITE,  
LLANWERN STEELWORKS**

**PERMIT EAWML/30003**

**2019 Annual Review of  
Environmental  
Monitoring**

*Report Number 1895r1v1d1219*

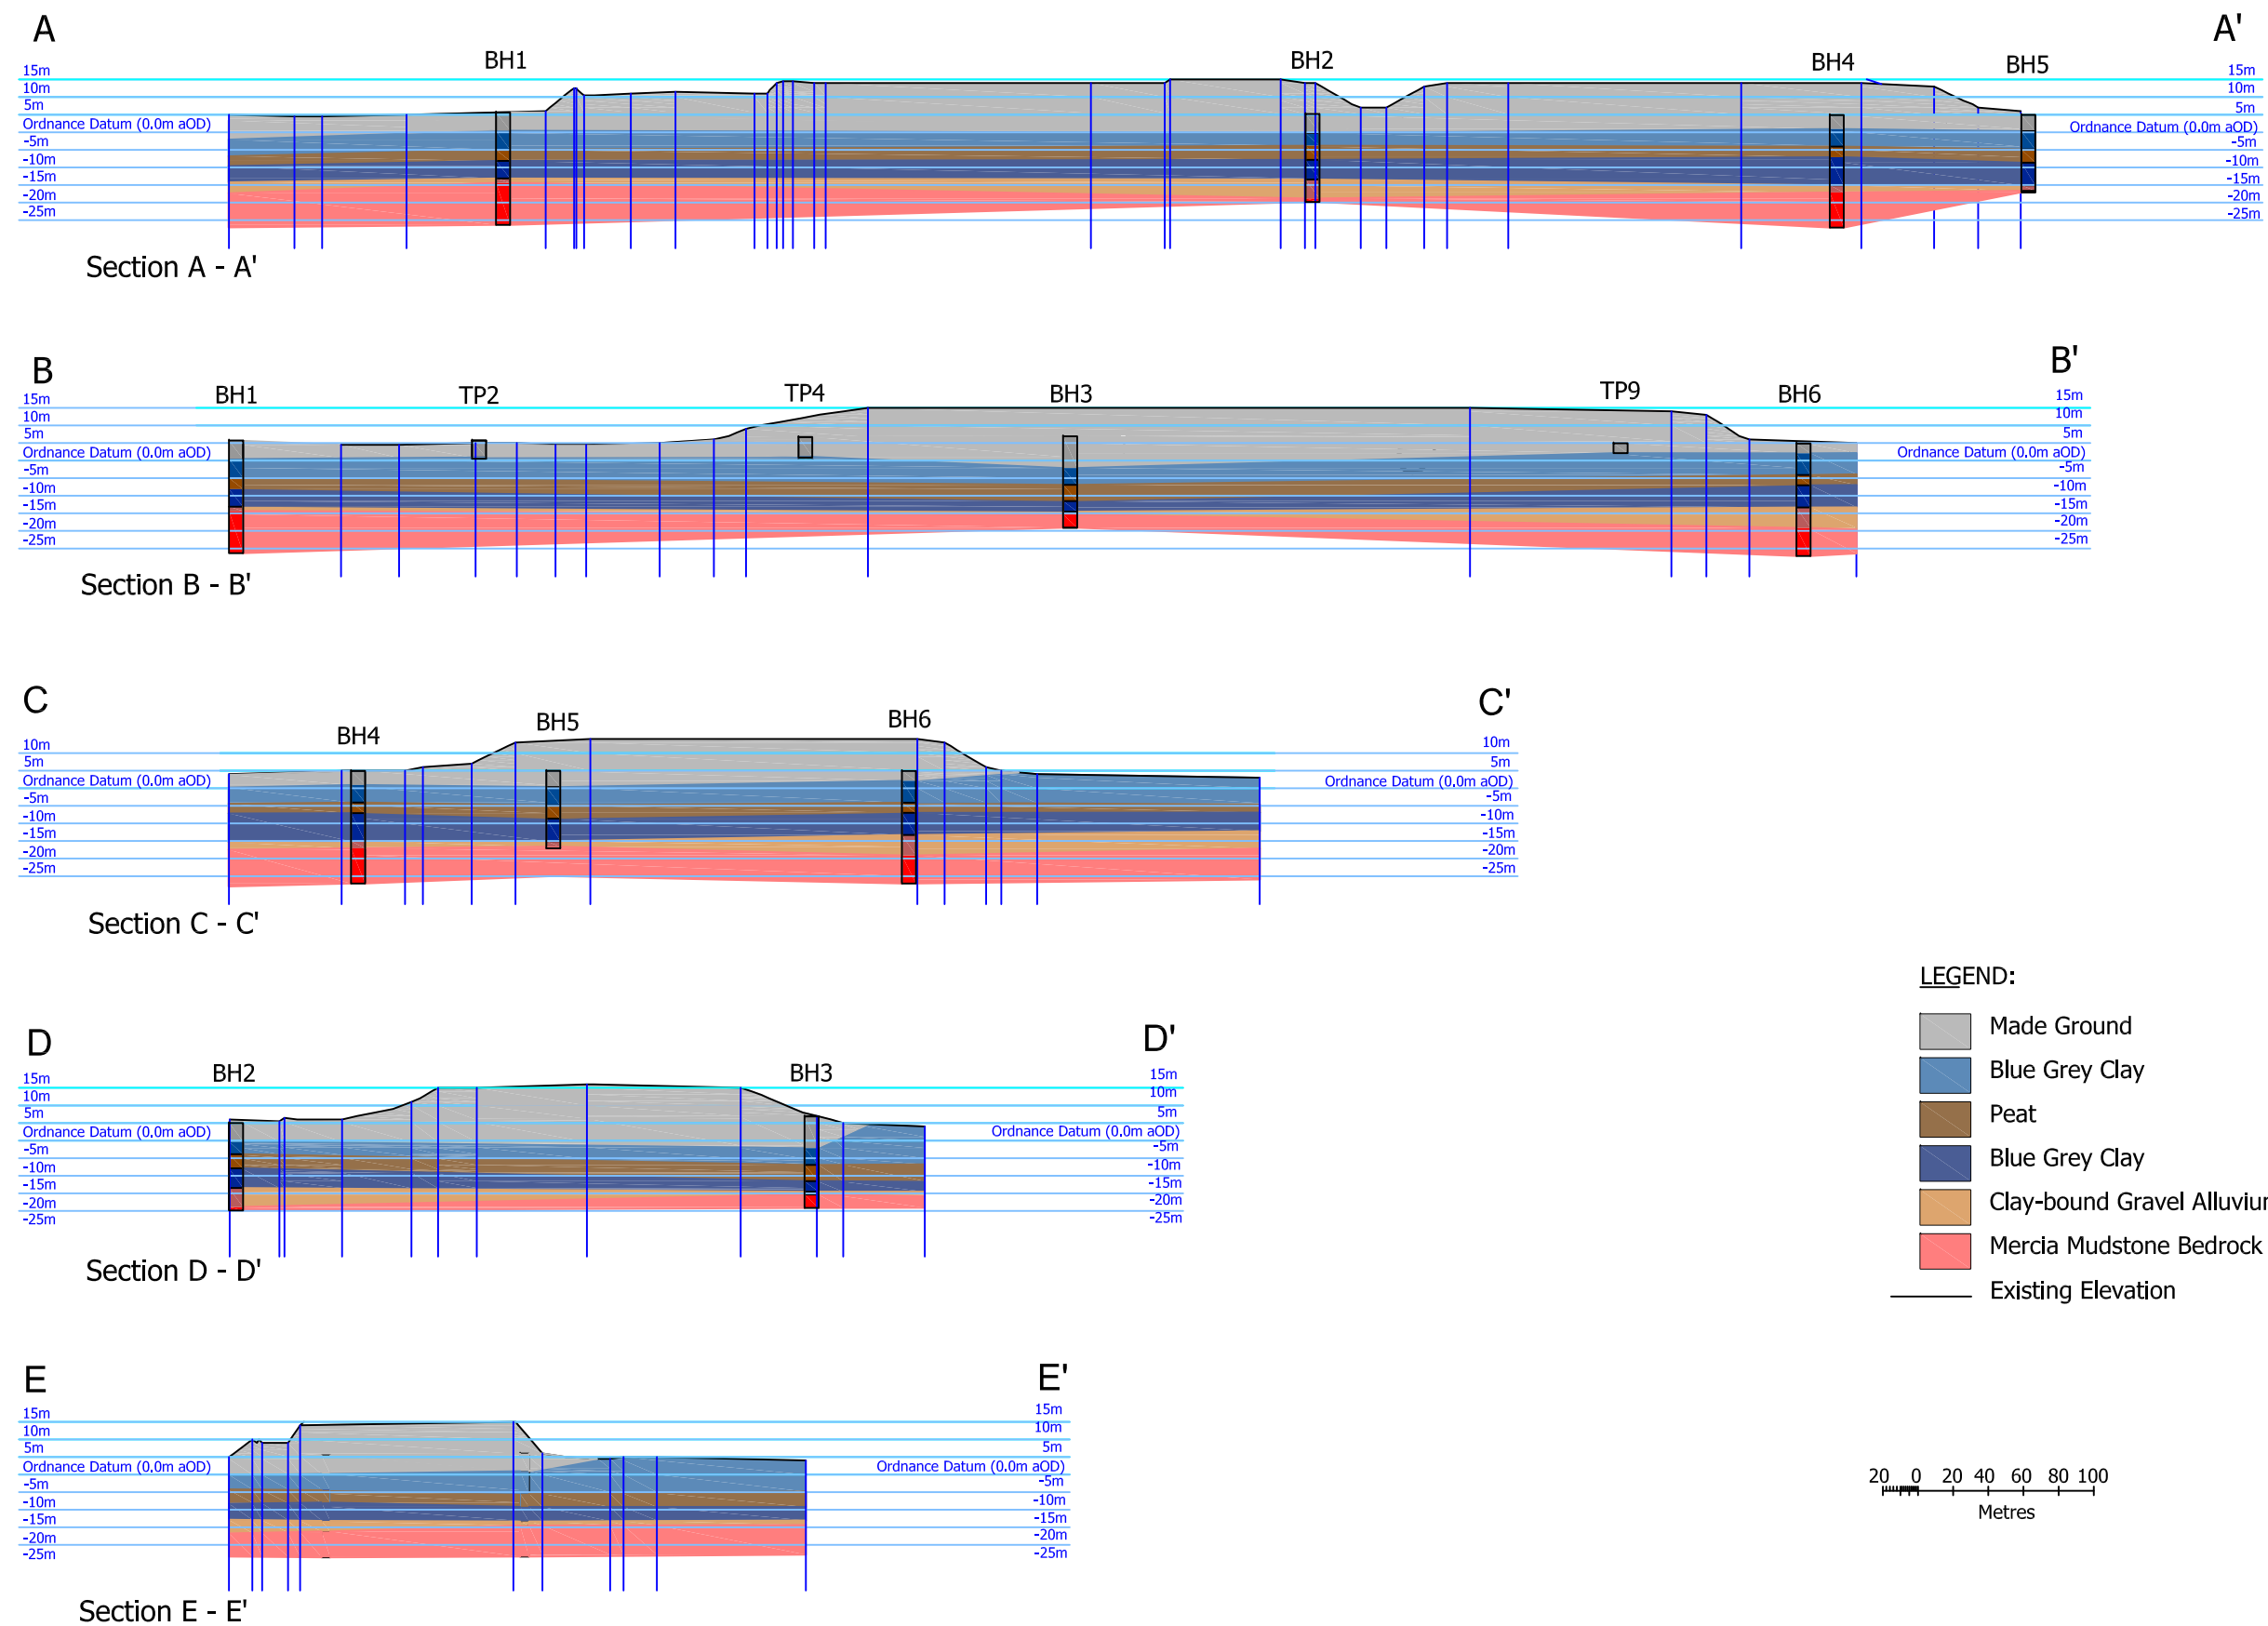
Figure 5 Geological Cross Sections

An examination of the cross sections in Figure 5 and the conceptual hydrogeological model in Figure 7 shows that the fill materials have been placed into a shallow excavation in the clay. This is consistent with historical information which indicates that the site was previously used for water settlement lagoons. The lagoons were dug and embankments constructed around them to contain the water. When the lagoons were decommissioned, they were backfilled with steel slag wastes and thus the water body in the made ground is contained by the clay materials.

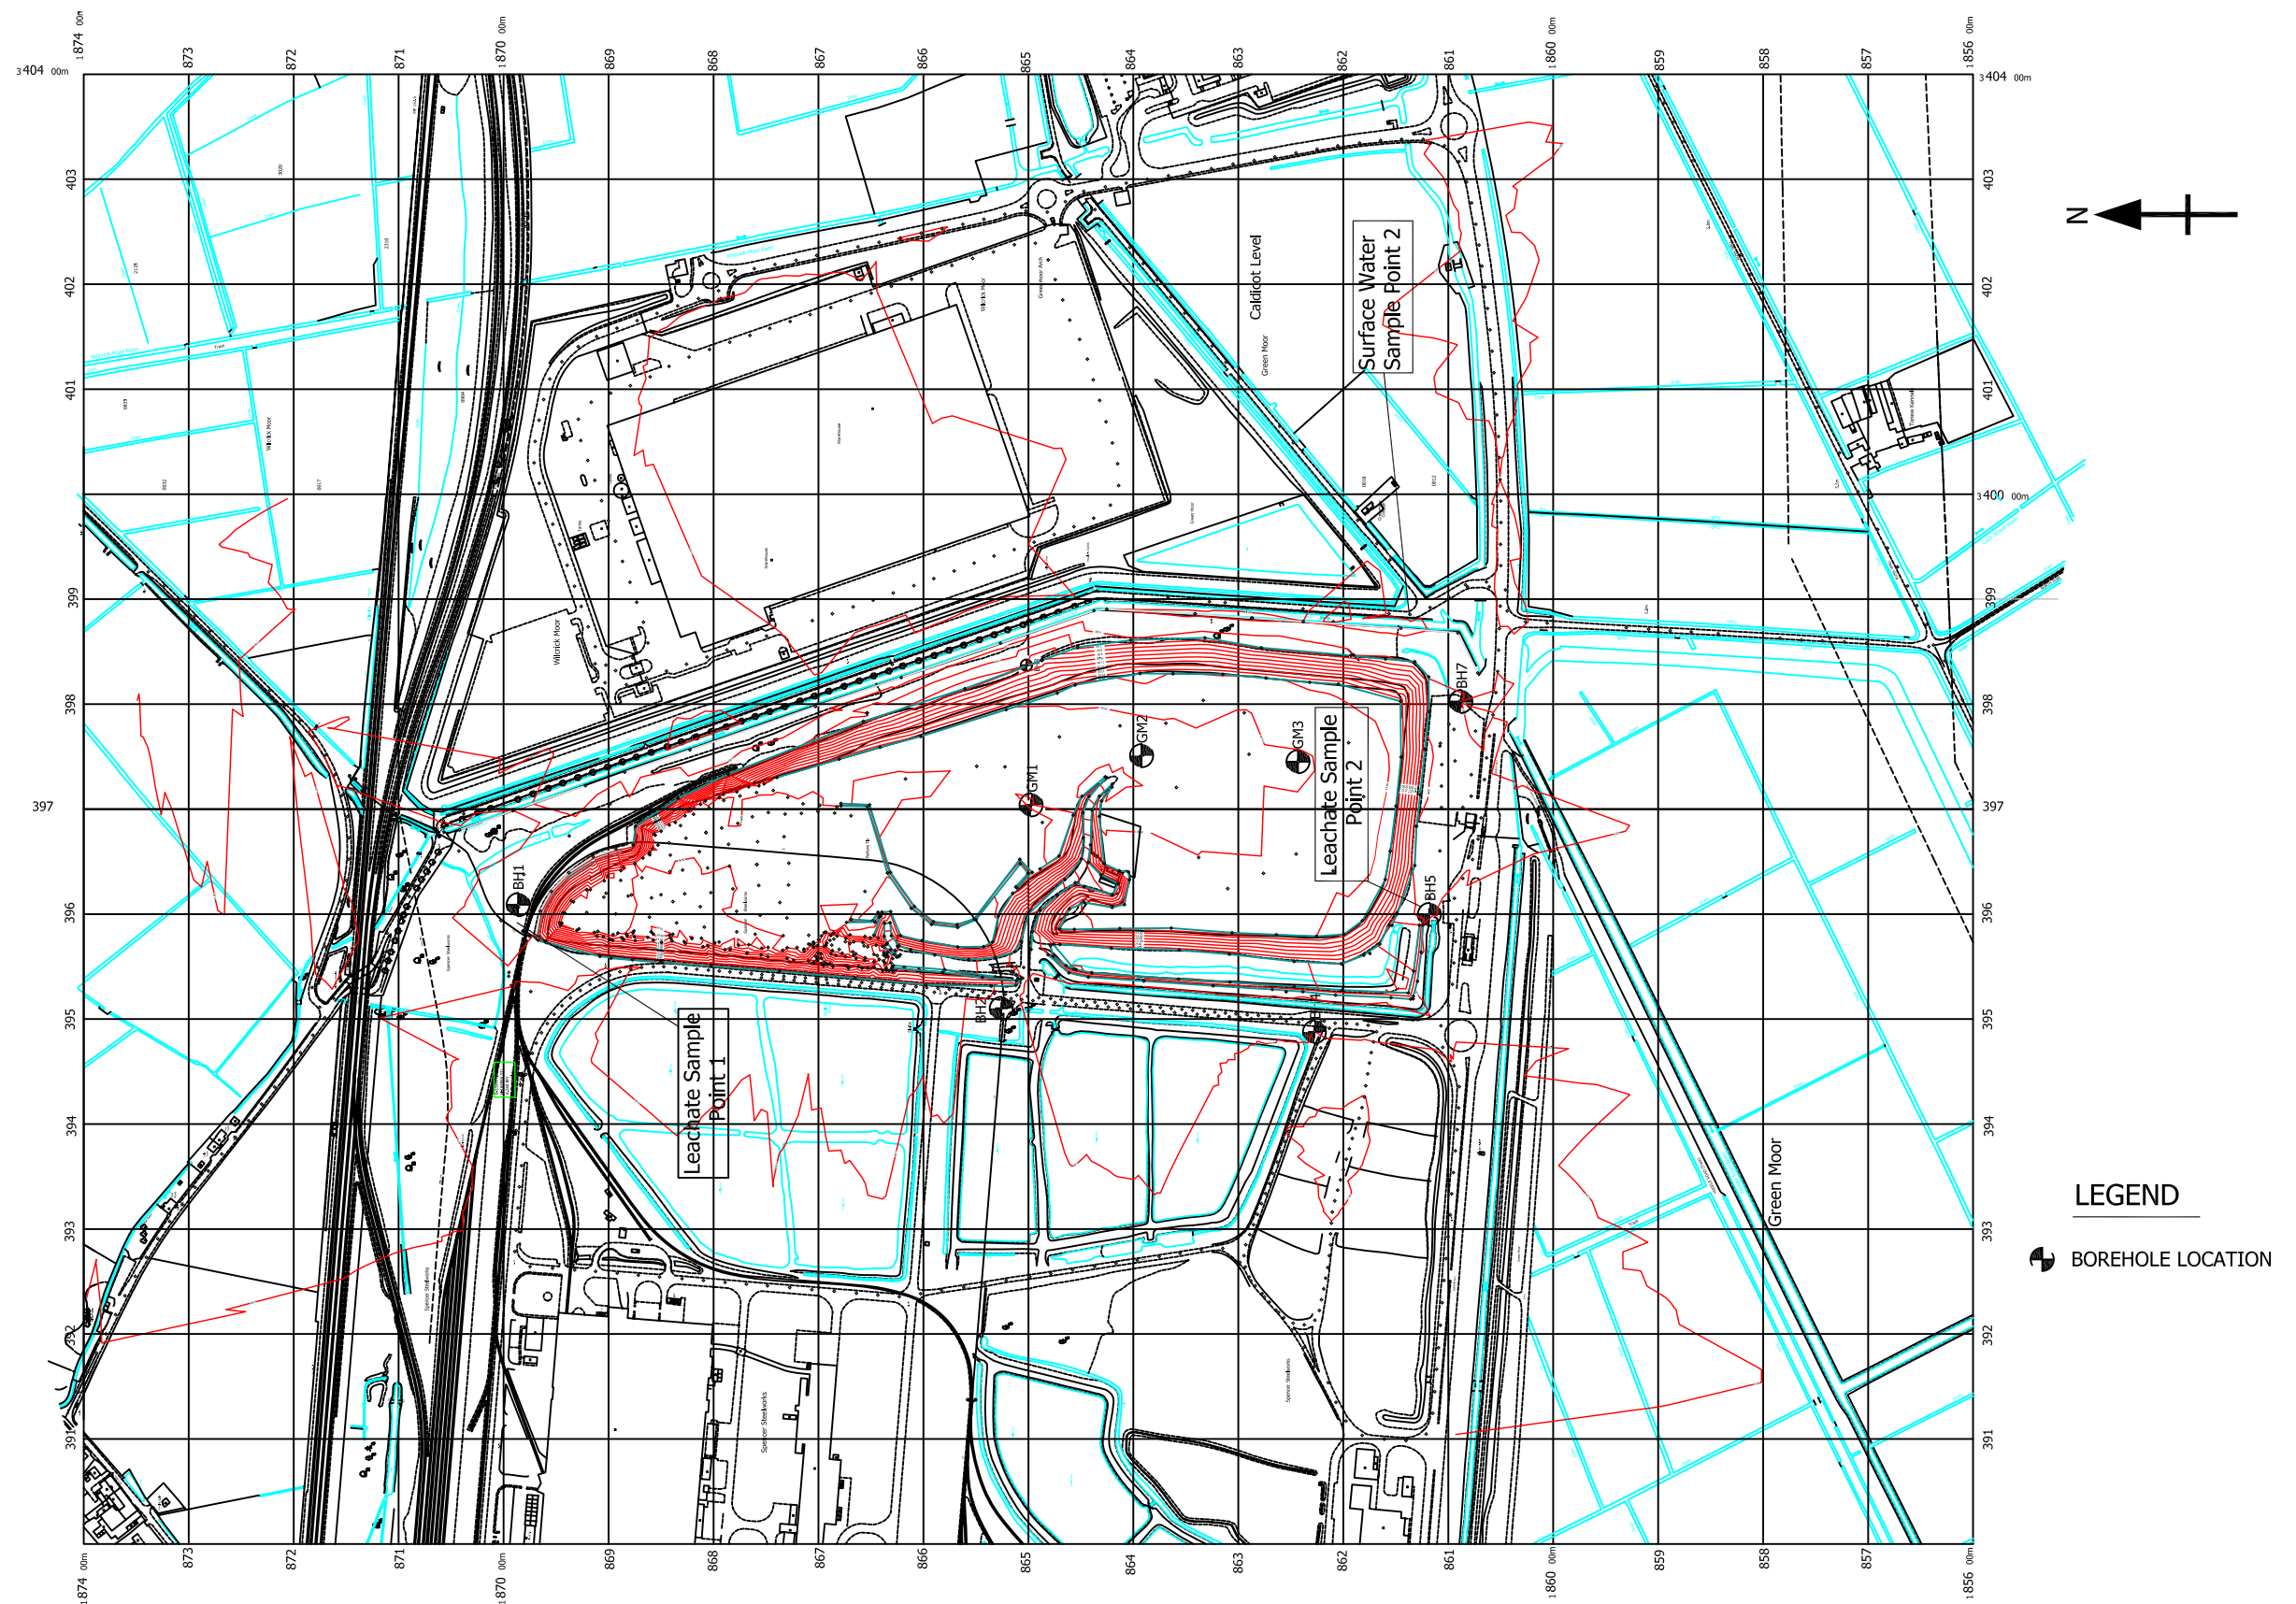
### Figure 6 Available Monitoring Newtowk

Leachate monitoring should comprise a walkover survey of the landfill edge, to examine for the presence of any leachate breakout and sampling from the perimeter ditches at positions EL1 and EL2, as shown on Figure 6. Due to the site being inaccessible this aspect requires review.

The monitoring positions available (BH's 1 to 7) are shown on Figure 6. All positions are currently inspected quarterly to ensure that they provide suitable monitoring infrastructure. Each headworks are unlocked but the site is secure.

With one position upgradient (SW1) and one position downgradient (SW2), one of the aims of the surface water monitoring programme is to detect any influences leaching of the waste mass may be having on local surface water between these two points (see Figure 6).

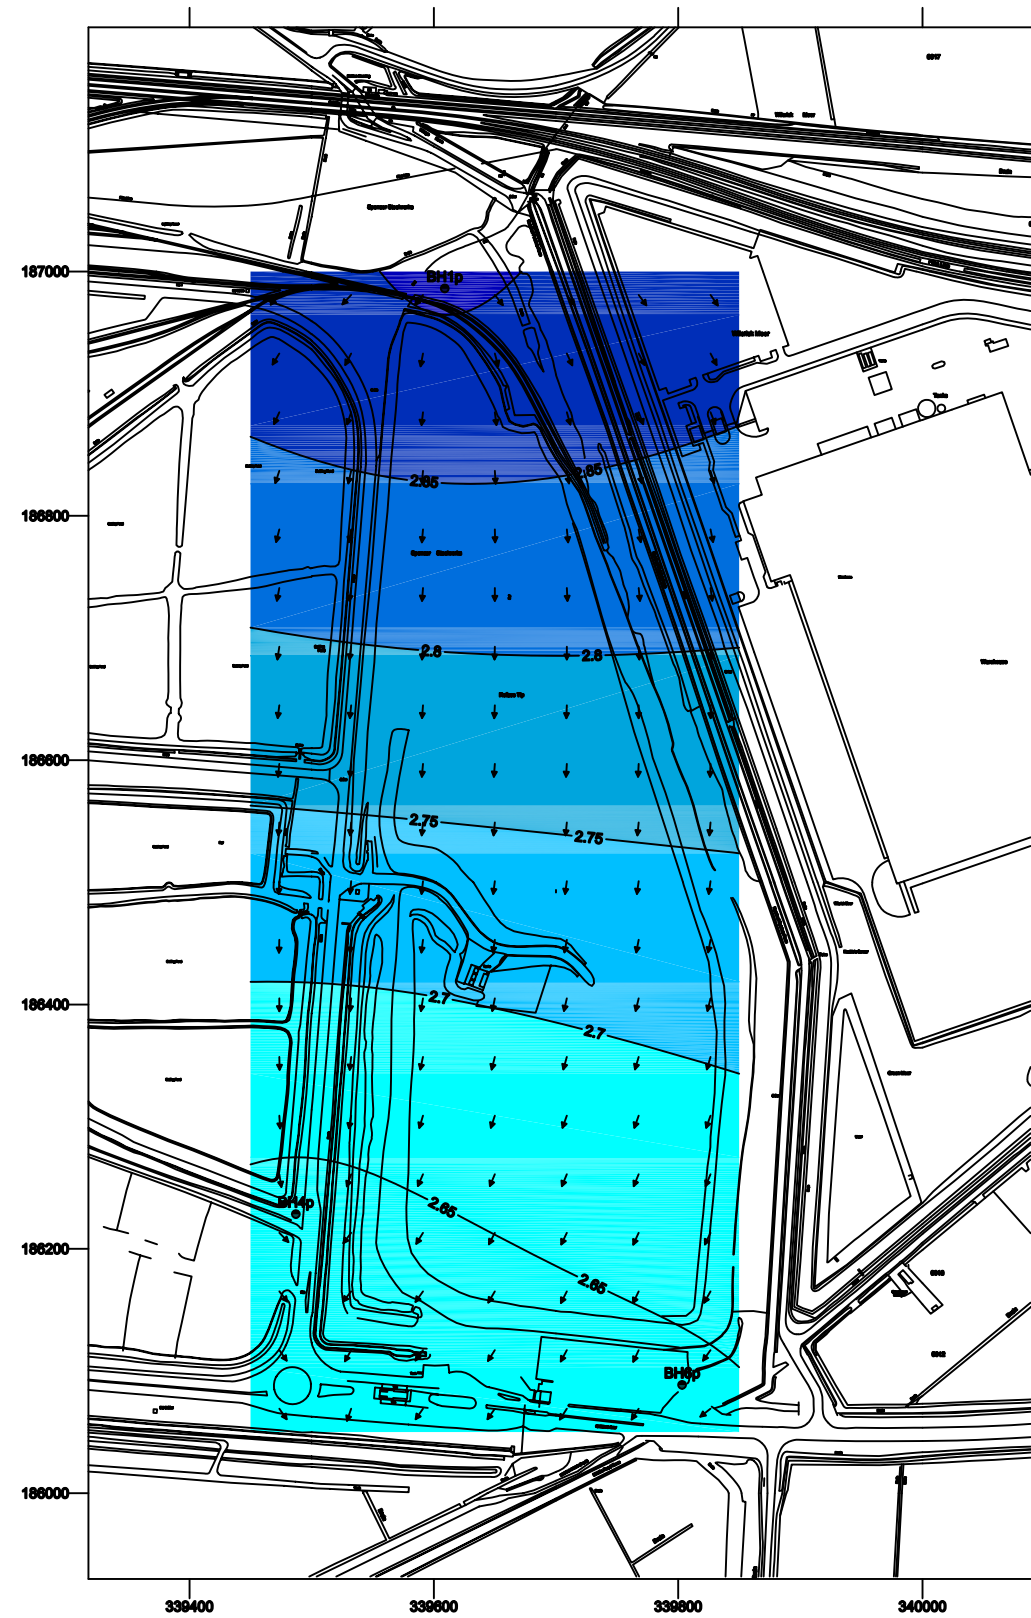
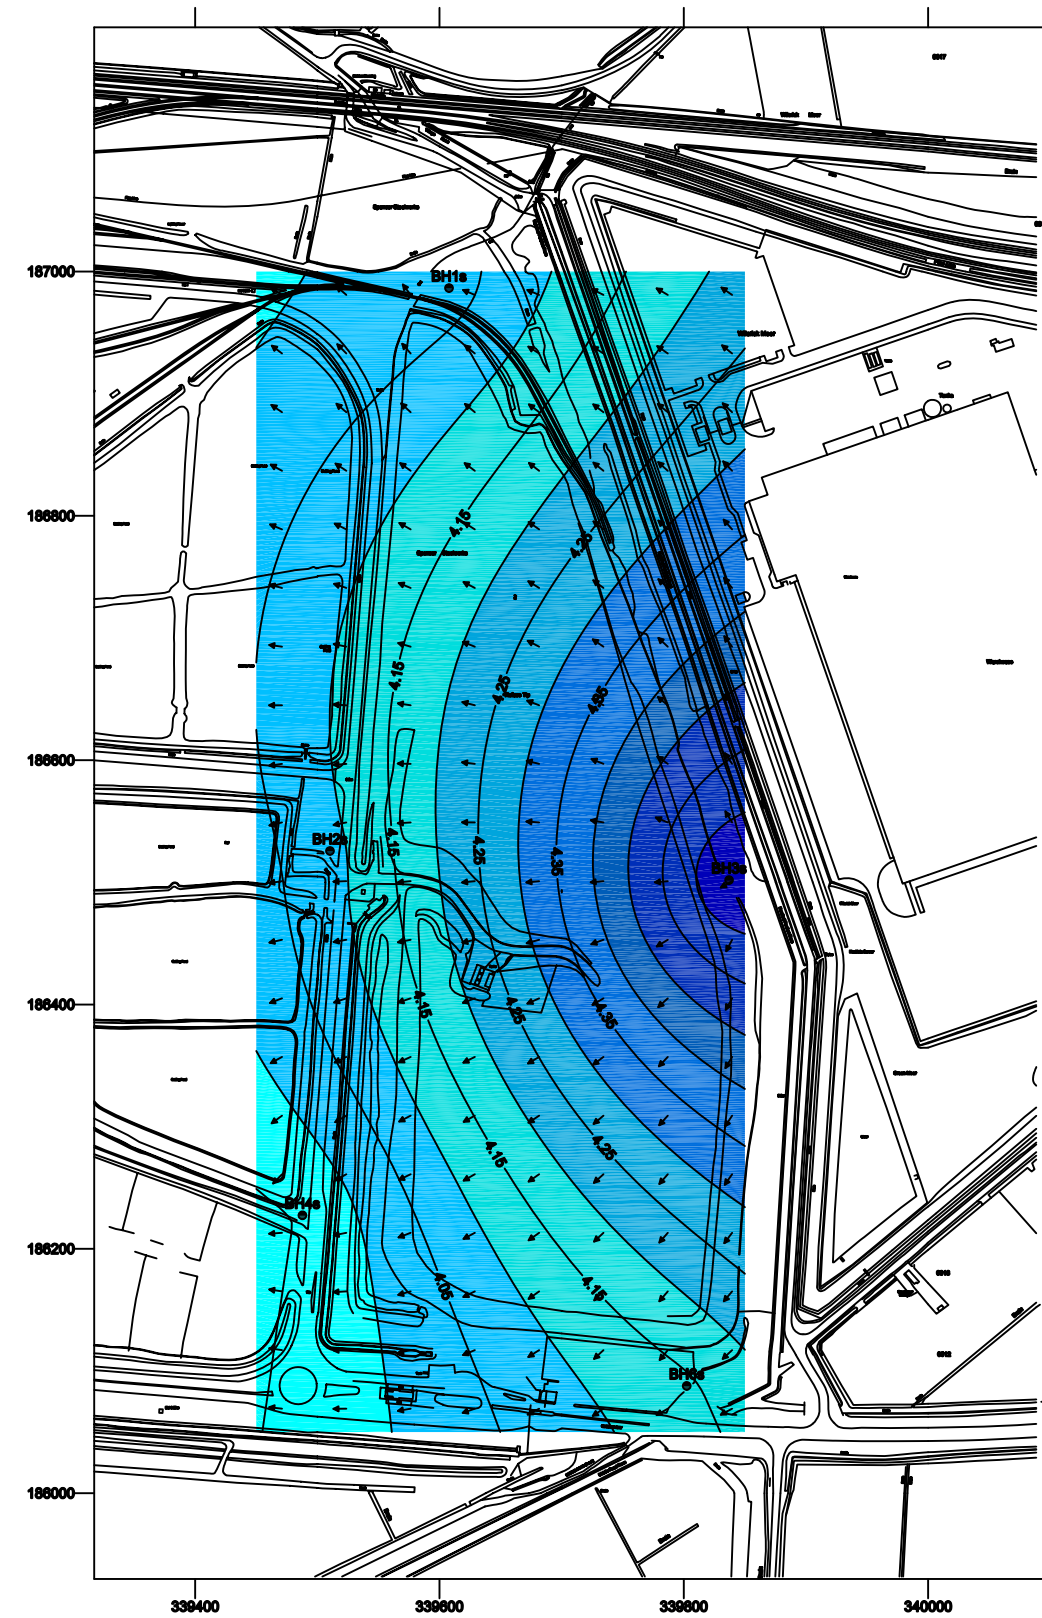
### Figure 8 Historical Groundwater Levels

Groundwater flow in the shallow fill has been historically examined by contouring the piezometric surface, as shown using historical data in Figure 8. The levels, based upon 6 boreholes and 5 trial pits, reduce in elevation from east to west and from centre to north and south. This is not unexpected. A surface water drain, transmitting water from nearby parts of the plant follows the western edge of the landfill at a level controlled by a weir at Drain 10. This water, destined for the works effluent treatment plant is considered to act as a fixed head in the fill materials, controlling the rise of groundwater above this level. This mechanism, therefore, also provides an opportunity for groundwater lowering by reducing the fixed head.

The water flowing in the fill is recharged by infiltration through the waste mass. This is considered to be leachate formed as a result of precipitation, infiltration and subsequent mounding within the waste mass. With the head distribution and flow pattern shown on Figure 8 there is no lateral recharge and therefore, the fill through which the leachate flows could reasonably be considered to be the leachate drainage blanket.

Groundwater flow in the Mercia Mudstone aquifer has been previously established by drilling three piezometers into the rock and measuring the piezometric head. The groundwater levels are sub-artesian and are confined by the lower clay layer. Upon piercing the lower clay and the clayey basal layer, groundwater was seen to rise to 2.9m AOD in the north of the site to 2.6m AOD in the south. Consequently, a very shallow groundwater gradient from north to south was previously detected, as shown on Figure 8.
