**EAST WASTE  
MANAGEMENT SITE,  
LLANWERN STEELWORKS**

**PERMIT EAWML / 30003**

**2017 Annual Review of  
Environmental  
Monitoring**

*Report Number 1680r1v1d0218*

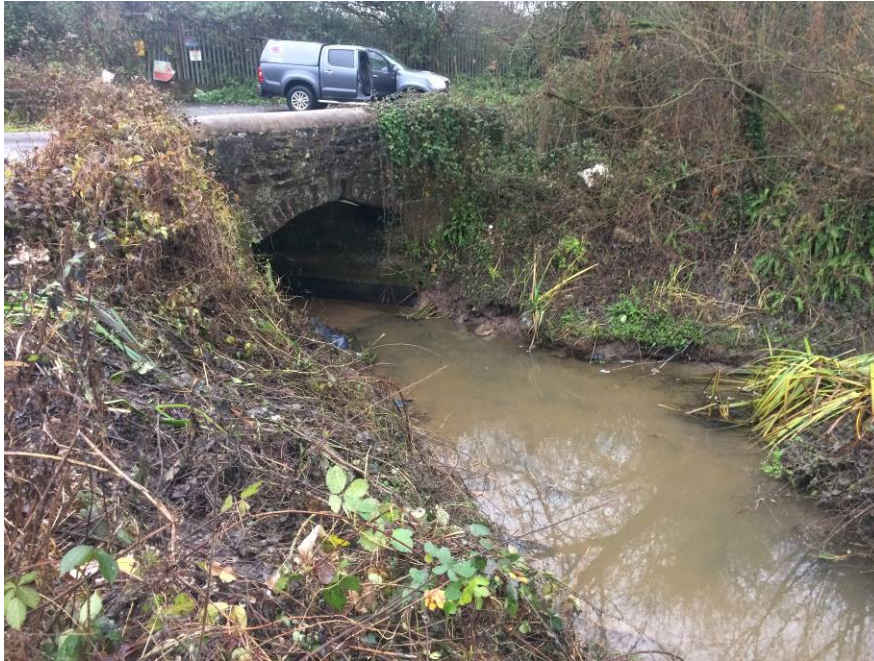
Continued scrutiny of upstream influences is also required as observations in December 2016 (see Plate 3) suggest that there are upstream sources of suspended solids.

Plate 3. Suspended solids in surface water upstream of site

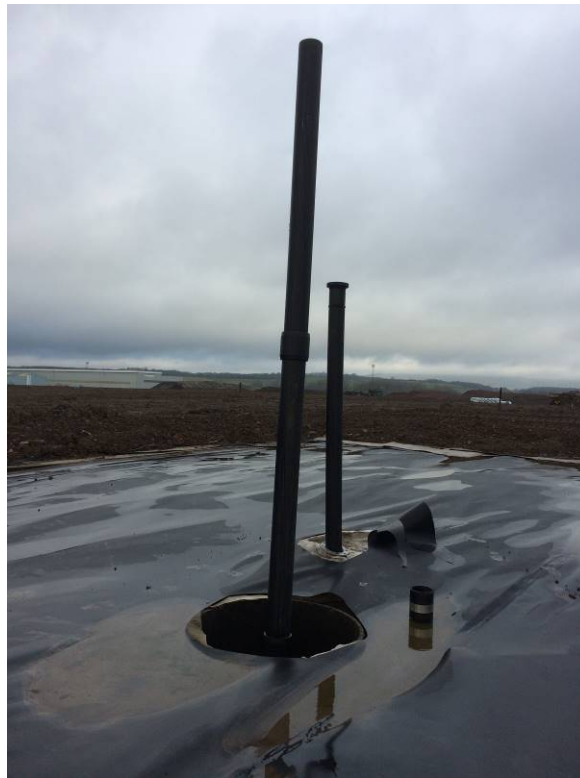
The gas wells will continue to be monitored as the restoration works progress. During this process the gas wells are being connected to the capping systems, as shown in Plate 4. However, as the gas is still free to vent to the atmosphere, only when the site is fully capped can a more representative assessment be made.

Plate 4. Construction of Gas Vents through Capping Systems
