**SOUTH SIDE  
QUEENSWAY WASTE  
MANAGEMENT SITE,  
LLANWERN STEELWORKS**

**2019 Annual Review of  
Environmental  
Monitoring**

*Report Number 1895r2v1d1219*

**December 2019**

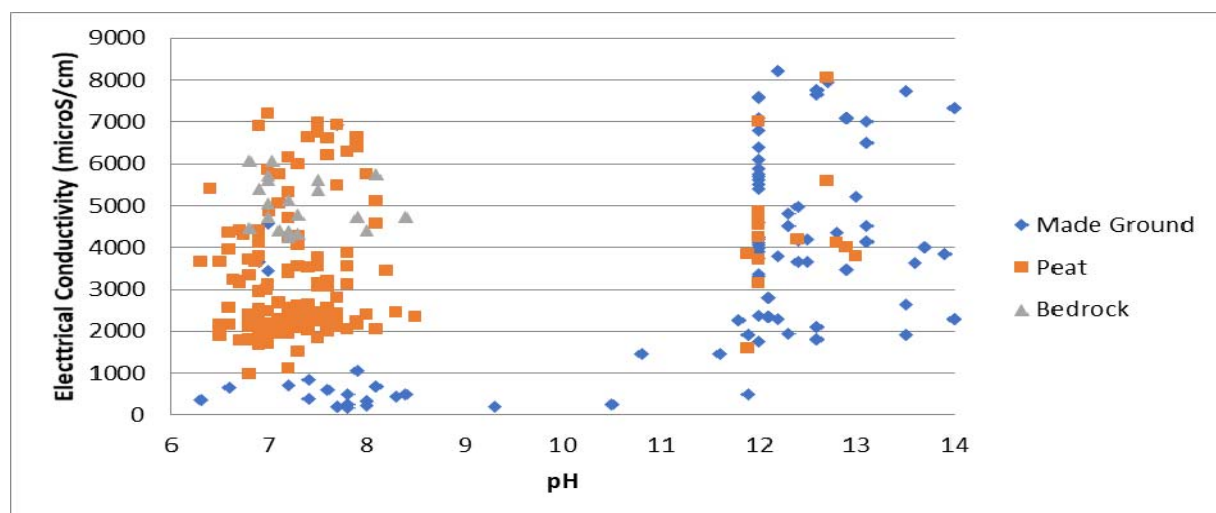
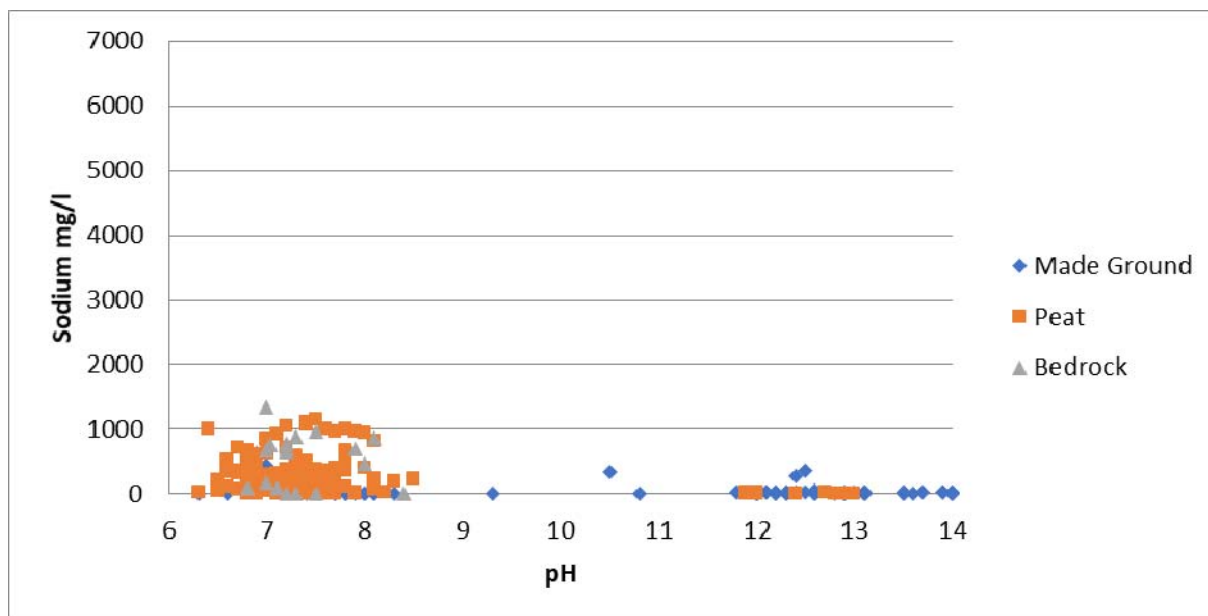
The data indicates that groundwater within the shallow made ground is distinct and characterised by elevated pH (typically > pH 11). This is principally because the made ground comprises steel slag that leaches lime. In comparison, the groundwater in the peat is circumneutral (pH 6 – 8) although there is potential evidence of some interconnection between the made ground and peat at BH202, as the pH is elevated at this point. Groundwater chemistry tends to become more dilute from north to south.

Because of the highly alkaline pH, most non-hazardous and hazardous substances are either below detection limits or at low concentrations in the groundwater recovered from the made ground. In recent years, hazardous substance cadmium has been detected on several occasions and sometimes at elevated concentration. In 2019, cadmium was only detected once, at BH18D, at 0.001 mg/l. In 2018, cadmium was detected from groundwater sampled from wells with screened intervals in the peat (BH13D, BH17, BH203D and BH205D) but this has not persisted.

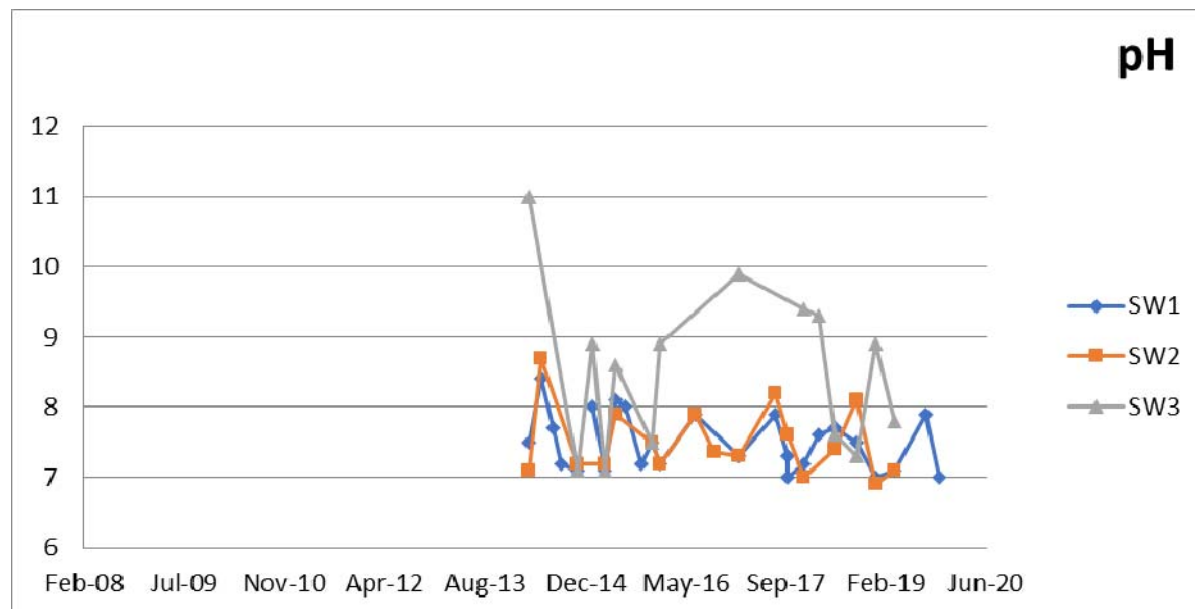
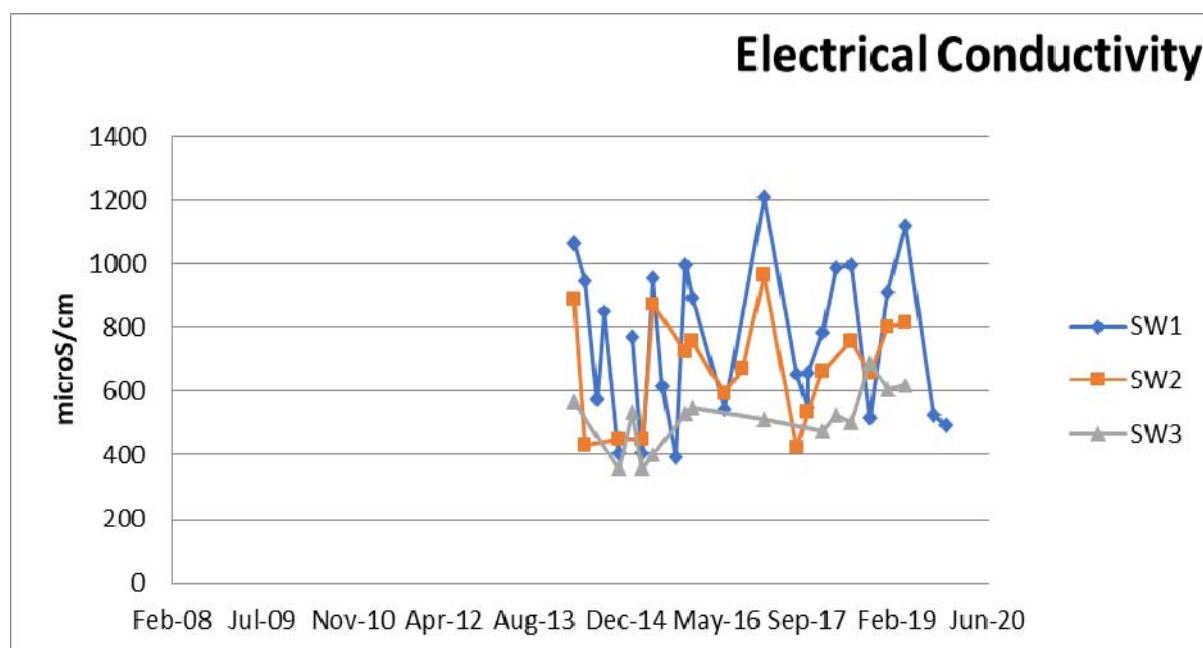
Surface water is typically circumneutral, moderately mineralised with low levels of non-hazardous substances. As surface water progress from east to west, the mineralisation decreases from ~ 800 microS/cm to less than 600 microS/cm. The main reason for this change is decreasing alkalinity although most parameters are lower downgradient of SW1. Apart from a few short-term breaches, all data is typically within Environmental Quality Standards.

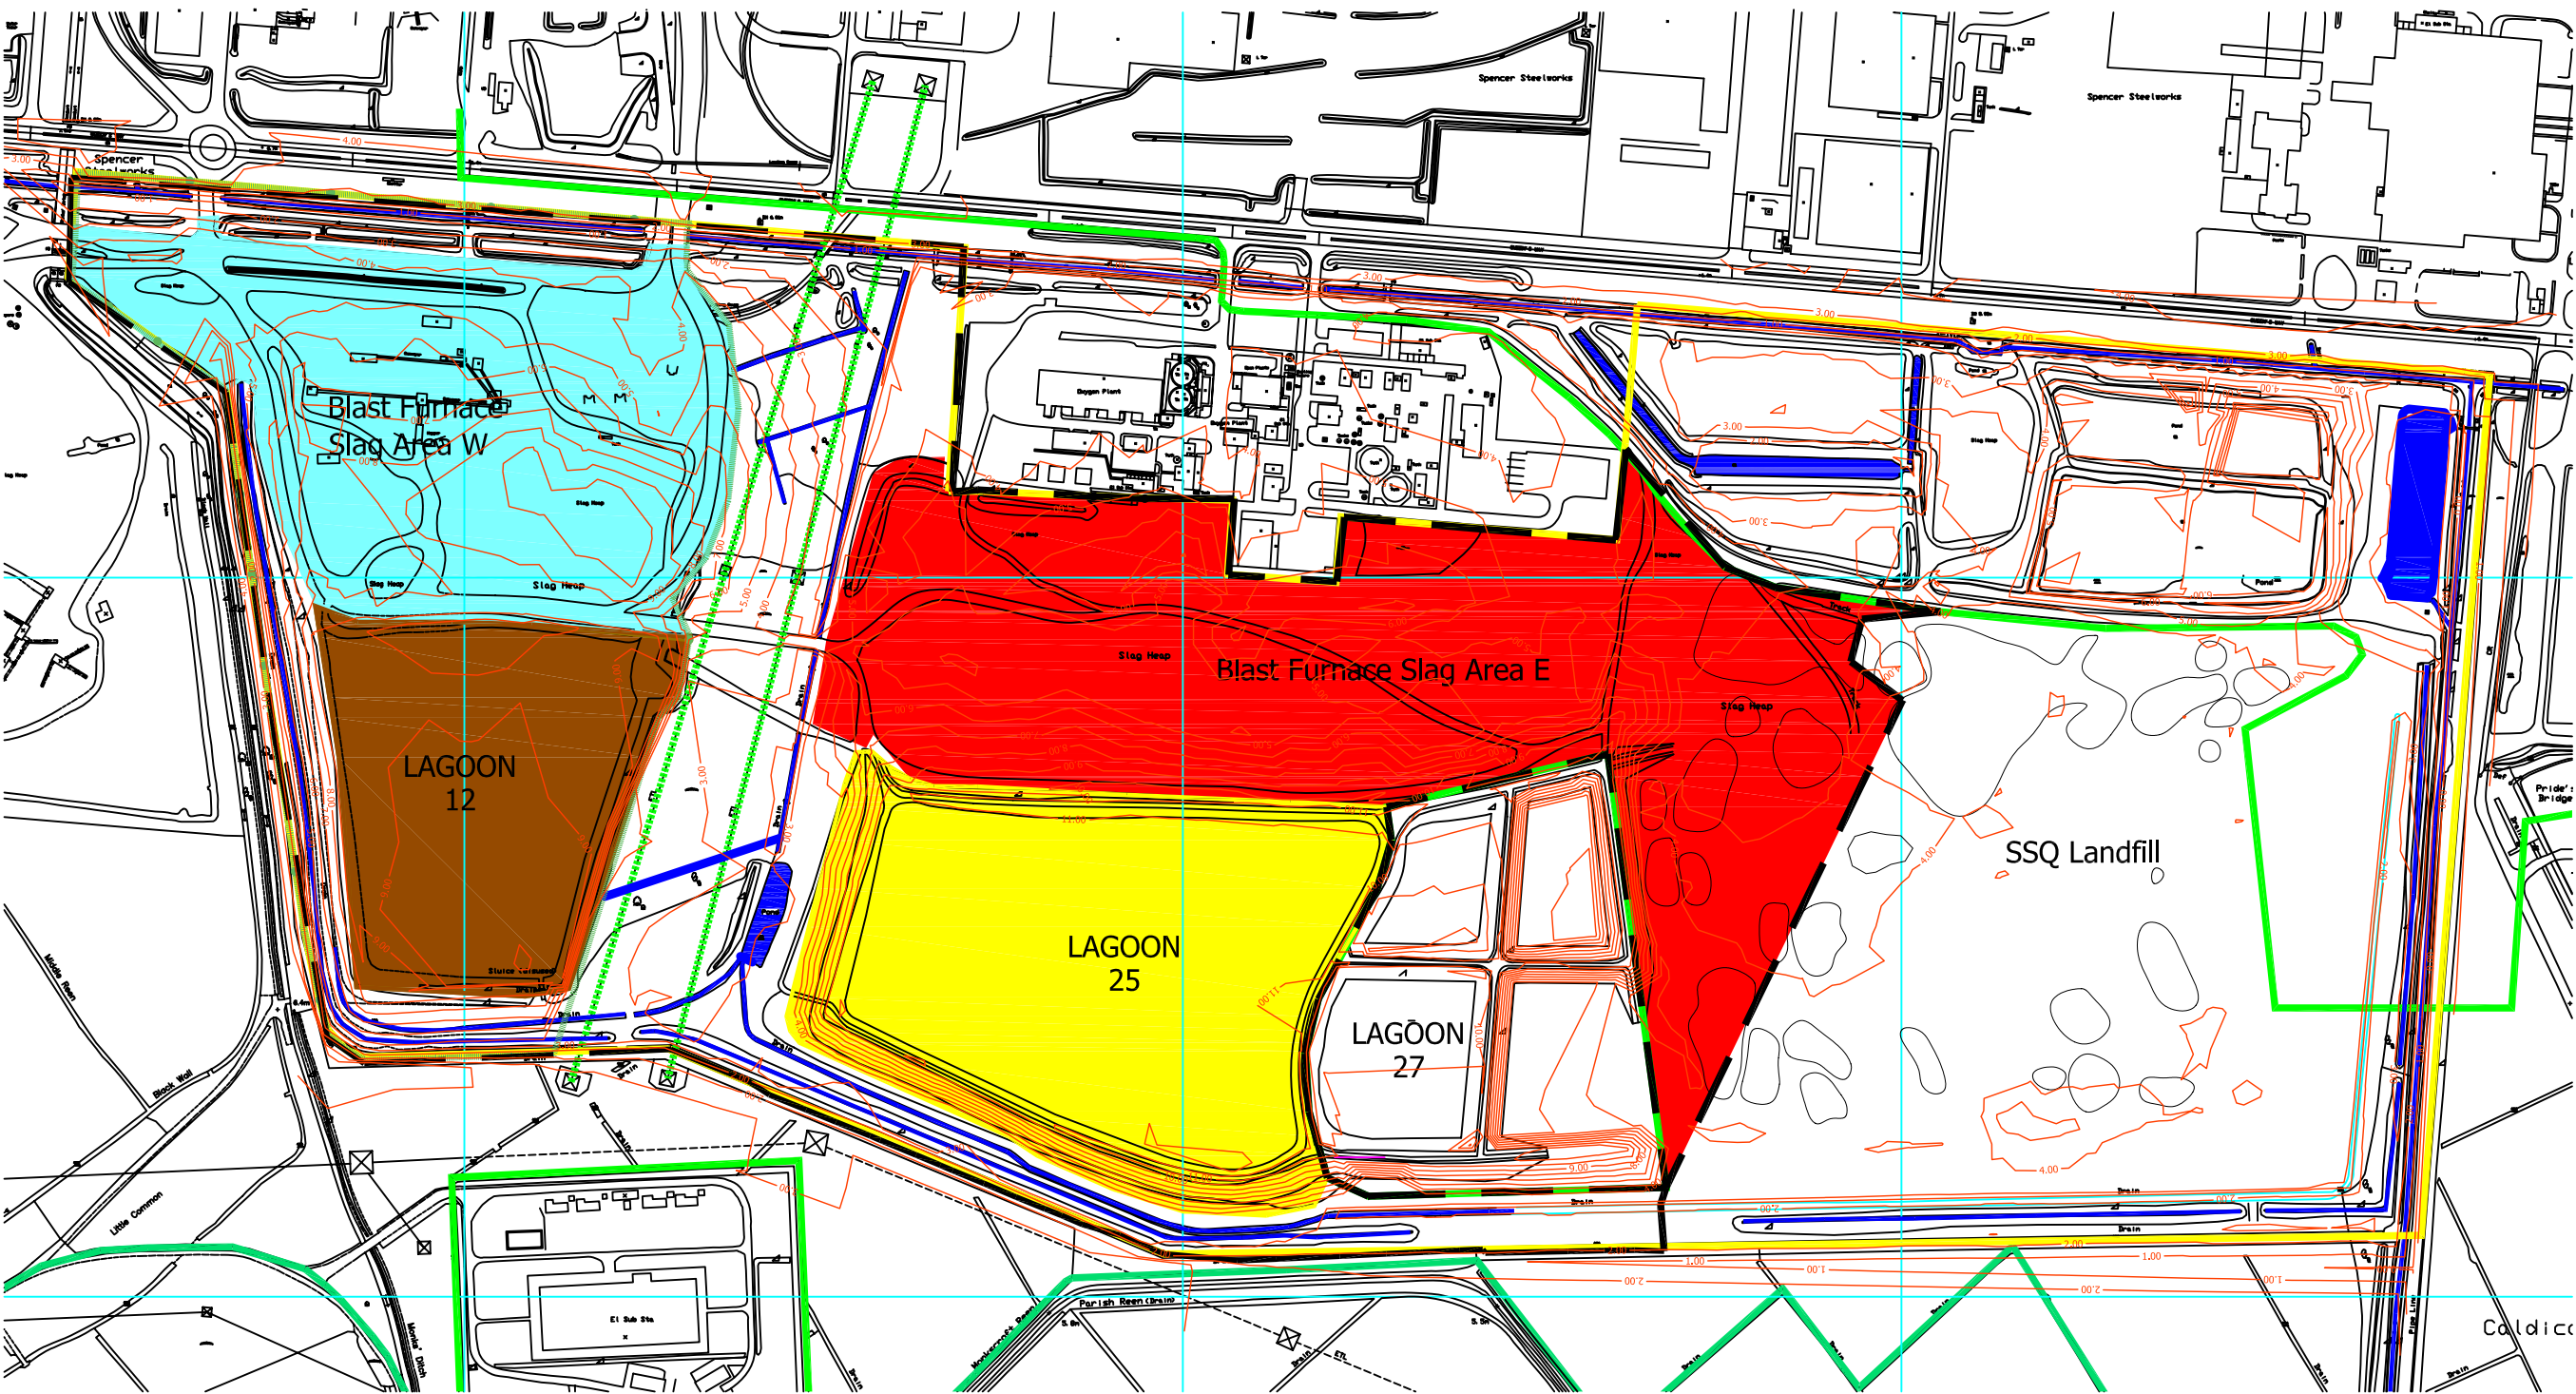
Figure 3 Areas of Site Included in Closure Plan

In the context of the areas of SSQ which have now been definitively closed and which are of most relevance to this report, these are distinguished from the other site areas as coloured blocks on Figure 3. On Figure 3, the area which has been definitively closed is outlined with a black dashed line with key sub-areas shaded. The closure plan, therefore, only referred to the areas within the dashed closure boundary and no other areas. The areas bound by the closure plan are:

Throughout the duration of disposal activities, steel and iron slag was deposited to the north and east of Lagoons 12 and 25. Deposits of coarse granular slag of up to 7m thickness covered the areas indicated on Figure 3 as Slag Area W, Slag Area E and the SSQ Non-Hazardous Landfill. Since its deposition, both steel slag and blast furnace slag have become commercially viable for a variety of applications and most of the deposit has now been removed. The entire area now occupied by SSQ Non-Hazardous Landfill has, therefore, been reduced to a 1m thick slag stabilising layer.
