**SOUTH SIDE  
QUEENSWAY WASTE  
MANAGEMENT SITE,  
LLANWERN STEELWORKS**

**2023 Annual Review of  
Environmental  
Monitoring**

*Report Number 2299r2v1d0124*

**January 2024**

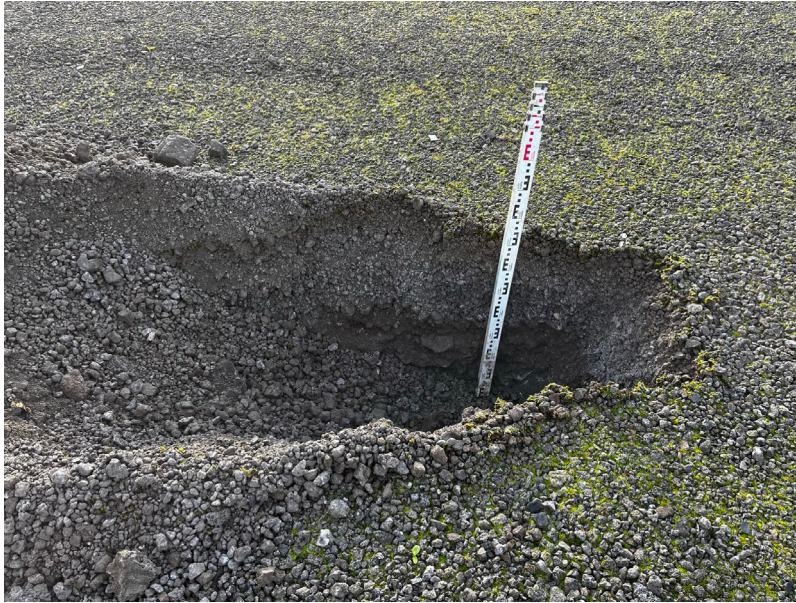
**Plate 2-2 Near surface slag development platform**

The area is currently covered with a blanket of fill materials comprising mainly steelmaking BOS slag (steel slag) which was deposited in the 1970's. This development platform is approximately 1m thick with a typical shallow profile shown in Plate 2-2.

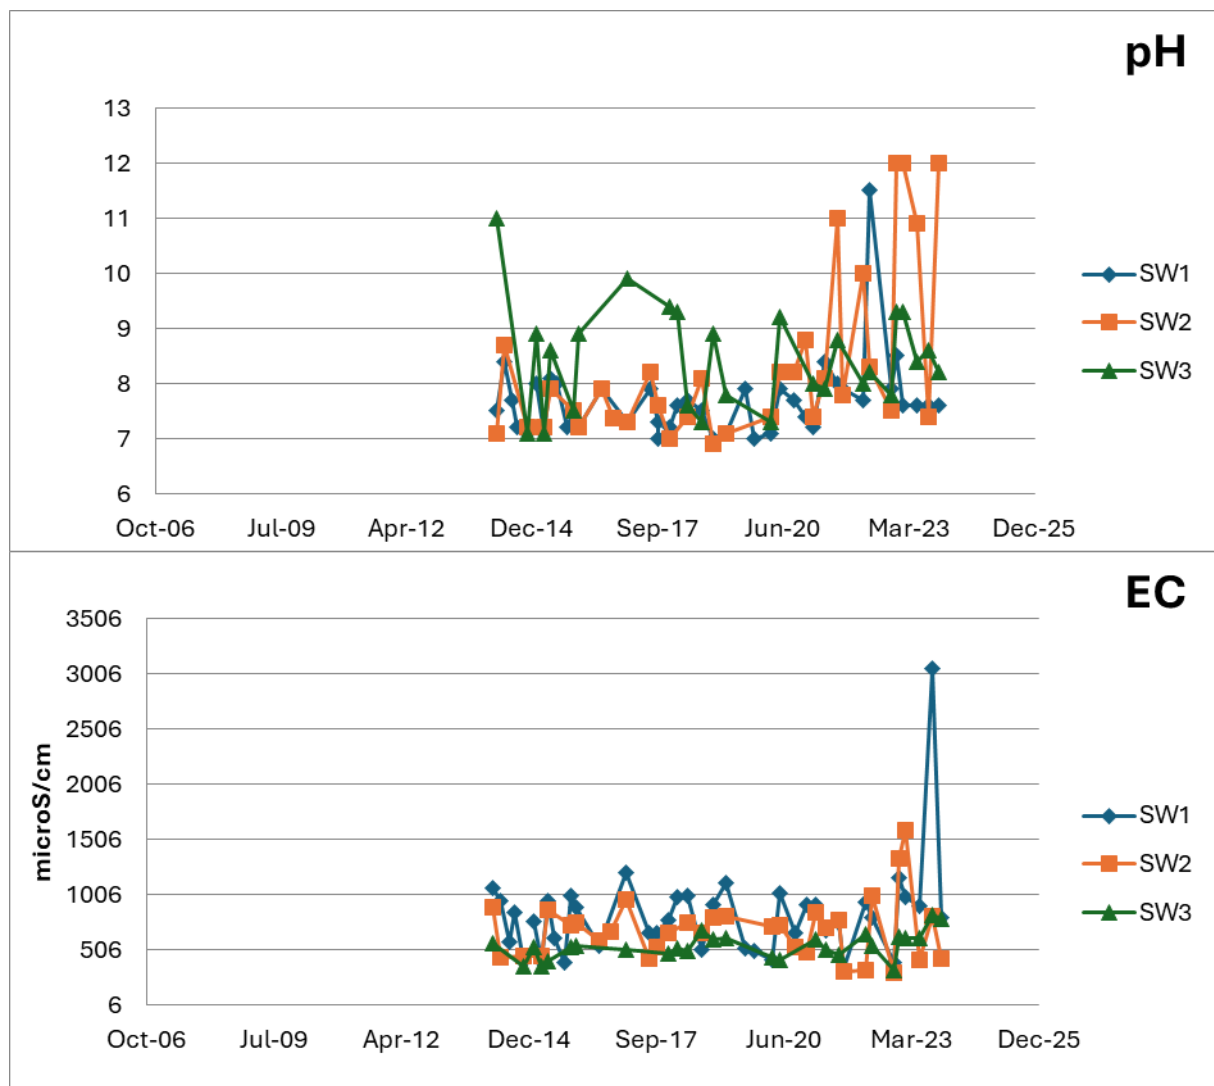
**Plate 6-1 Variations in surface water chemistry**

The data gathered during the past 12 months continues to suggest that surface water is becoming increasingly alkaline. This is based on the upwards inflection of the pH observed at all sample points over the past 24 months. It appears that there is a long-term underlying upwards trend in surface water pH with short-term spikes in pH, particularly at SW2. This is clearly shown in Plates 6-1 and 6-2. Sample position SW2 is downstream of SW3 and upstream of SW1, adjacent to powerline alley.

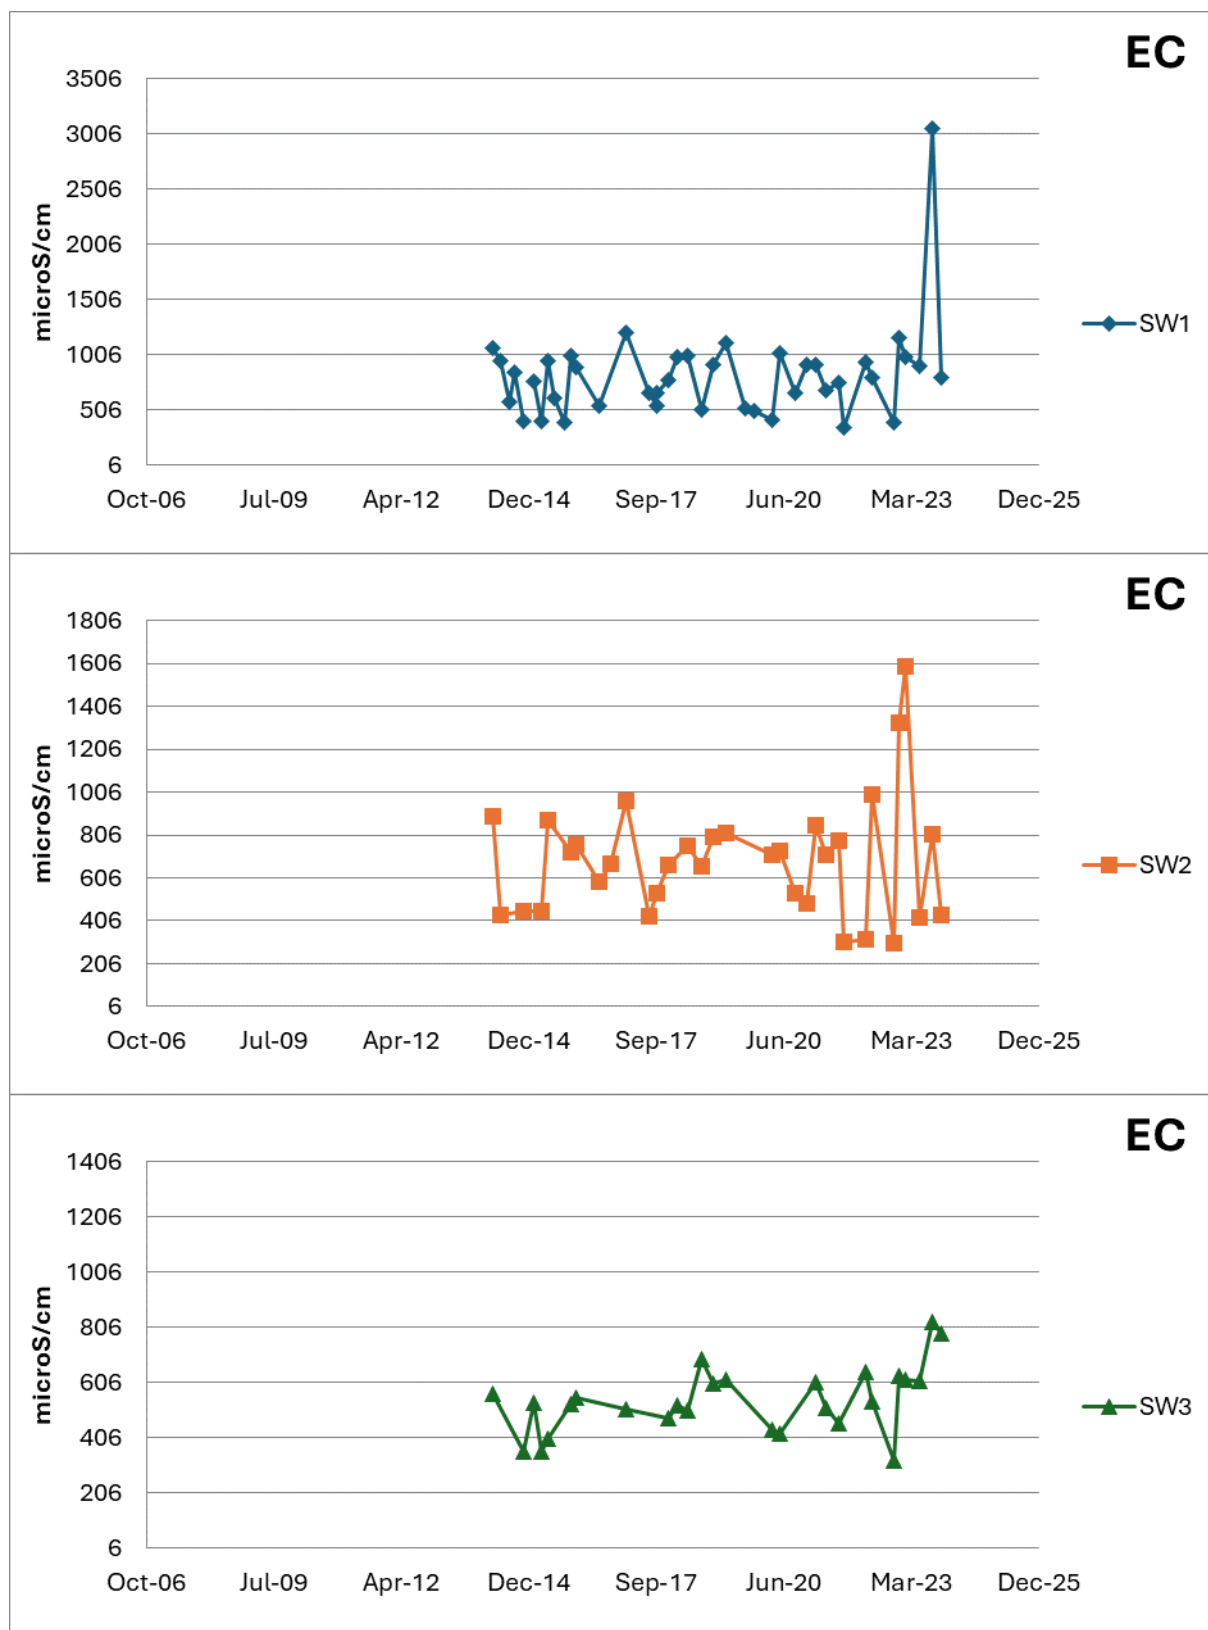
**Plate 6-3 Variation in Electrical Conductivity (EC) in surface water**

Whilst pH has increased, there is no clear trend with Electrical Caducity or any other parameter apart from possibly potassium and nickel (see Appendix 2). The data varies considerably for several parameters with Electrical Conductivity sometimes doubling/halving between quarterly sampling events, as shown in Plate 6-3. There are sometimes short-term

variations in trace metal concentrations but no persistent trends indicating deteriorating water quality.

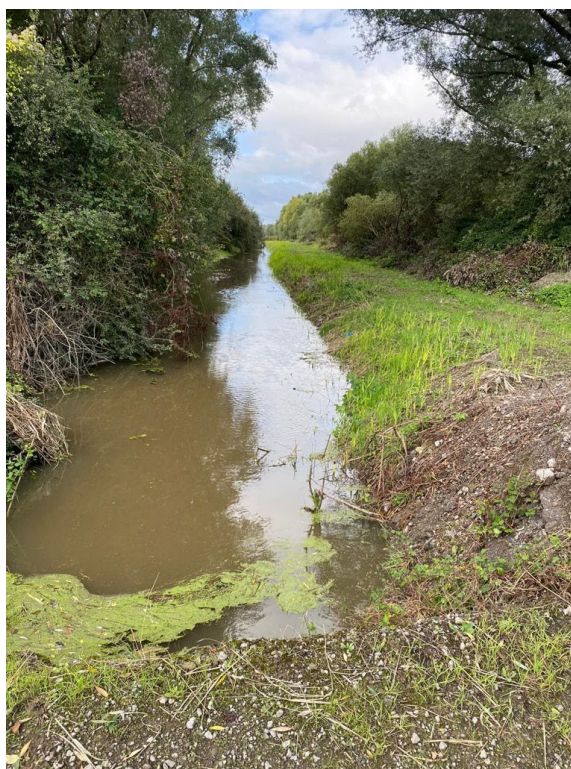
**Plate 6-5 Raised surface water levels in October 2021**

Some of the data trends may be influenced by the timing of sampling relative to ditch clearance and maintenance, as shown in Plate 6-4. In October 2021, some of the highest surface water levels observed were found at SW1 (compare Plates 6-4 and 6-5). This was due to significant rainfall in the preceding 24 hrs.
