**SOUTH SIDE  
QUEENSWAY WASTE  
MANAGEMENT SITE,  
LLANWERN STEELWORKS**

**2022 Annual Review of  
Environmental  
Monitoring**

*Report Number 2215r2v1d0123*

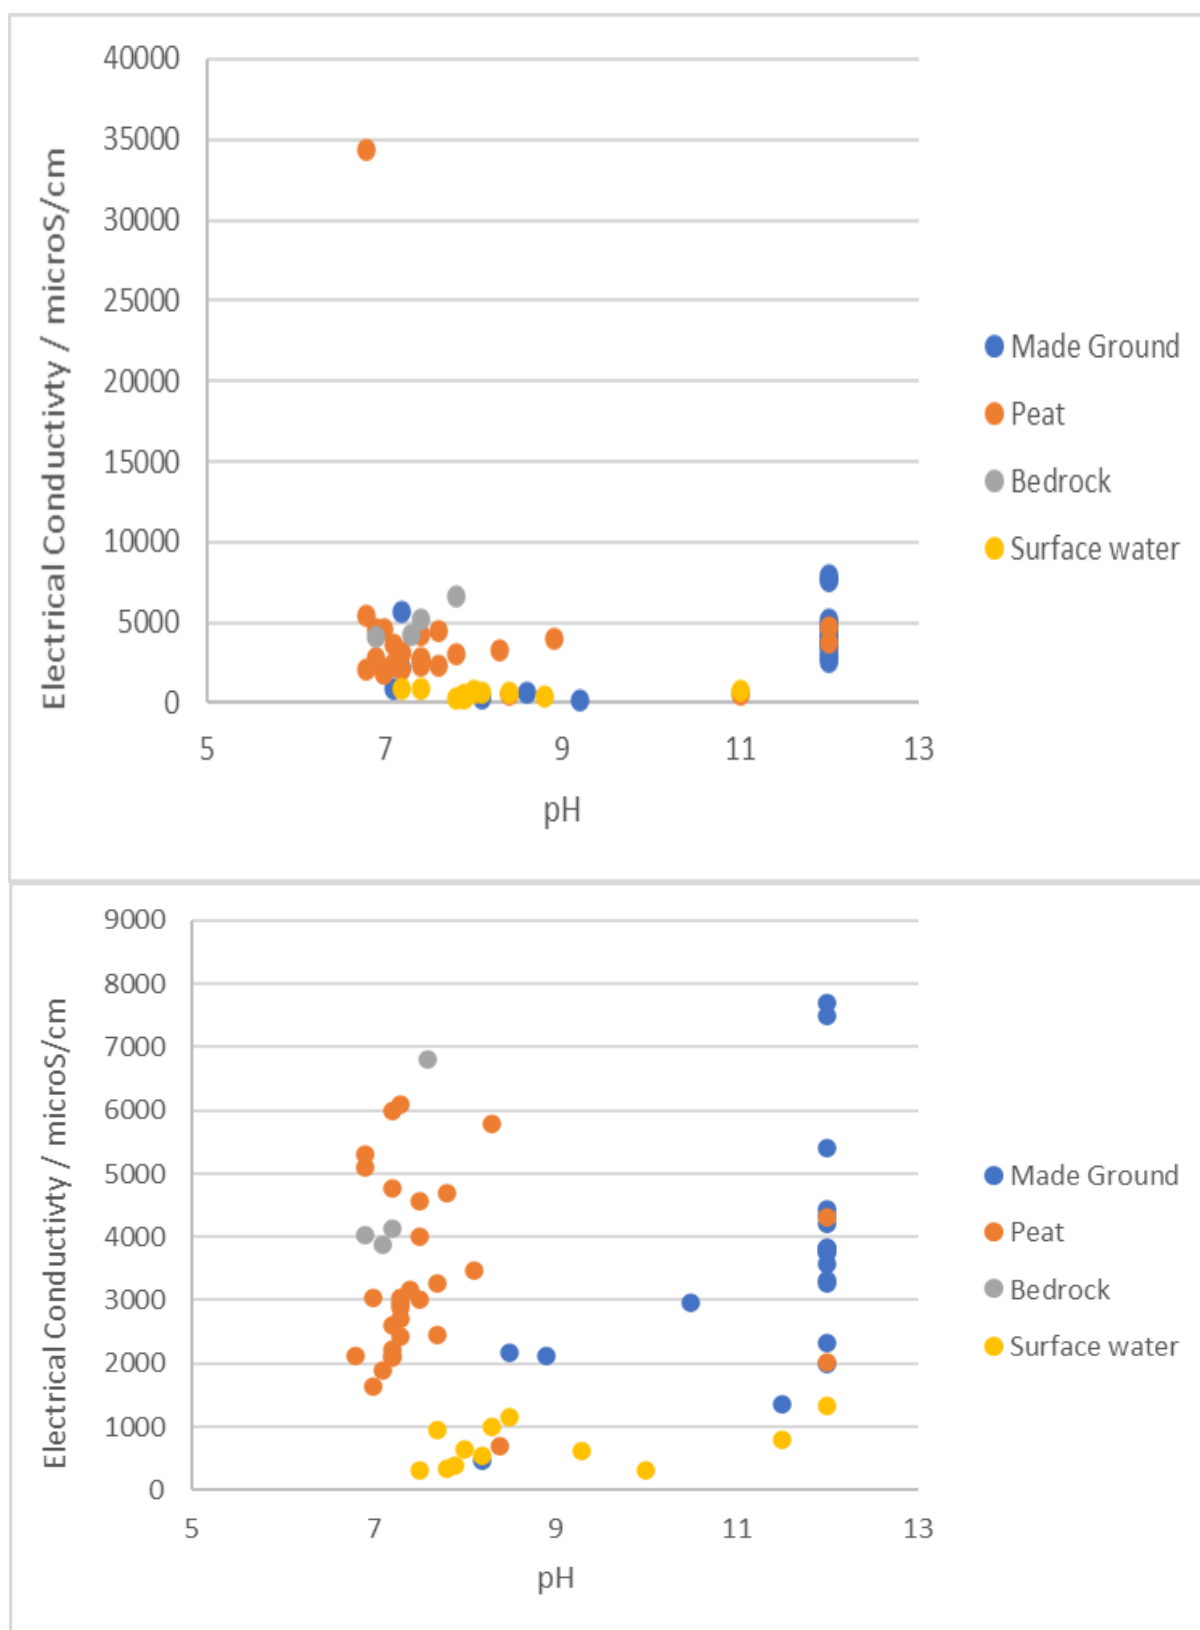
**Plate 5-1 pH and Electrical Conductivity during 2021 (top) and 2022 (bottom)**

The data indicates that groundwater within the shallow made ground is distinct and characterised by elevated pH (typically > pH 11). This is principally because most of the made ground comprises steel slag that releases a strongly alkaline pH during weathering. In comparison, the groundwater in the peat is circumneutral (pH 6 – 8) although the elevated pH at BH202 suggests that there could be localised interconnection between the made ground and peat at this point. Groundwater chemistry tends to become more dilute from north to south.

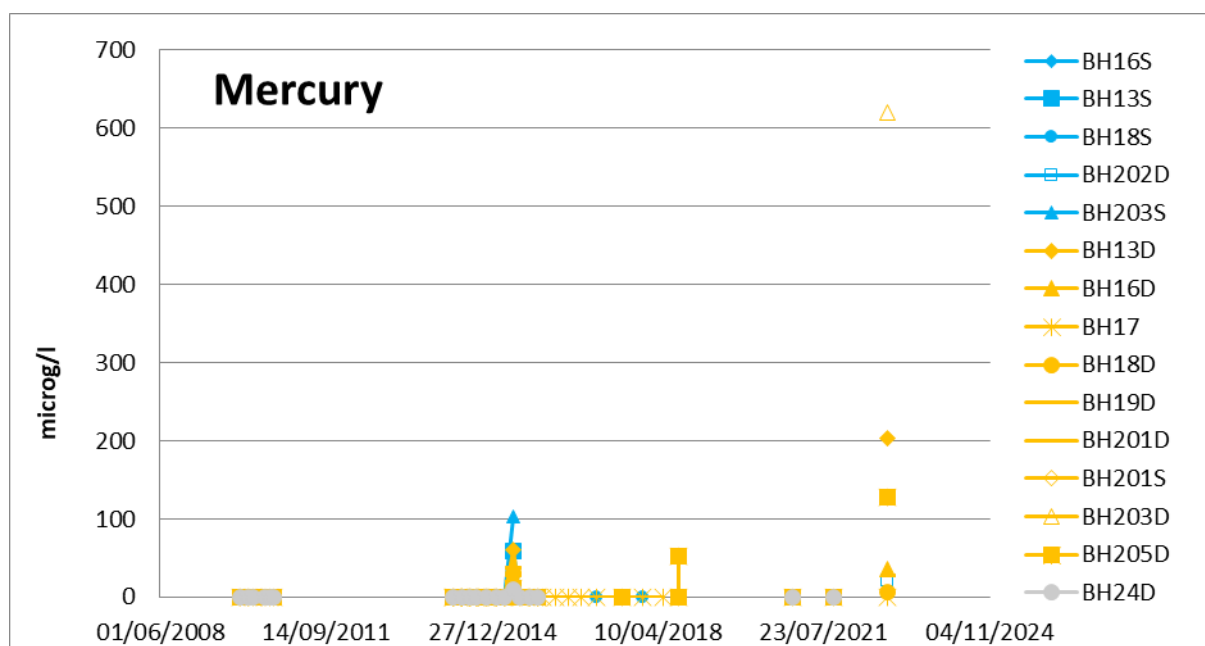
**Plate 5-4 Mercury concentrations in groundwater**

Because of the highly alkaline pH, many non-hazardous and hazardous substances are sometimes below detection limits or at low concentrations in the groundwater recovered from the made ground. In recent years, hazardous substance cadmium has been detected on several occasions, and sometimes at elevated concentration. During 2022, cadmium was not found above the analytical detection limit. Surprisingly, significantly elevated concentrations of mercury were however detected in 2022 with 0.621 mg/l reported at BH203D. Elevated concentrations were also detected at BH13D and BH205D, as shown in Plate 5-4. Mercury was also found at elevated concentration in surface water, with the highest concentration at QSW1, downstream of the lagoons. Nickel and lead were detected at several positions in 2022 but at lower concentrations than observed previously.

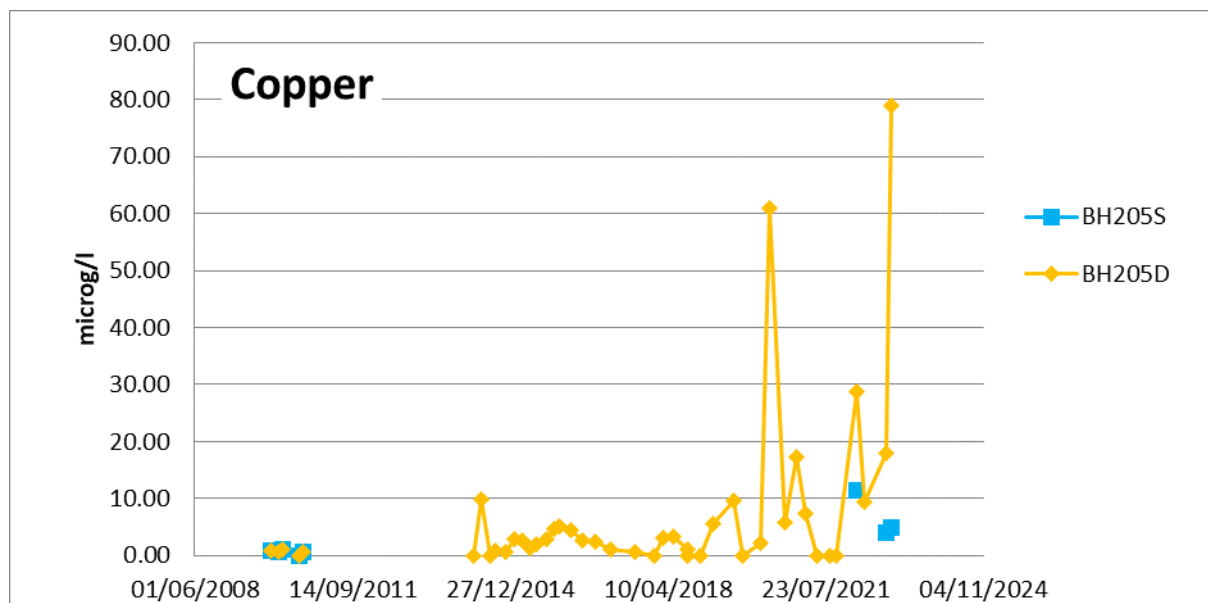
**Plate 5-5 Copper concentrations at BH205**

Chromium, copper, lead (and other metals) have also been found above their freshwater Environmental Quality Standards (EQS) from time to time, although there is no general upward trend. Exceptions do however occur, with copper detected at its highest concentration at BH17 in December 2022 and copper increasing at BH205D, as shown in Plate 5-5. This position is upstream of the lagoons and has also shown increasing concentrations of chloride, phosphate and ammonia in recent years.

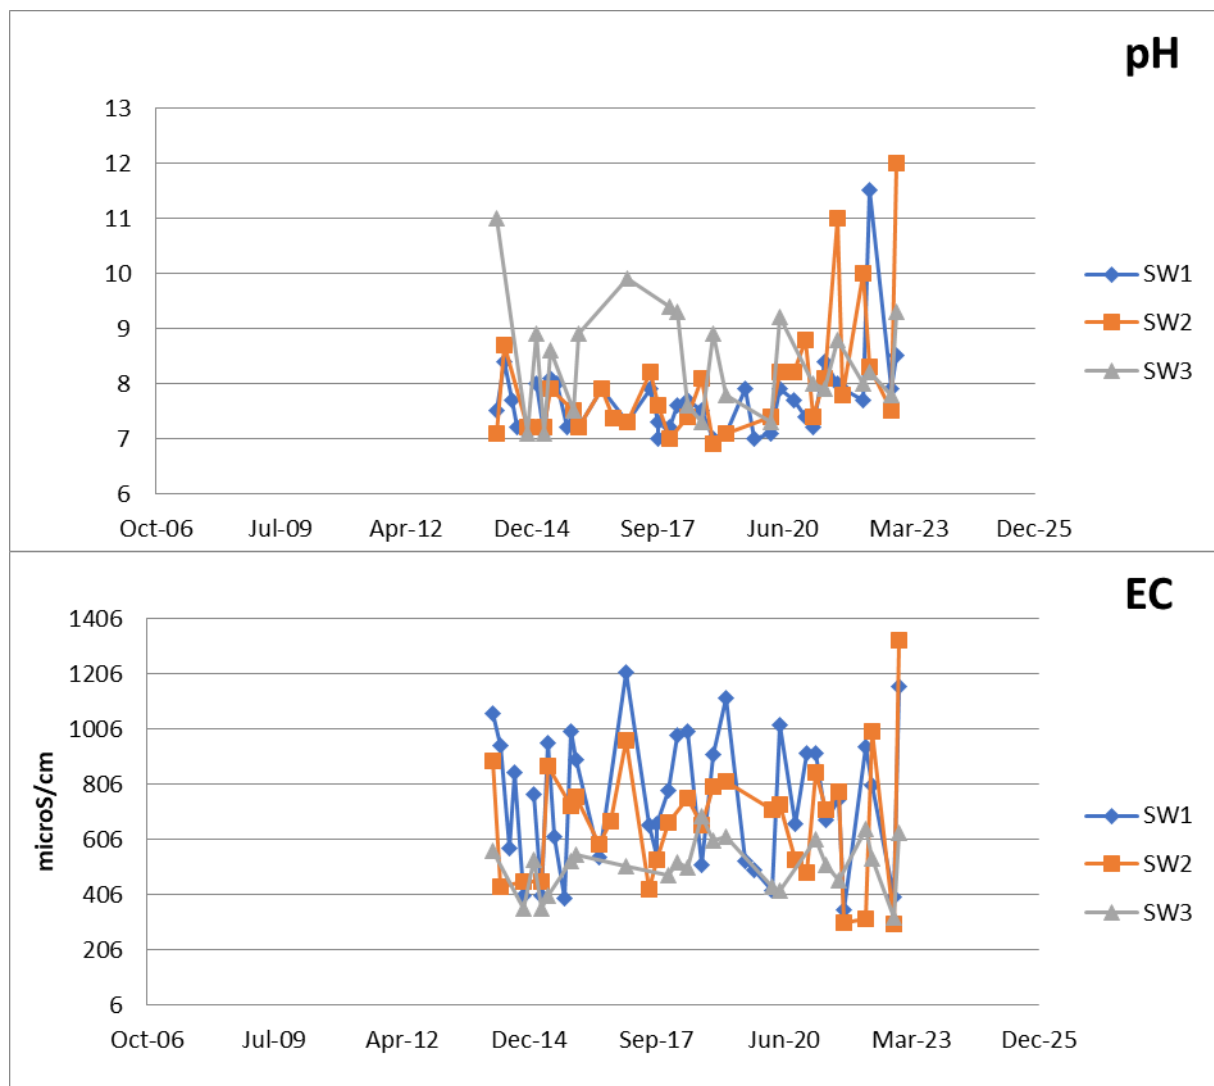
**Plate 6-1 Variations in surface water chemistry**

The data gathered during the past 12 months suggests surface water is becoming increasingly alkaline. This is based on the upwards inflection of the pH observed at all sample points over the past 24 months. It appears that there is a long-term underlying upwards trend in surface water pH with short-term spikes in pH, particularly at SW2. This is clearly shown in Plates 6-1 and 6-2. Sample position SW2 is downstream of SW3 and upstream of SW1, adjacent to powerline alley.

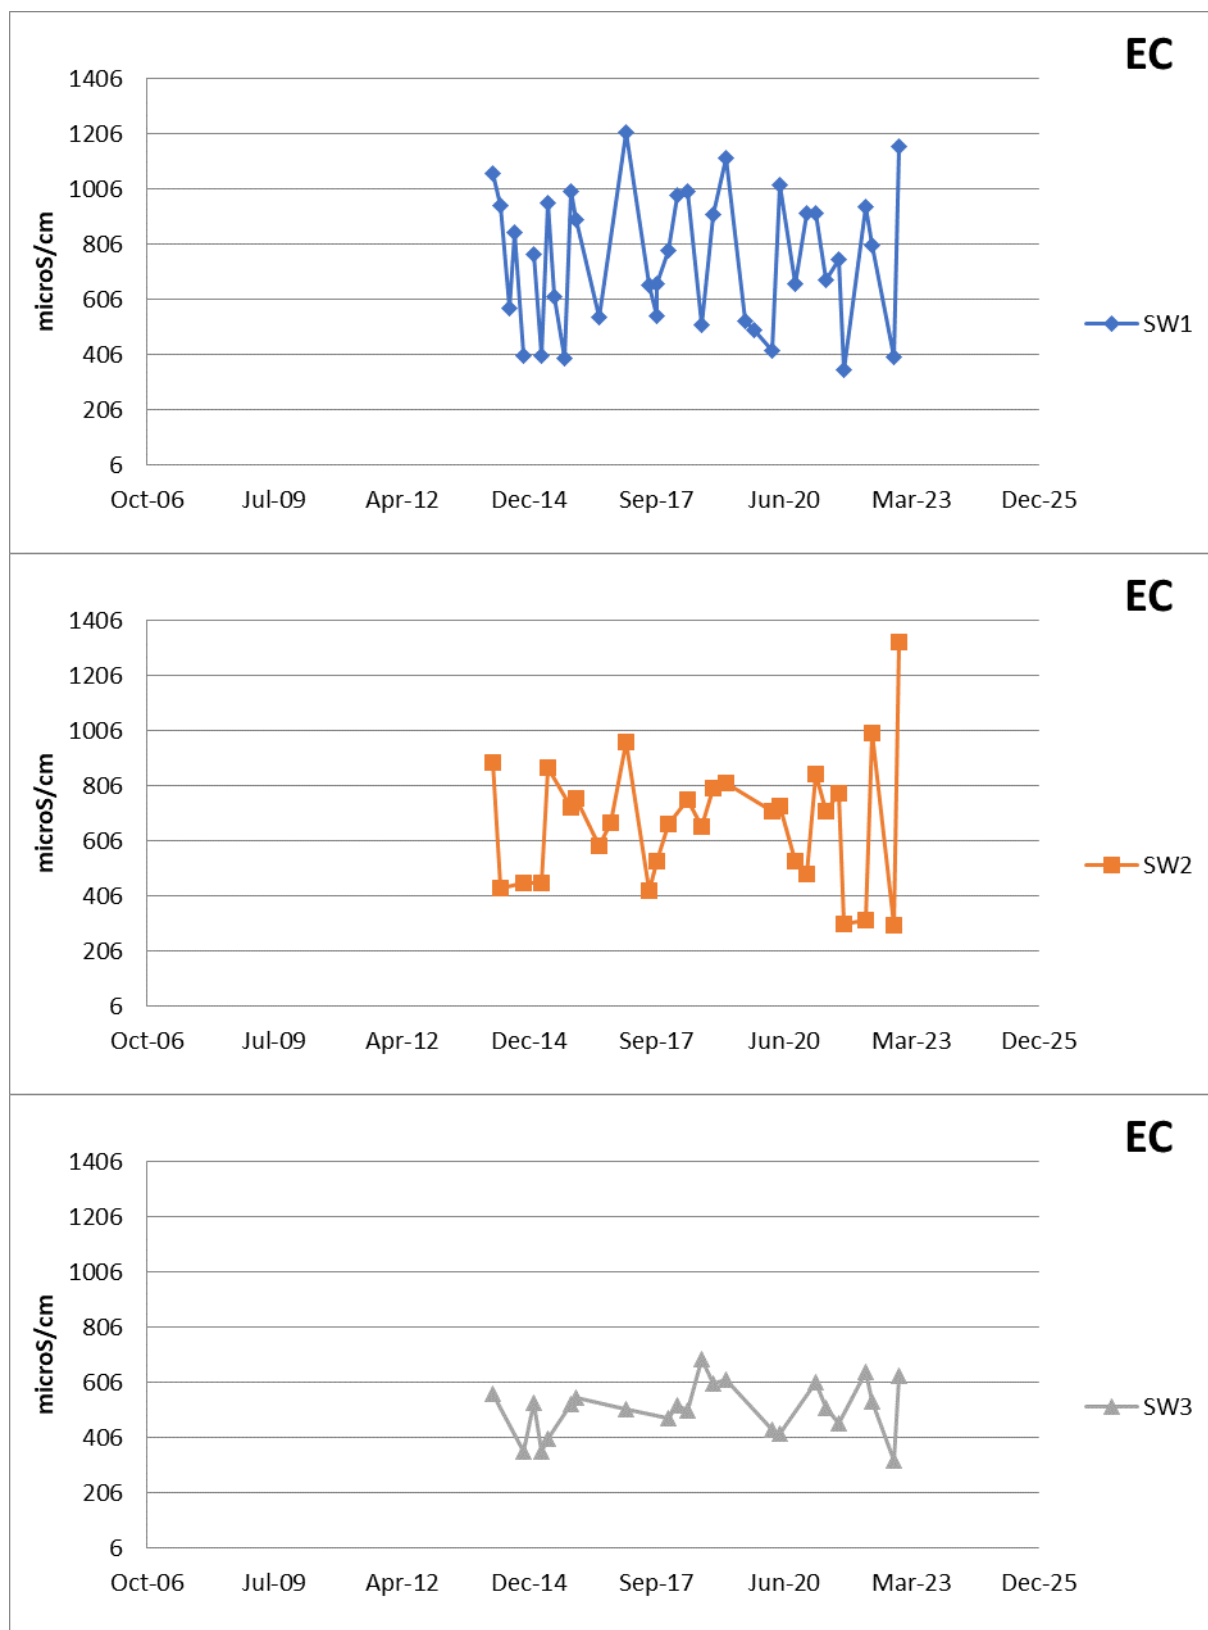
**Plate 6-3 Variation in Electrical Conductivity (EC) in surface water**

Whilst pH has increased, there is no clear trend with Electrical Caducity or any other parameter apart from possibly potassium and nickel (see Appendix 2). The data varies considerably for several parameters with Electrical Conductivity sometimes doubling / halving between quarterly sampling events, as shown in Plate 6-3. There are sometimes short-term

variations in trace metal concentrations but no persistent trends indicating deteriorating water quality.
