| | | <p align="center"><b>NETWORK RAIL</b></p> <p align="center"><b>Underwater Examination Report</b></p> | | | | | | | |
| Examination Type: Underwater | | NR ID: | | | Exam Date: 18/04/2023 | | | | |
| Structure Name: Barmouth Viaduct (Timber) | | | | Type: | BV | | Exam ID: | 15614452 | |

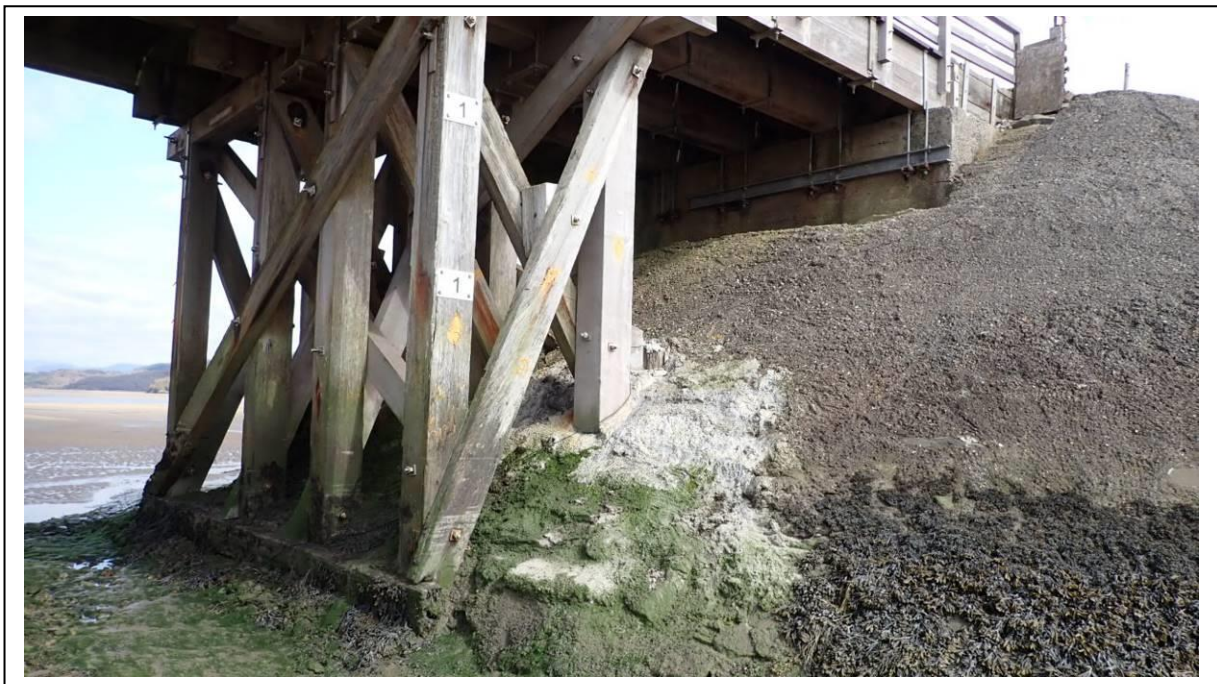
Abutment is fronted by a sloping concrete revetment in fair overall condition. (Photo 1)  
No scour or undermining at the interface with the river bed.

Photo 1 Low Mileage abutment and Trestle 1

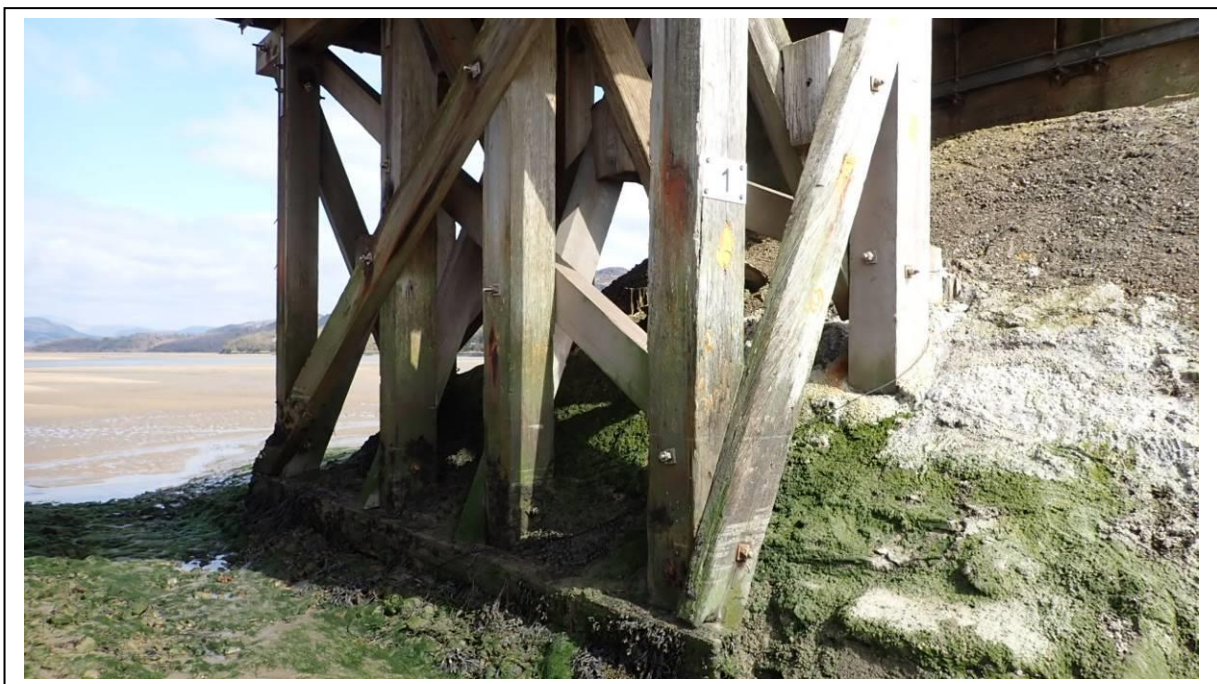
Trestle 1 is fronted by the same sloping concrete revetment as the low mileage abutment and is in fair overall condition (Photo 2) with the following defects noted:

Photo 2 Trestle 1

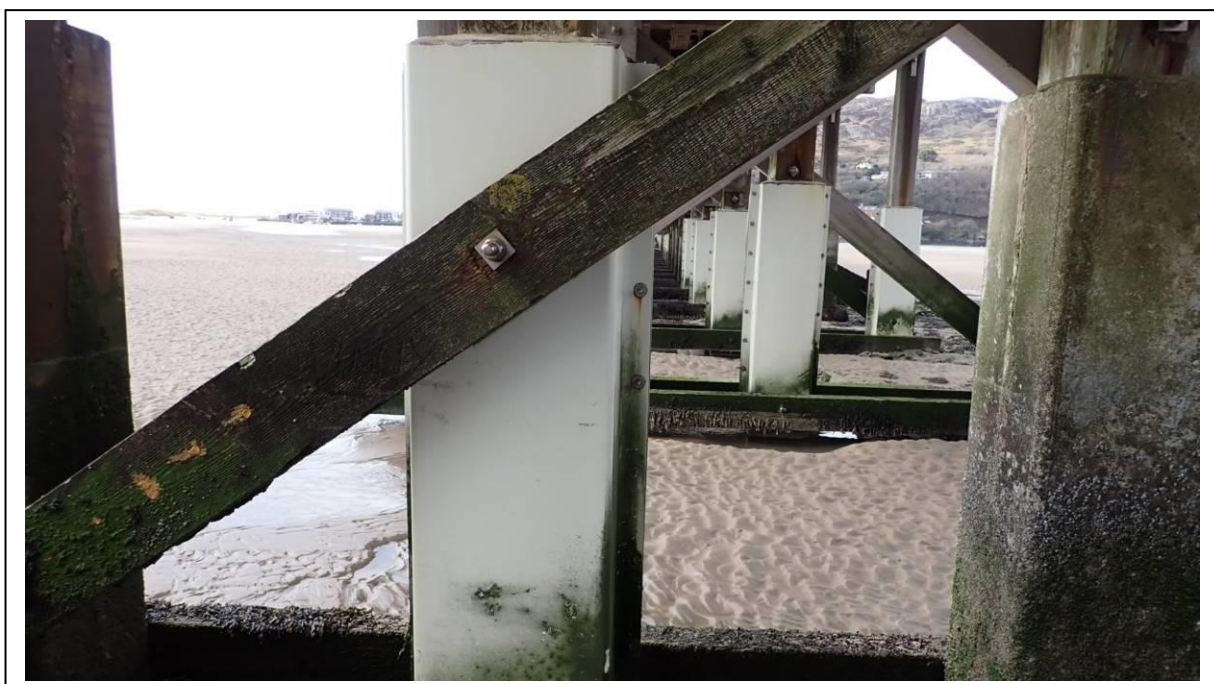
Pile 2 – Fair overall condition with a concrete encasement to the lower 2.3m from bed level. The concrete encasement is in fair overall condition. (Photo 10)

Photo 10      Trestle 10 – Pile 2, new encasement

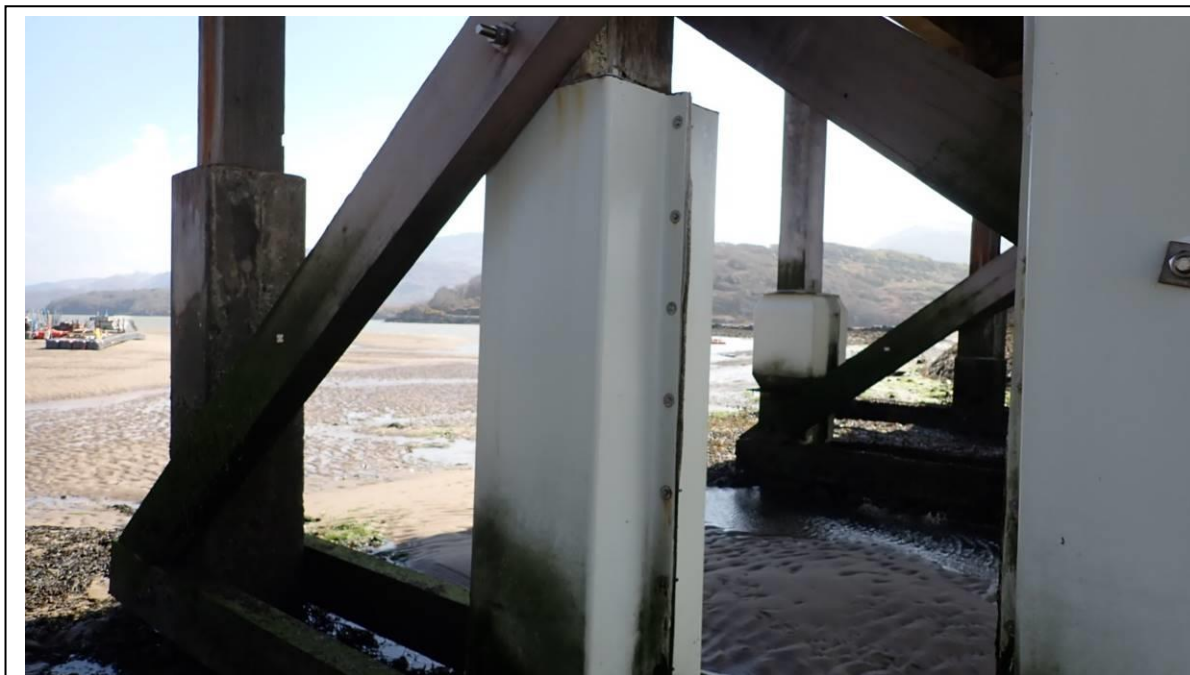
Pile 3 – Fair overall condition with a new concrete encasement to lower 2.5m from bed level. The pile where seen has splits. (Photo 11)

Photo 11 Trestle 4 – Pile 3, new encasement

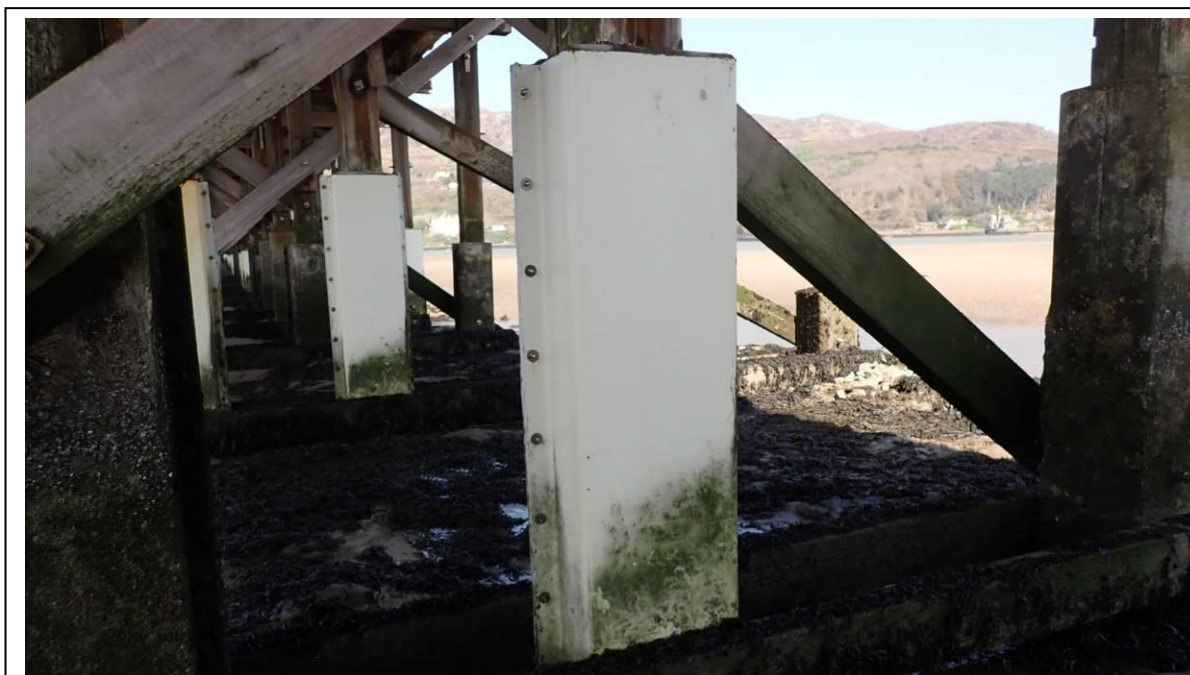
Pile 3 – Fair condition with concrete a new encasement to lower 2.5m from bed level. Where seen there are splits. (Photo 12)

Photo 12 Trestle 6 – Pile 3, new encasement

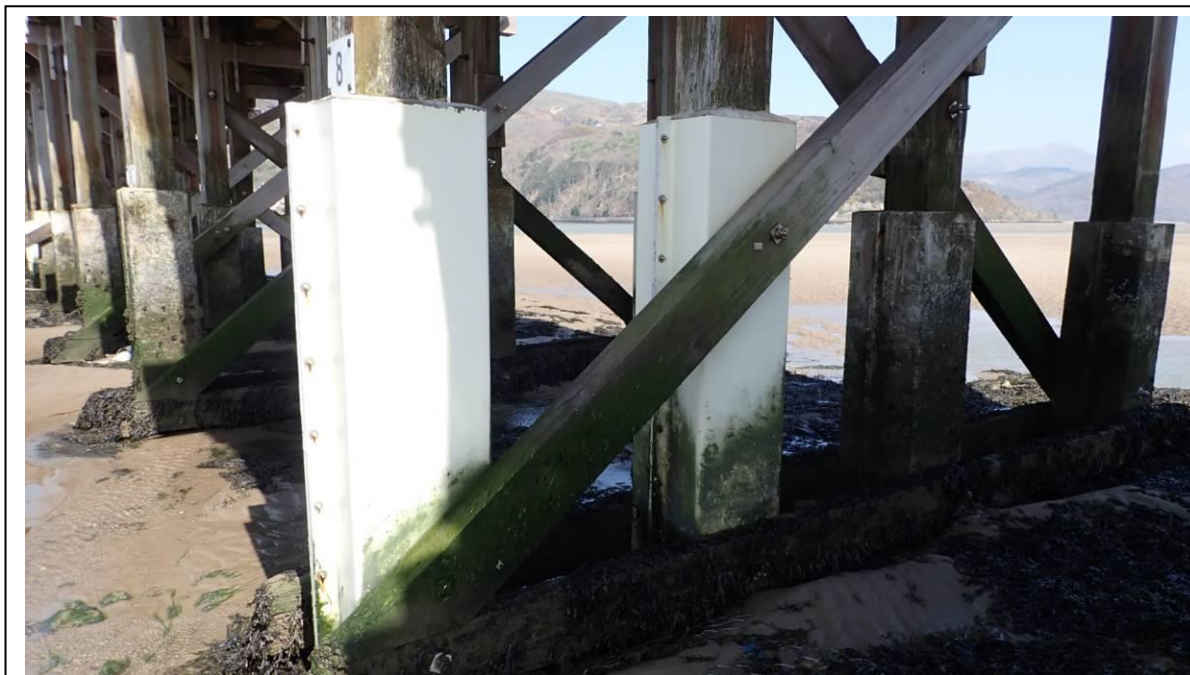
Pile 1 – Fair condition with a new concrete encasement to lower 2.5m from bed level. Rest of pile where seen has splits. (Photo 13)

Photo 13 Trestle 8 – Pile 1, new encasement

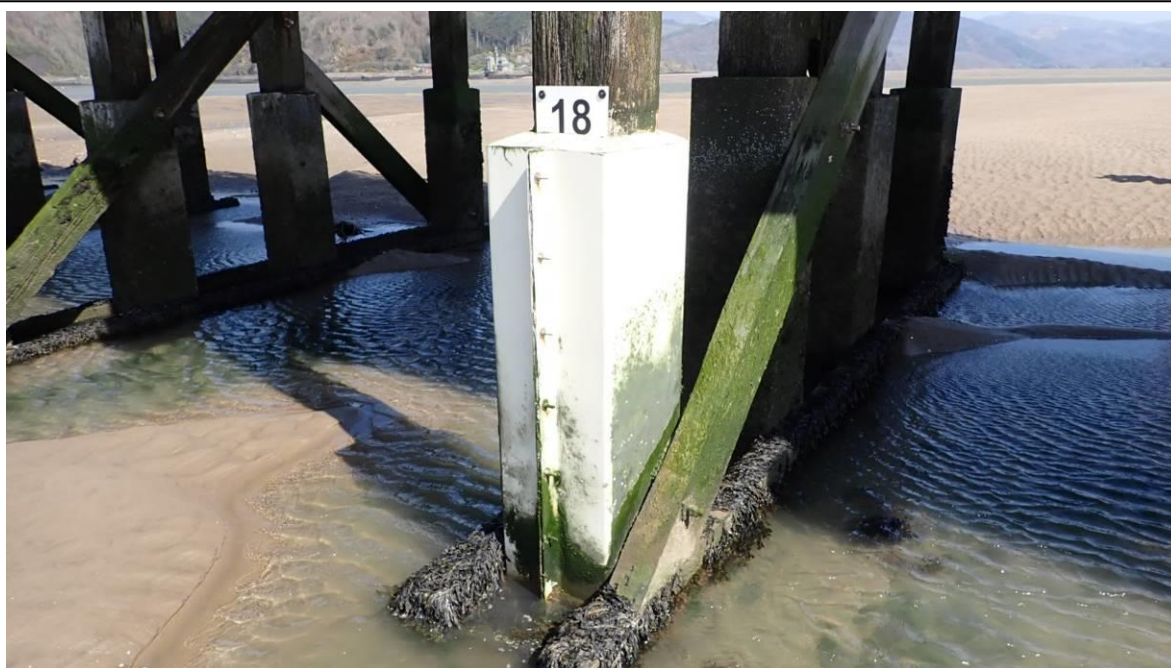
Photo 19 Trestle 18 – Pile 1, new encasement

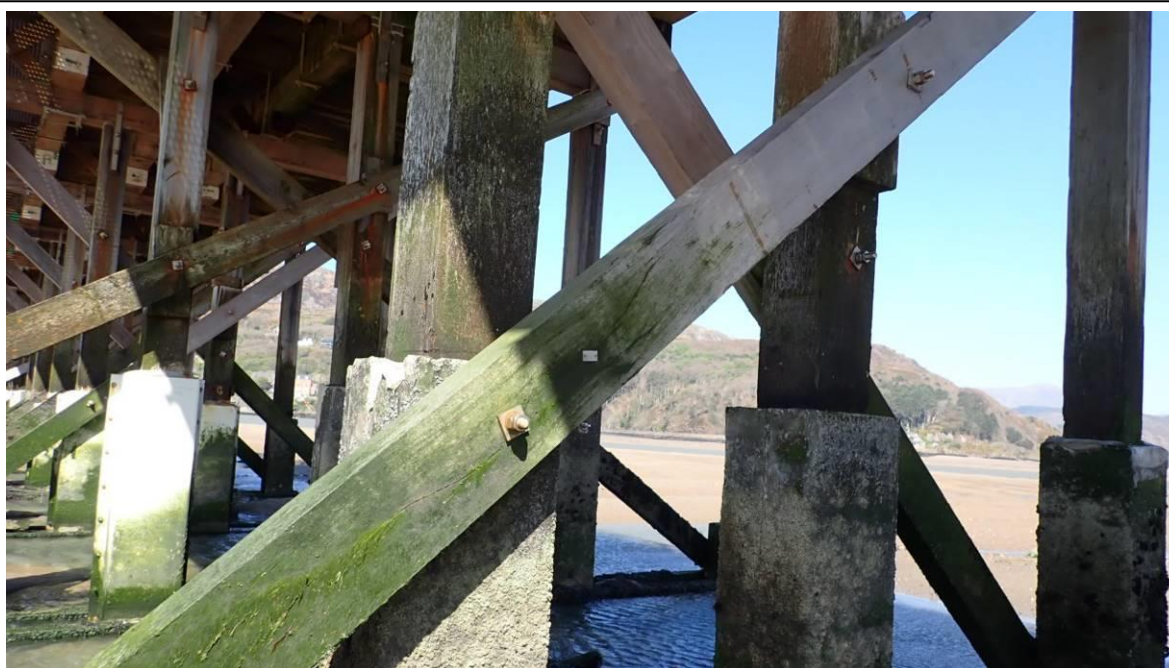
LM diagonal brace, replaced. (Photo 25)

Photo 25 Trestle 26 – NEW LM diagonal brace

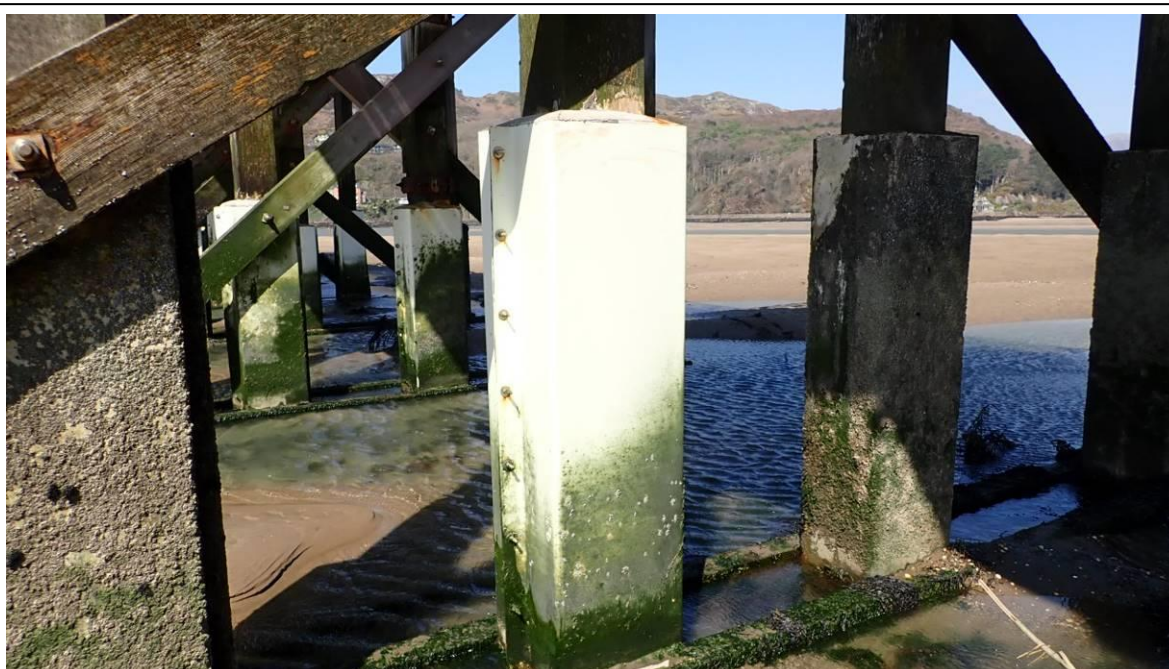
Pile 2 – Fair condition. A new concrete encasement to lower 2.5m from bed level has been installed. Where seen the pile has splits. (Photo 26)

Photo 26 Trestle 27 – Pile 2, new encasement

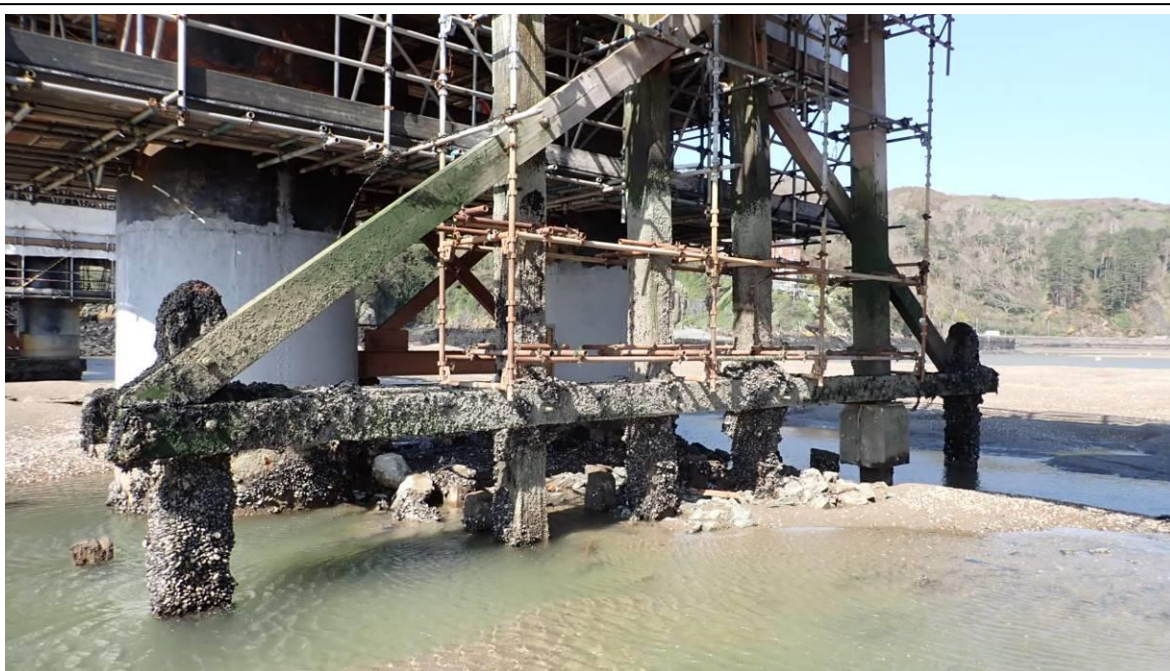
Trestle 112 (Photo 36) in fair overall condition with the following defects noted.

Photo 36 Trestle 112

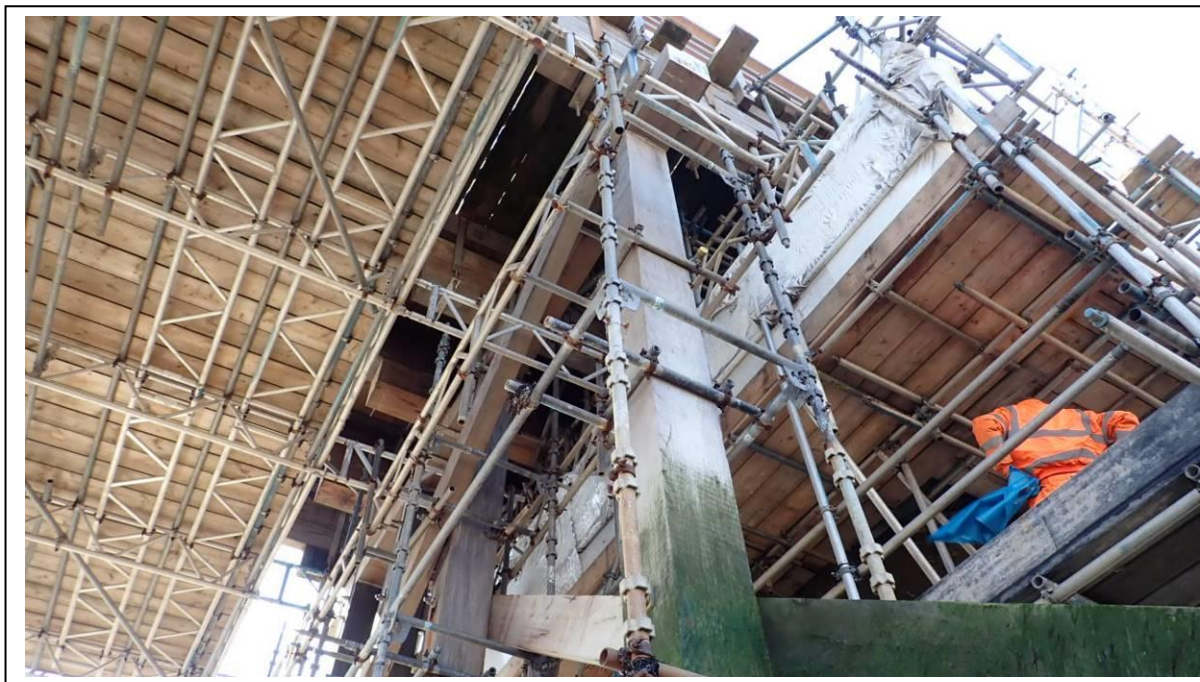
Pile 4 – Fair condition with a new concrete encasement below the horizontal brace and a new timber pile. (Photo 37)

Photo 37 Trestle 112 – Pile 4, new encasement

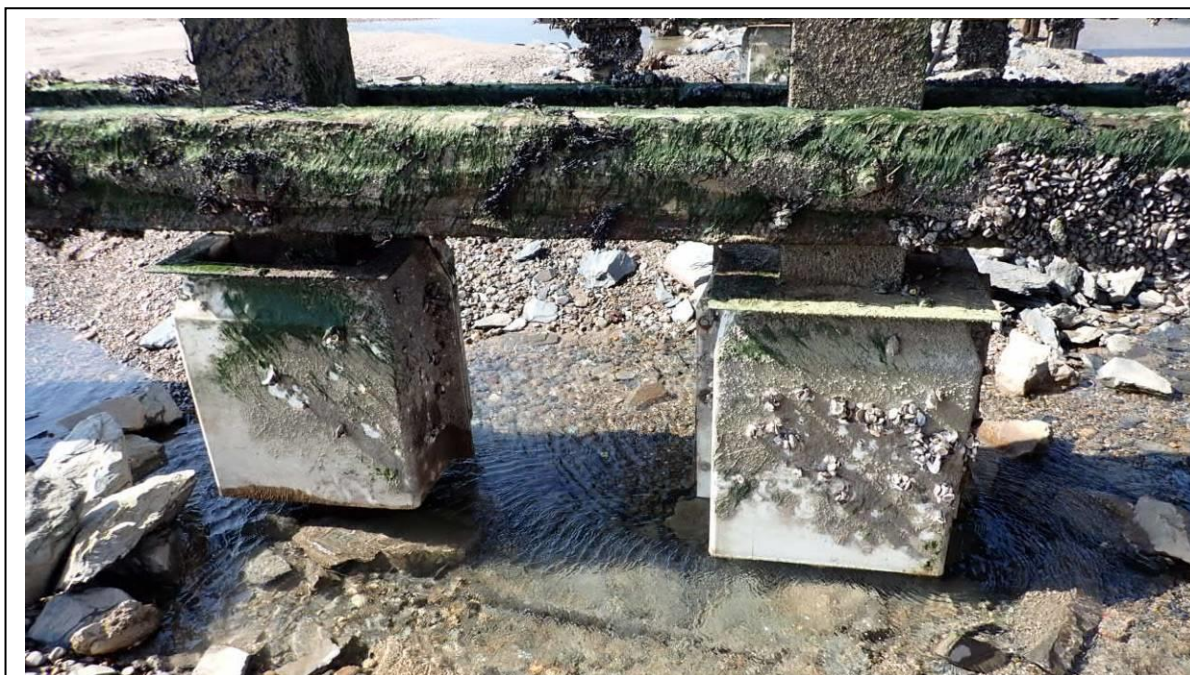
Pile 1 – Fair condition with a new concrete encasement and new pile. (Photo 39)

Pile 2 – Fair condition with a new concrete encasement and new pile. (Photo 39)

**Photo 39** Trestle 102 – View of new encasements / piles to piles 1 & 2

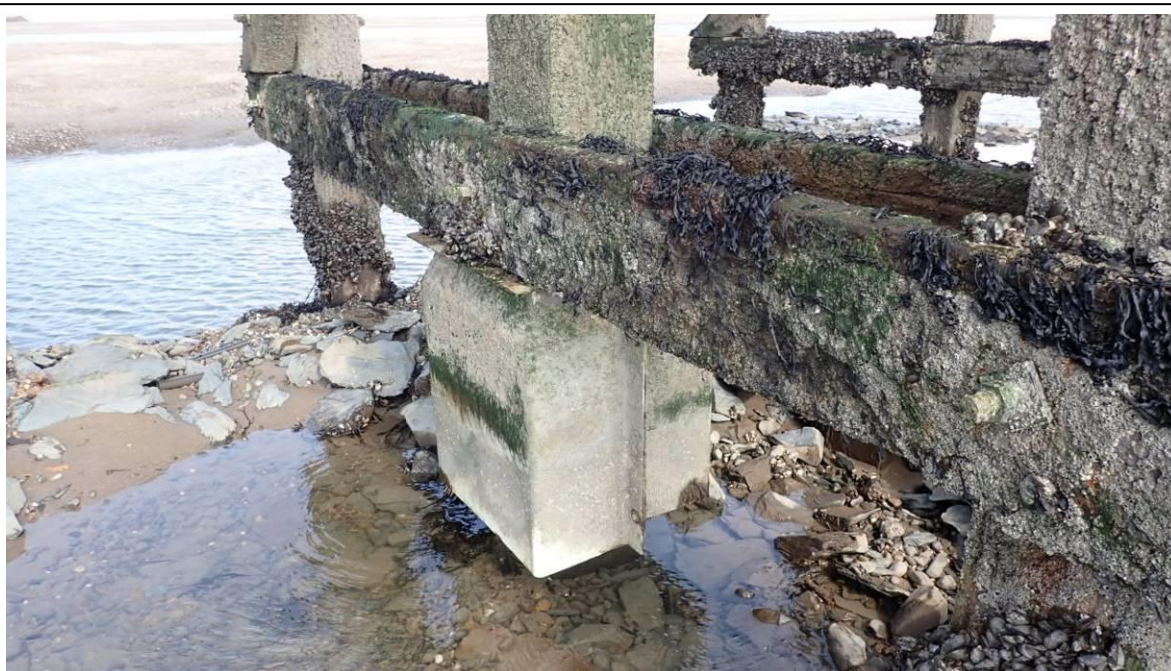
Pile 3 – Fair condition with a new concrete encasement to bottom 1.2m above bed level. A new timber pile has been installed. (Photo 42)

**Photo 42** Trestle 93 – Pile 3, New encasement and pile

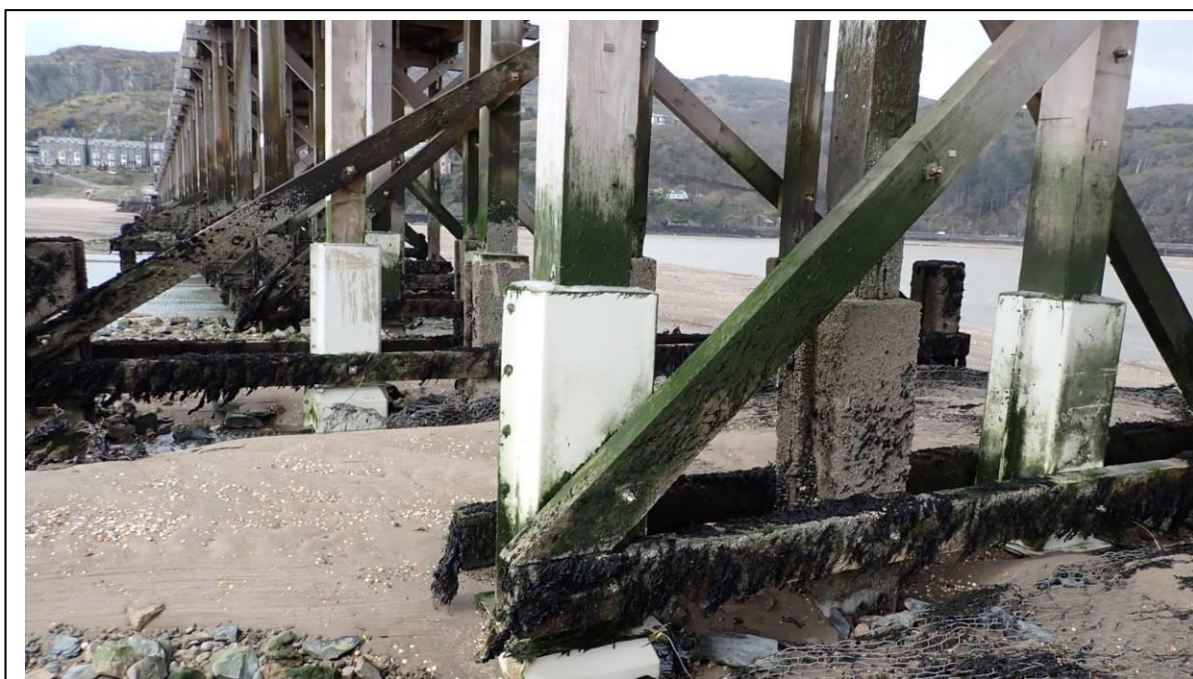
Pile 1 – Fair condition with a new concrete encasement to lower 1.5m from bed level. A new pile also been installed. (Photo 50)

Photo 50 Trestle 71 – Pile 1, new encasement and pile

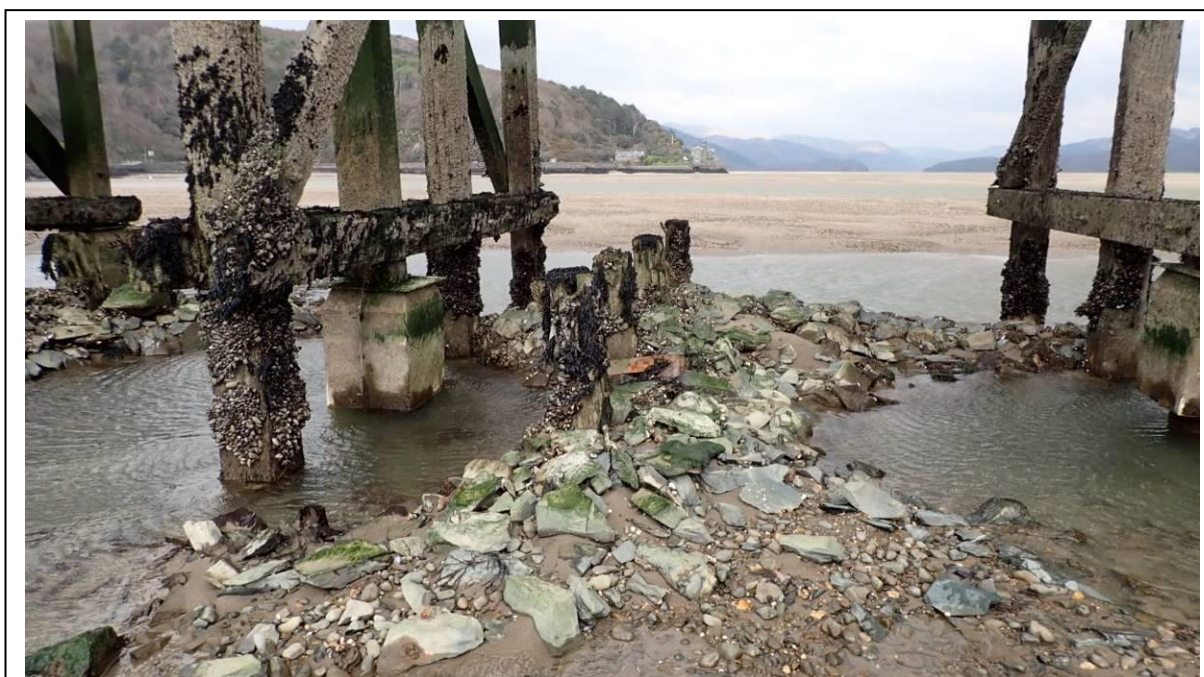
Photo 56 Remain of old timber piles from spans 80 – 112
