| Location Plan: | <b>Mostyn Sea Wall</b><br>Assessment Date: 16/03/2023 | |
| | CARRS Exam ID: | <b>15614043</b> |
| | Structure Reference: | <b>W1990286</b> |

# COASTAL ASSET CONDITION SURVEY REPORT

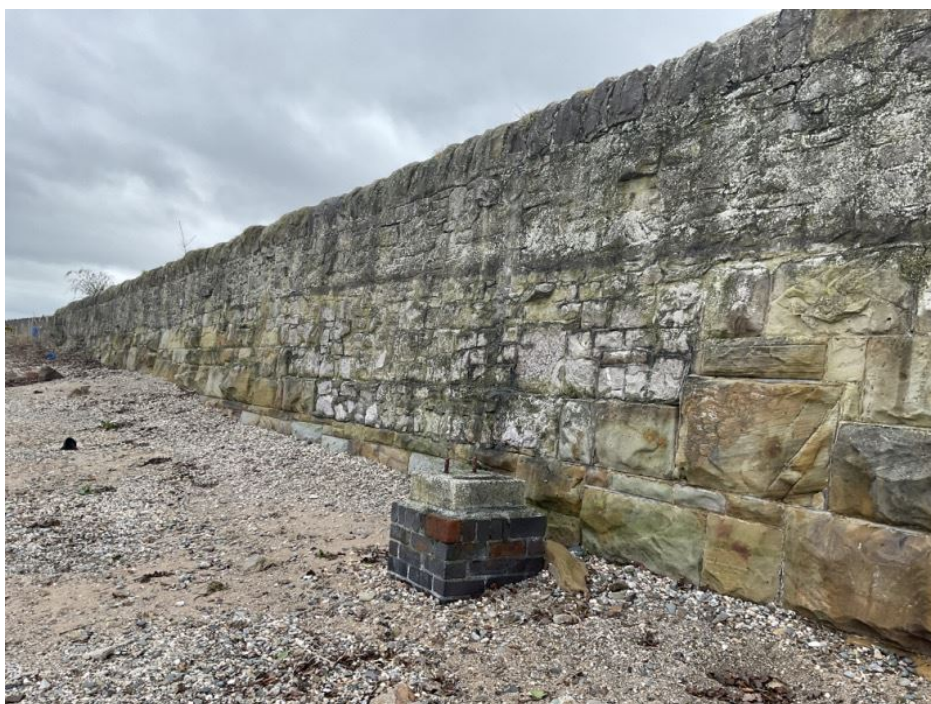
**Section A**  
**Wall section**  
**Photo number: 5**

| Minor Elements | Photo No. | Attributes and General Notes | Condition Grade | Weighting (1-9) | Overall (CG x W) |
|---|---|---|---|---|---|
| Wall section | 5 | Masonry (Fractures in masonry blocks and precast units, voids and weathered masonry units, spalling and exposed reinforcement, seepage through wall). | 4 | 9 | 36 |

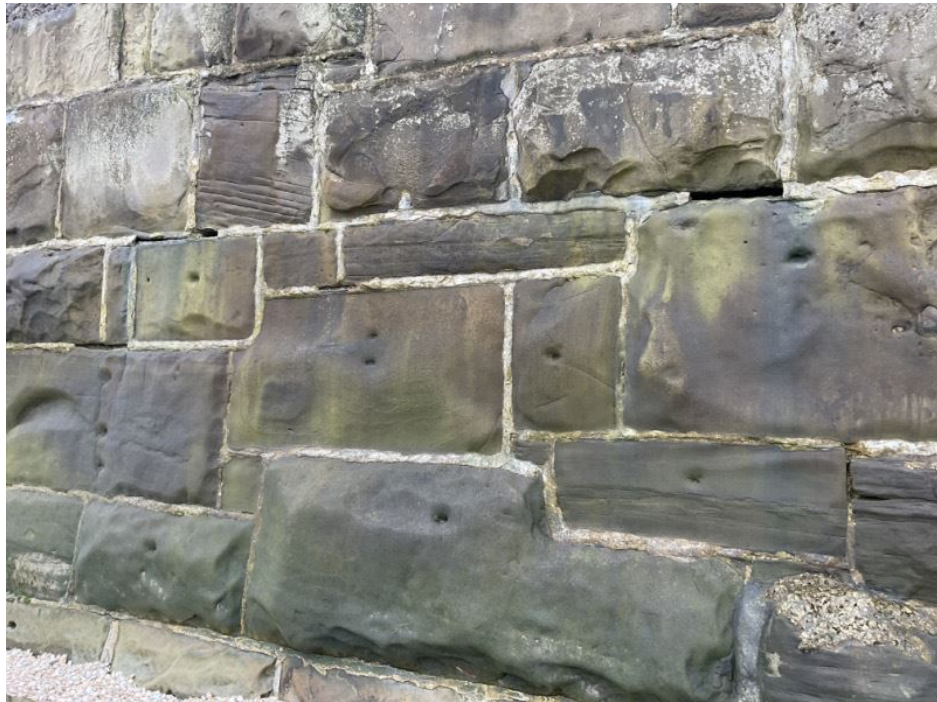
| Defect Ref No. | Defect Location (NGR) | Major Element | Minor Element | Photo Ref | Severity | Probability | Risk Score | Below MHWS | Defect Group | Defect Description | Recommendations | Defect Priority |
|---|---|---|---|---|---|---|---|---|---|---|---|---|
| D2 | 315253, 381177 | Wall | Wall section | 41, 82 | 2 | 2 | 4 | True | Repointing | Open joints. Some sections had been observed to have been repointed in the 2023 inspections, although open joints were still visible along asset length. | Repoint open joints. | 10 |

**Section A**  
**Wall section**  
**Defect Ref: D2**  
**Description:** Open joints. Some sections had been observed to have been repointed in the 2023 inspections, although open joints were still visible along asset length.  
**Photo number: 41**

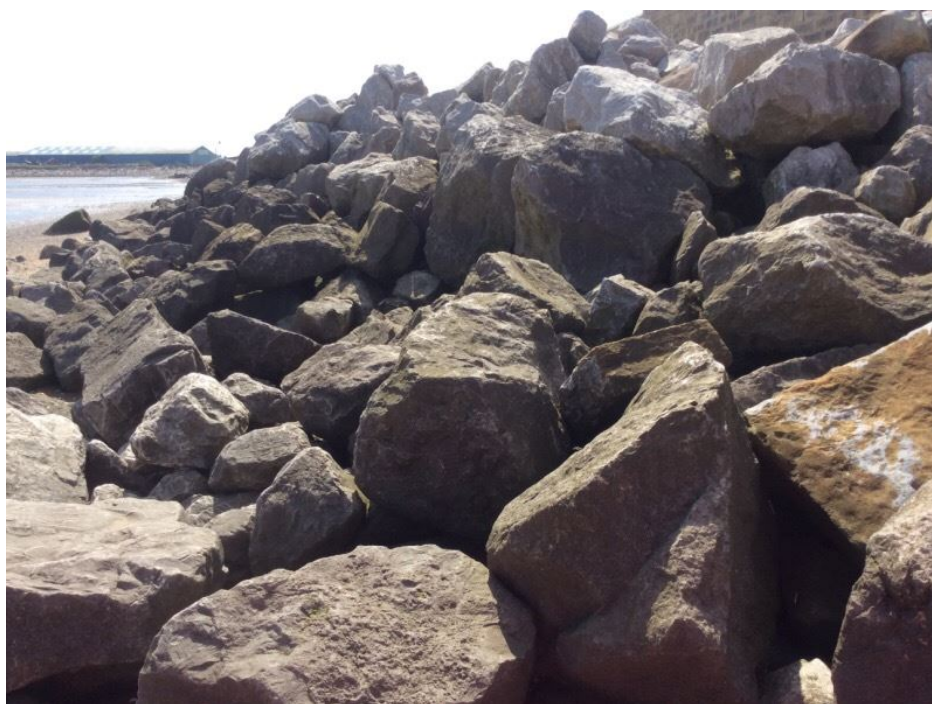
| Defect Ref No. | Defect Location (NGR) | Major Element | Minor Element | Photo Ref | Severity | Probability | Risk Score | Below MHWS | Defect Group | Defect Description | Recommendations | Defect Priority |
|---|---|---|---|---|---|---|---|---|---|---|---|---|
| D10 | 314999, 381300 CNH3 199.077 | Wall | Wall Armour | 22, 75 | 2 | 3 | 6 | True | Loss/damage of rock-armour | Expelled rock armour. No significant change observed in the 2023 examinations. | Replace expelled rock armour units. | 7 |

**Section A**  
**Wall Armour**  
**Defect Ref: D10**  
**Description:**  
Expelled rock armour.  
No significant change  
observed in the 2023  
examinations.  
**Photo number: 22**

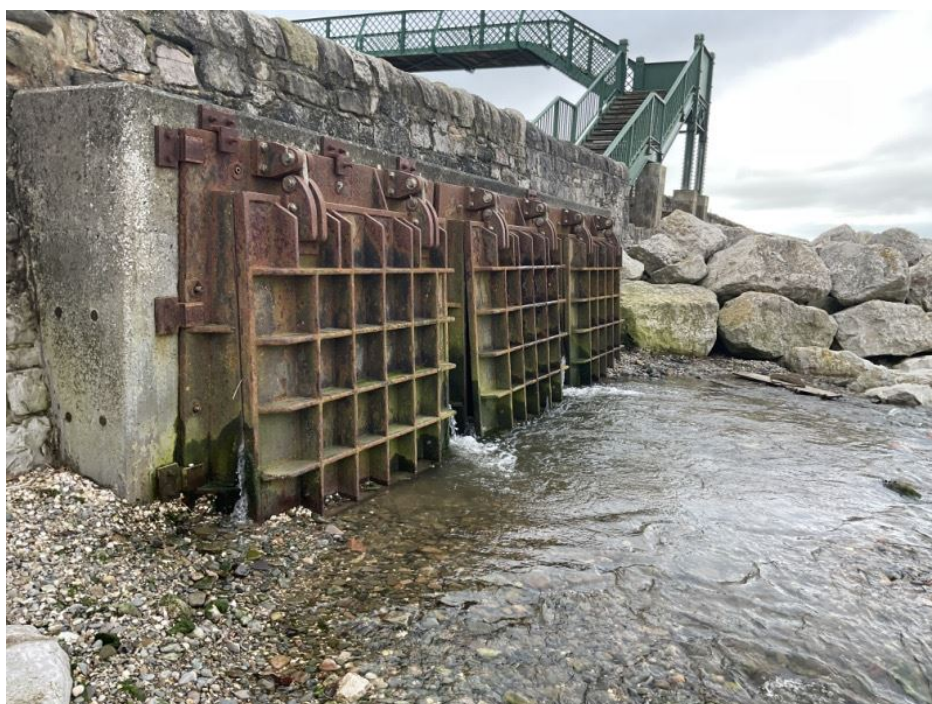
**Section A**  
**Wall section**  
**Defect Ref: D20**  
**Description:** Nuts and washers for wall mounted flap valve missing. No change observed between the 2022 and 2023 examinations.  
**Photo number: 35**

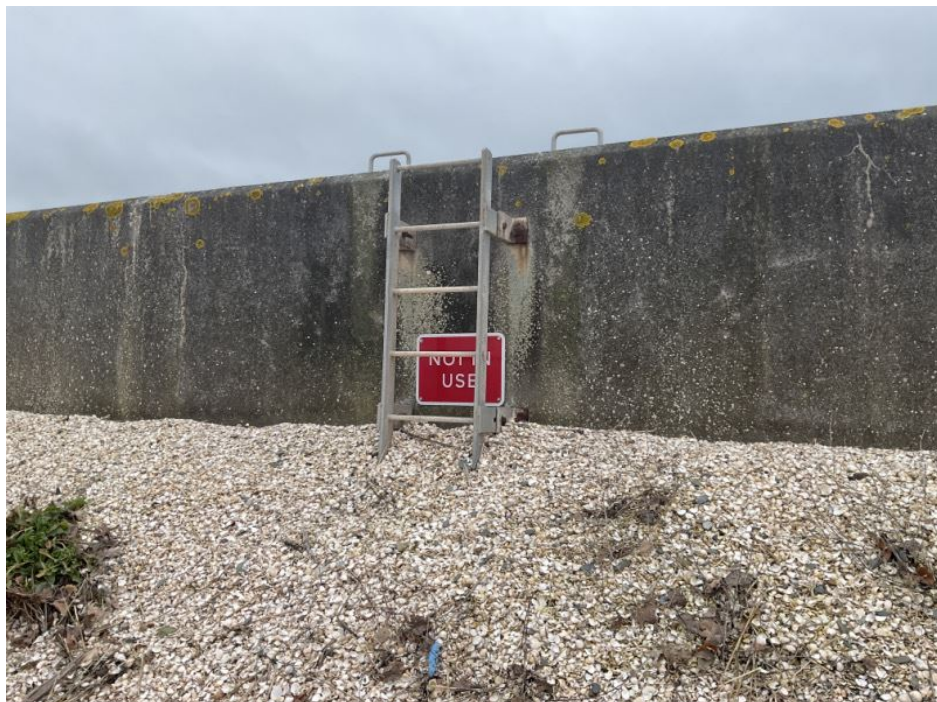
**Section A**  
**Wall section**  
**Defect Ref: D27**  
**Description:** Spalling and exposed reinforcement. Repairs noted between concrete units. No significant change observed between 2022 and 2023 examinations.  
**Photo number: 10**

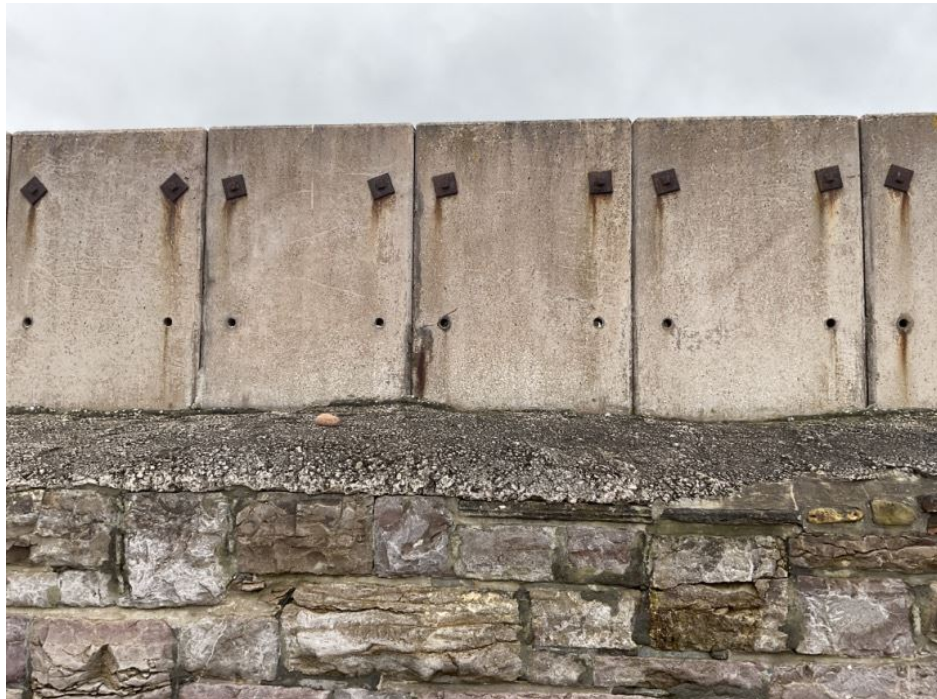
**Section A**  
**Wall section**  
**Defect Ref: D32**  
**Description:** Spalled concrete and missing block work. No change observed between the 2022 and 2023 examinations.  
**Photo number: 24**

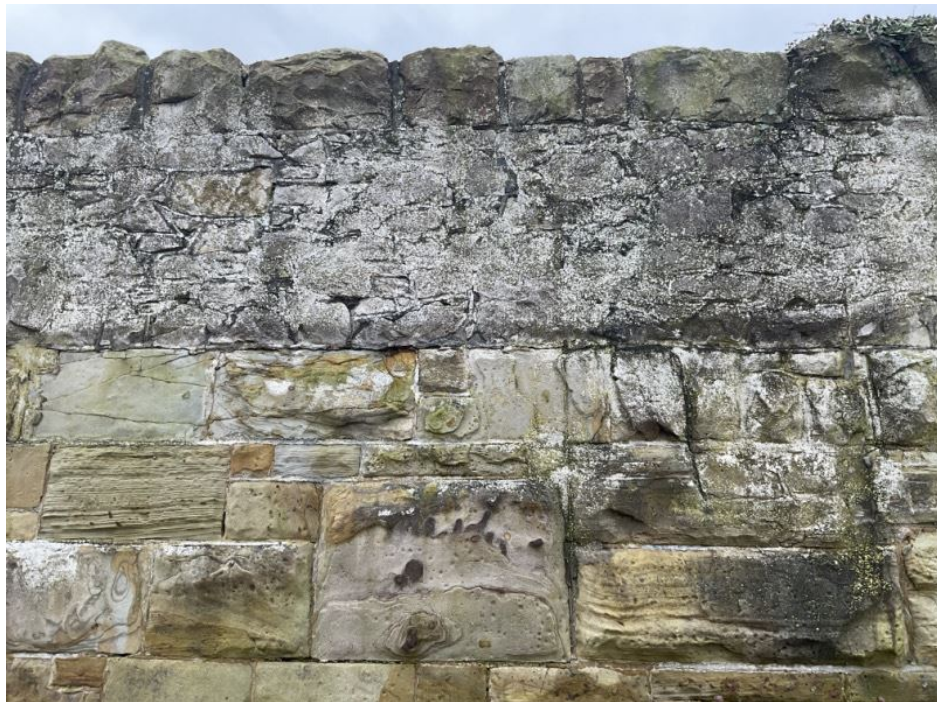
**Section A**  
**Wall section**  
**Defect Ref: D47**  
**Description:**  
Fractures and open joints in wall area near to pedestrian crossing. No significant change observed 2023 in inspections.  
**Photo number: 61**
