## Abandoned Anchors Freshwater West

## Greenlink Interconnector Project

JDN document no.:	JDN.6746.SEI.TN.90.98.01
Aconex document no.:	P-021001_EC_12400.A032#GL22&ADD010

The purpose of the document is to provide details regarding the abandonment of 2 3Te Deltaflipper anchors at the Freshwater West landfall.

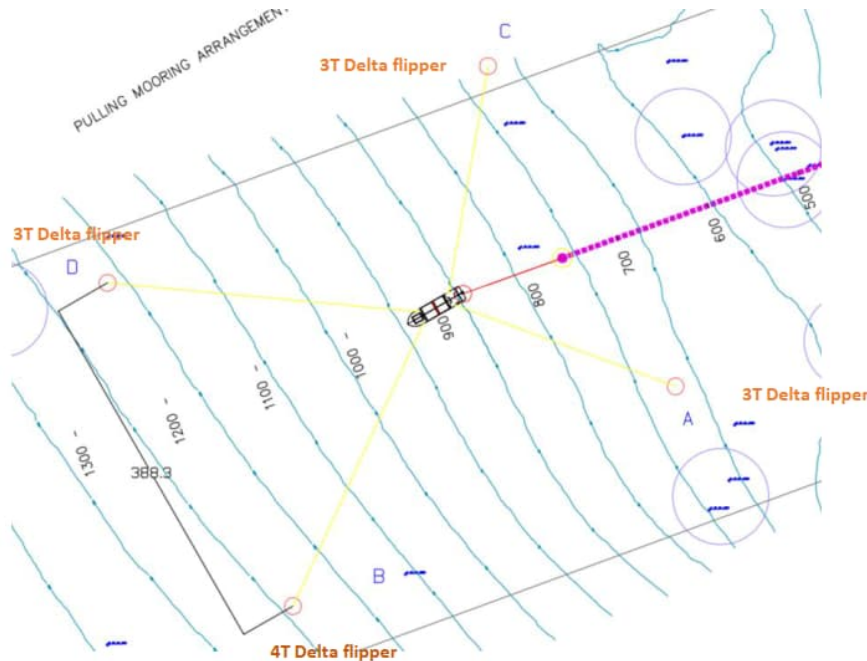
Figure 1-1: 4 point mooring pattern for HDPE push/pull operations

As can be seen in the above layout, both aft anchors were 3T Delta Flippers. The rigging arrangement is shown Figure 1-2. The steel pennant wire consists of a 30 m 36 mm soft loop steel wire to which a 22 mm chain is connected and guided through the pennant buoy. The forerunner arrangement consists of a 50m 32mm and a 25 m 24 mm steel wire connected to an orange A7 buoy.

However due to adverse weather conditions, the buoys parted from the two anchors and whilst numerous attempts were made to locate and recover the anchors as described in section 4 of Annex A these were unsuccessful with the anchors being completely buried beyond a practical depth that can be detected, let alone recovered.

The Navigational Risk assessment in Annex A demonstrates that these anchors are not a risk to Navigation and as such no further efforts to either locate or recover these will be made.

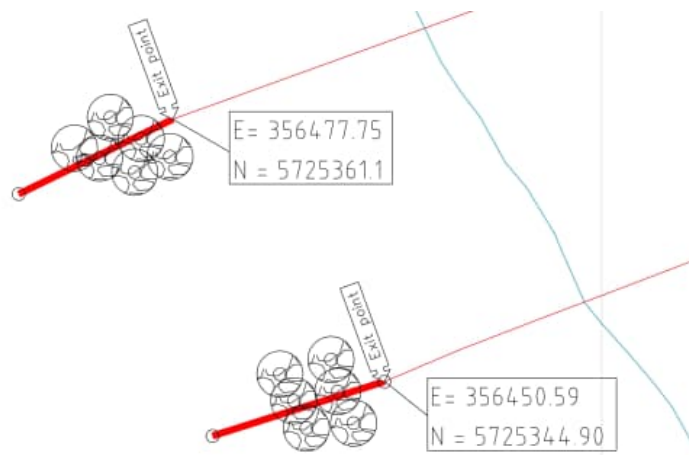
Figure 5 - top view of the installed asset. Note the rock bags have been removed and the pipe (red) with bellmouth (yellow) has been lowered below seabed in April 2024.
