| Location Plan: | <b>Avalanche East Sea Wall</b><br>Assessment Date: 20/04/2021 | |
| | Structure Reference: | <b>W2291320</b> |

# COASTAL ASSET CONDITION SURVEY REPORT

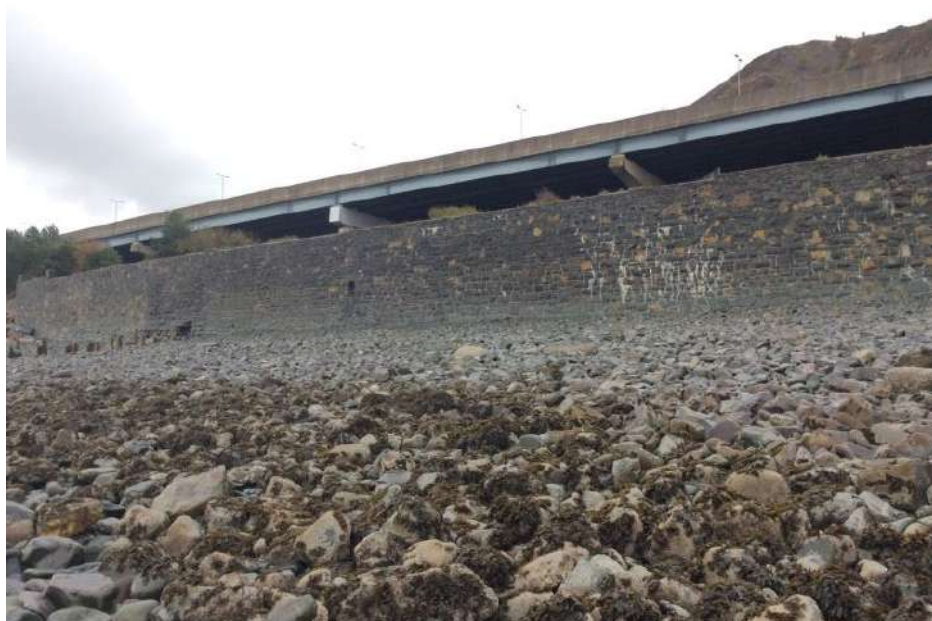
**Photo number: 102**

**Description:** Open joints. 600mm deep near the repair. Between the 2020 and 2021

examinations, no change to defects. Open joints are still present with some minor loss of blocks

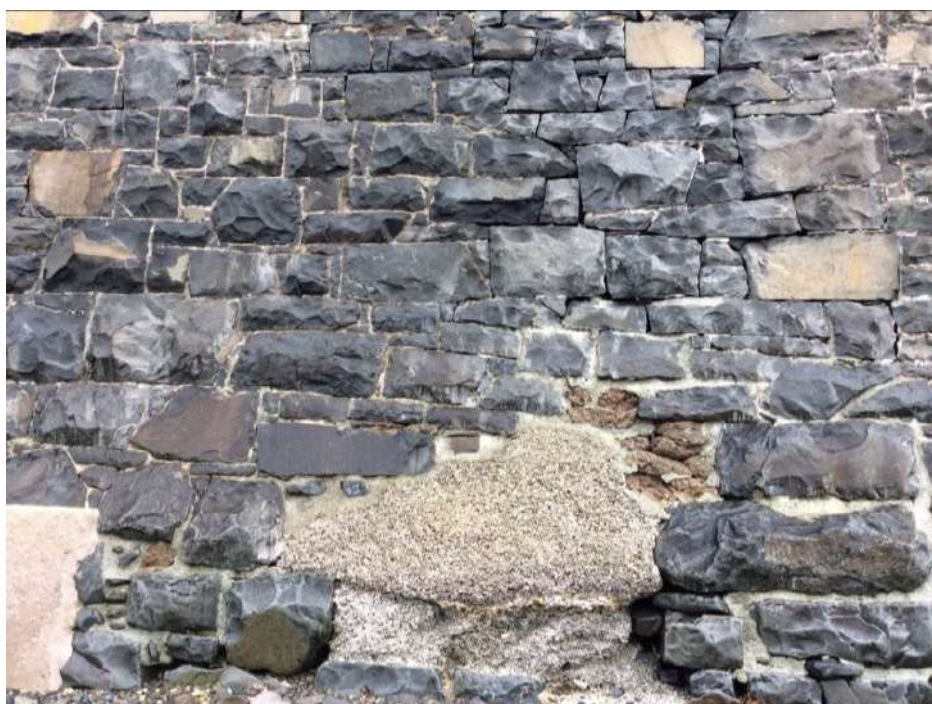
**Description:** Open joints. 600mm deep near the repair. Between the 2020 and 2021

examinations, no change to defects. Open joints are still present with some minor loss of blocks

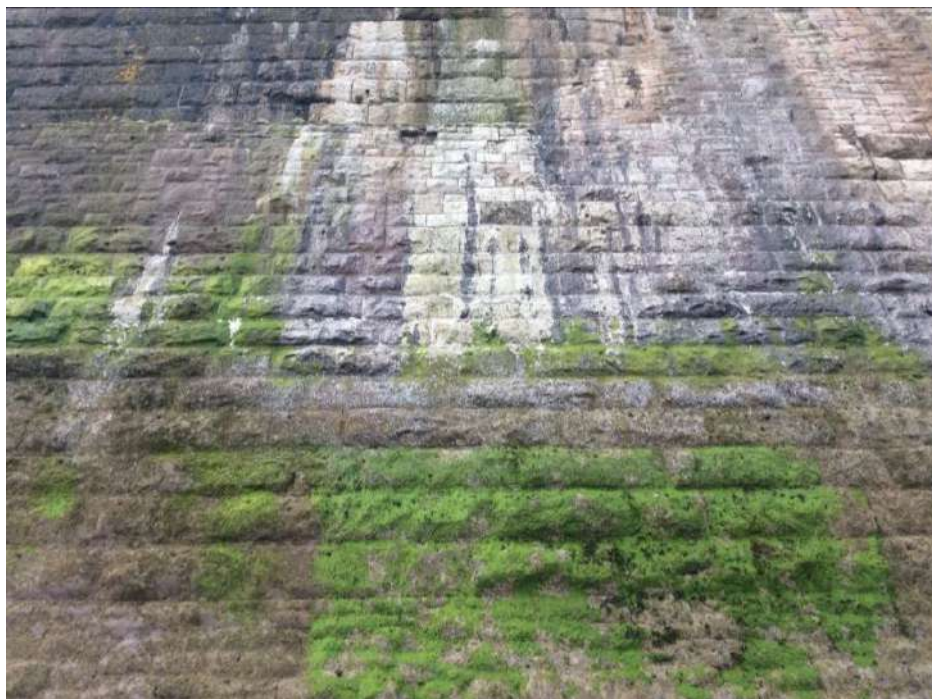
**Description:** Open joints. 600mm deep near the repair. Between the 2020 and 2021

examinations, no change to defects. Open joints are still present with some minor loss of blocks

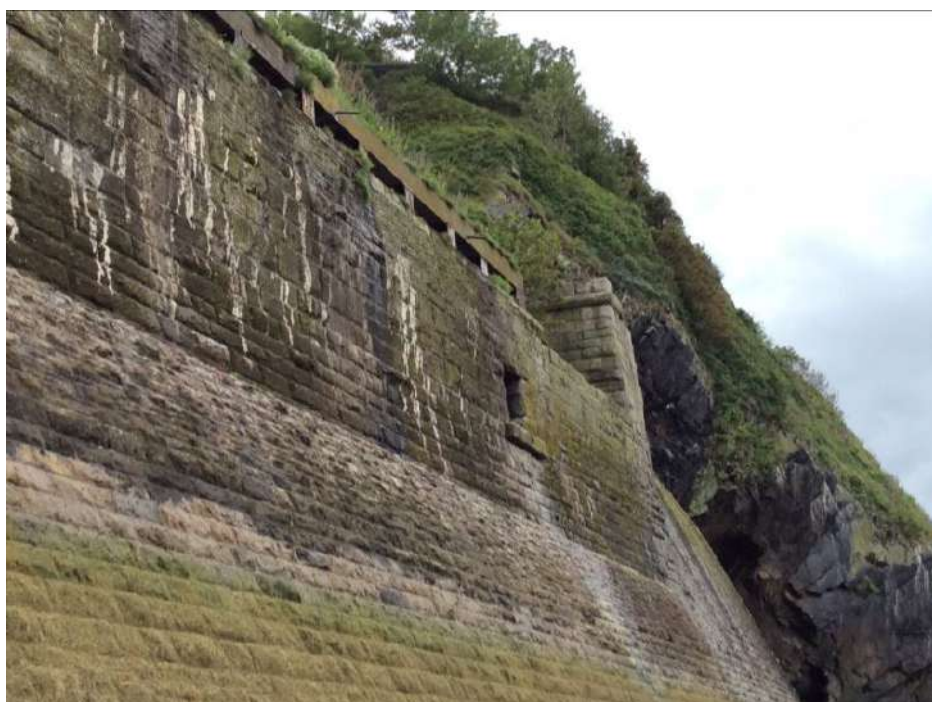
**Description:** There are Missing blocks around the outfall. Between the 2016 and 2020 examinations, all the outfalls have missing blocks. Between the 2020 and 2021 examinations, there is no change.

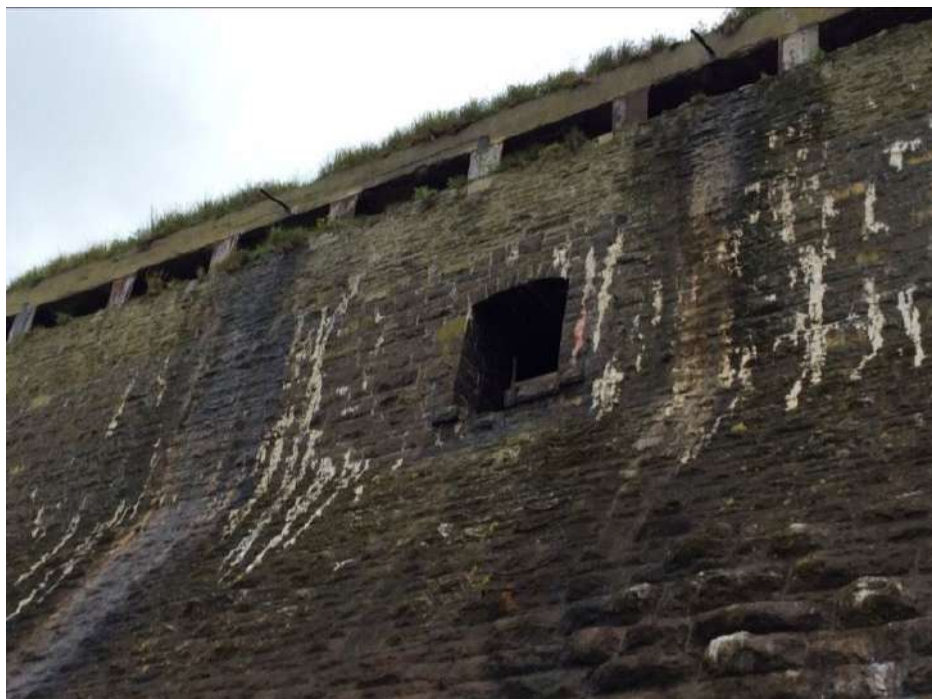
**Description:** There are Missing blocks around the outfall. Between the 2016 and 2020 examinations, all the outfalls have missing blocks. Between the 2020 and 2021 examinations, there is no change.

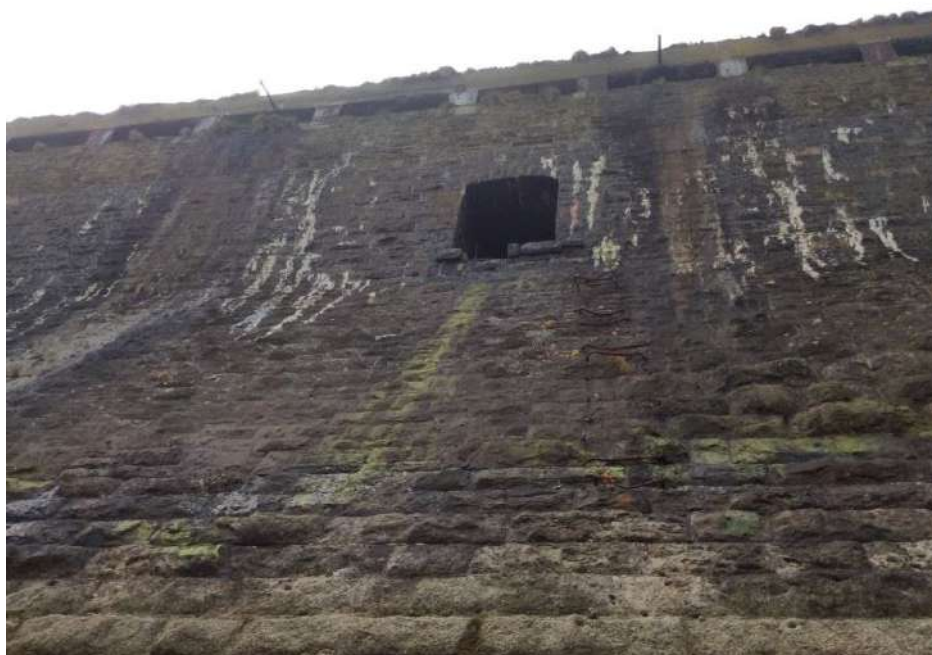
**Description:** There are Missing blocks around the outfall. Between the 2016 and 2020 examinations, all the outfalls have missing blocks. Between the 2020 and 2021 examinations, there is no change.

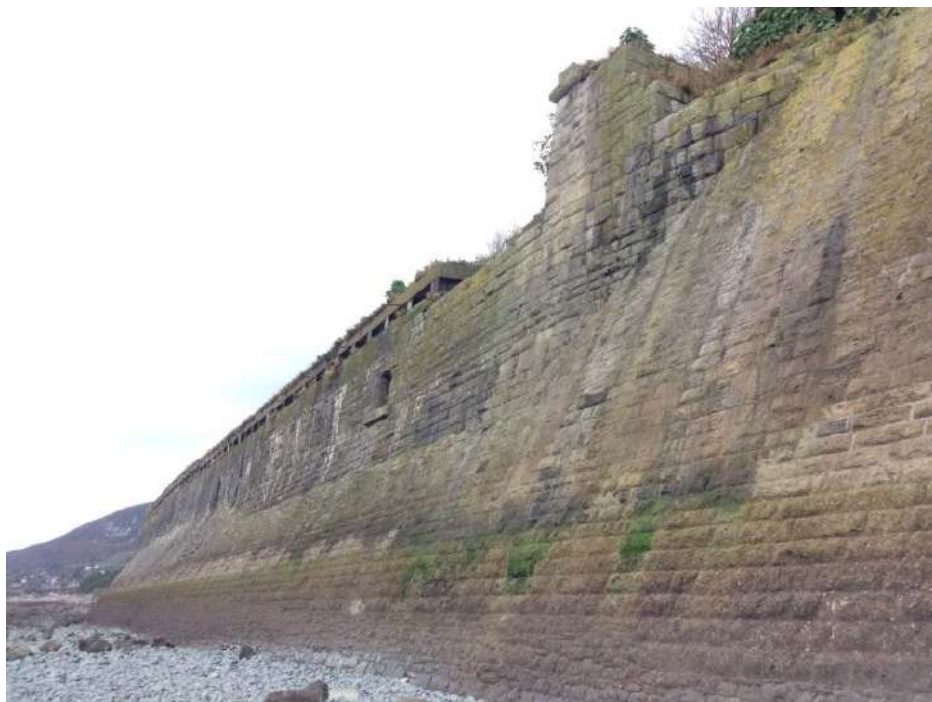
**Photo number: 107**

Seepage through the wall. Between the 2020 and 2021 inspections, there has been no change.

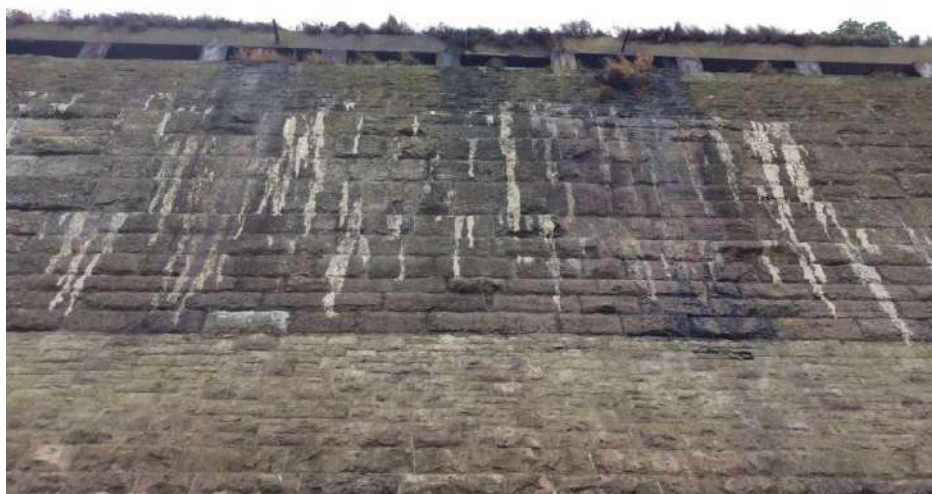
**Photo number: 113**

Vegetation growth on top of the wall.  
Between the 2020 and 2021 examinations, there is no change.

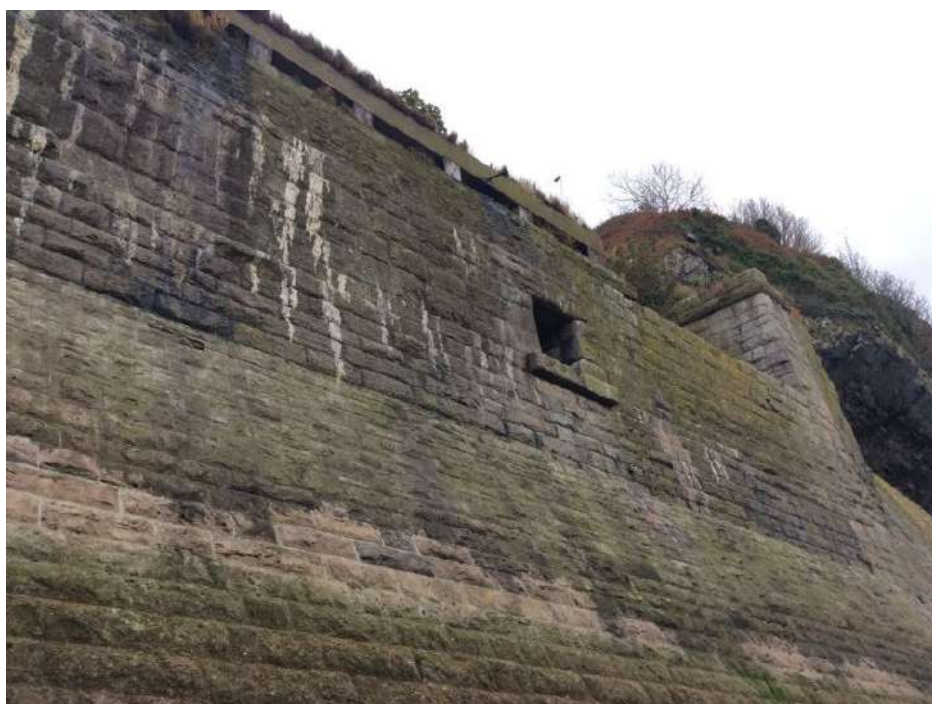
**Photo number: 114**

Vegetation growth on top of the wall.  
Between the 2020 and 2021 examinations, there is no change.

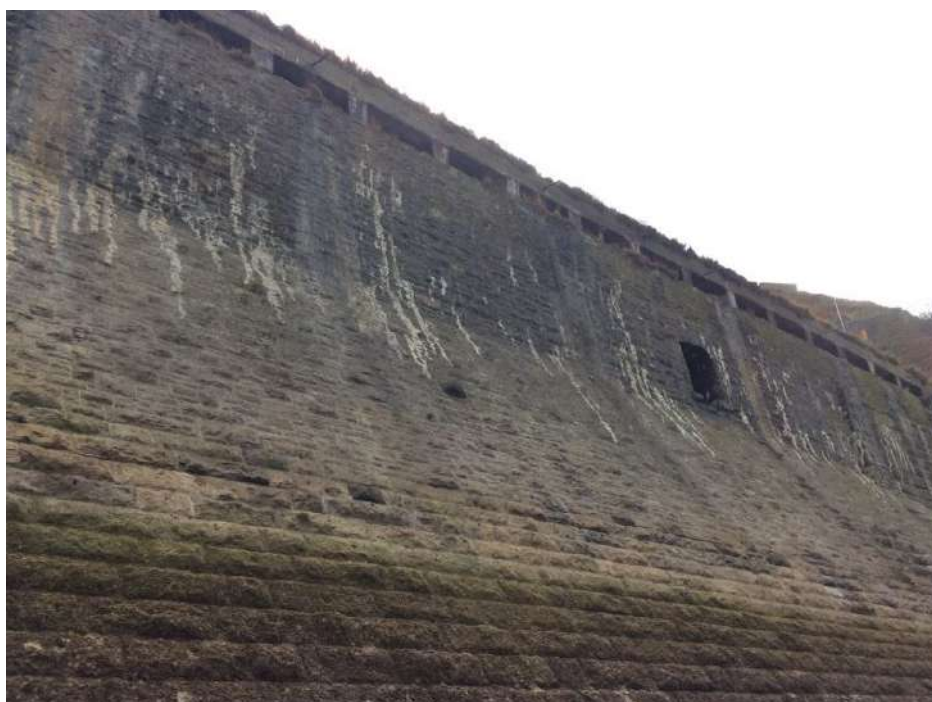
**Photo number: 127**

**Description:** Mineral seepage. Between the 2020 and 2021 examinations, there is no change.

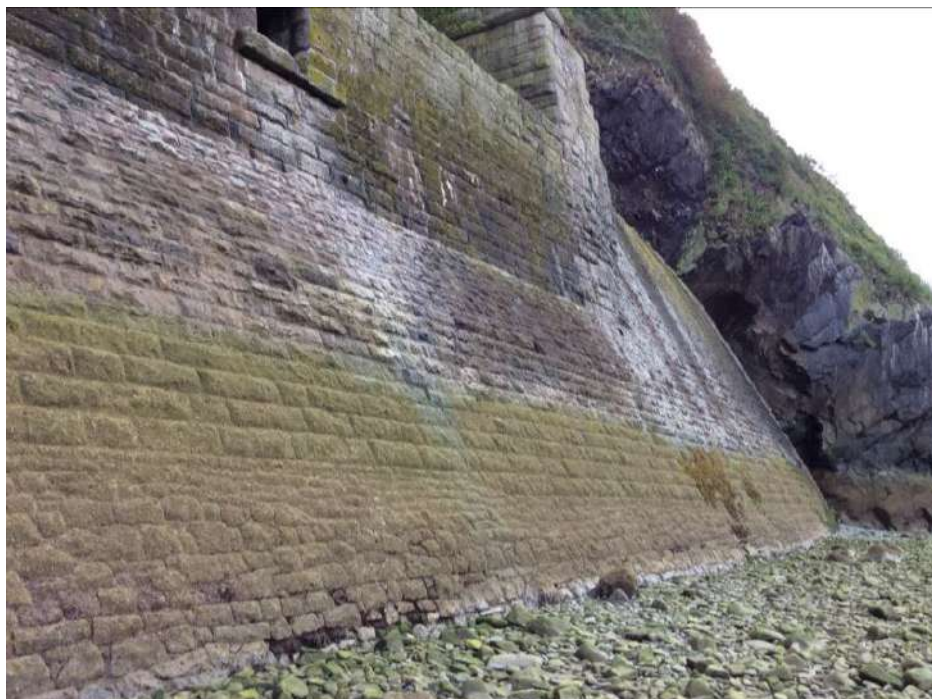
**Section A**  
**Wall section**  
**Defect Ref: D9**  
**Description:** Mineral seepage. Between the 2020 and 2021 examinations, there is no change.  
**Photo number: 70**

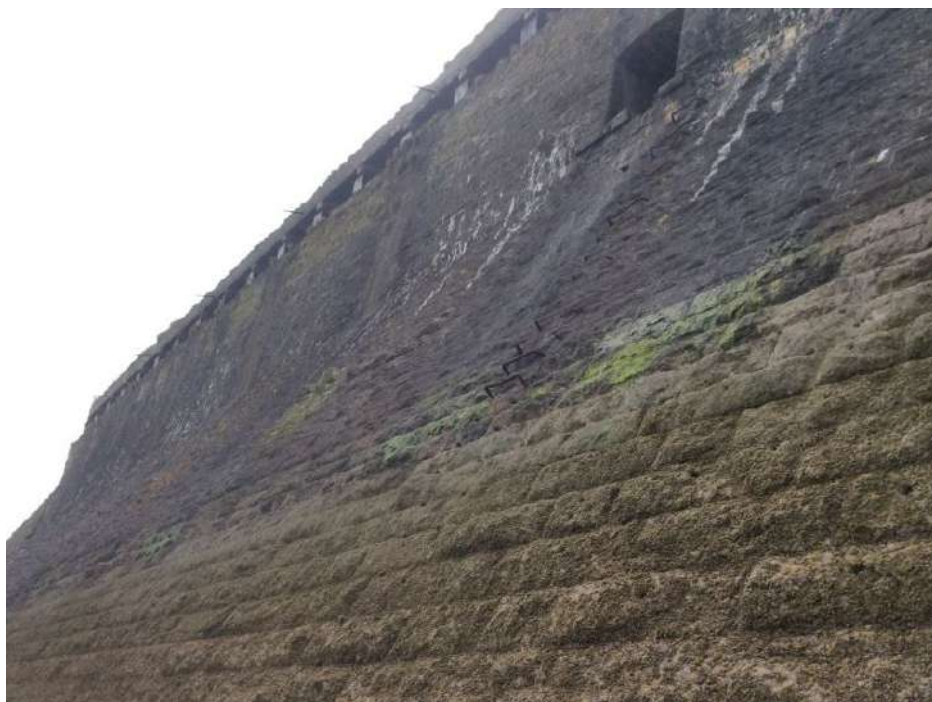
**Section A**  
**Wall section**  
**Defect Ref: D9**  
**Description:** Mineral seepage. Between the 2020 and 2021 examinations, there is no change.  
**Photo number: 89**

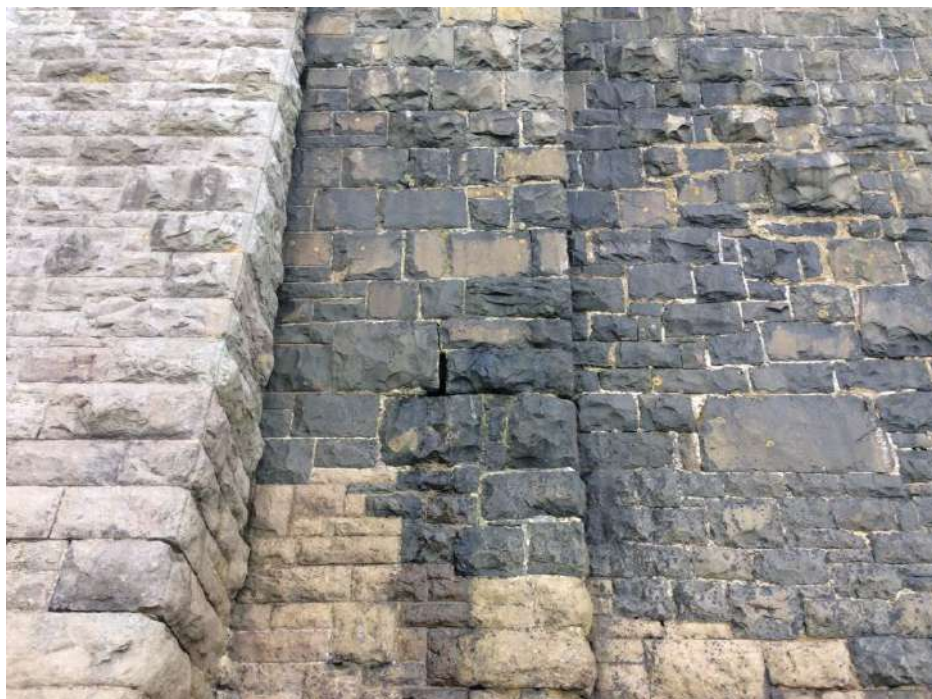
**Photo number: 143**

**Description:** There is a large open joint with seepage. The joint has been filled. Between the 2020 and 2021 examinations, additional large open joints were visible due to reduced wall toe protection.

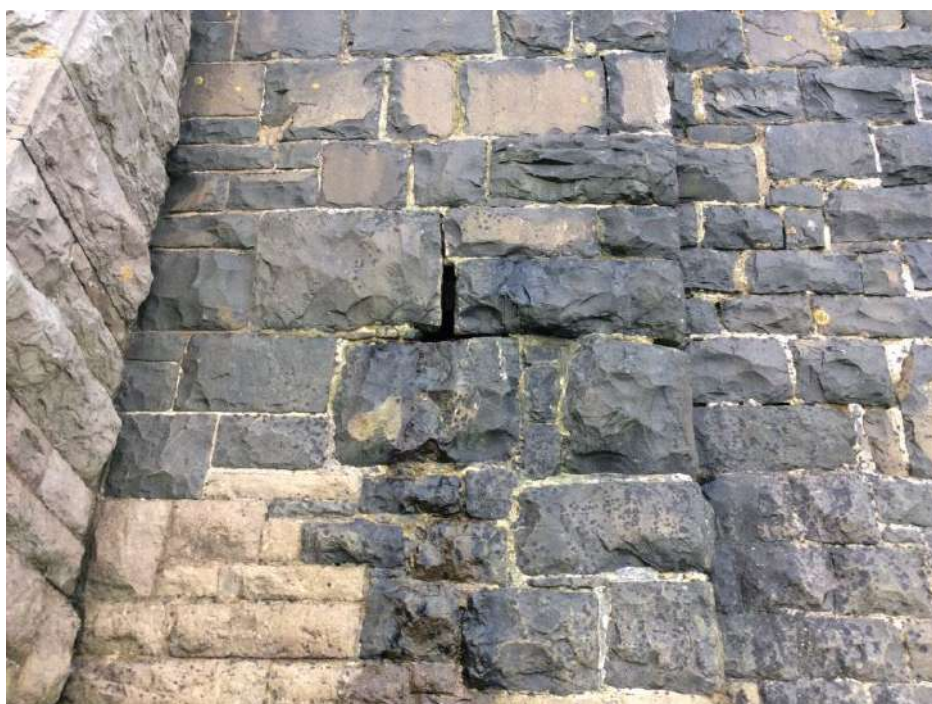
**Photo number: 145**

**Description:** There is a large open joint with seepage. The joint has been filled. Between the 2020 and 2021 examinations, additional large open joints were visible due to reduced wall toe protection.

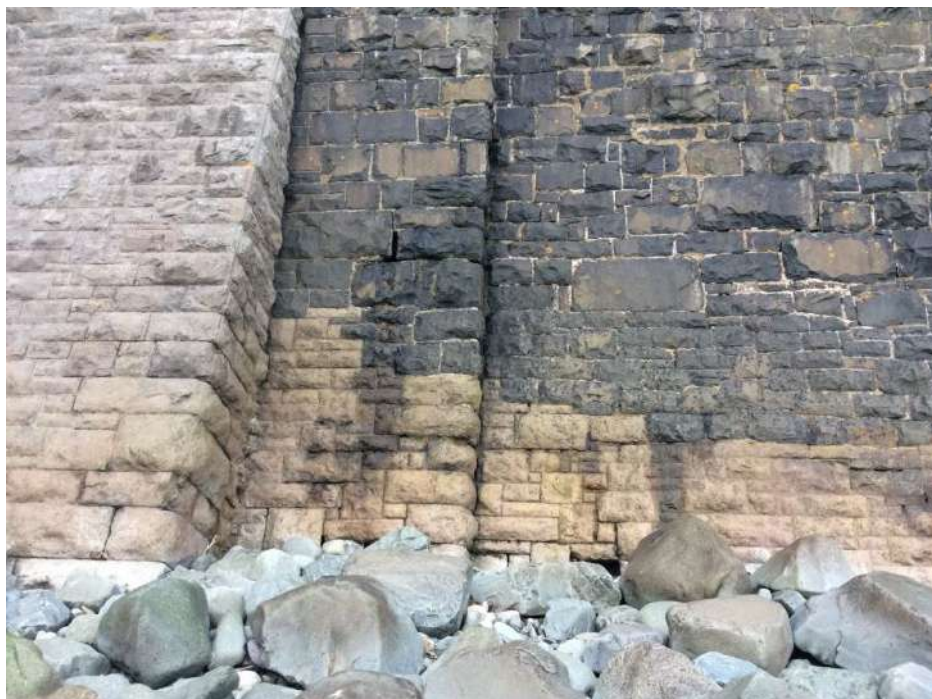
**Photo number: 146**

**Description:** There is a large open joint with seepage. The joint has been filled. Between the 2020 and 2021 examinations, additional large open joints were visible due to reduced wall toe protection.

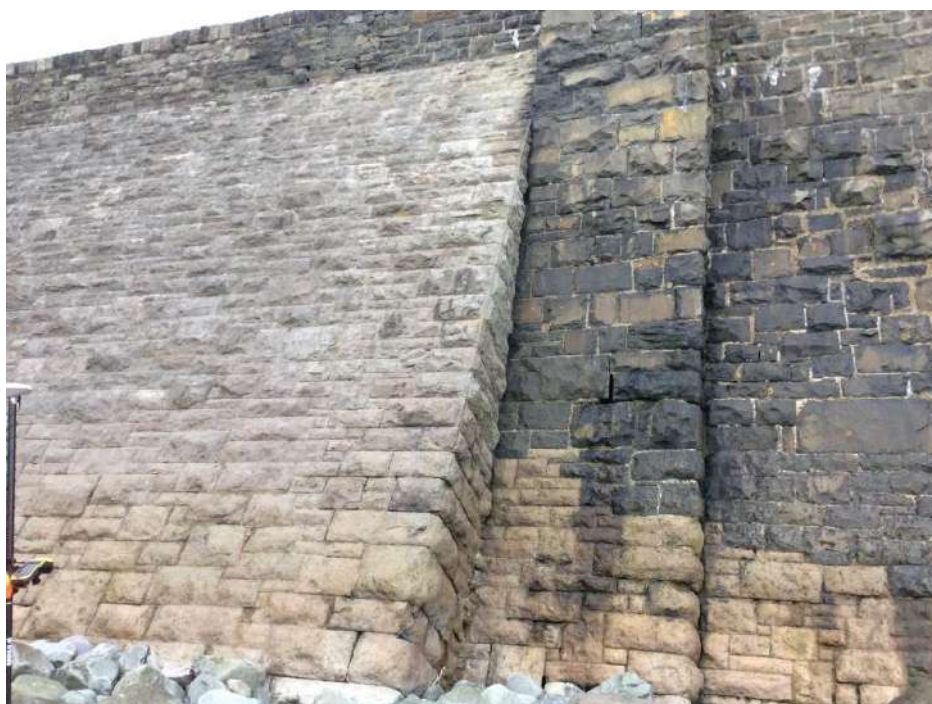
**Photo number: 142**

**Description:** There is a large open joint with seepage. The joint has been filled. Between the 2020 and 2021 examinations, additional large open joints were visible due to reduced wall toe protection.

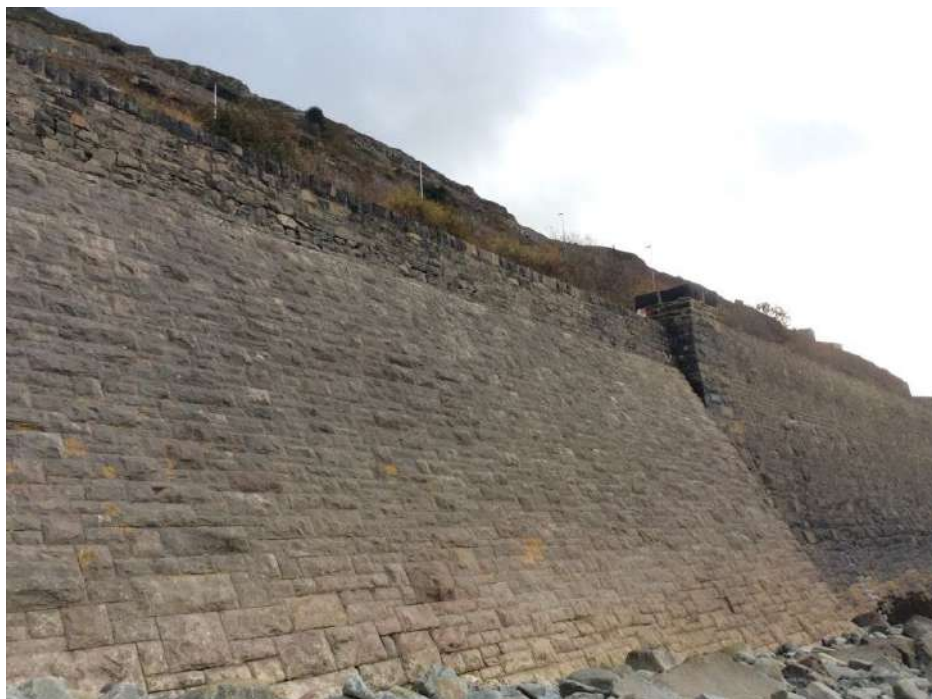
**Section A**  
**Parapet/Capping**  
**Defect Ref: D11**  
**Description:** There are Large open joints present. Between the 2016 and 2020 examinations, the defect has been repaired.  
**Photo number: 147**

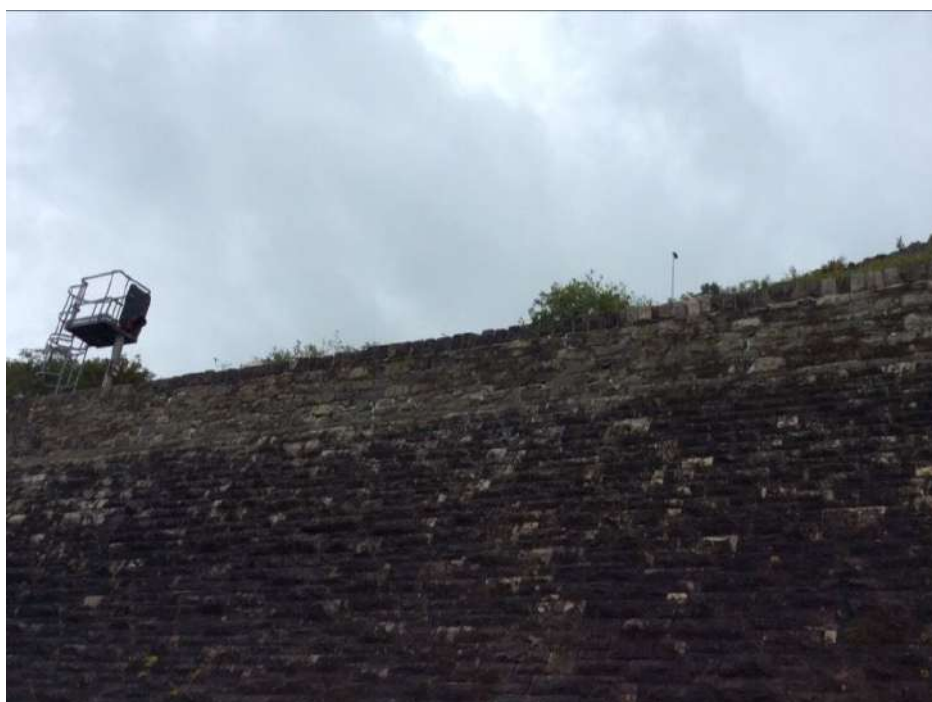
**Section A**  
**Parapet/Capping**  
**Defect Ref: D11**  
**Description:** There are Large open joints present. Between the 2016 and 2020 examinations, the defect has been repaired.  
**Photo number: 57**

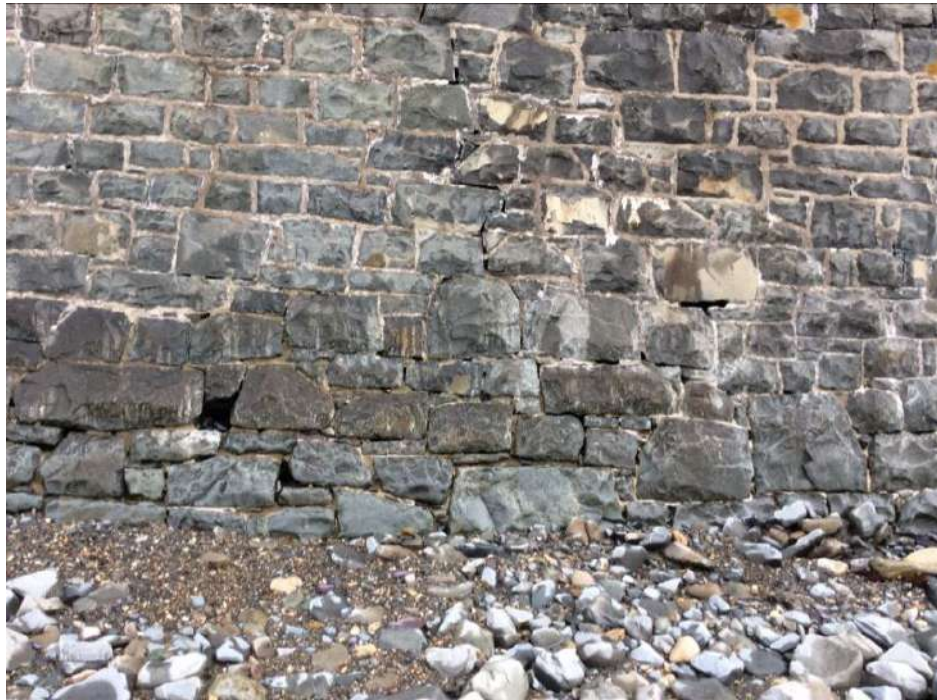
Large fracture in the wall from the bottom up approx. 3m with missing blocks and voids at the bottom in the adjacent wall.

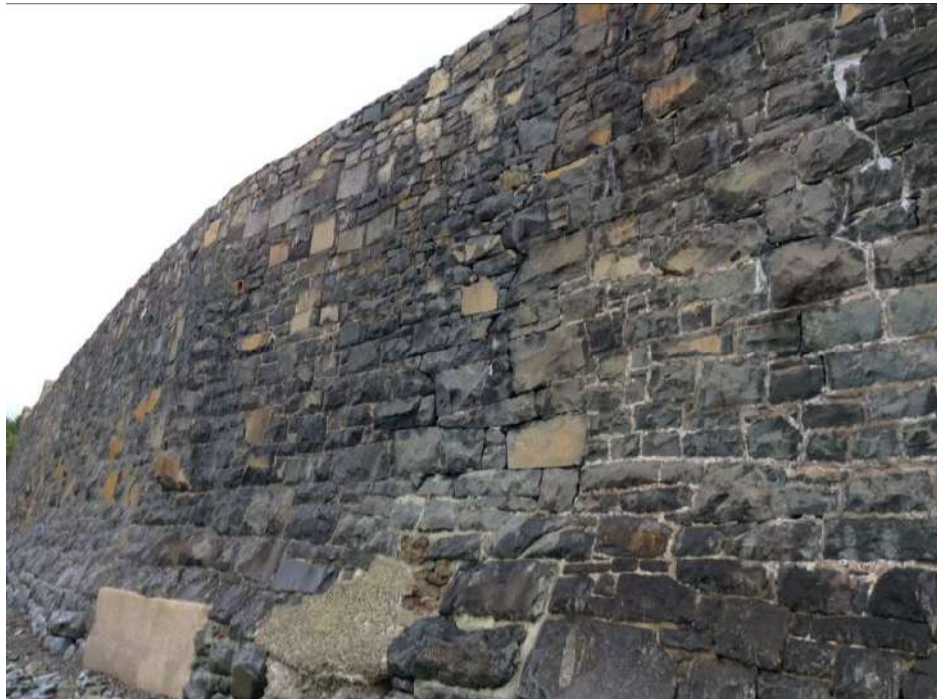
Large fracture in the wall from the bottom up approx. 3m with missing blocks and voids at the bottom in the adjacent wall.

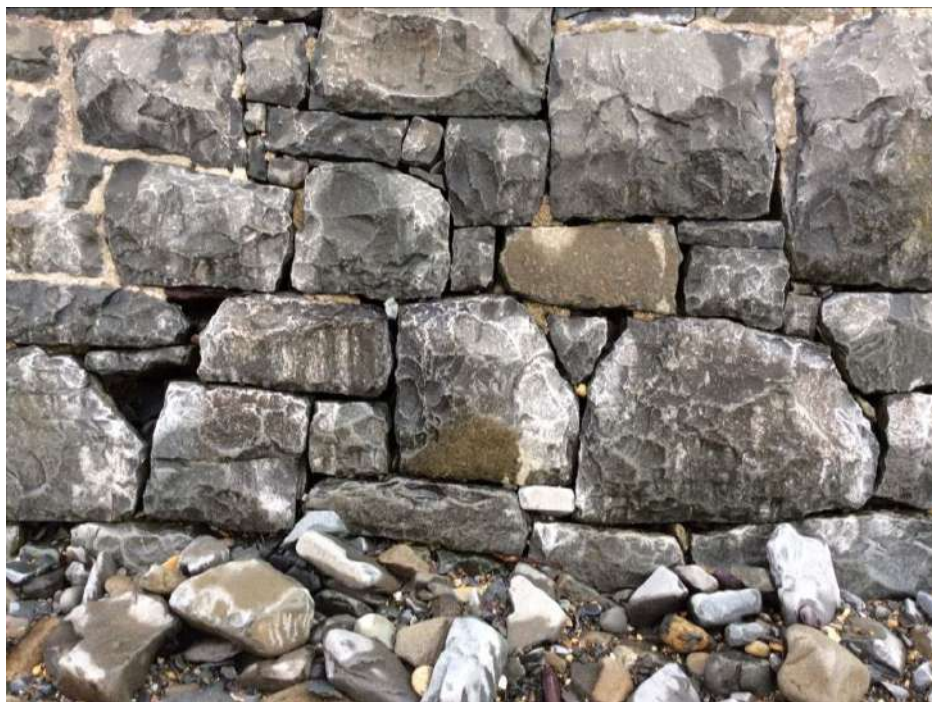
Large fracture in the wall from the bottom up approx. 3m with missing blocks and voids at the bottom in the adjacent wall.

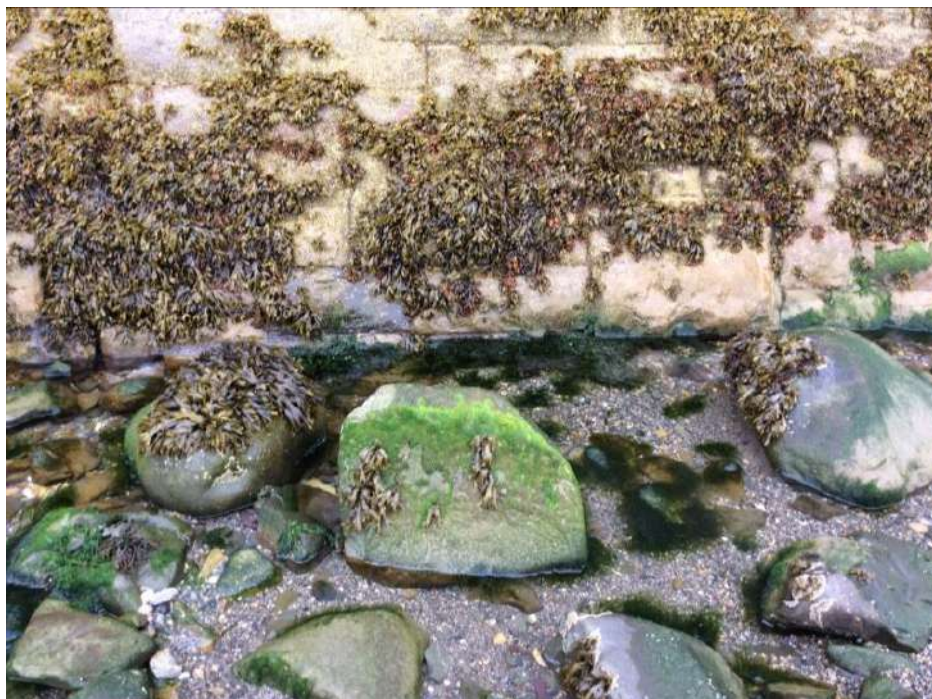
**Section A**  
**Wall section**  
**Defect Ref: D15**  
**Description:**  
Undermining with  
pooling water approx  
150mm deep.  
Defect not found in  
2021 potentially  
buried in shingle  
**Photo number: 59**

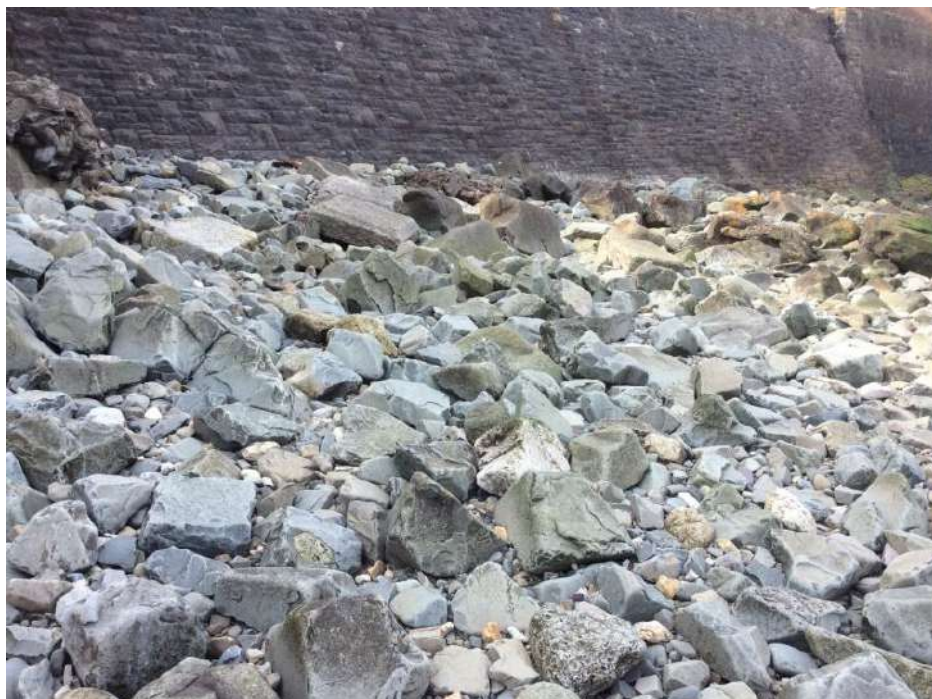
**Section A**  
**Wall section**  
**Defect Ref: D15**  
**Description:**  
Undermining with  
pooling water approx  
150mm deep.  
Defect not found in  
2021 potentially  
buried in shingle  
**Photo number: 96**

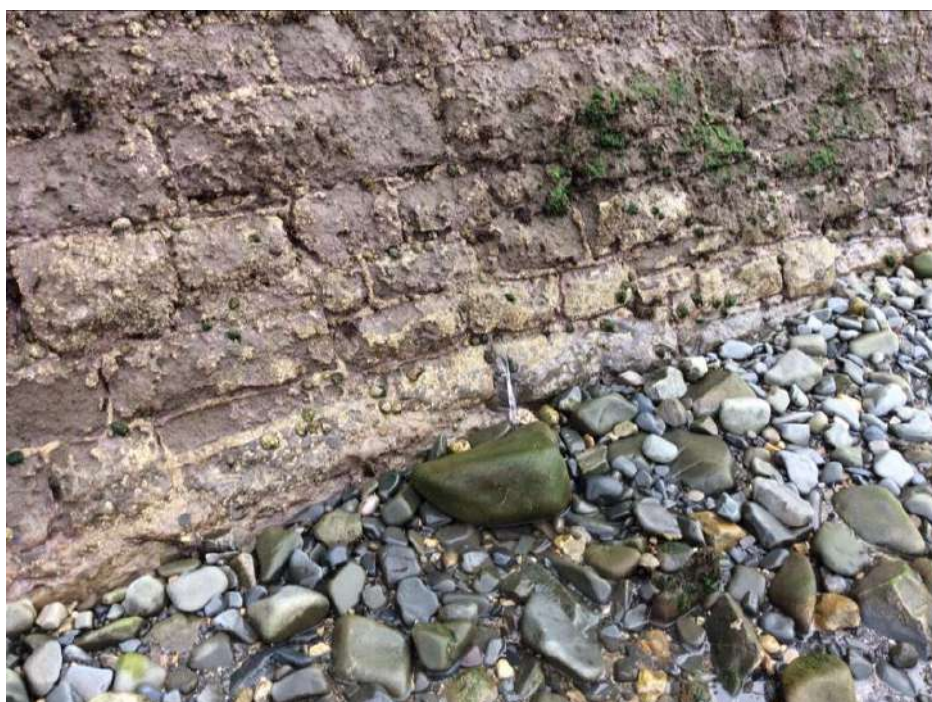
**Section A**  
**Wall section**  
**Defect Ref: D16**  
**Description:** During  
the 2020 inspection,  
there is a critical and  
visible seepage point  
in the toe of the wall.  
Between the 2020  
and 2021  
examinations, there is  
no change.  
**Photo number: 68**

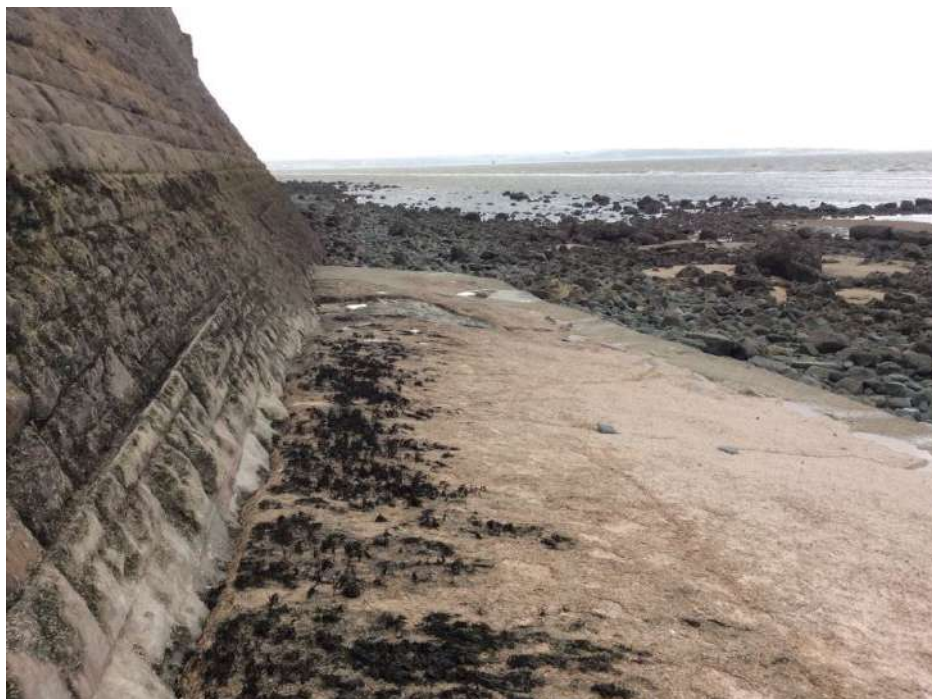
**Section A**  
**Wall Apron**  
**Defect Ref: D17**  
**Description:** Minor spalling across the concrete apron. Between the 2020 and 2021 examinations, there is no change.  
**Photo number: 140**

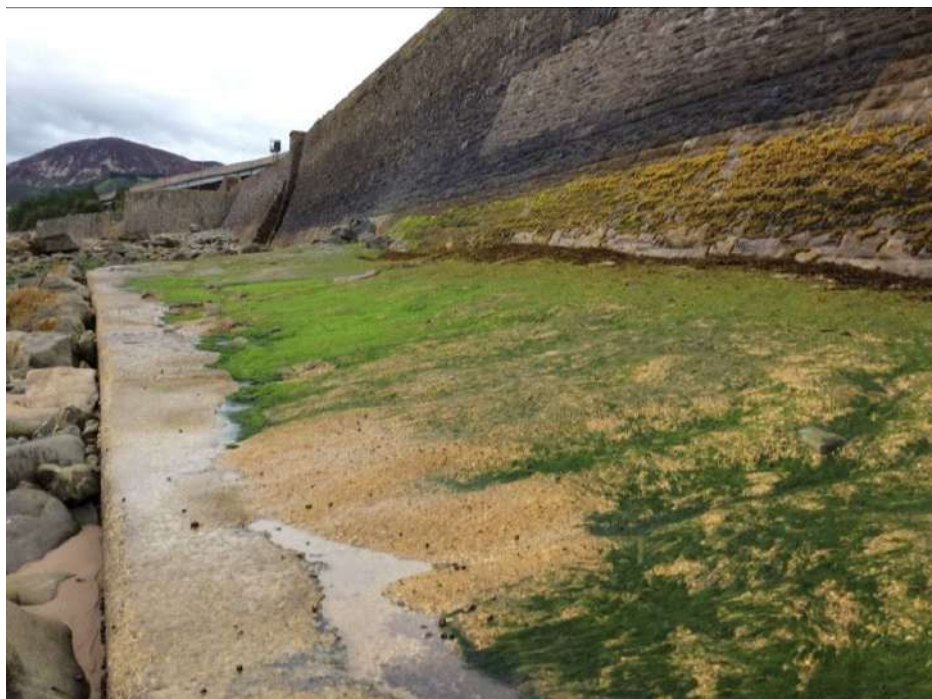
**Description:** Minor spalling across the concrete apron. Between the 2020 and 2021 examinations, there is no change.

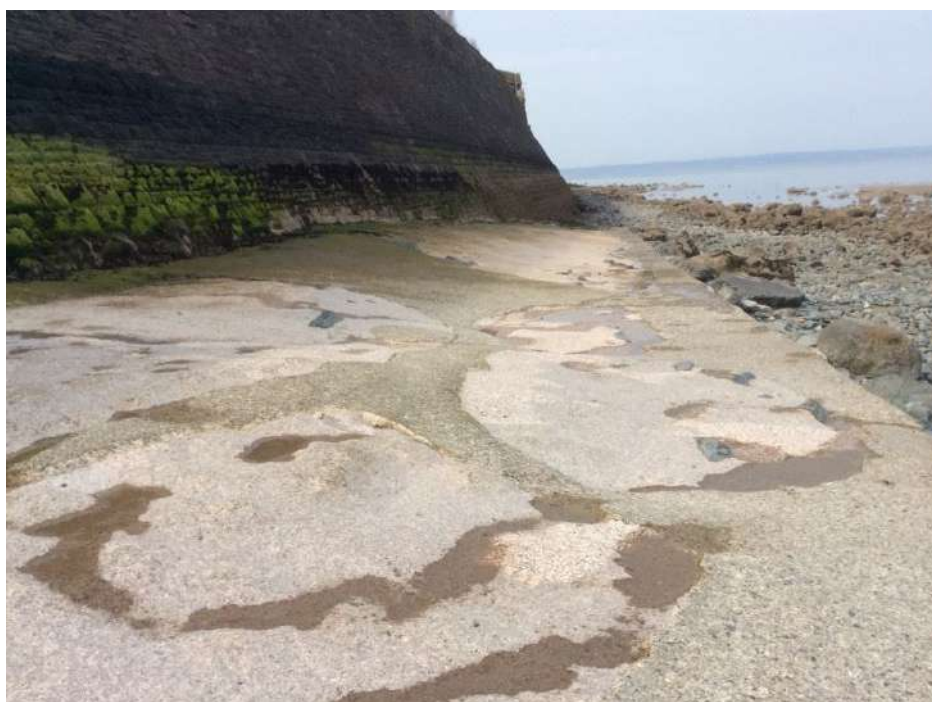
**Description:** Minor spalling across the concrete apron. Between the 2020 and 2021 examinations, there is no change.
