PENRHOS SUBSTATION

Site Walkover Summary

794-ENV-GDE-21696
Penrhos Substation
1
15 April 2025

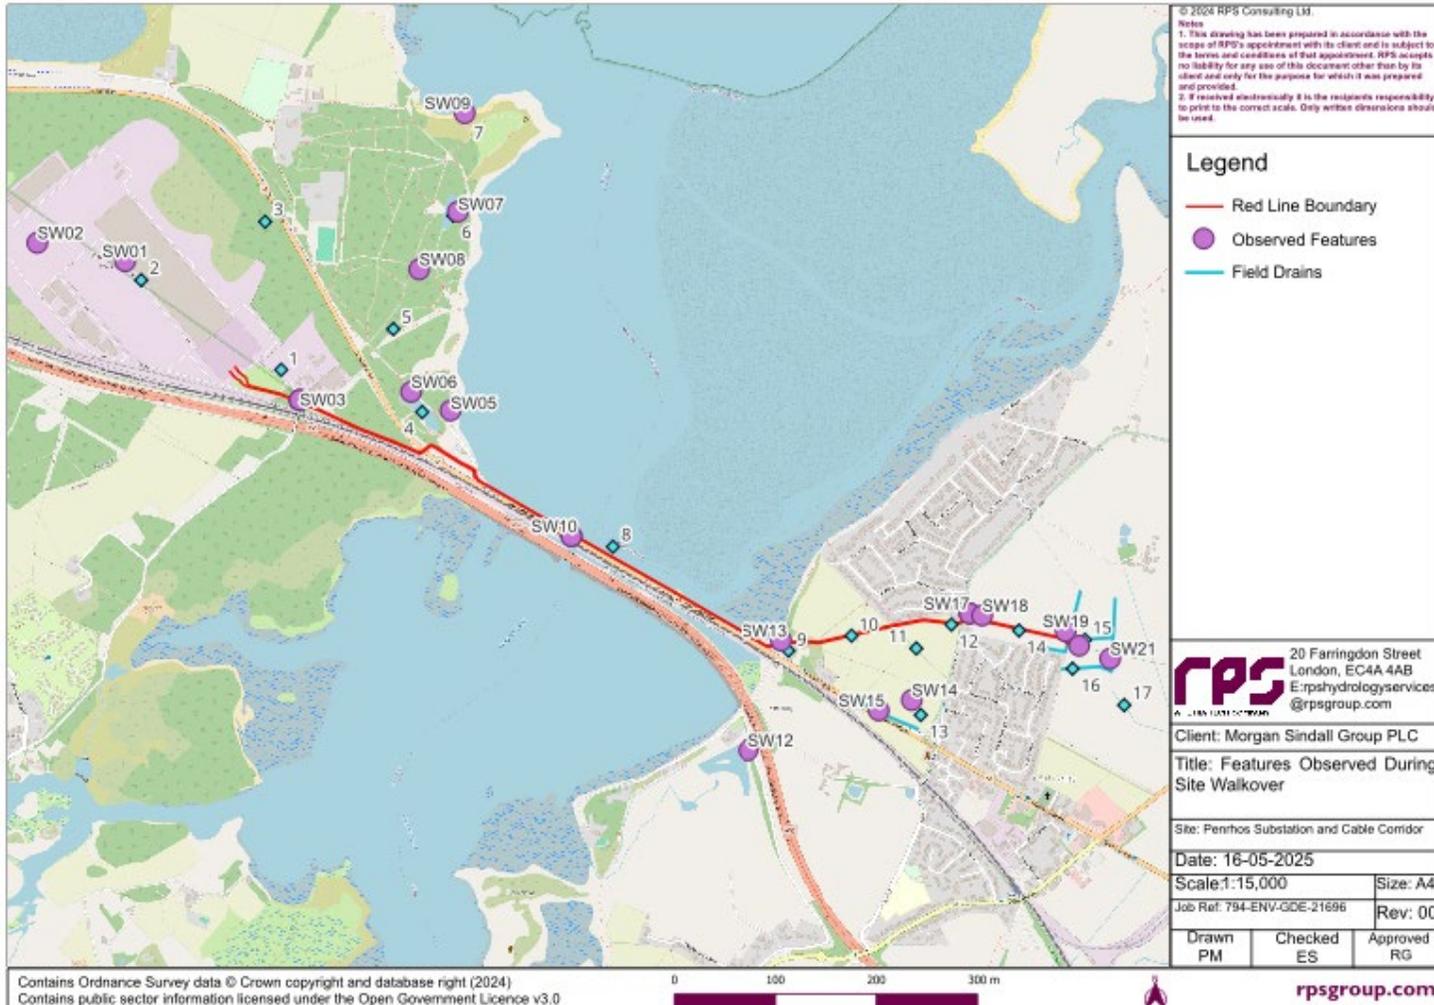
Figure 2 - Site Walkover observed feature locations

- 3.4 A walkover of the substation compound (centred on NGR SH 26549 80972) was undertaken. It was observed that the site was generally flat. Drains were present along the central road (as shown in Figure 2) . The compound has been largely demolished, although two small buildings remain.
- 3.5 Historical remediation validation reports written by Geo² Remediation Ltd in 2020 indicated the presence of monitoring wells on the substation site. Subsequently, one of the primary aims of the
