## Event Duration Monitoring

### Trigger Exceedance Notification

Report type: Stage 6: Close Out Report

Location: Combined Sewer Overflow at Dunns Lane/Park Street

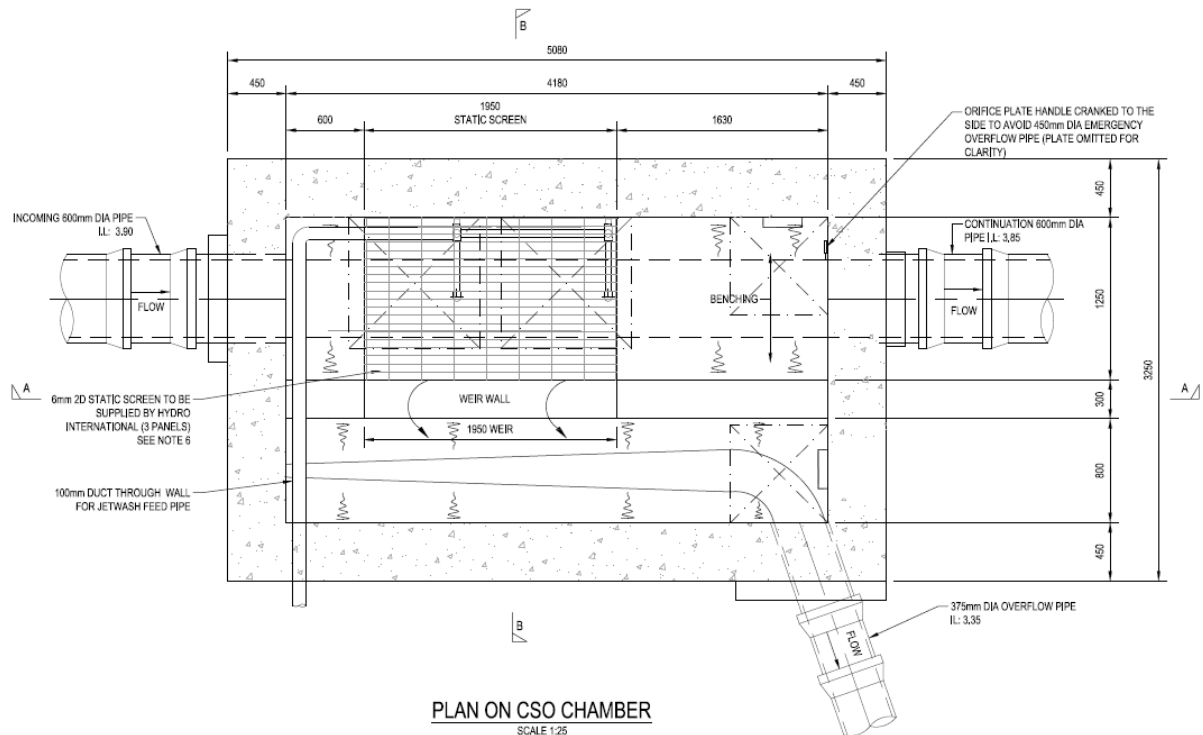
Figure 3: Plan View of CSO chamber

The CSO consists of a concrete chamber with a 600mm diameter incoming pipe and a 600mm diameter continuation pipe connecting to the downstream network. The PFF is controlled with an orifice plate. When the flow entering the CSO is greater than 62l/s, the entering flow surcharges, and weirs to the Storm water system before discharging to the environment via a 375mm outfall pipe.

Telemetry is via a Cello monitor; a spill is triggered when the level reaches 100%.
