## Event Duration Monitoring

### Trigger Exceedance Notification

Report type: Stage 2: Full Investigation Proposal

Location: CSO 121 at Sandfields Pumping Station (Outfall 'L')

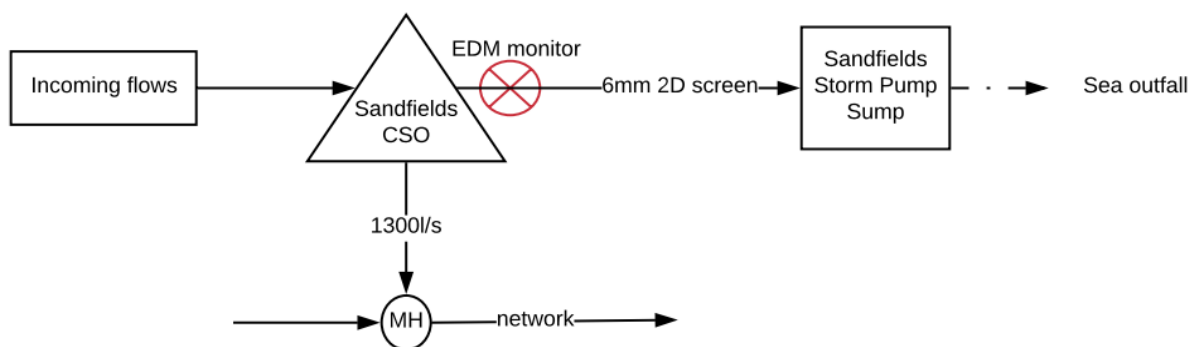
Figure 4: SPS Configuration

Discharges are monitored by an ultrasonic level detector, used for EDM purposes. PFF is controlled by a penstock in the CSO stilling and screening chamber. Flows enter the SPS from the combined network inlet sewer. Flow gravitates through the pumping station and into the adjacent interceptor trunk sewer passing Easterly through the asset compound.

If the flow coming into the CSO exceeds the capacity of the downstream flow control, a spill occurs due to the downstream network surcharge. Spill flows pass up, through the screen and over the weir and gravitates to the discharge point via the long sea outfall. If there is a high tide and the outfall becomes hydraulically locked, flow enters the storm pump sump, and the pumps lift flows to create sufficient hydraulic head to pass flows down the outfall.

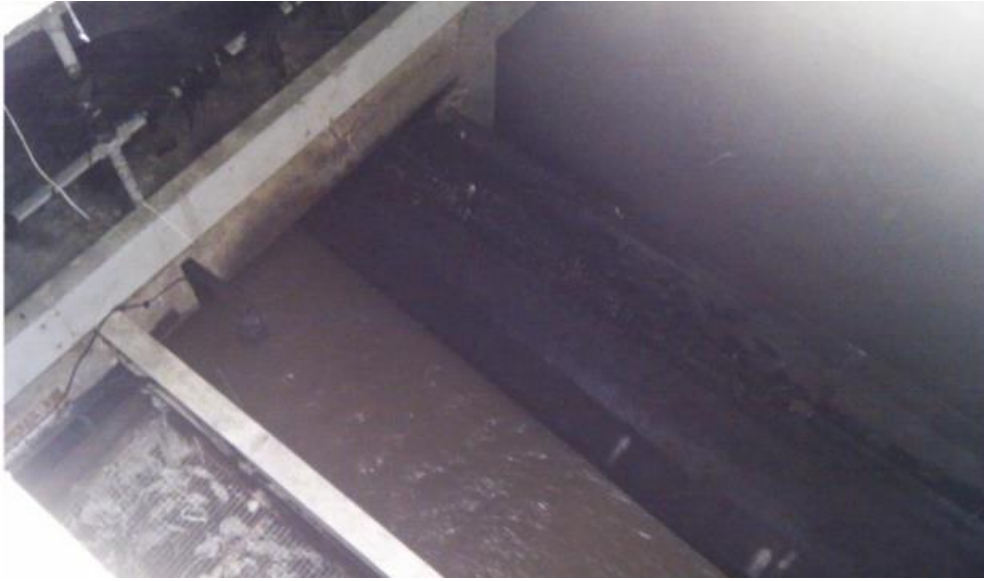
Figure 5: Internal View of Screen Chamber

A detailed Root cause cannot be determined at this stage as there are concerns over the reliability of the data due to the current location of the EDM monitor. Work to be carried out to move EDM monitor to the spill channel, currently reading off the screen level monitor.

We are planning work to install a new monitor in the CSO, once the monitor is in place and we have collected some data from it, we will undertake a detailed root cause. Access to the asset is difficult and there are H&S issues that need to be overcome.
