Clydach Geomorphology Survey

29/08/2025

Stage 1 Geomorphology Assessment

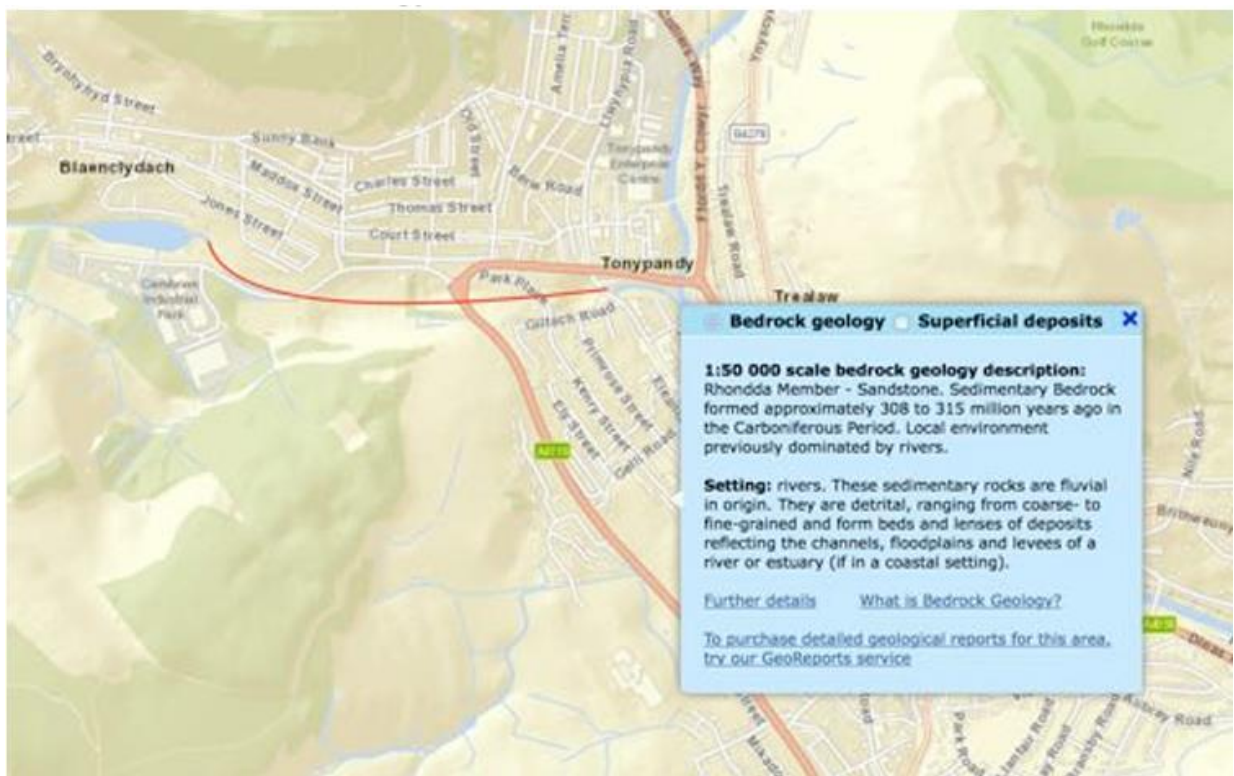
Figure 2: Bedrock geology of the area around the watercourse of Cwm Clydach (Source British Geological Survey and Google Earth). Proposed Depleted Reach shown in Red.

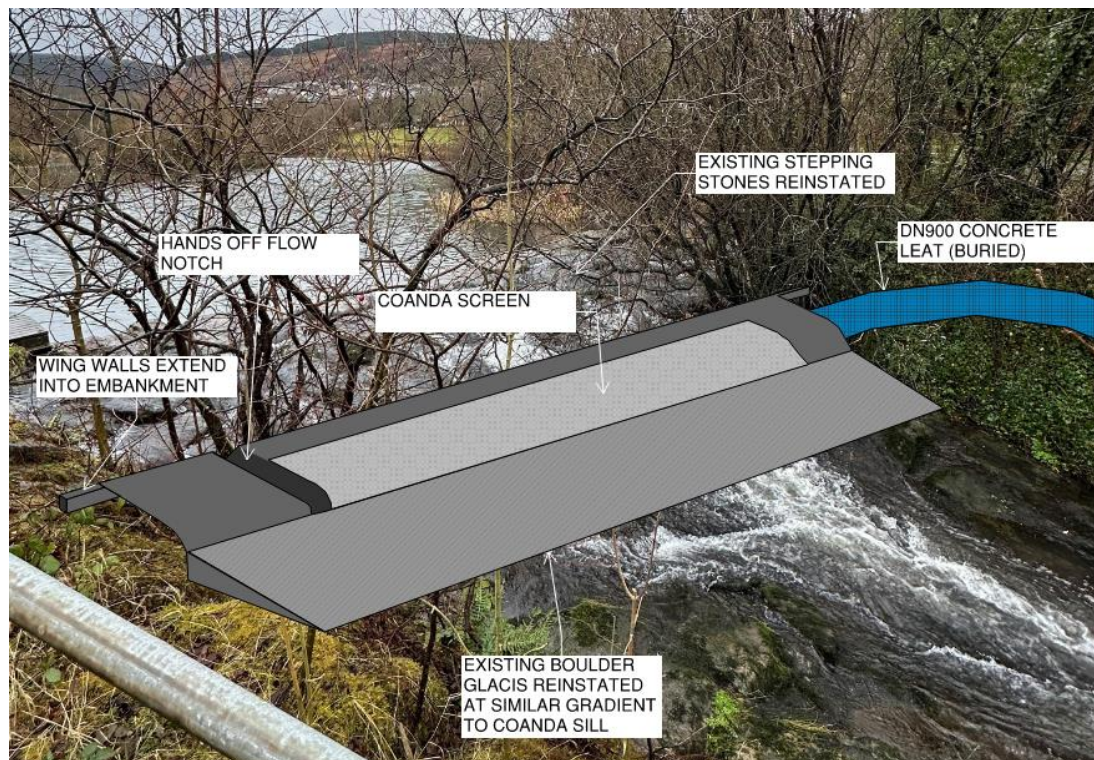
The below images show an annotation of the intake, including an illustration of proposed structures. See Location B for more images.

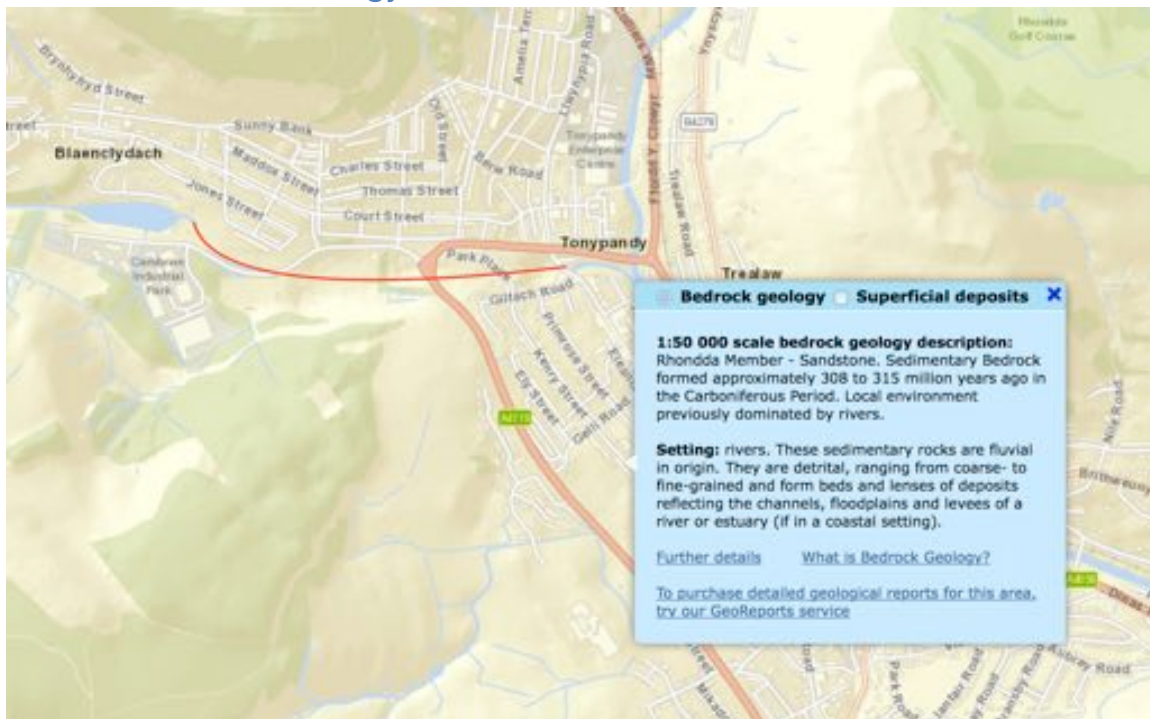
Figure 2: Bedrock geology of the area around the watercourse of Cwm Clydach (Source British Geological Survey and Google Earth). Proposed Depleted Reach shown in Red.

The underlying solid bedrock geology is Sandstone, however the entire depleted reach in question is manmade, with the majority (97%) of the route being a concrete culvert, with only the upper 30 meters being unknown origin large rocks set in a concrete channel. There are no known natural rocks or featured within the depleted reach.
