| | | <b>NETWORK RAIL</b><br><b>Bridge Detailed Examination Report</b> | | | | | | | | | | |
| ELR: LLA | | Contract Mileage: 004 m 1320 yds 60.00 ch | | | | | | Struc. Ref: 4 60 | | | | |
| Structure Name: River Gwilli. | | | | | | Type: BU | | Exam ID: 16370968 | | | | |

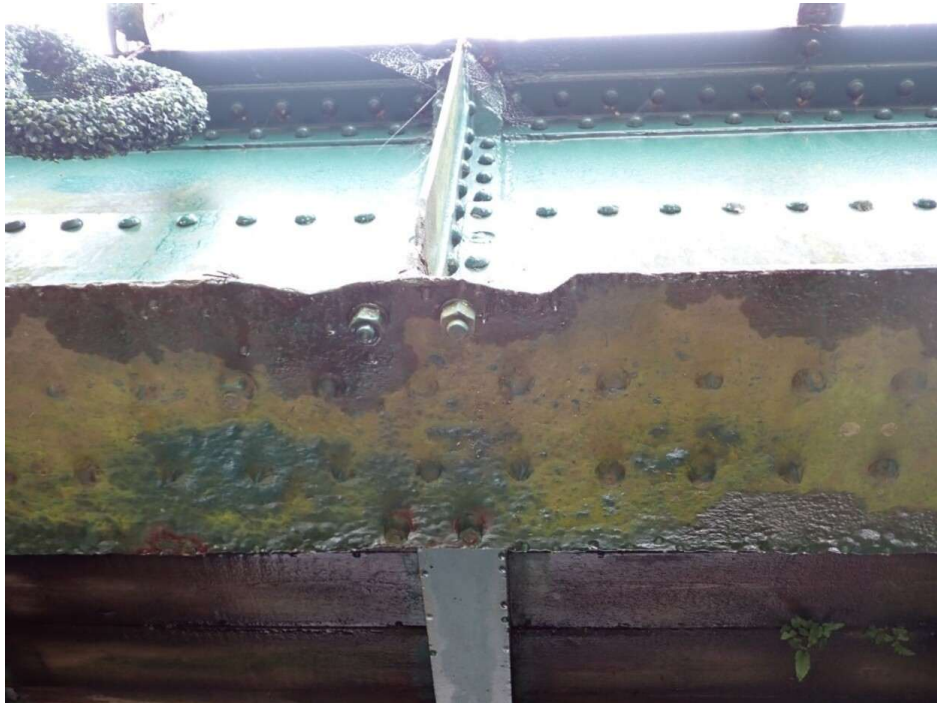
[Photo 12: Loss of Section \(28/08/2024\)](#)

| <p>Main Girder 1 (DK1-MGE1):</p> <p>To the outer edge of the main girder an area of old standing loss of section 300mmL x 50mmD directly below the 4th stiffener from LM end. NFD. Photo 12</p> <p>--</p> <p>To the inner edge of the main girder at the connection with the first cross girder is an area of old standing loss of section 250mmL x 50mmD. NFD. Photo 13.</p> <p>--</p> <p>To the inner edge of the main girder at the connection with the second cross girder and area of old standing loss of section to 280mmL x 45mmD. NFD.</p> <p>--</p> <p>LM End for the girder is an area that has been cut out 400mmL x 120mmD between the bearing stiffener and the first stiffener. The edges to the area is starting to show light surface corrosion. NFD. Photo 14.</p> <p>--</p> <p>Remainder of girder and stiffeners showing extensive deep corrosion &lt;8mm. NFD. Painted over and paintwork still intact.</p> <p>--</p> <p>Deep pitting/loss around stiffener connections to top flange of old standing painted over and show NFD.</p> <p>--</p> <p>Repairs to loss of section at each end of girder remain solid and intact.</p> <p>---</p> <p>Main Girder 2 (DK1-MGE2):</p> <p>Girder shows extensive deep pitting which has been painted over &lt;8mm. NFD.</p> <p>--</p> <p>Corrosion sores beginning to show through the paintwork throughout length of bottom flange &lt;2mm deep. NEW. Photo 15.</p> <p>--</p> <p>Loss of section to all stiffeners in centre (previous height of removed span beams). Worst 100mm x 40mm x 10mm. NFD. All painted when bridge was repaired. Photo 16,17.</p> <p>--</p> <p>Deep pitting/loss around stiffener connections to top flange of old standing painted over and show NFD.</p> <p>--</p> <p>Repairs to loss of section at each end of girder remain solid and intact.</p> <p><a href="#">See photo: 12 - Loss of Section (28/08/2024)</a></p> <p><a href="#">See photo: 13 - Loss of Section (28/08/2024)</a></p> <p><a href="#">See photo: 14 - Cut Out (28/08/2024)</a></p> <p><a href="#">See photo: 15 - Main Girder 2 Bottom Flange (28/08/2024)</a></p> <p><a href="#">See photo: 16 - Typical Loss to Stiffeners (28/08/2024)</a></p> <p><a href="#">See photo: 17 - Typical Loss to Stiffeners (28/08/2024)</a></p> | | | |

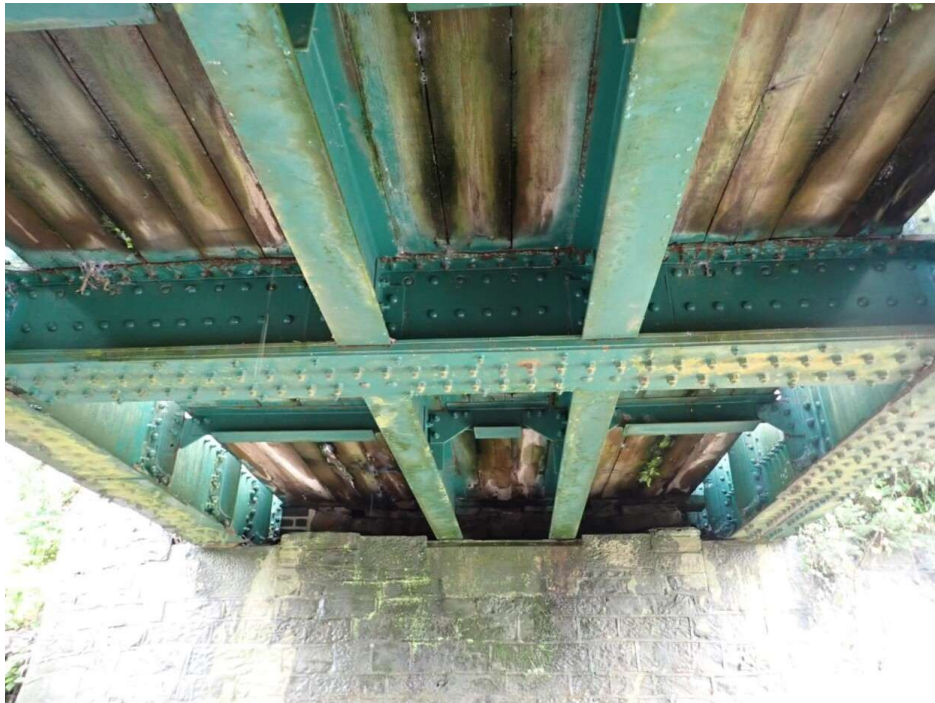
[Photo 18: LM Cross Girder \(28/08/2024\)](#)

| <p>(DK1- XGI1)</p> <p>Both cross girders in similar condition. Repairs carried out previously remain solid. Deep pitting visible to webs below paintwork. &lt;8mm deep. NFD.</p> <p>--</p> <p>Corrosion to top angles &lt;2mm. NEW. Photo 18,19.</p> <p><a href="#">See photo: 18 - LM Cross Girder (28/08/2024)</a></p> <p><a href="#">See photo: 19 - HM Cross Girder (28/08/2024)</a></p> | | | |

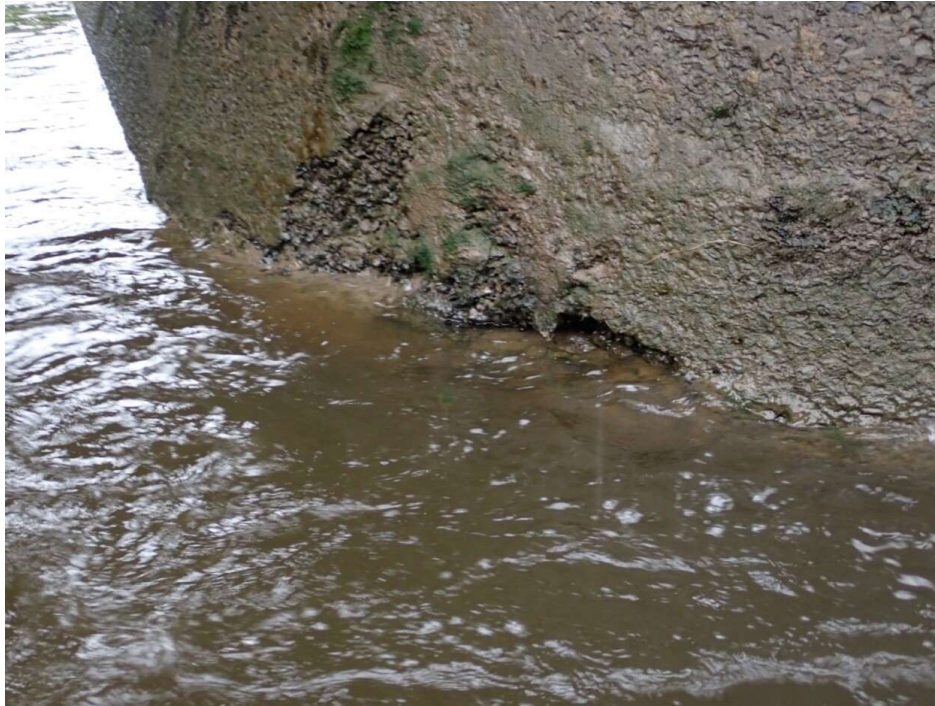
[Photo 23: Spalling \(28/08/2024\)](#)

| LM Abutment (ES1-ABT1)<br>Wall of uneven appearance to top stone section. Concrete apron to lower portion of wall. Photo 22.<br>--<br>Isolated stones loose to hammer mainly to upper courses. NFD.<br>--<br>Isolated spalling located at upside end return wall at water level 300mm L x 250mm H x <100mm deep. This is of longstanding. NFD. Photo 23.<br>--<br>Diagonal step joint fracture to upside on rounded area of return. Open 50mm at top of wall with stones displaced forward 50mm around tree growing from fracture. Open 10m at bottom of fracture. Full height of abutment from concrete apron. NEW. Photo 24,25.<br>---<br>HM Abutment (ES2-ABT1)<br>Previously reported - Isolated stone work displaced at worst located between DK1 MGE1&MGI1 to top 3No courses, 500mm L x 500mm W and pushed forward <20mm with fracturing <4mm wide. note, isolated stones loose to hammer. This is of longstanding and shows no further deterioration. Photo 26<br>--<br>Isolated pointing repairs have been carried out with open joints remaining mainly at the lower ¼ of the abutment. Date tab present on pointing repairs upside (1/11/16) and intact. Photo 27,28.<br><a href="#">See photo: 22 - LM Abutment (28/08/2024)</a><br><a href="#">See photo: 23 - Spalling (28/08/2024)</a><br><a href="#">See photo: 24 - Fracture (28/08/2024)</a><br><a href="#">See photo: 25 - Displacement Around Tree (28/08/2024)</a><br><a href="#">See photo: 26 - Loose to Hammer (28/08/2024)</a><br><a href="#">See photo: 27 - HM Abutment (28/08/2024)</a><br><a href="#">See photo: 28 - Date Tab (28/08/2024)</a> | | | |

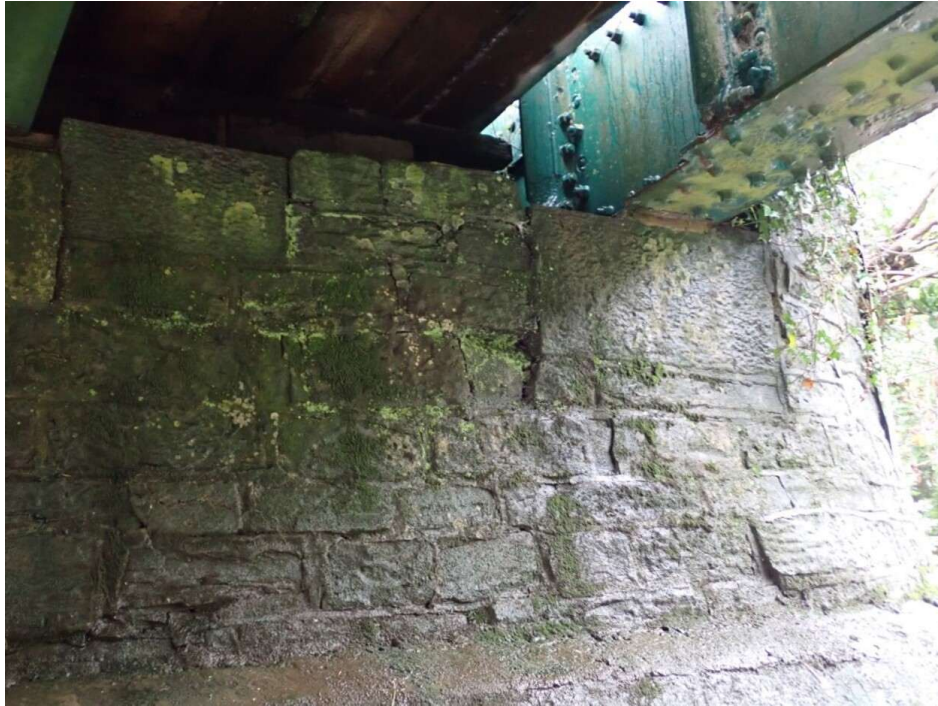
[Photo 29: Typical Bedstone \(28/08/2024\)](#)

| General Weathering only. Photo 29.<br><a href="#">See photo: 29 - Typical Bedstone (28/08/2024)</a> | | | |

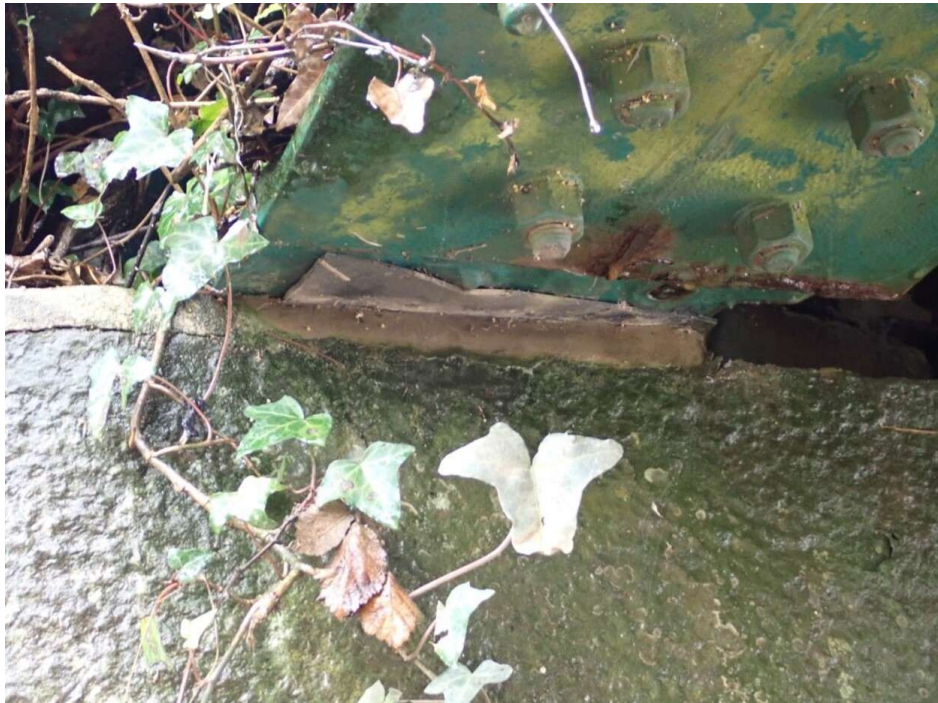
[Photo 30: Lead Bearing \(28/08/2024\)](#)

| Lead bearings present only visible where sticking out from under upside LM girder end. Photo 30<br><a href="#">See photo: 30 - Lead Bearing (28/08/2024)</a> | | | |

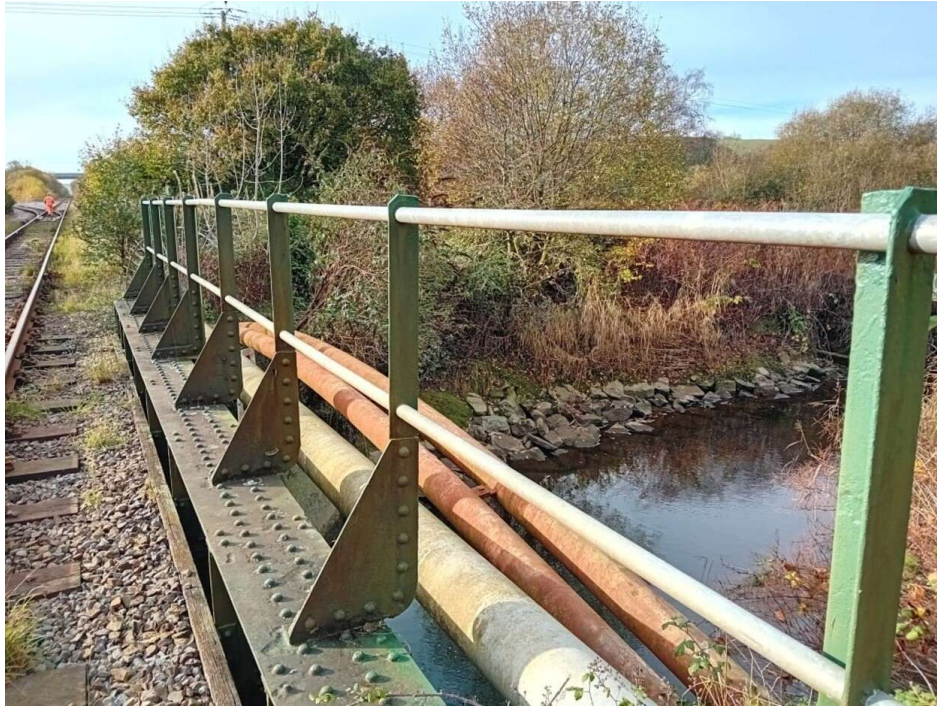
[Photo 33: Upside Handrail \(12/11/2024\)](#)

| Handrail to the upside of structure. Firm and secure. Old standing loss to several stiffener plates of uprights and base plate of upright. Painted over and paint remains intact. NFD. Photo 33,34.<br>--<br>To the downside wire mesh fencing present preventing fall from height to river below. All secure and intact. Vegetation is beginning to grow through the mesh at both HM and LM ends. NEW. Photo 35.<br><a href="#">See photo: 33 - Upside Handrail (12/11/2024)</a> | | | |

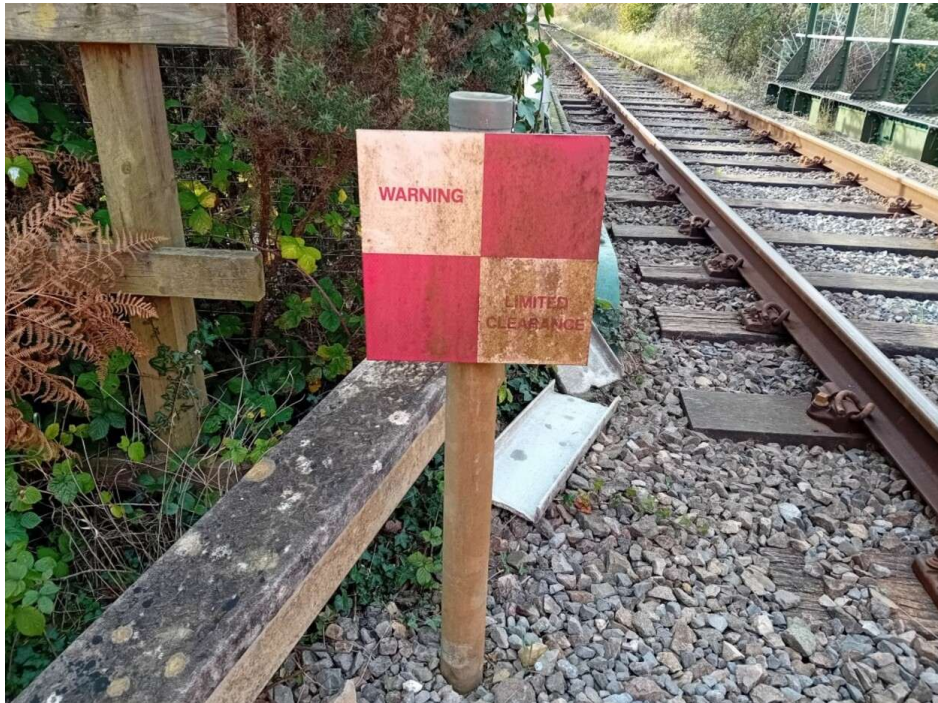
[Photo 36: Typical Limited Clearance Plate \(12/11/2024\)](#)

| Water level indicators present to both abutments and clean.<br>--<br>Limited clearance signs present to HM upside and LM downside only. Both plates are dirty with algae. Photo 36.<br><a href="#">See photo: 36 - Typical Limited Clearance Plate (12/11/2024)</a> | | | |
