Pollution Incident Storyboard

Details	
Reported By	Adam Davies
Email	Adam.Davies3@dwrcymru.com
Contact Number	07990715669
Incident Date	19/10/2025 16:32
10 Day Report Date	29/10/2025
WIRS/NIRS Number	2509390
SAP Number	317604898
Address & Postcode	Westcliff, Pennard, Southgate, Swansea, SA3 2AP
Grid Reference	SS5538787144
Catchment	Southwest
Incident Type	
Notification Type	POLFAX
Could this incident have been Self-Reported?	No
If Yes – How?

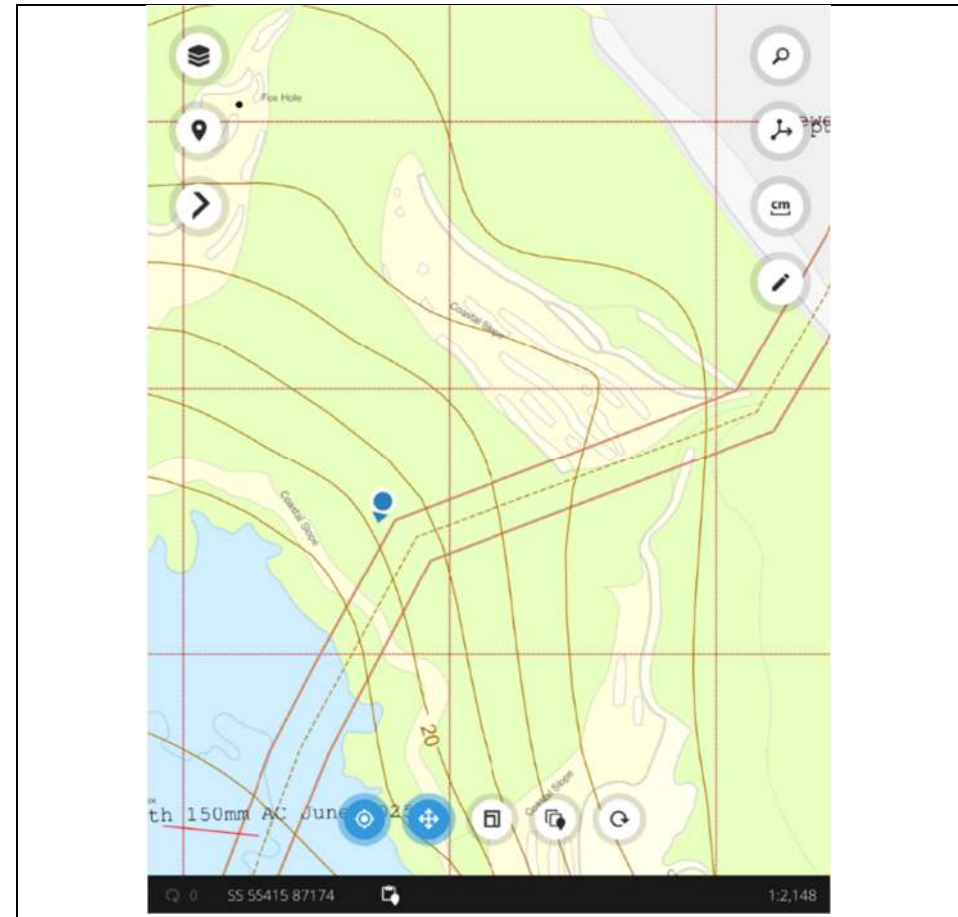
GIS location of photo opposite

W3W ///sometimes.flown.package
Effluent has backed-up the line due to obstruction (metal sampling pot)
and has discharged from the nearest weak-point in the network

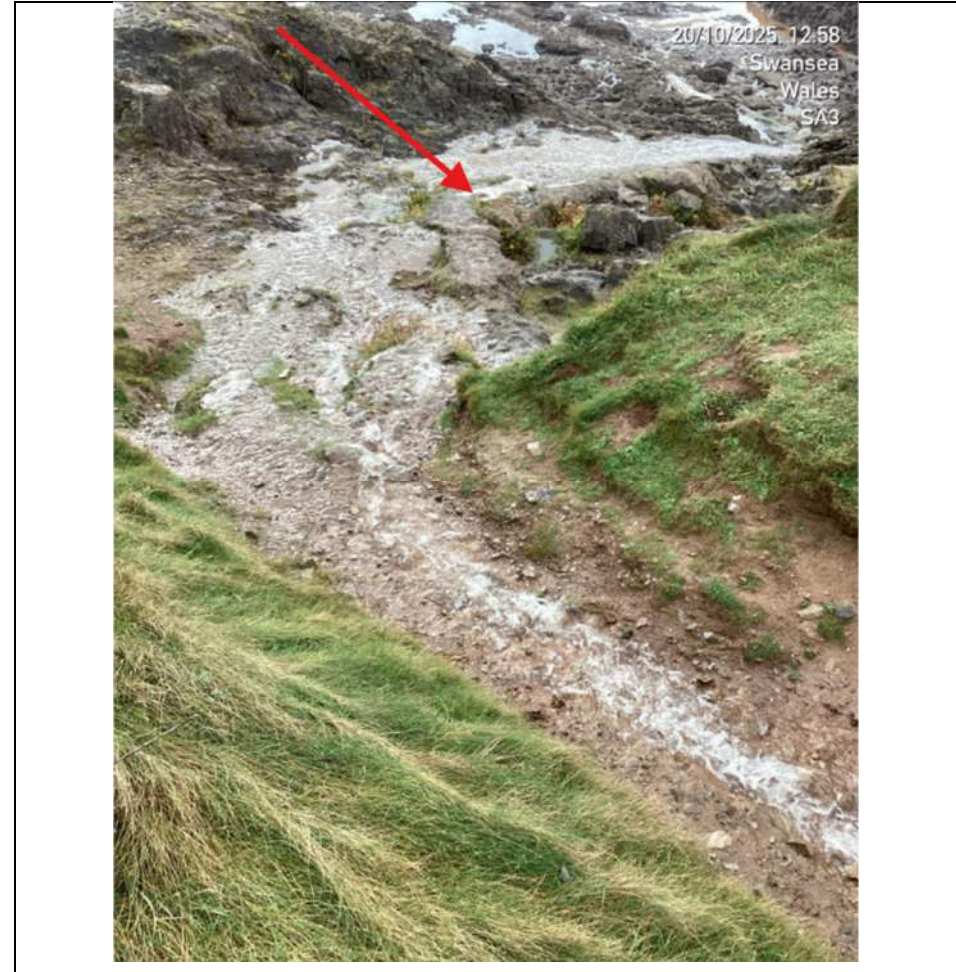
Red arrow indicates hatch-plate access point (look

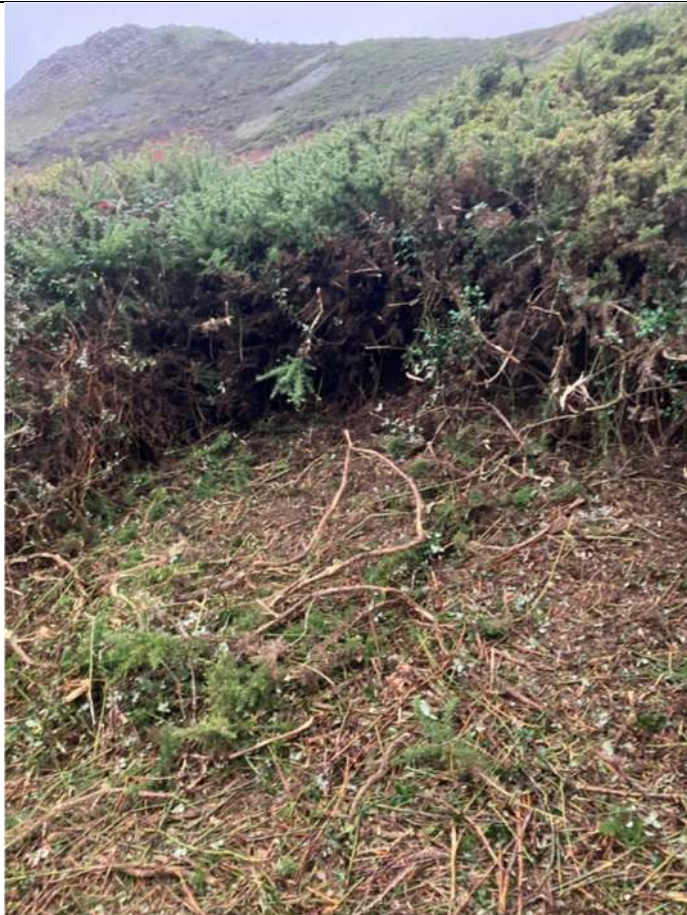
Approx. 10m² cut-back

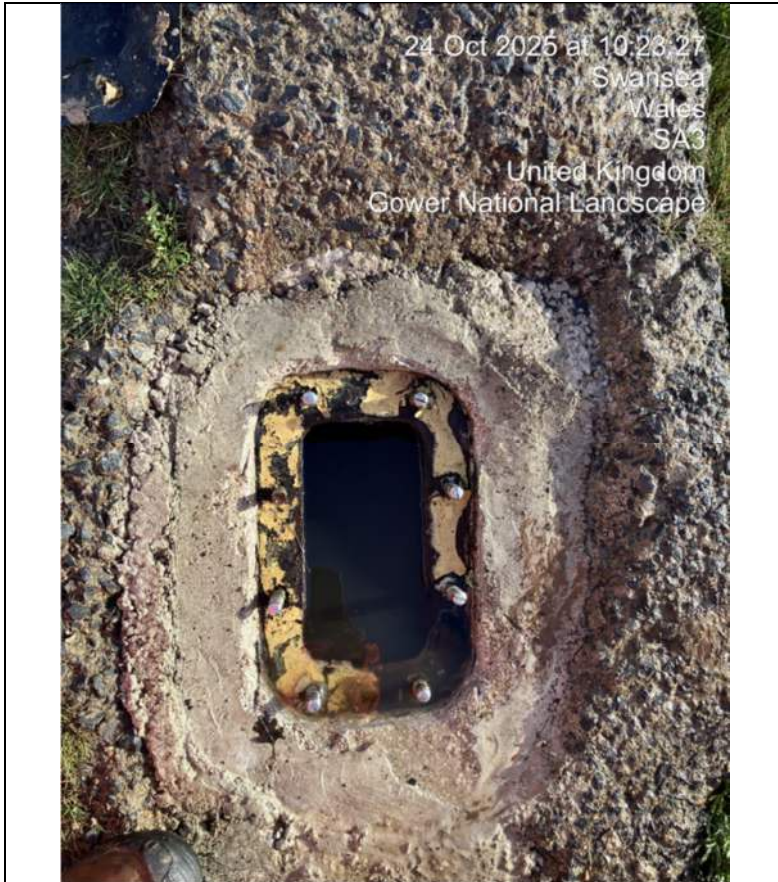
Isolation/drain-down of Final Effluent (FE) line at Southgate PS required before civil works began

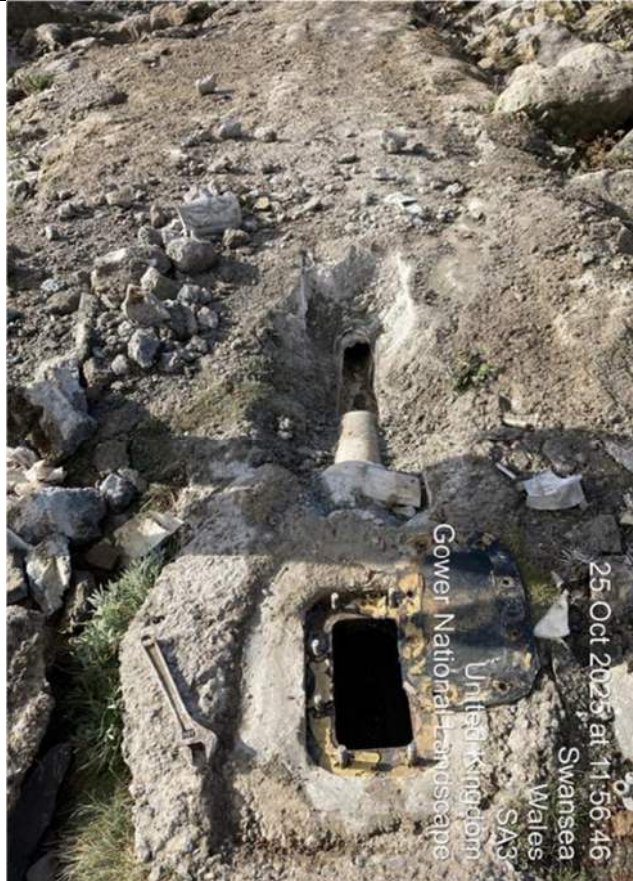
Excavation on FE line.

Repair crew have been to site cut into the pipe and removed the blockage, which was 2 x sampling containers, a permanent repair was unable to be completed due to the pipe being lined and unable to connect with couplings, a temporary repair has been undertaken with half a piece of plastic pipe over the cut out section weighted down flow has now returned with no seepage, a permanent repair will be undertaken during the week using resin patches to seal, further update to follow.

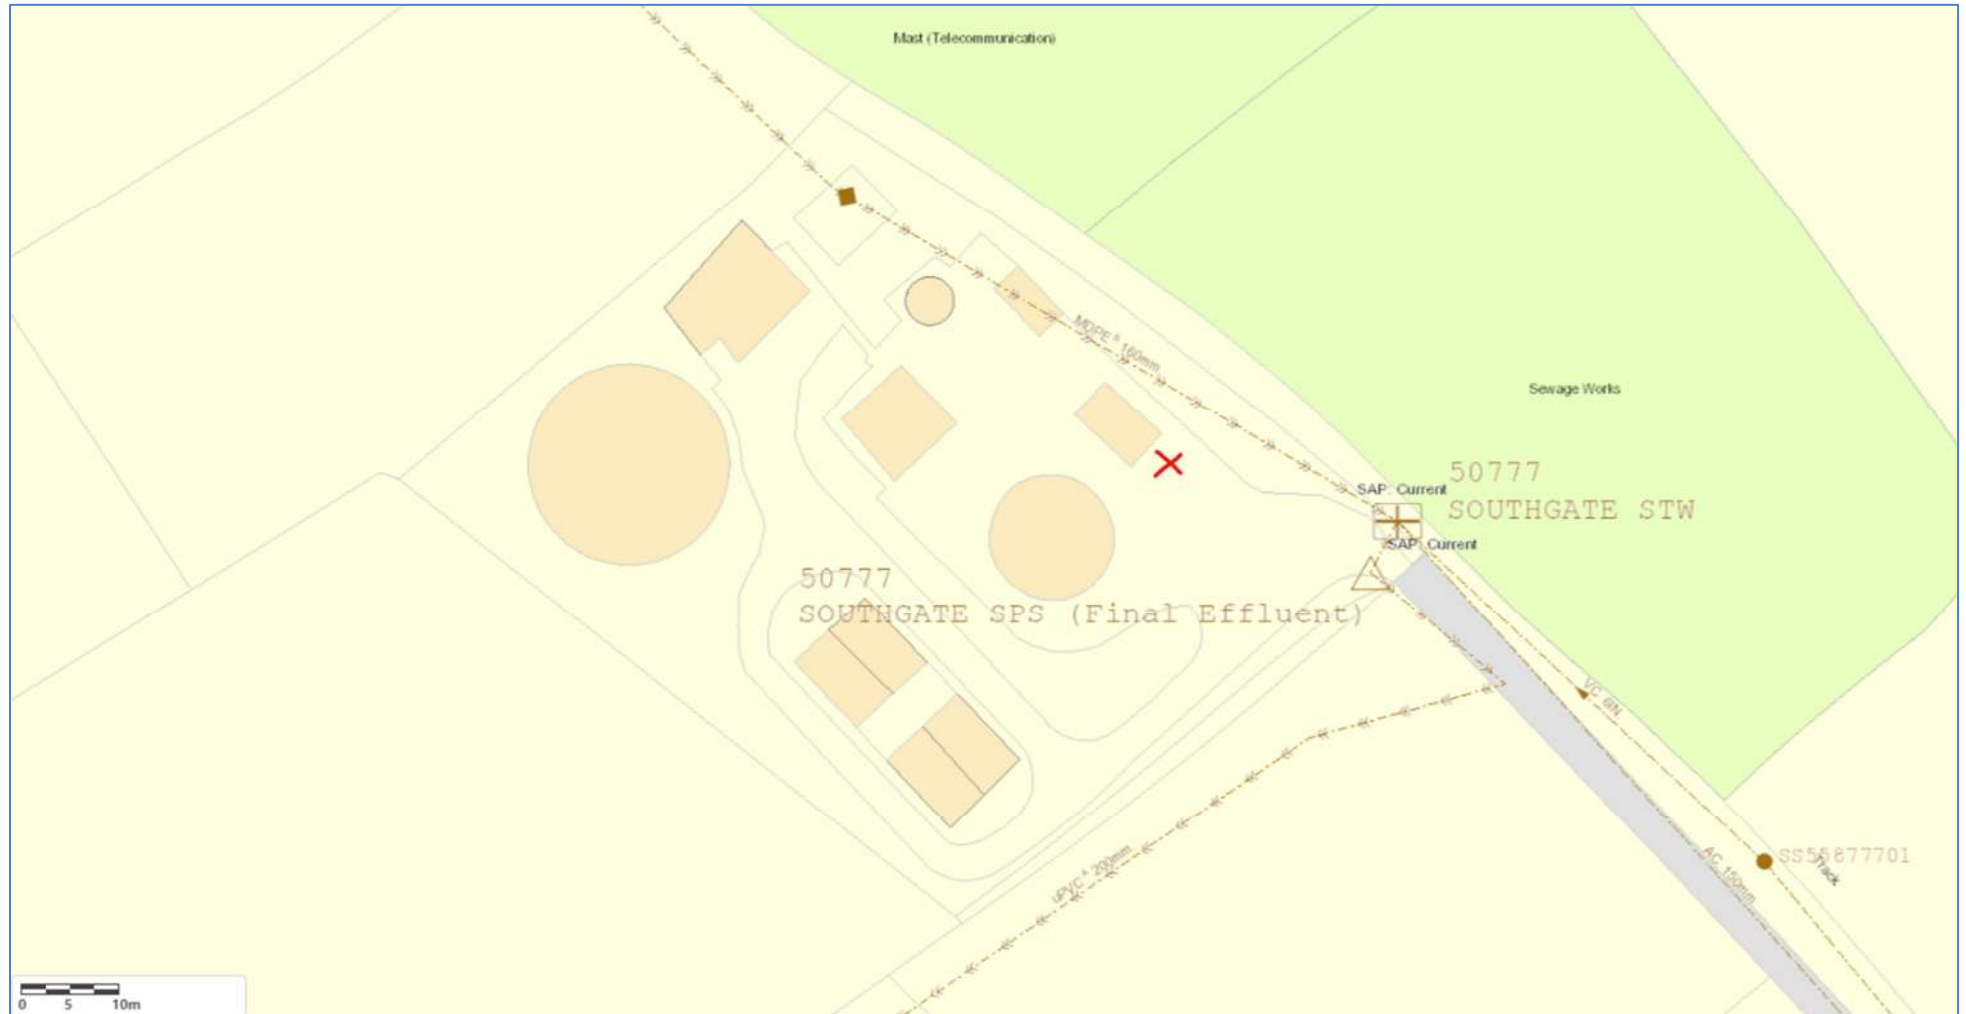
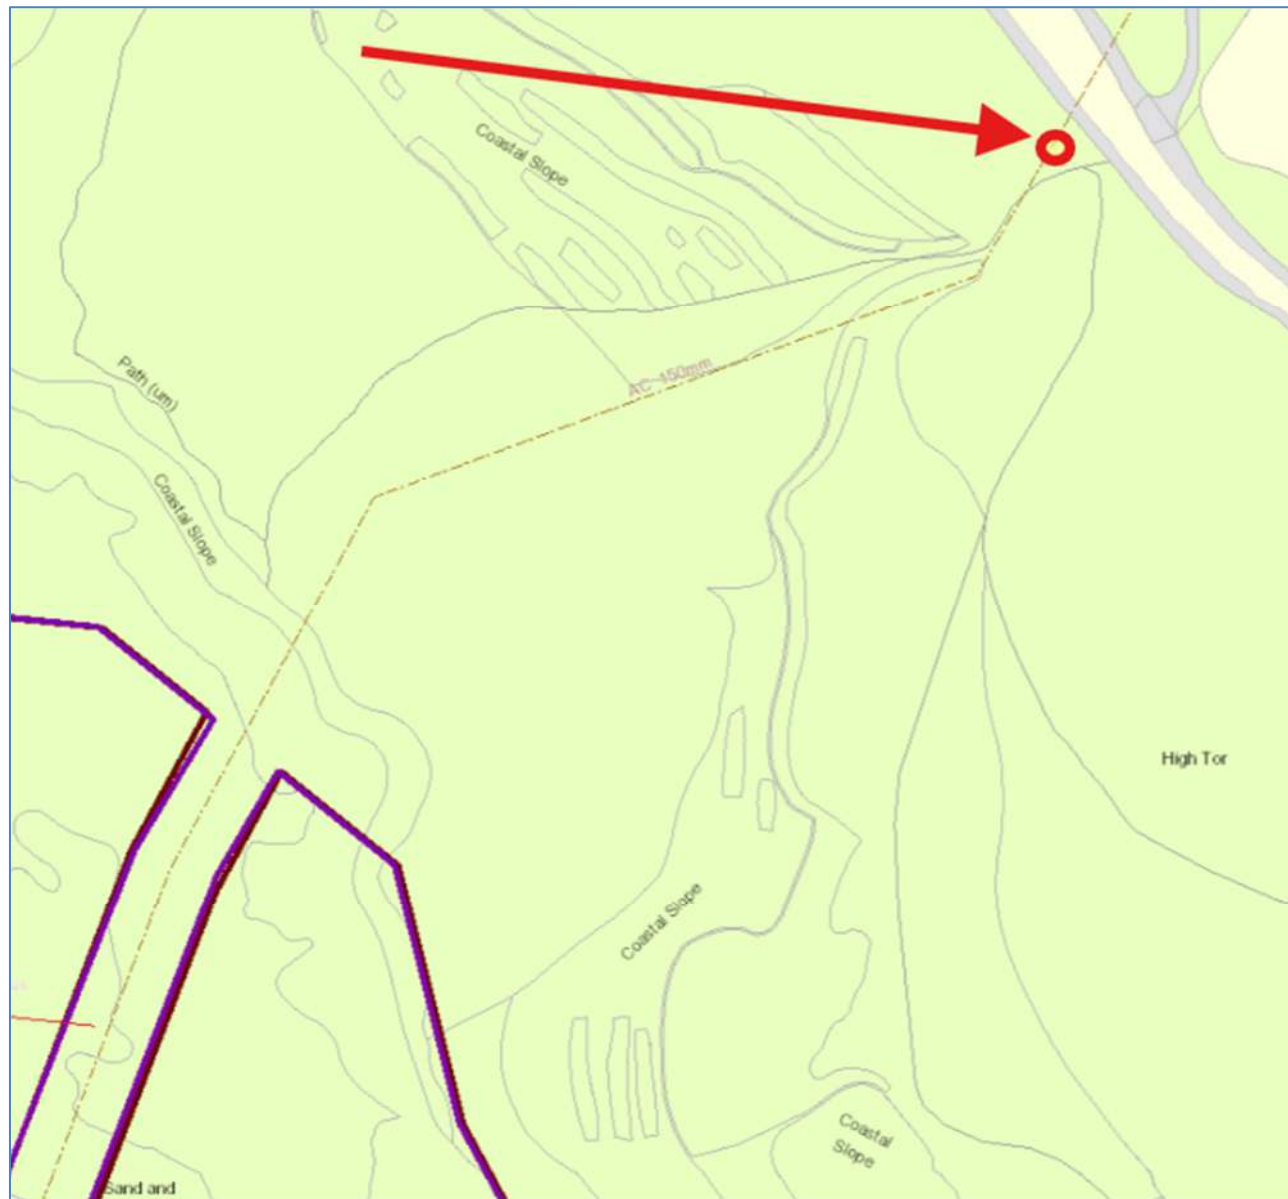
Appendix: AGA Sampling spot at Southgate Treatment Works (marked with red cross)

Given the historical context of ongoing issues at Southgate, it is plausible that an outside third party may have conducted unsanctioned sampling from several easily accessible inspection chambers *[see Appendix below]*. This is, of course, conjecture (as no definitive evidence is available), however it remains the only reasonable explanation as to the origin of the metal sampling pot that ultimately caused the blockage.
