# PENRHOS SUBSTATION

## Site Walkover Summary

794-ENV-GDE-21696  
Penrhos Substation  
1  
15 April 2025

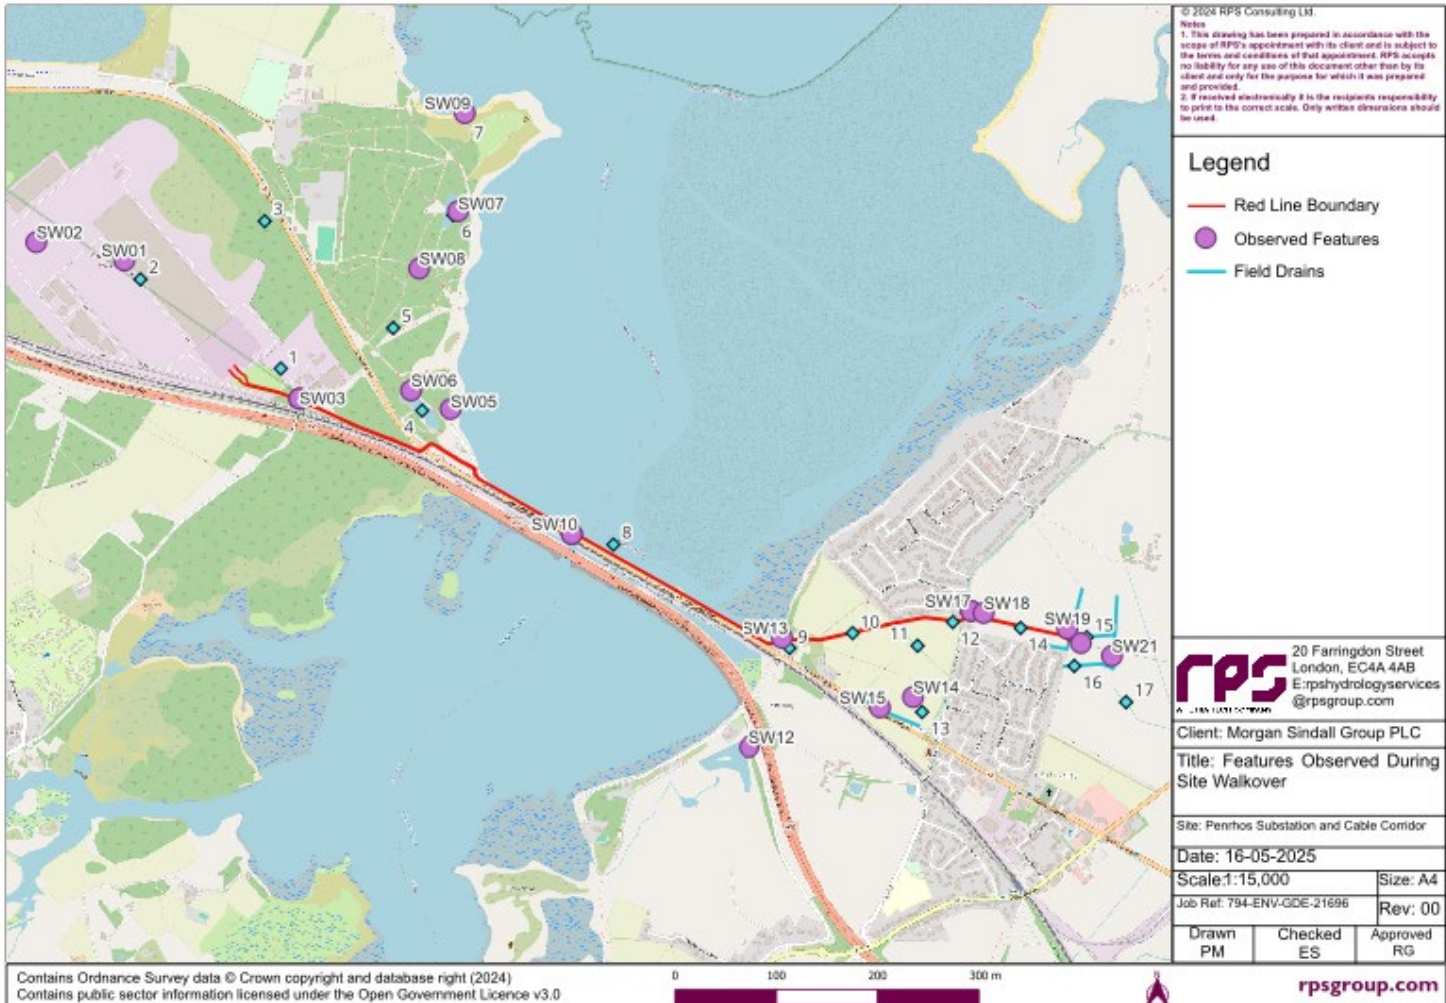
Figure 2 - Site Walkover observed feature locations

- 3.4 A walkover of the substation compound (centred on NGR SH 26549 80972) was undertaken. It was observed that the site was generally flat. Drains were present along the central road (as shown in Figure 2) . The compound has been largely demolished, although two small buildings remain.
- 3.5 Historical remediation validation reports written by Geo<sup>2</sup> Remediation Ltd in 2020 indicated the presence of monitoring wells on the substation site. Subsequently, one of the primary aims of the
