Compliance Assessment Report CAR_NRW0046223

Permit being assessed: AB0064101

For: PONTNHIR STW PONTNHIR NEWPORT, held by DWR CYMRU CYFYNGEDIG

Type of assessment carried out: Site Inspection, Reason: Routine.

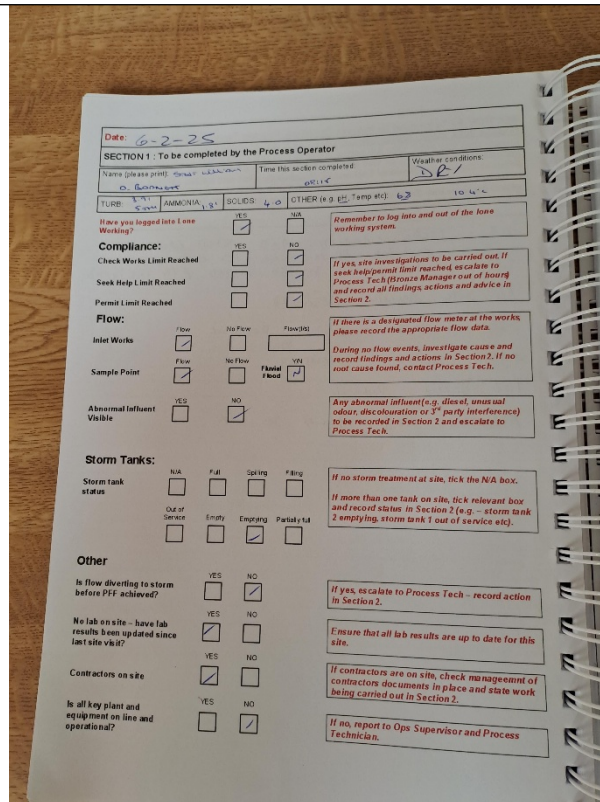
The critical parameter board was observed (Figure 31) which is backed up by an escalation process if an exceedance in effluent quality is detected. All tests listed are undertaken daily. The DCWW daily sample book was observed (Figure 32) with all results within consented limits for the day of the visit.

Figure 32 (Bottom) – The daily sample book as observed during the visit.
