SWL24-380-01-WFS-02

**Point of Ayr Gas Terminal:
Water Features Survey**

Rev	Date	Description	Prepared by:	Approved by:
P01	30.01.2026	Initial Submission	George West	Mark Pickett
P02	10.02.2026	Update after Client comments	George West	Mark Pickett

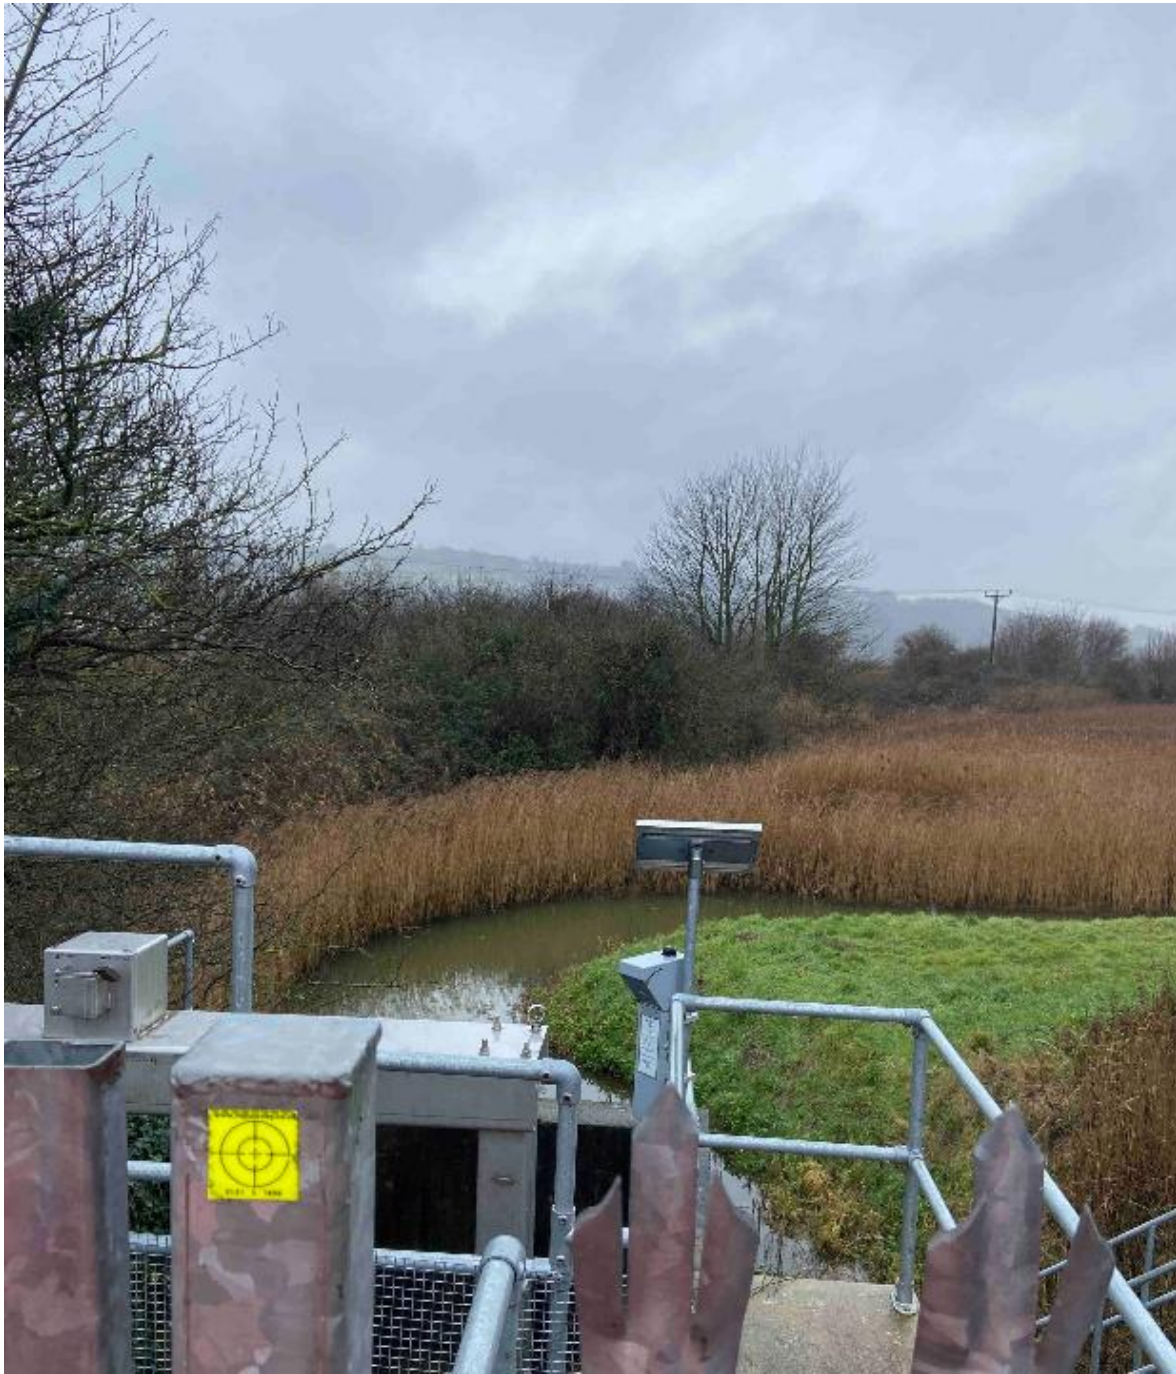
Photograph 13: Location 10: View of the lagoon from the sluice gate at the east end of the lagoon. Photo taken facing West.

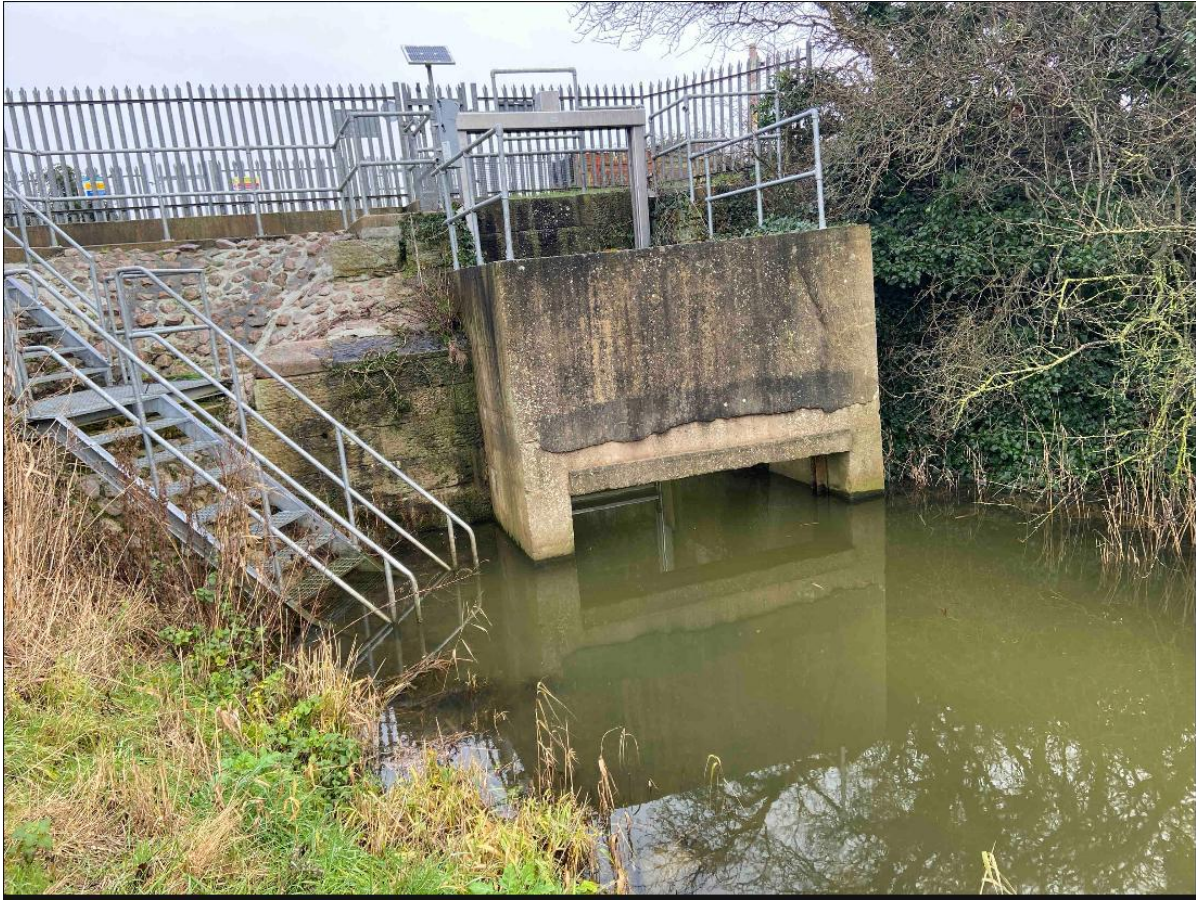
Photograph 15: Location 10: View of the sluice gate from the banks of the lagoon. Photo taken facing East.
