## Compliance Assessment Report CAR\_NRW0050242

**Permit being assessed:** EP3698FL.

**For:** Nantycaws H C I Transfer & Treatment Facility, **held by:** CWM Environmental Ltd

**Type of assessment:** Site Inspection,

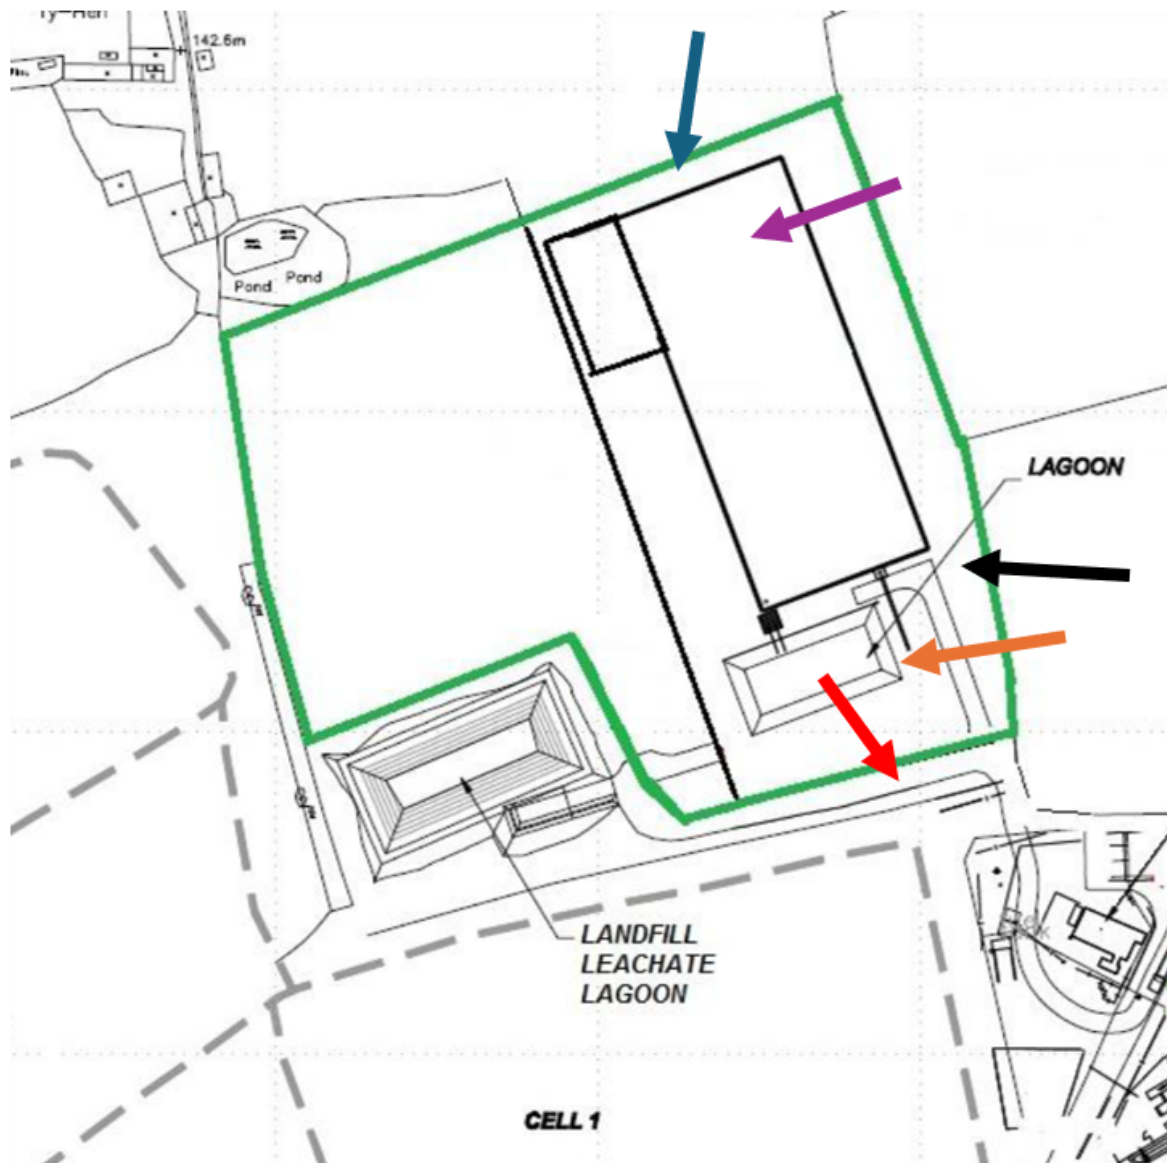
Figure 14 Map showing locations of findings discussed above.

During the visit, the land was found to be highly saturated, indicating a possible failure of the containment system. Pooling of dark brown/black liquid was observed, and this liquid appeared to be flowing beyond the permitted site boundary into an adjacent field. Samples were collected and have been submitted for laboratory analysis. (Location shown on map below demarked by the blue arrow).

**Action:** Inspect and test the drainage from the concrete pad and hard standing to confirm capacity, fall, and function diverting runoff to the designated system; check for proper operation, clearing any blockages and repairing any defects found. Evidence to submit: Inspection report, findings, maintenance records.
