# GREENLINK MARINE ENVIRONMENTAL STATEMENT- WALES

Welsh and Irish Landfall Final Selection Report

P1975\_R4484\_RevF1  
June 2019

Greenlink Interconnector  
- connecting the power markets  
in Ireland and Great Britain

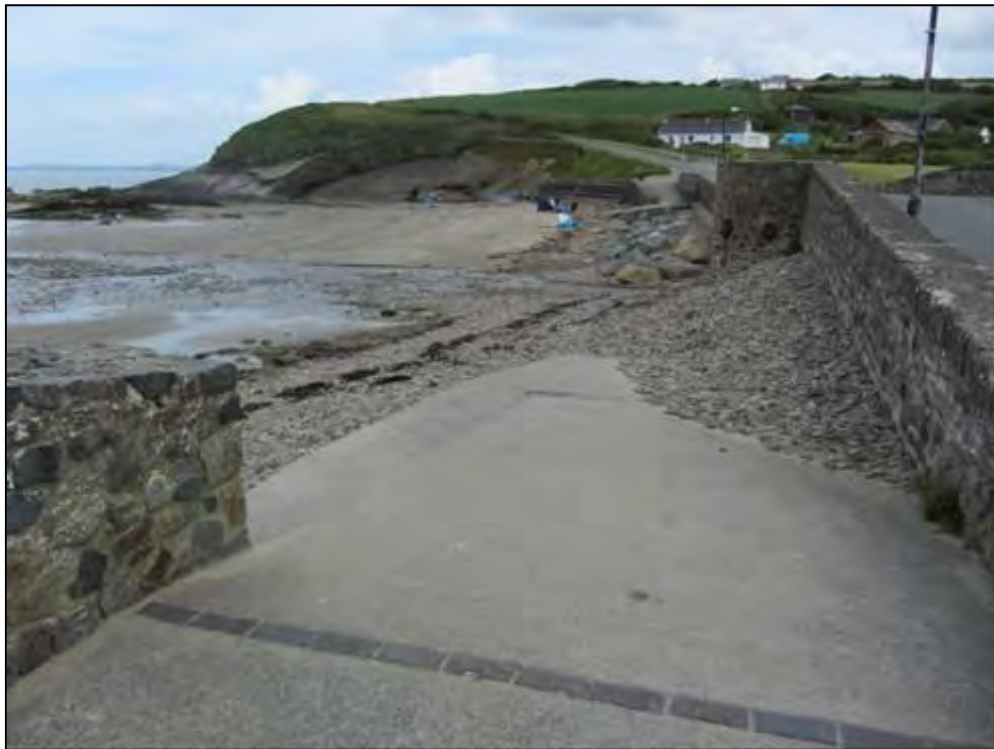
**Figure 3-2 Broad Haven**

The admiralty chart indicates the offshore geological conditions to be sand/mud/gravel. However there is some exposed bedrock at the northern edge of the beach and a small seawall and stormwater culvert in the vicinity of the proposed landfall.

Therefore, subject to geophysical and geotechnical survey results there are no technical reasons not to situate the export cable landfall at Broad Haven.

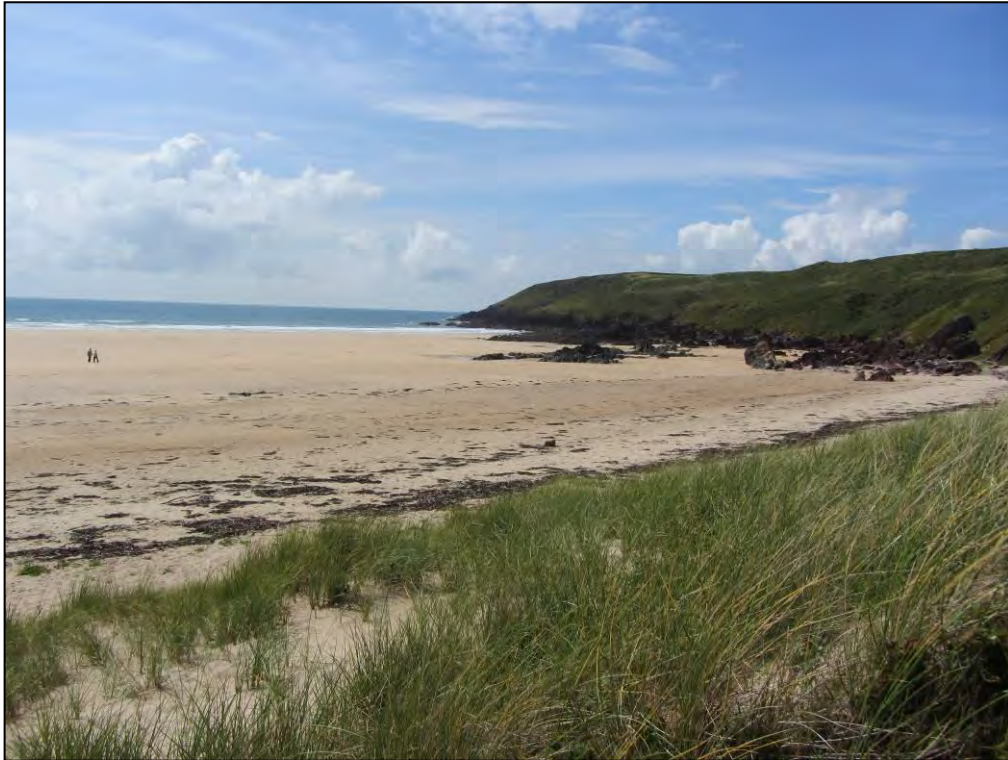
**Figure 3-3**      **Freshwater Bay West (North end)**

The most advantageous factor of selecting this landfall is that it has the shortest onshore route to the converter station and National Grid tie-in point. In order to select this landfall a detailed unexploded ordnance survey would be required to locate any stray munitions on the seabed in the area of the proposed cable route. If this landfall option is to be further considered early consultation should be sought with the Ministry of Defence.

Due to the proximity to the firing range and harbour mouth, further studies (in addition to the usual surveys required at any landfall location) will be needed to determine the effects of ordnance, anchors and thermal insulation in order to prove the feasibility of this landfall.

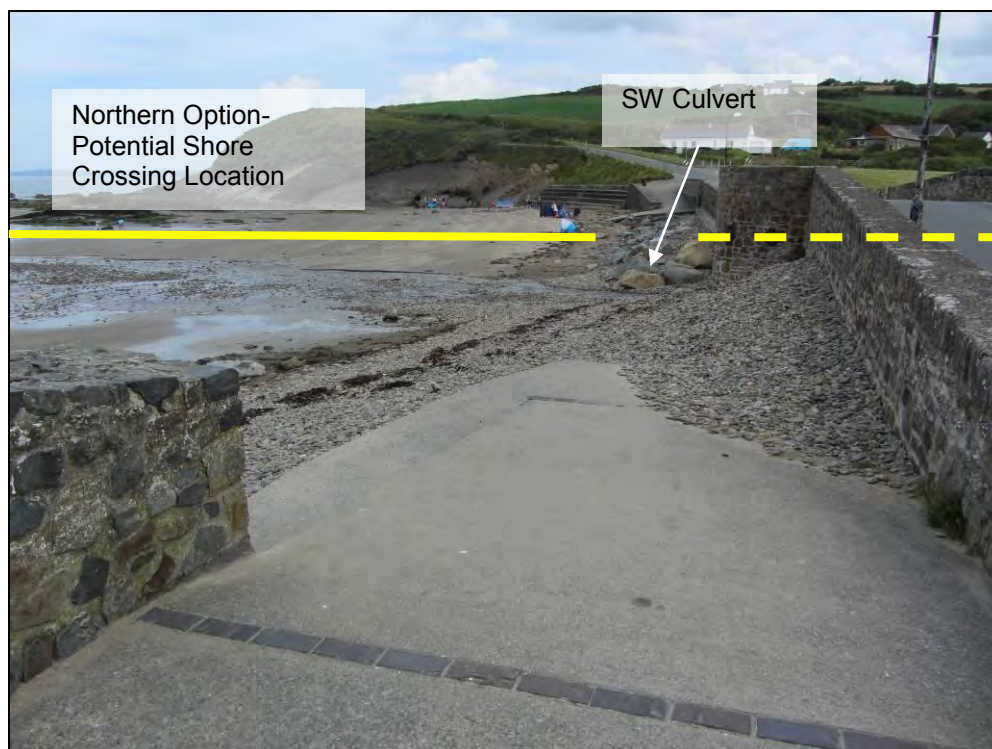
- It necessitates a technically challenging but feasible crossing of Milford Haven (~3km);
- Broad Haven is a high value recreational amenity area and it is probable that the permit construction window will exclude the summer months;
- Desire to avoid laying the cable along the seafront and through the town where possible;
- Admiralty chart indicates some areas of rock in the nearshore;
- Crossing under seawall is required if routing at the northern end of Broad Haven (not a major concern);
- Stormwater culvert at the northern end of the beach may impact on northern shore crossing route options.

**Figure 4-1** Crossing Option at Northern end of Broad Haven

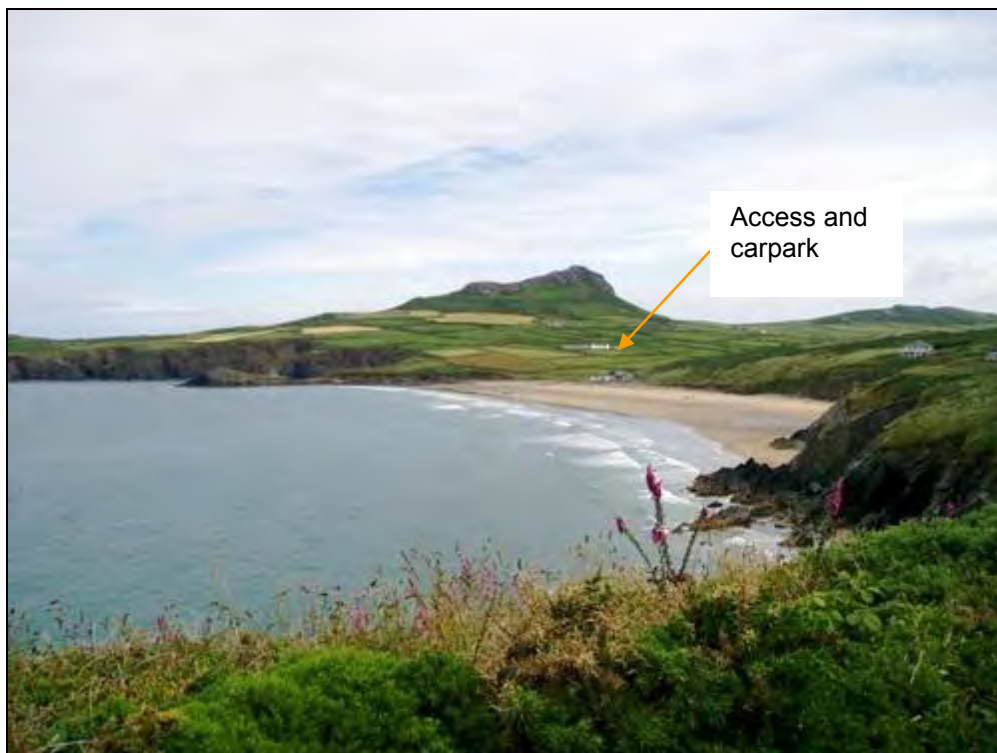
- Sandy beach with rock outcrops at northern extent, although rock noted in the nearshore on the admiralty chart;
- Exit from a beach landfall could be through to the public car-park (approximately 40m x 120m);

However the feasibility of the onshore route and the potential for public opposition due to the high recreational amenity value would need to be further investigated if this option is to be considered further.

**Figure 4-11 Whitesands Beach, view from the South**

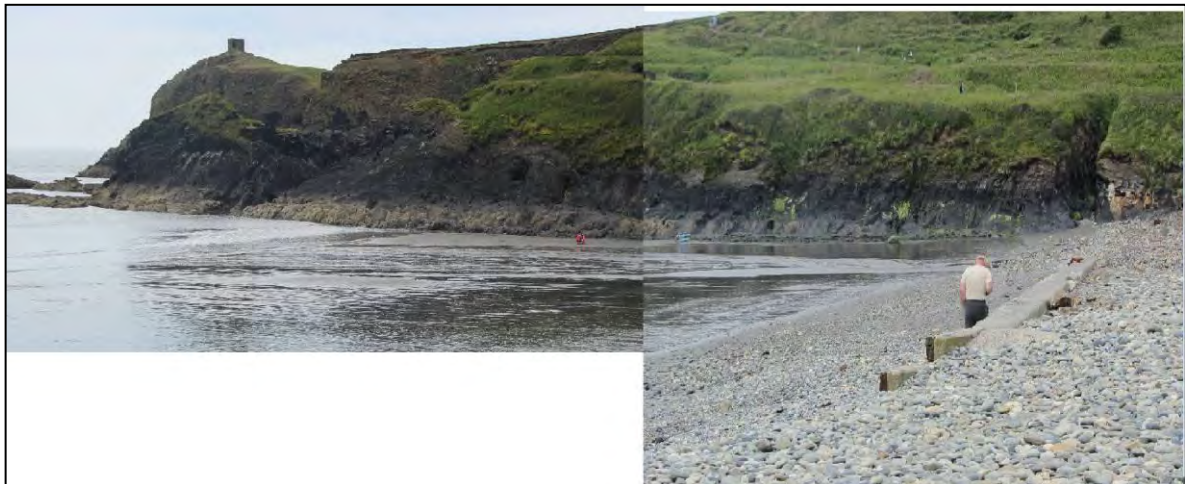
- Exposed bedrock to the west of the beach;
- To the east the foreshore comprises pebbles overlying sand;
- A small (<2m) high concrete seawall is the sea defence for the public carpark which runs along the beachfront (~30m x 120m long);
- Admiralty chart indicates shells and pebbles are present in the nearshore. The water depth increases quickly to ~25m at the end of the inlet approximately 400m offshore;
- Beach is used for access to the nearby "blue lagoon", which is a disused slate quarry which has been infilled with seawater through a breach in the outer wall. This lagoon is a popular location for tourism activities that include coasteering;
- Road access is generally suitable except for the final access to the beach which is approximately 4 to 5m wide. Much longer onshore route than Broad Haven.

**Figure 4-12** Abereiddy Beach, looking towards the North

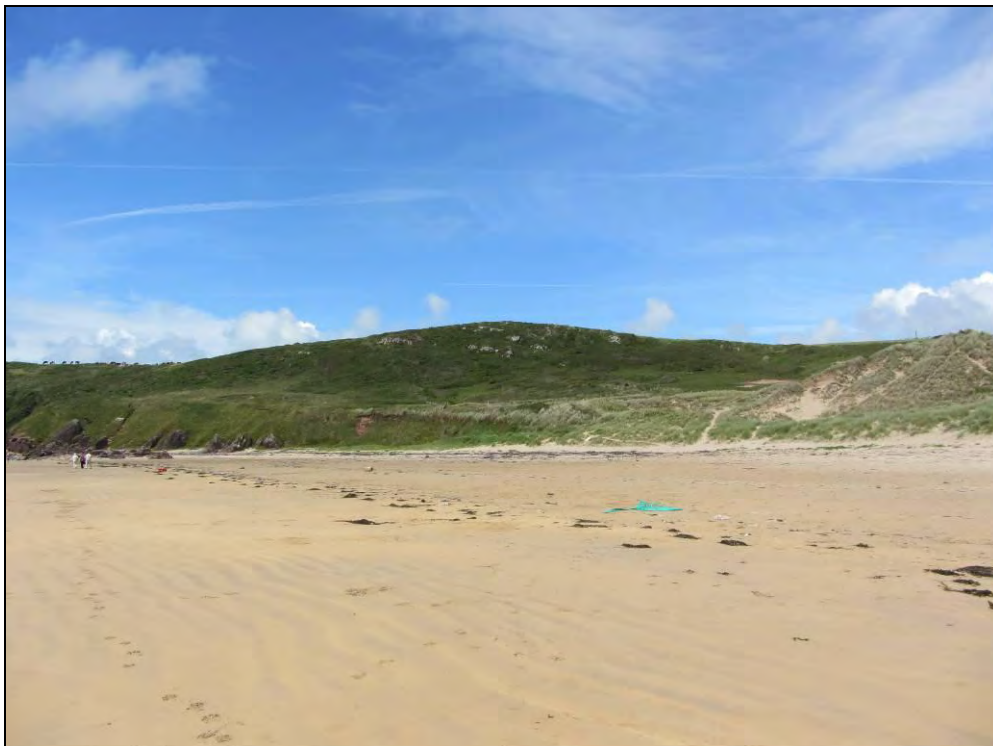
- Proximity to firing range;
- Proximity to Milford Haven harbour entrance;
- Shore crossing and working area likely to be through dunes to public carpark and subsequently be likely be subject to environmental restrictions;
- Evidence of land movement in the slope behind dunes leading up to the public access road;
- Potential for rock to be encountered in the nearshore (slate and conglomerate exposed on the beach at low tide at far Northern end of beach), areas of rock identified on admiralty chart.

**Figure 5-1** Freshwater West, Northern end of beach.

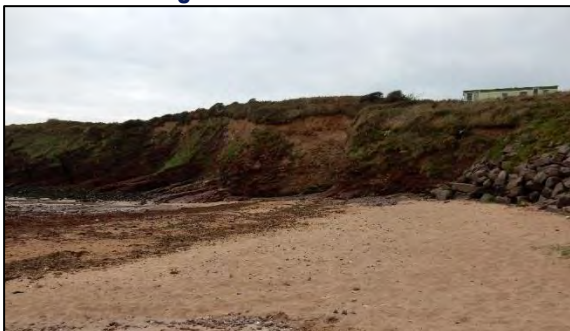
Rathmoylan Cove is an exposed beach facing due south. There are cliffs surrounding the cove on both sides approx. 15 m in height showing evidence of deep erosion, exposing red sandstone geological features including a sea cave on the eastern edge of the cove. Rock protection is installed along the rear of the beach and there is also rock outcrop along the shoreline which was covered in seaweed (see **Figure 4-1 and 4-2**).

**Figure 4-1: View of eroding cliffs from the rear of the cove looking east.**

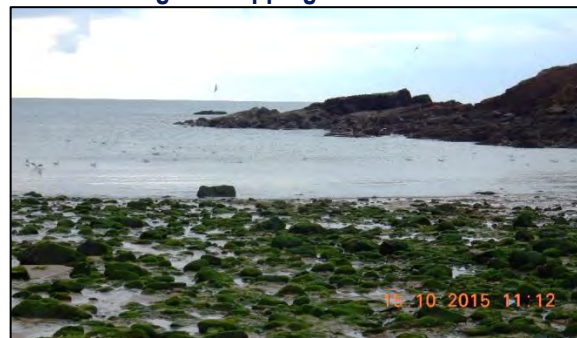
**Figure 4-2: View of the shoreline looking south east including outcropping rock and birds.**

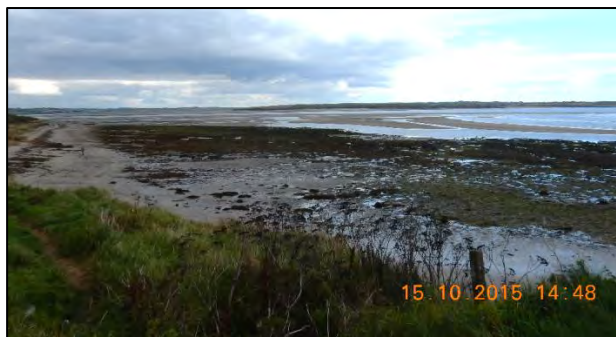
Newtown Beach is located to the north east of the Hook Head Peninsula, on the western side of the entrance to Bannow Bay. The landfall lies within the Bannow Bay SAC and SPA and would also require the cable to cross through the Hook Head SAC offshore. Bannow Bay SAC has a number of qualifying aspects including sandflats not covered by seawater at low tide and shifting dunes (see **Figure 4-3**) which would not be suitable for cable installation due to potential ecological impacts.

**Figure 4-3: View from the rear of the beach looking north east.**

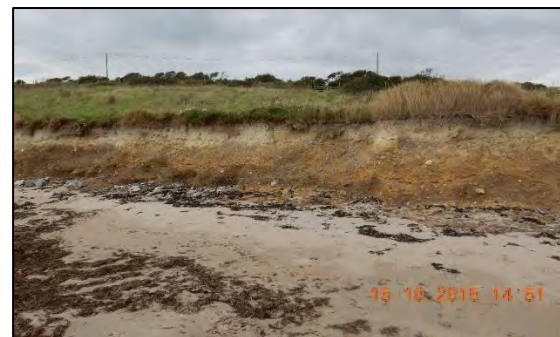
At the rear of the beach eroding vegetation on shallow cliffs is evident (see **Figure 4-4**). There was rock outcrop uncovered at low tide along the shoreline which was covered in seaweed. Birds were observed along the seashore including seagulls and oystercatchers.

**Figure 4-4: View of the eroding vegetation at the rear of the beach.**

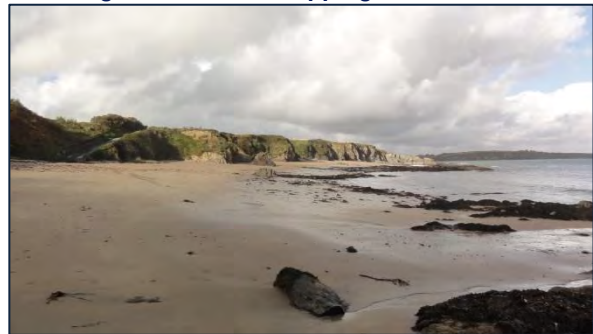
Surrounding the beach are heavily vegetated cliffs of moderate height (< 15 m) with only minor signs of erosion on the northern side of the beach. Height and apparent stability would suggest HDD would be possible but would require appropriate geological assessment and survey of ground conditions for confirmation. At the base of the cliffs on the southern side, there were the remains of a large stepped concrete structure but with no indication of what it was. There was also a large letter 'C' installed on one of the cliff faces – possibly a beach monitoring station.

**Figure 5-4: View of the beach looking north west including cliffs and outcropping rock.**

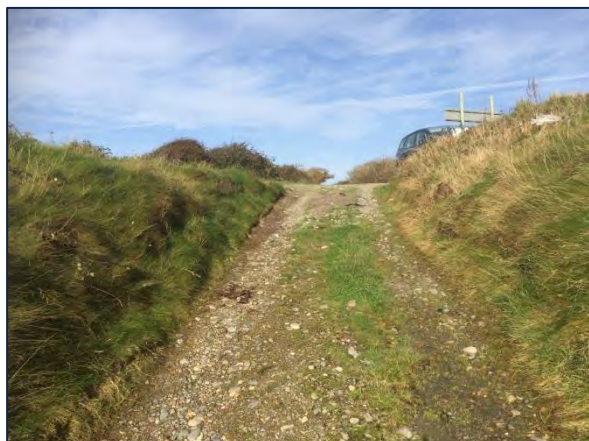
**Figure 6-3: Bannow Beach access track to the beach - largely solid and composed of stones and turf.**

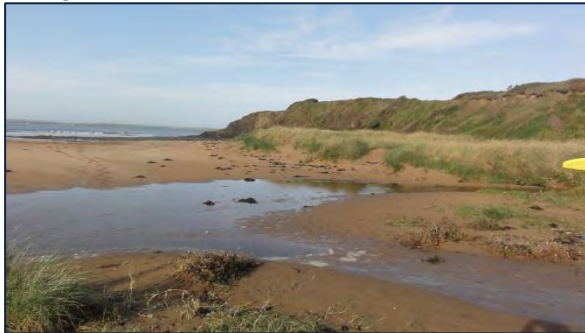
Options for installation would include HDD and open-cut trenching. It is likely that the flow of fresh water onto the beach would make keeping a trench open difficult and may risk exposure of the cable during adverse weather conditions. More information is required regarding the stability of sediment on the beach through an appropriate geological assessment and survey of ground conditions.

Figure 7-1: Freshwater outlet/river at Booley Bay - facing west-north-west.

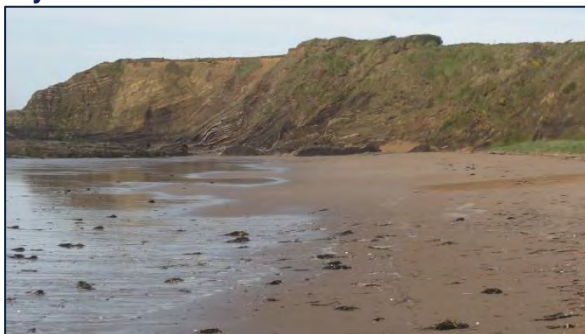
The surrounding headland was dominated by vegetated cliffs to the north and south (Figures 7-3 and 7-6); both sides demonstrated low levels of coastal erosion with minor evidence of disruption by landslides. Adjacent to the access road and track was a freshwater riverine input, surrounded by unmanaged vegetation. The river water flowed directly onto the beach where the water flow was diverted along the upper reach of the beach to the southern rock outcrop where it was forced towards the sea by rocks.

Figure 7-3: Rock headland to the north of Booley Bay. Evidence of saturated sand.

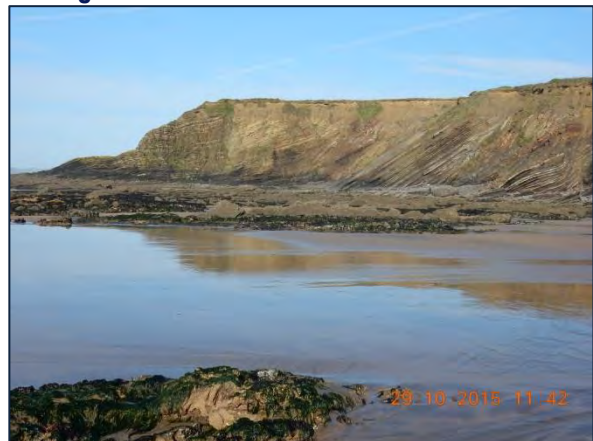
Figure 7-6: View of the rock headland and outcrop looking north-west.

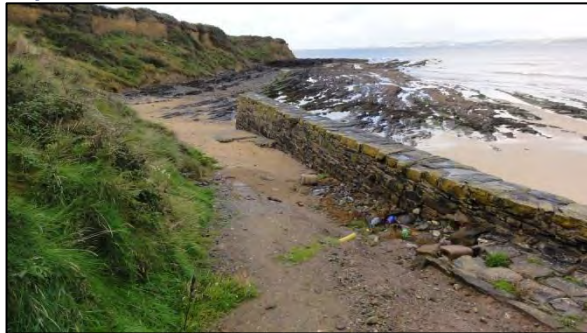
**Figure 8-1: Part of the Access Road to Boyce's Bay.**

An access track, approximately 50m in length, leads from the end of the access road down to the beach. The access track to the beach is approx. 3 m wide composed of rough terrain, and has an established sea wall of good condition at the bottom. The sea wall is approximately 2 m high and 1.2 m wide at the base. It appears to have been built on solid bed rock with a similar composition to rock outcrops observed to the north and south of the beach (**Figure 8-1**).

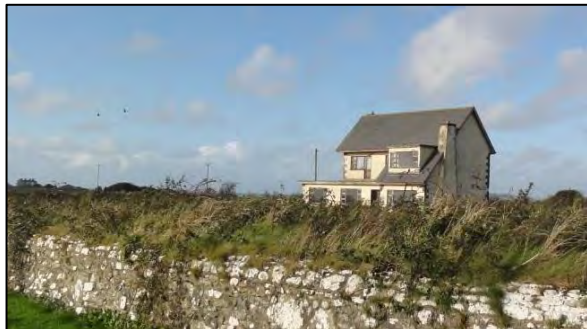
**Figure 8-3: Derelict house to the south of the access road.**

The three private properties consist of a derelict property at the junction with the L4045 local road (**see Figure 8-3**), a farm house associated with the dairy farm and a private property called 'Lumsdin Lodge' on the southern side of the access path. Alternative accesses appear to be available, off the L4045 local road, to the dairy farm and associated farm house, and the derelict property.

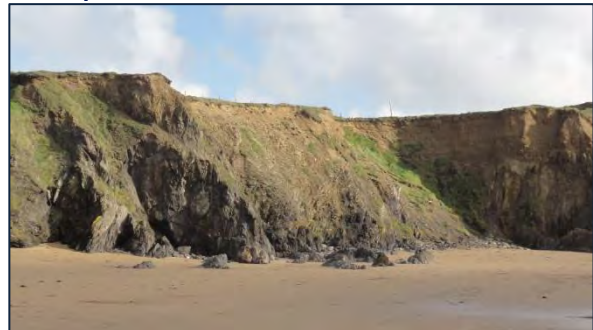
The beach is large and flat. The site is very exposed to southerly wind conditions and weather conditions on the day yielded waves of approx. 1 m. The profile of the beach has a shallow gradient; wide and long with less than 2° of slope. Looking north from the water's edge, patches of stable vegetated cliff were observed in the centre with patches of exposed rock. Cliffs to the east and west demonstrate evidence of coastal erosion and more recent landslips (**Figure 9-6**).

Figure 9-6: Evidence of loss of vegetation due to landslip.

The apparent instability of the cliffs and warning signs combined with the exposed beach make this site unsuitable for HDD without significant and extensive geotechnical survey to determine the ground conditions. Open cut trenching would be a possibility on the beach but the stability of the access path for installation would also need to be assessed.

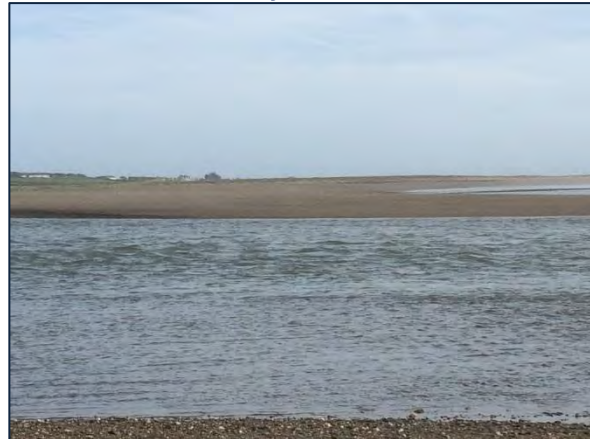
The beach is the largest of all visited with enormous variation in morphology from east to west. To the east, an environmentally protected estuary outlet was observed with extreme current flows shown by the turbulent waters. A spit of sand extended outwards along the estuary outlet with evidence of rip currents and an apparent offshore sediment bar where estuarine outlet meets tides and waves. This bar would likely cause problems during installation as indicates shifting sediments.

Figure 10-4: Estuarine outlet with turbulent water flowing towards the sea. Looking east from the spit towards the estuary.

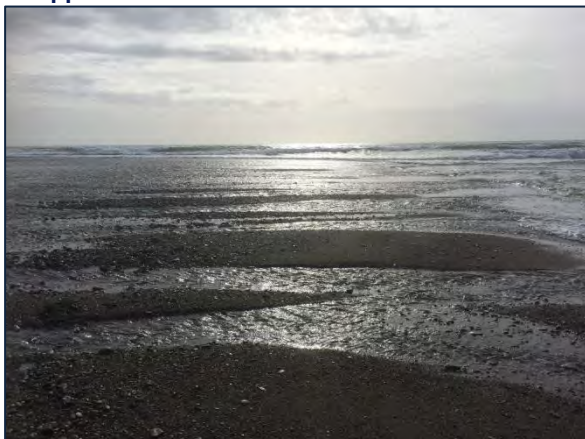
Figure 10-5: Sand patches and breaking waves on an apparent offshore sediment structure.

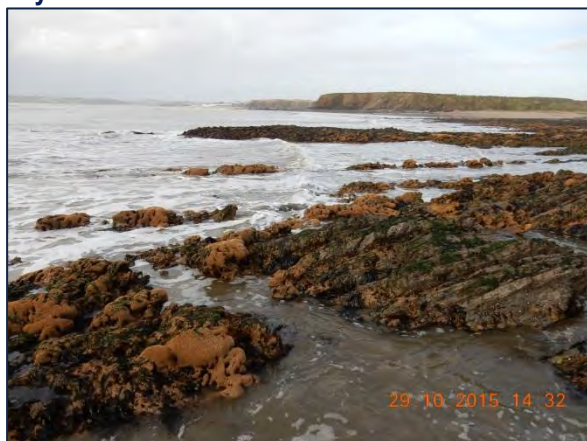
Similar to Booley Bay landfall, the rock outcrop separating Booley and Dollar Bay was covered with honeycomb reef worm (*Sabellaria alveolata*). While not listed as part of the River Barrow and Nore SAC, it is a species that is sensitive to changes in sediment regime and physical disruption (including storm damage). Most of the intertidal rock at the site was covered but the extent offshore would need additional survey.

Figure 11-3: Honeycomb worm reefs on intertidal rock outcrop separating Dollar Bay and Booley Bay.

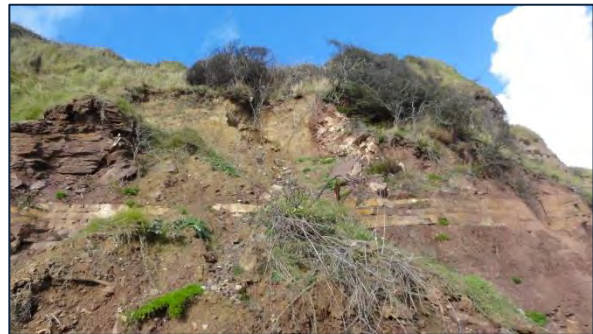
Figure 12-4: Evidence of landslip and underlying rock.

The site would not be suitable for open-cut trenching due to the volume of rock and the seawall approaching the path. HDD may be suitable but geotechnical data assessment would be required to confirm suitability.

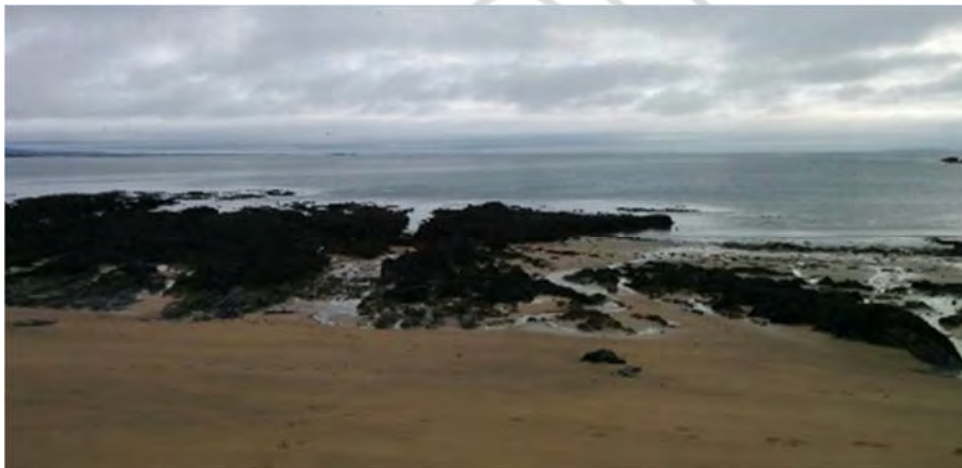
**Photo 1: Outcropping rock**

The northern side of the beach is bounded to the west by coastal cliffs with bedrock outcropping in places along the beach but more frequently towards the shoreline as shown in Photo 1.

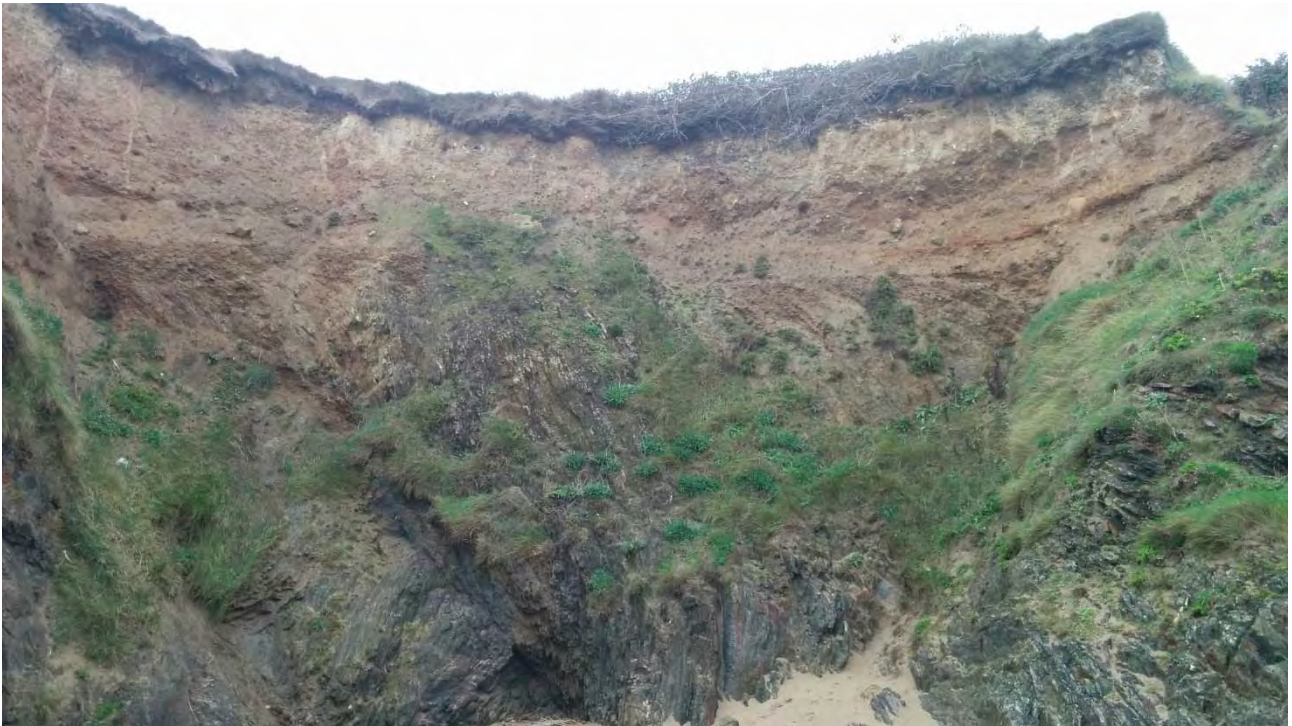
The cliffs are comprised of outcropping rock with a cover of 1 to 2.0m of overburden. While the cliffs are vegetated with grass and scrub in places, there is an abundance of unvegetated subsoil (potentially glacial till) towards the top of the slope as indicated in Photo 2.

**Photo 2: Subsoil overlying bedrock**

The slope morphology changes along the cliff with the greatest variability in the bedrock. Towards the crest of the slope the overburden is either standing at a steep to sub-vertical angle or is densely vegetated. Minor visual indicators of slope movement and shallow slumping of the subsoil material were observed along the slope as indicated in Photo 2 and Photo 3 below.

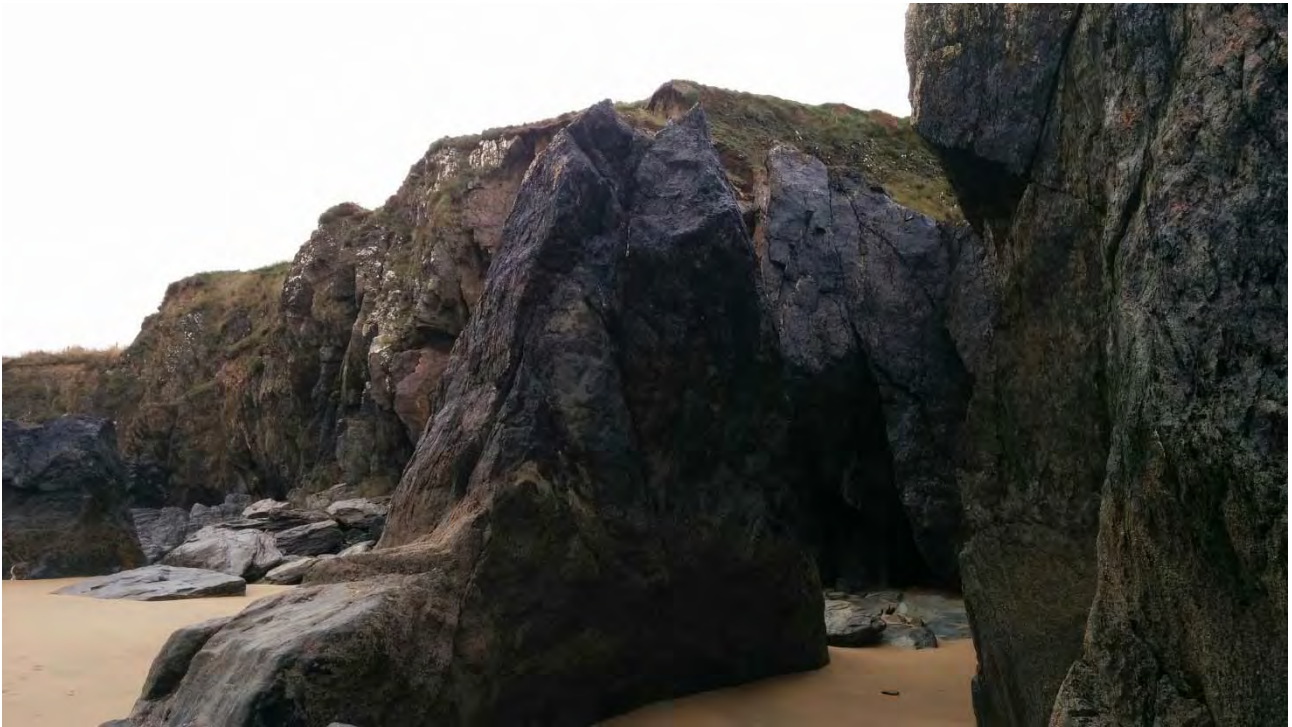
The bedrock is highly variable along this section of beach ranging from the interlayered meta-sediments indicated in Photos 2 and 3 to more massive greywackes at the northern end of the beach as show on Photo 4.

**Photo 4: North side of the Beach.**

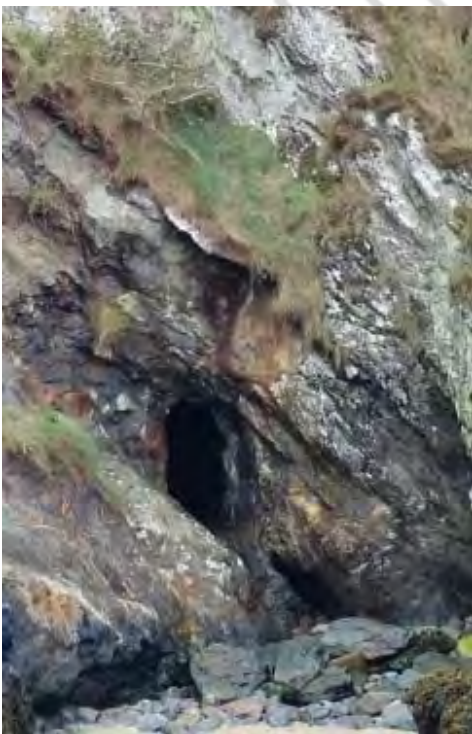
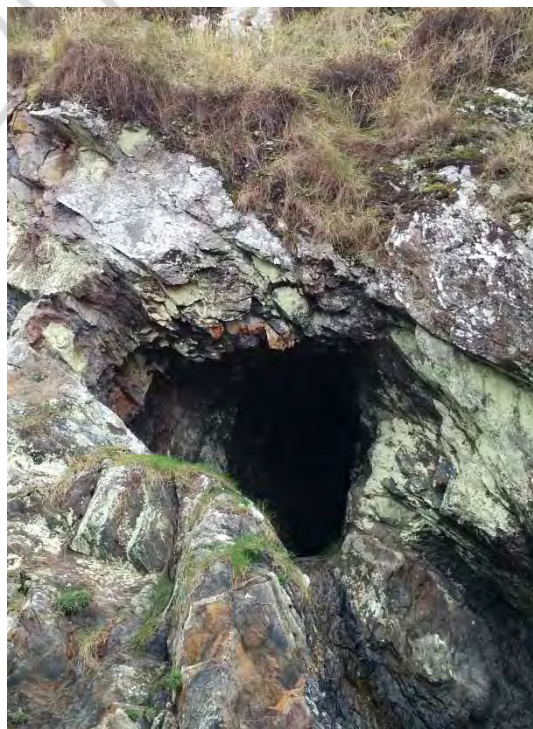
A number of caves are also present at a number of locations along the cliff face in this location (see Photo 7).

**Photo 7: Caves**

Based on the geological sensitivity of this area (as noted in Section 2.4), along with the restrictions due to public access *etc.*, horizontal directional drilling (HDD) is likely to be the optimum solution at this location.

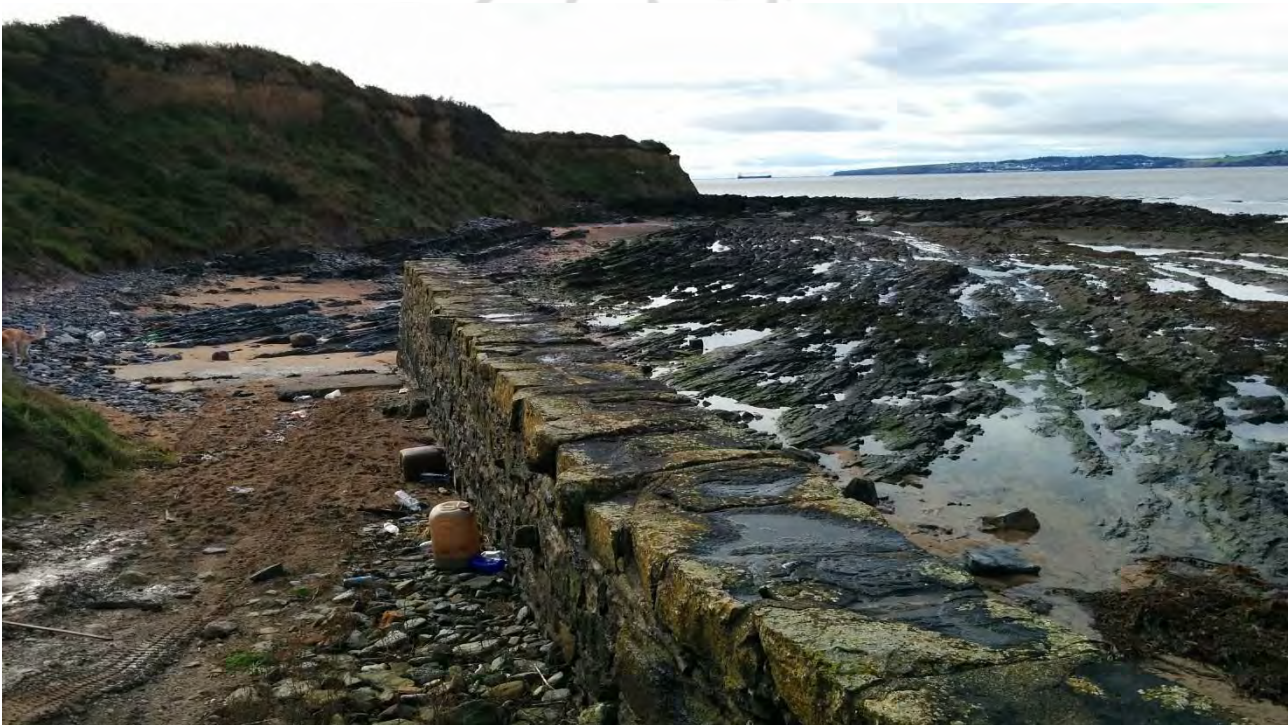
Limestone visibly outcrops along the southern end of the beach both at the base of the surrounding cliffs in this location and along the beach.

**Photo 8: Access to Boyce's Bay with outcropping limestone**

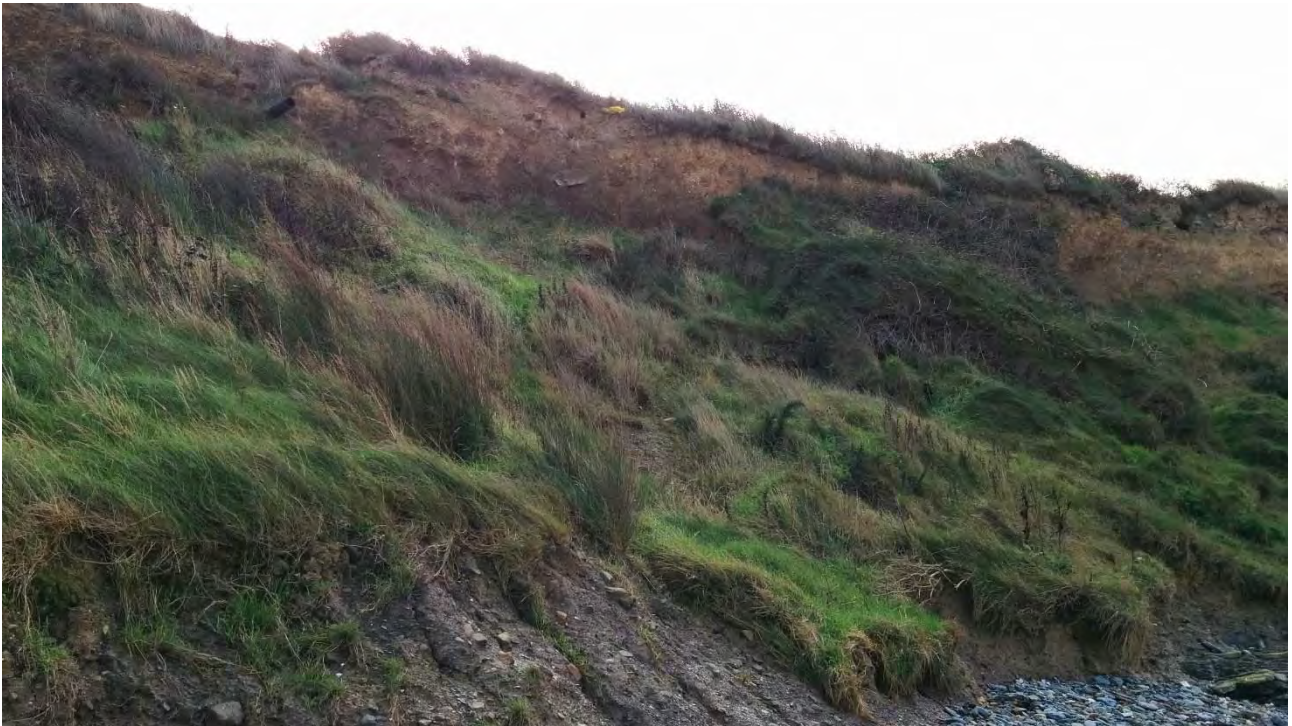
The surrounding cliffs at this location are comprised predominantly of subsoil of potentially glacial till. They are densely vegetated with grasses and scrub but there are many indicators of instability and slope movement as shown in Photo 9.

**Photo 9: Soil slopes along Southern side of Boyce's Bay**

Due to the nature of the cliffs in this location and the tell-tale indicators of ongoing slope instability in this location, trenching is unlikely to be a viable option in this location. This along with the geological sensitivity of this area (as noted in Section 2.4), indicates that horizontal directional drilling (HDD) is likely to be the optimum solution at this location.

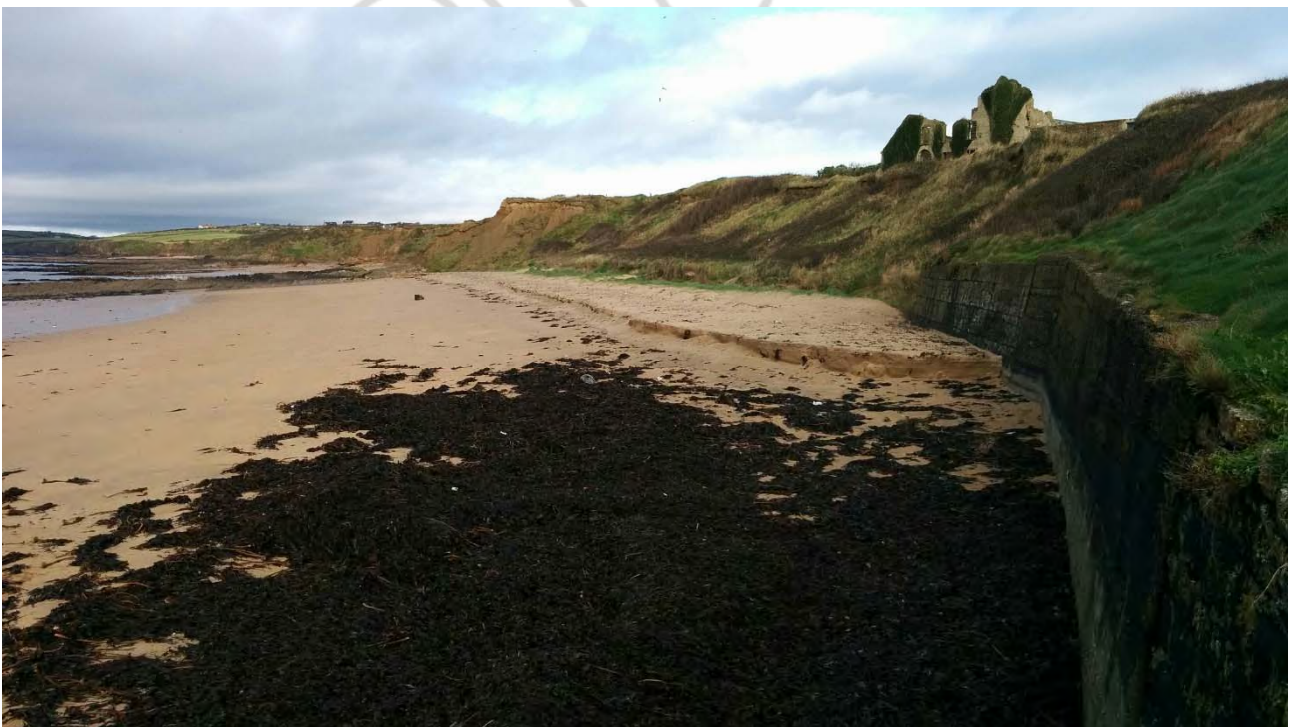
Moving in a northerly direction along the beach, the outcropping rock becomes less frequent and the beach is bounded predominantly by soil slopes.

**Photo 10: Looking North along Boyce's bay.**

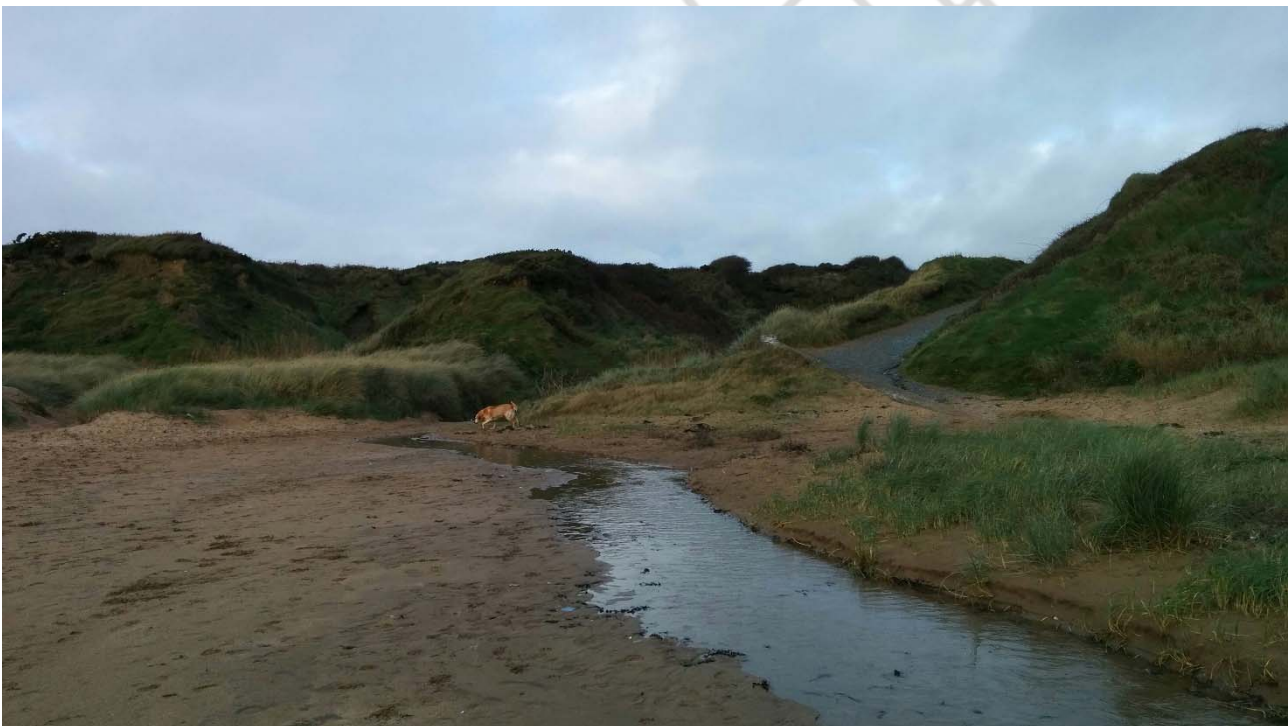
The access to Booley Bay runs parallel to a freshwater river. On both sides of the river the area is dominated by vegetated headlands to the north and south (Photo 12).

**Photo 12: Freshwater stream**

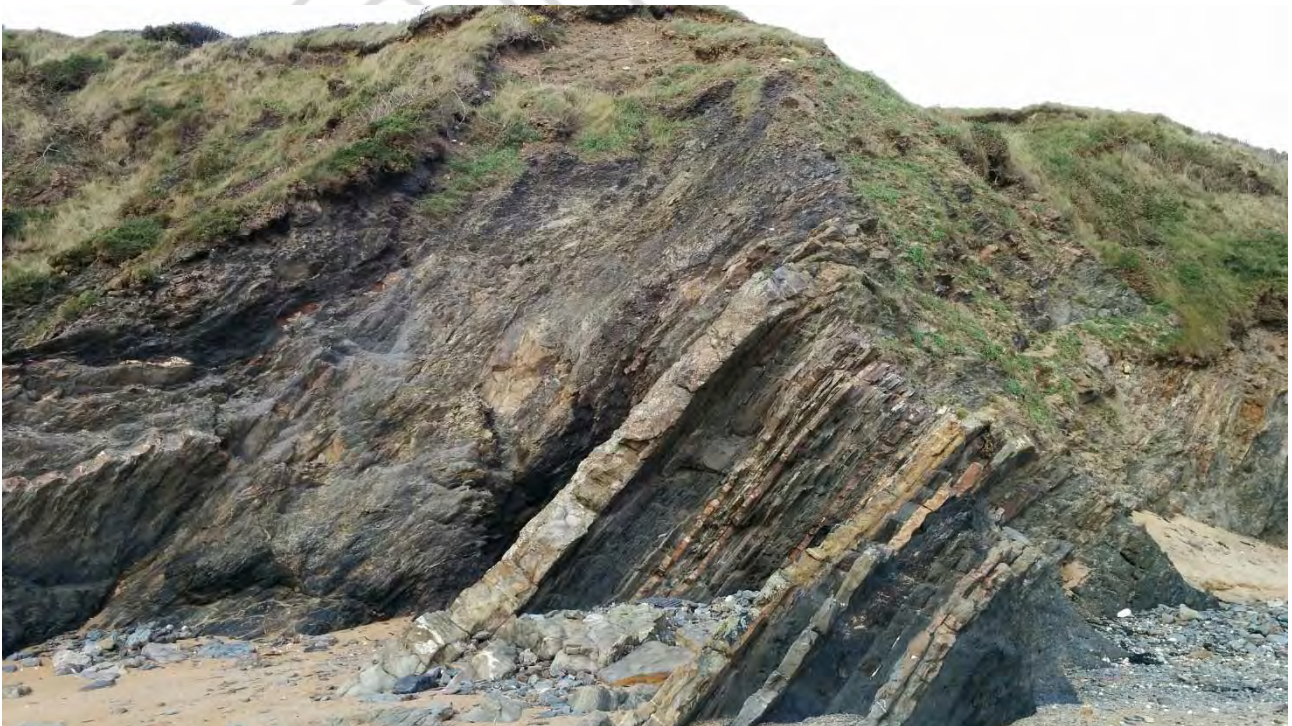
The dune system transitions into an area of outcropping rock and cliffs. Rockhead is irregular and a thin soil cover is generally present except in areas where depression in the rockhead have been infilled with subsoil material (Photo 14).

**Photo 14: Rock outcrops showing variability of rock present**

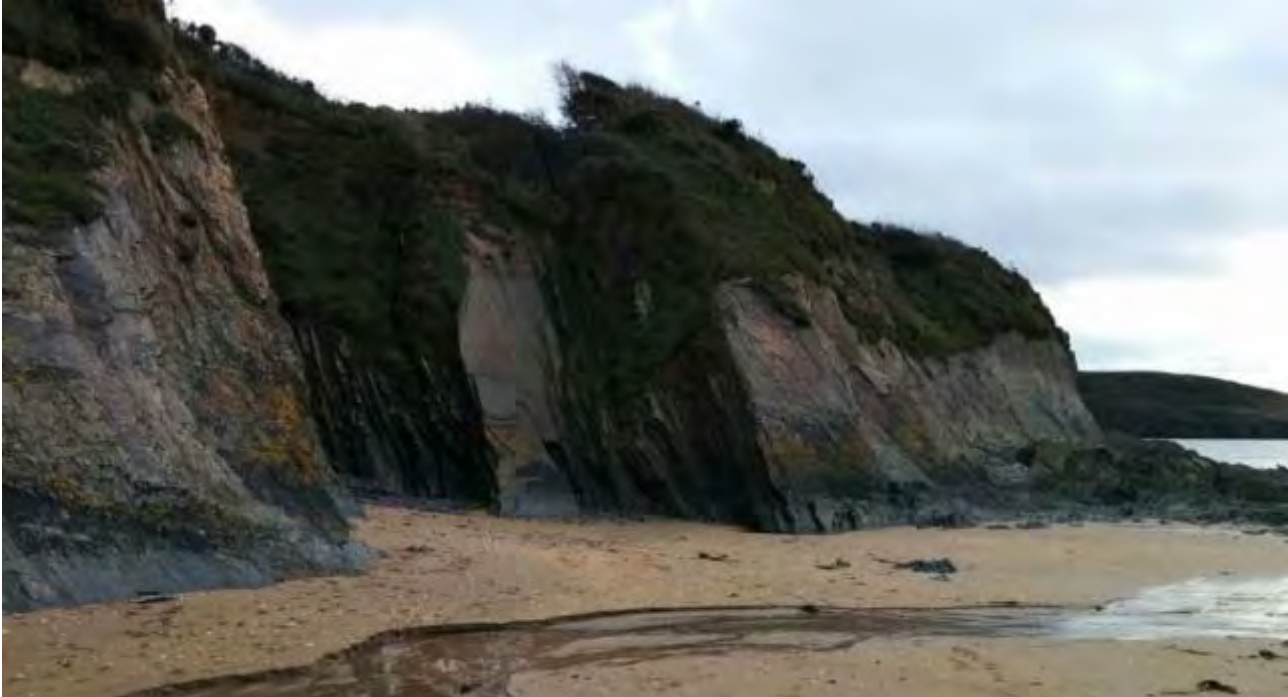
The southern side of Booley Bay is dominated by steeply dipping slate dominated meta-sediment with a thin soil cover vegetated with grass towards the top of the slope as shown on Photo 16:

**Photo 16: Southern side of Booley Bay**

Trenching across the dune system may not be viable from an environmental point of view and may lead to further instability in this location. Based on the geological sensitivity of this area (as noted in Section 2.4) horizontal directional drilling (HDD) is likely to be the optimum solution at this location.
