## NOTE TO FILE

| Contract | Llanelltyd Sheet Pile Removal |
| Subject | Llanelltyd Sheet Piling Geomorphological Assessment |

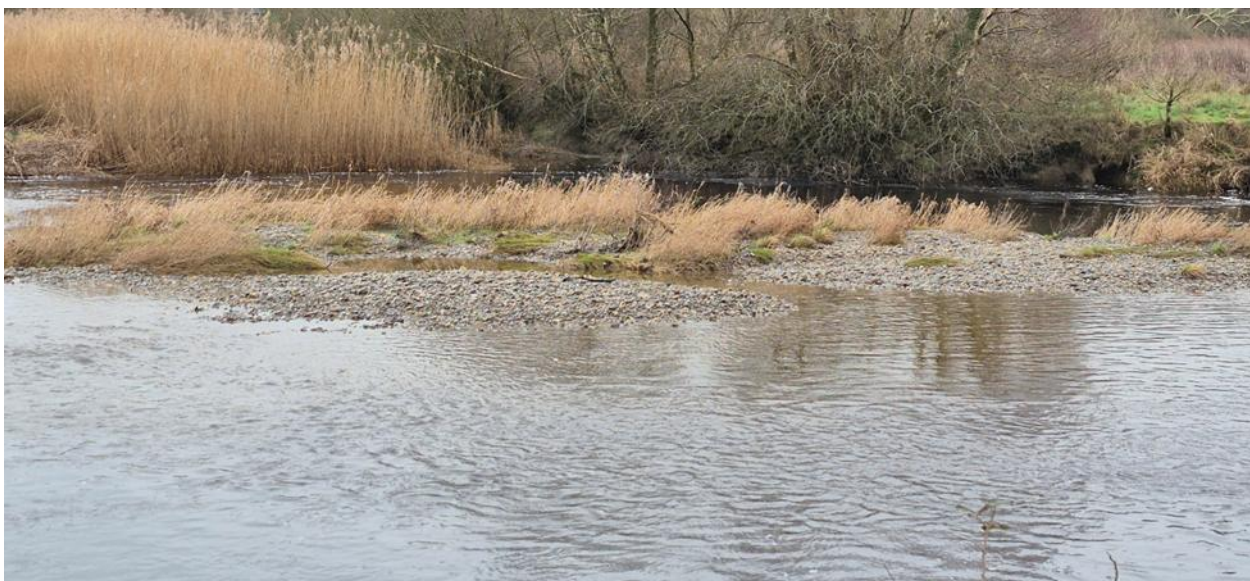
Upstream of the site, the Mawddach shows more variation within the channel, with an abundance of in-channel features including lateral, point and mid-channel bars (see Figure 3-7). This includes more flow biotypes as well, with runs, glides, and some riffles. At lower tide levels more riffles are likely to be present in this system given the healthy supply of sediment.

Figure 3-7 Some vegetated mid-channel bars on the Afon Mawddach (right bank looking upstream)

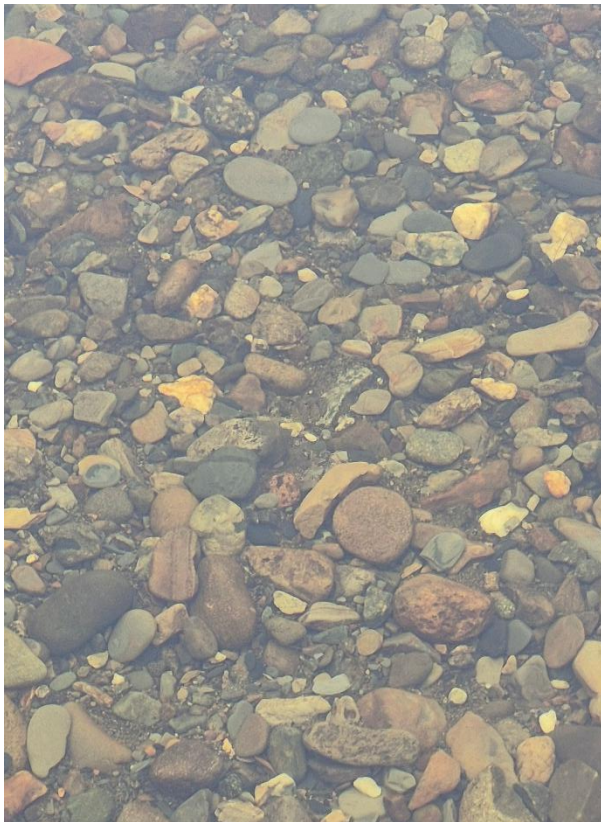
The sediment observed here was poorly sorted, fine to medium sized gravels, with a proportion that were sub-rounded to sub-angular (see Figure 3-8). This could indicate that the bed has likely been deposited in variable conditions and transported through the system relatively quickly, most likely due to the flashy nature of the Mawddach. There are also a lot of fines within the system, with a great deal deposited on some of the exposed point bars in this section (see Figure 3-9).

Figure 3-8 Poorly sorted bed material in the Afon Mawddach (right bank looking downstream)

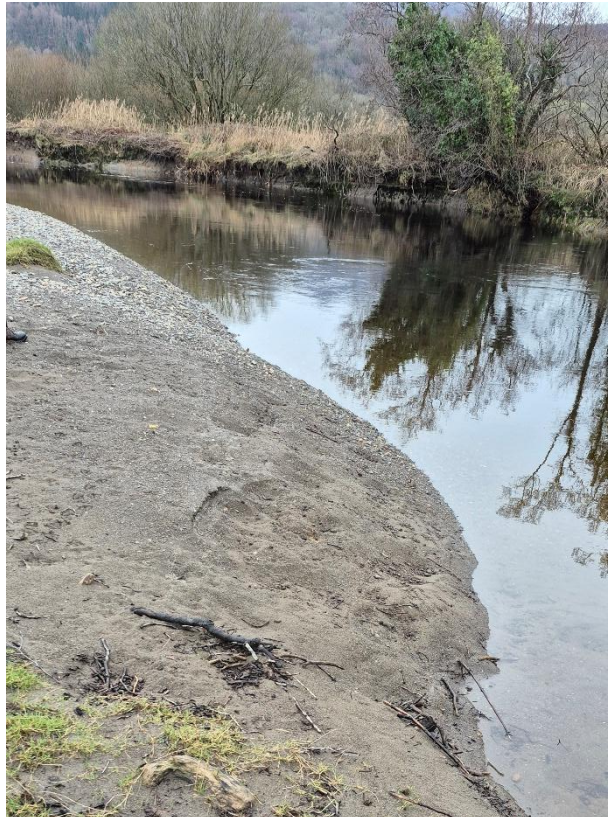
Figure 3-9 Point bar with a large quantity of fine sediment in the foreground (right bank looking upstream)

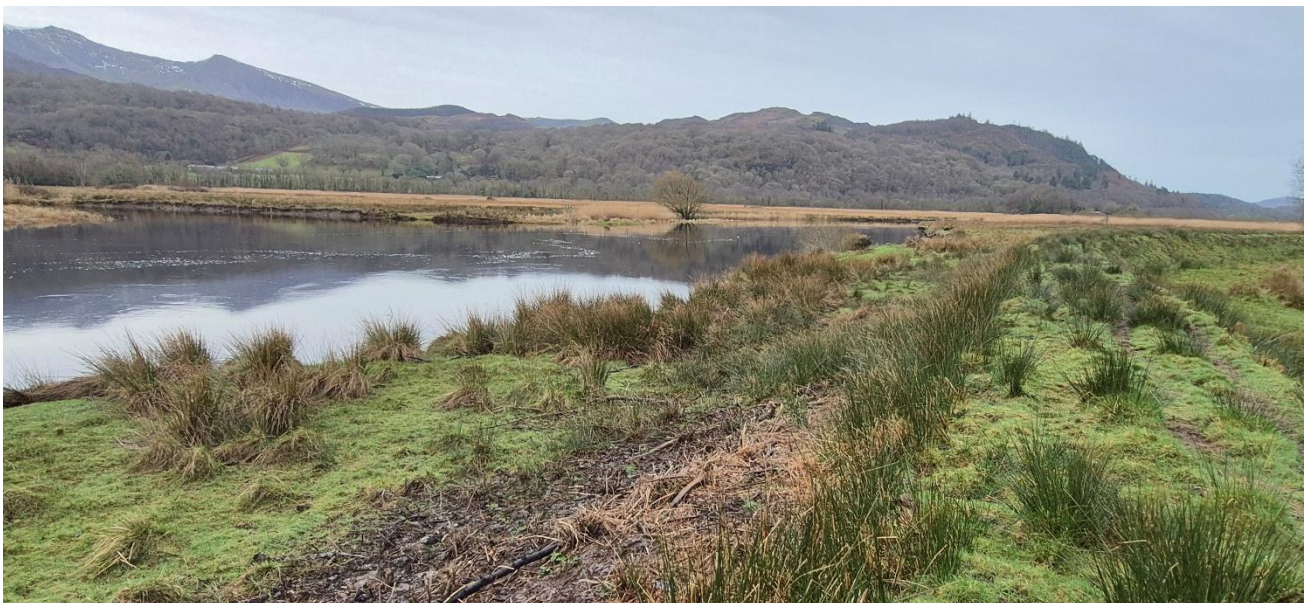
Figure 3-12 View of the confluence between the Afon Mawddach and Afon Wnion (right bank looking downstream)
