NOTE TO FILE

JBA Project Code	2026s0165
Contract	Llanelltyd Sheet Pile Removal
Client	Natural Resources Wales
Day, Date and Time	17/03/2026
Author	James Nixon BSc MSc
Reviewer / Sign off	Natasha Todd-Burley BSc (Hons) PhD CGeog (Geomorph) FRGS
Subject	Llanelltyd Sheet Piling Geomorphological Assessment

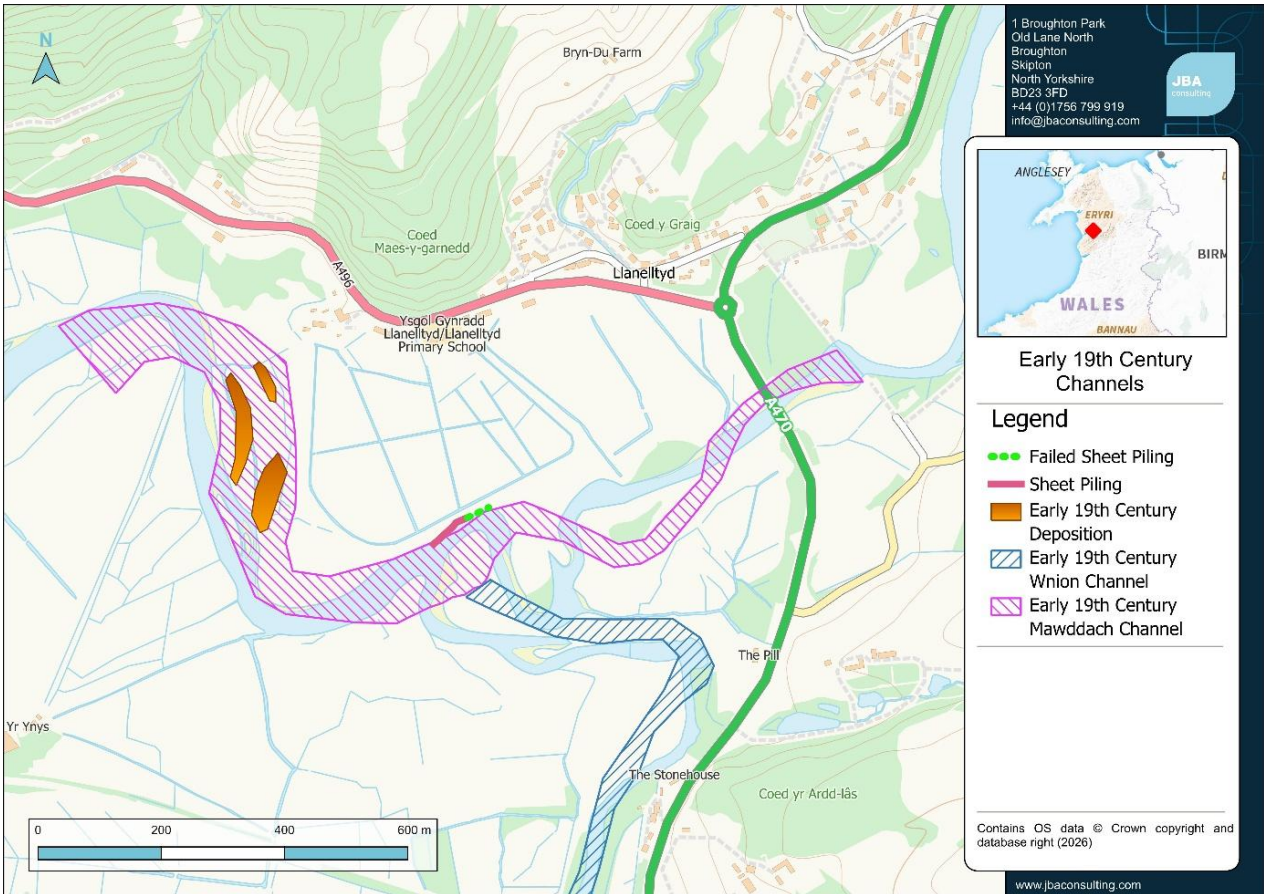
Historical maps show that there has been constant but relatively slow planform change since the early to mid-19th century to the present day. The earliest map shows that the section of channel just downstream of the original Llanelltyd bridge was more sinuous than it is today (Figure 2-2), with a straighter planform appearing on this section of channel from the late 19th century, suggesting that this reach may have been straightened. The meander bend that was present in the early 19th century has migrated further downstream to its current location and become much more sinuous with a tighter apex on the planform. The positioning of this meander bend along the length of this reach has not changed significantly since the end of the 19th century, with it staying in roughly the same place just upstream of the confluence with the Afon Wnion (Figure 2-3). However, the planform has

Figure 2-2 Channels of the Afon Mawddach and Afon Wnion in the early 19th century

The earliest maps available (early 19th century) also suggest that more deposition is now occurring just upstream of the site with the increased sinuosity, instead of around 600m downstream of the sheet piling, where historic mapping from the early 19th century suggests more in-channel deposition with a much wider channel (Figure 2-2).

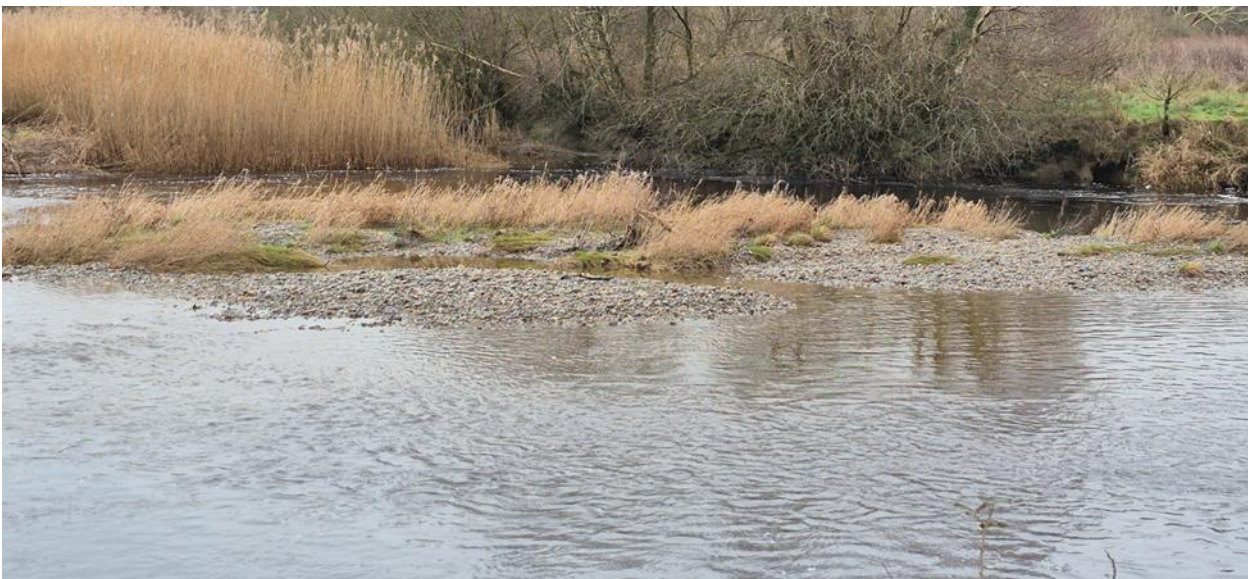
Upstream of the site, the Mawddach shows more variation within the channel, with an abundance of in-channel features including lateral, point and mid-channel bars (see Figure 3-7). This includes more flow biotypes as well, with runs, glides, and some riffles. At lower tide levels more riffles are likely to be present in this system given the healthy supply of sediment.

Figure 3-7 Some vegetated mid-channel bars on the Afon Mawddach (right bank looking upstream)

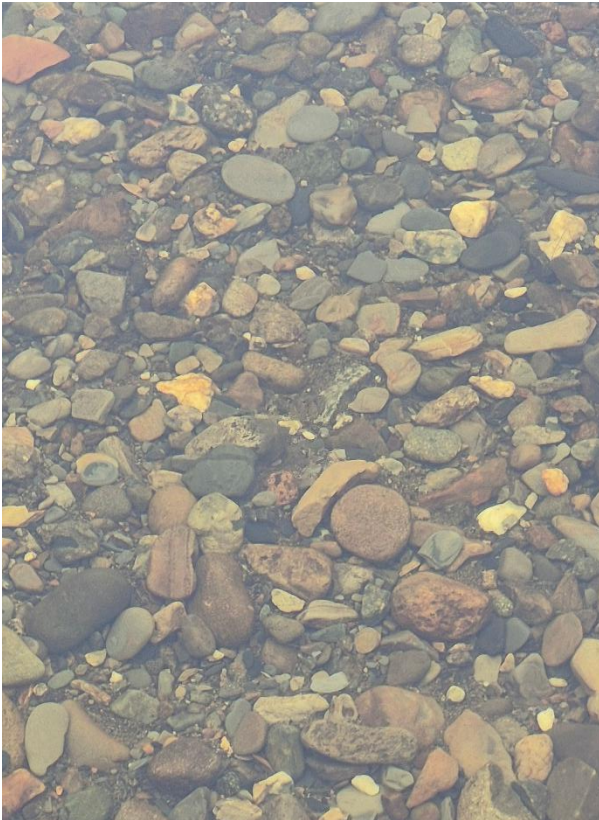
The sediment observed here was poorly sorted, fine to medium sized gravels, with a proportion that were sub-rounded to sub-angular (see Figure 3-8). This could indicate that the bed has likely been deposited in variable conditions and transported through the system relatively quickly, most likely due to the flashy nature of the Mawddach. There are also a lot of fines within the system, with a great deal deposited on some of the exposed point bars in this section (see Figure 3-9).

Figure 3-8 Poorly sorted bed material in the Afon Mawddach (right bank looking downstream)

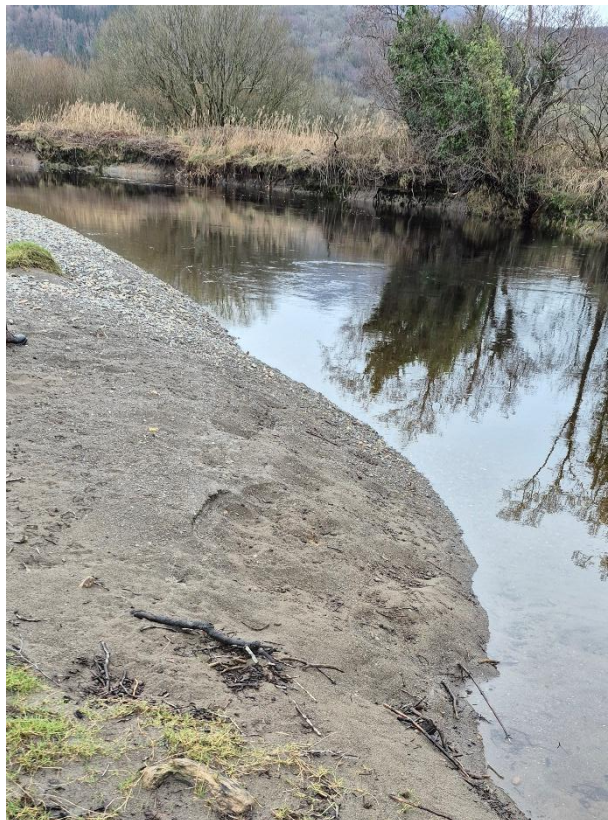
Figure 3-9 Point bar with a large quantity of fine sediment in the foreground (right bank looking upstream)

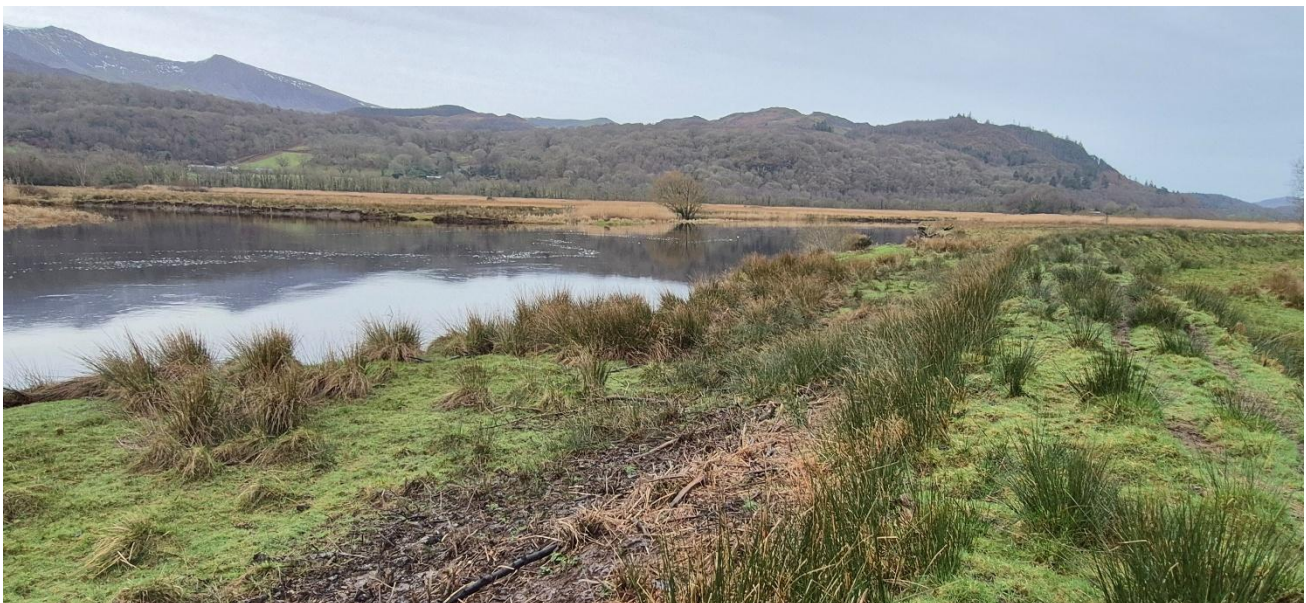
The Afon Wnion joins the Afon Mawddach immediately downstream of the site and was observed to have caused erosion along the left bank at the mouth of the Wnion and more crucially on the right bank immediately downstream of the 100m of sheet piling. This erosion has started to destabilise the other (downstream) end of the of the sheet piling leading to its deterioration and imminent failure (see Figure 3-11). Aerial imagery from 2006, shows that the bank here has retreated around 6-10m, due to the flow velocity out of the Wnion. This is also an increasing threat to the section of sheet piling that is yet to fully fail.

Figure 3-12 View of the confluence between the Afon Mawddach and Afon Wnion (right bank looking downstream)
