SAB, Flood risk and Drainage Technical Note

Cog Road, Sully

Cleaning • Surveys • Lining • Civils  
Job - 20958 - 01 - 001

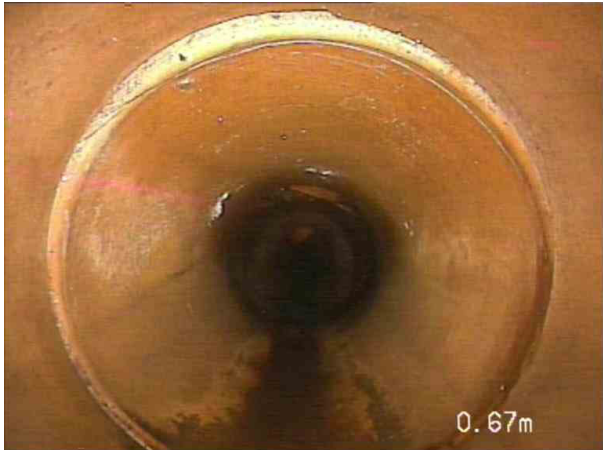
1, 00:00:17, 0.67 m  
Crack, circumferential at joint from 10 o'clock to 3 o'clock

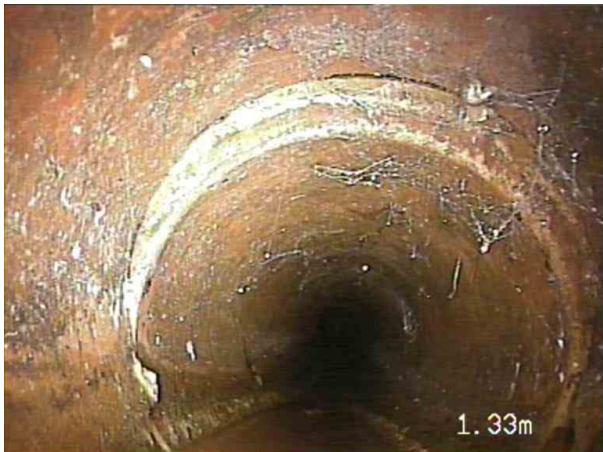
1, 00:00:29, 1.33 m  
Joint displaced, large

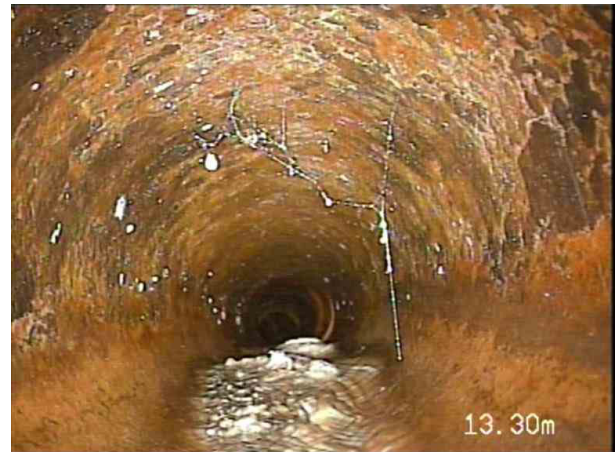
2, 00:02:00, 13.30 m  
Attached deposits, fouling from 5 o'clock to 7 o'clock, 10% cross-sectional area loss, LIVE LINE

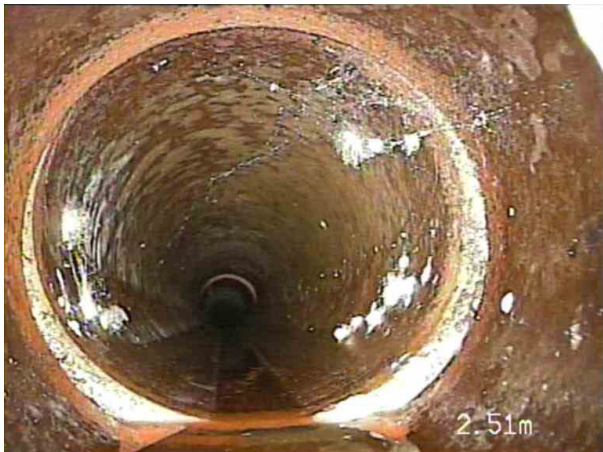
1, 00:00:33, 2.51 m  
Joint displaced, large

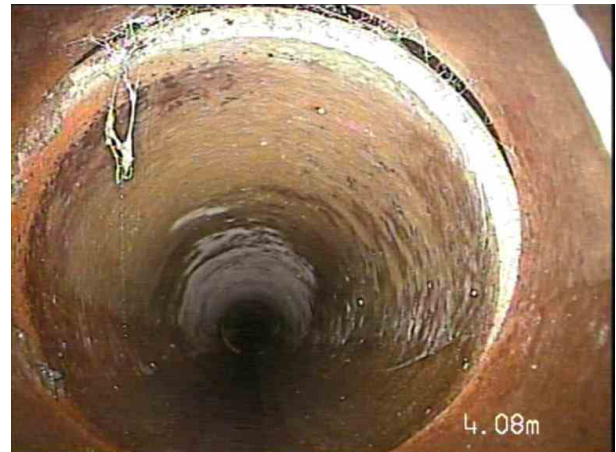
2, 00:00:50, 4.08 m  
Joint displaced, large

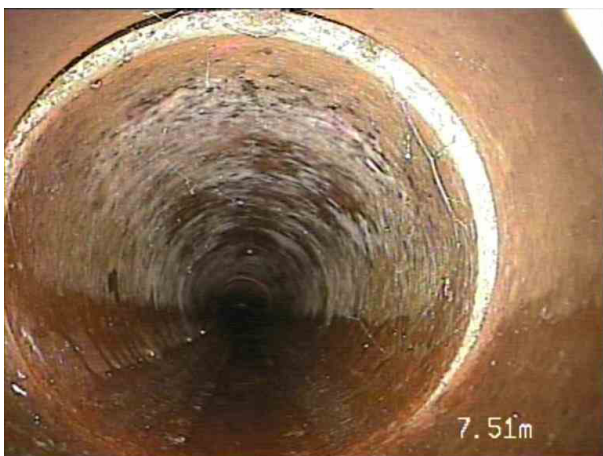
3, 00:01:15, 7.51 m  
Joint displaced, medium

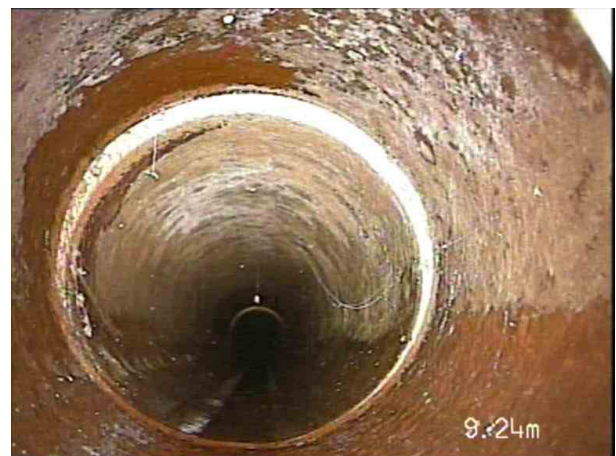
4, 00:01:31, 9.24 m  
Joint displaced, medium

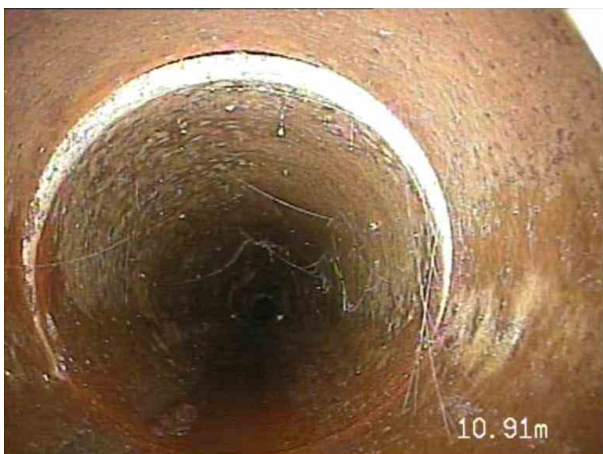
5, 00:01:44, 10.91 m  
Joint displaced, medium

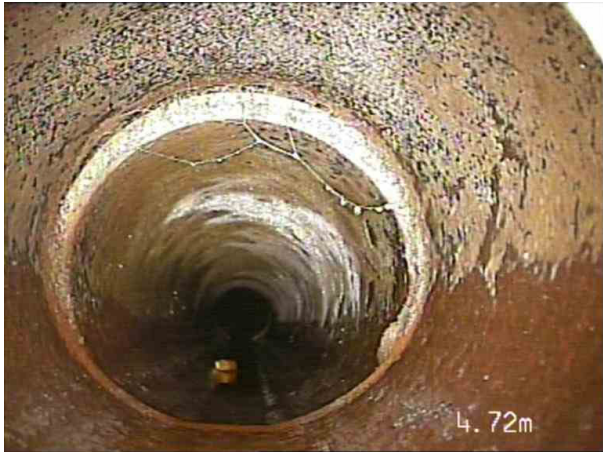
1, 00:00:41, 4.72 m  
Joint displaced, medium

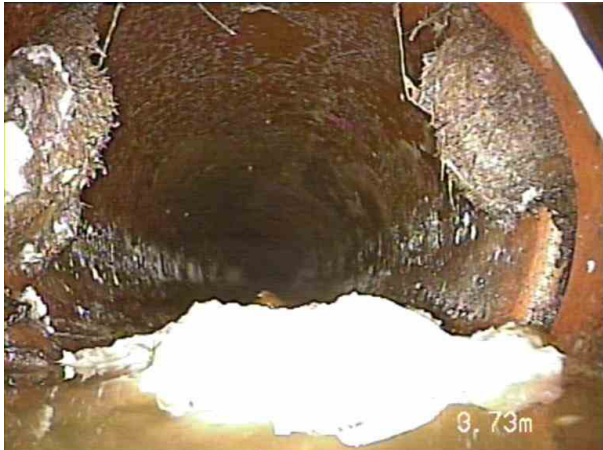
1, 00:00:47, 3.71 m  
Roots, mass at joint, 20% cross-sectional area loss

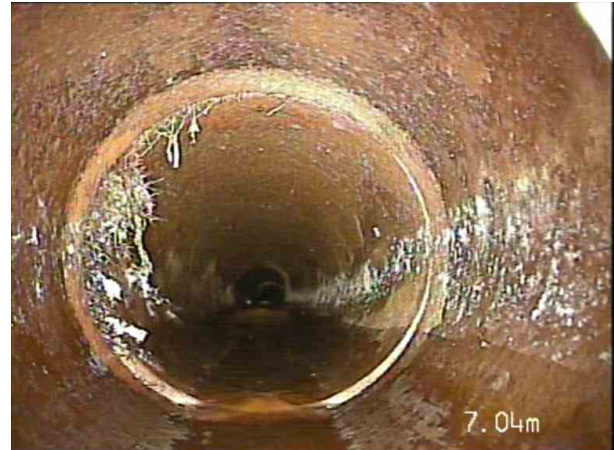
2, 00:01:16, 7.00 m  
Roots, mass at joint, 10% cross-sectional area loss

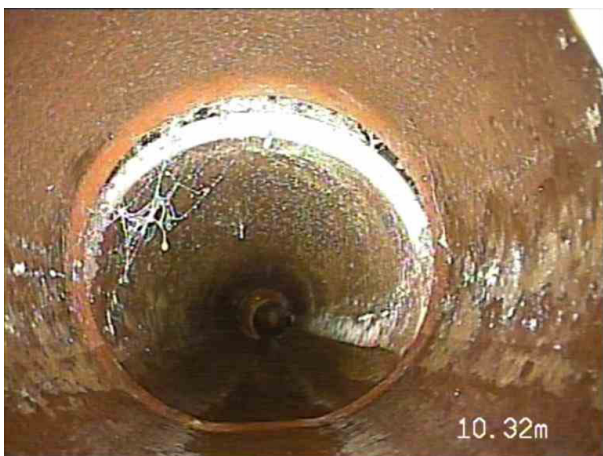
3, 00:01:52, 10.32 m  
Joint displaced, large

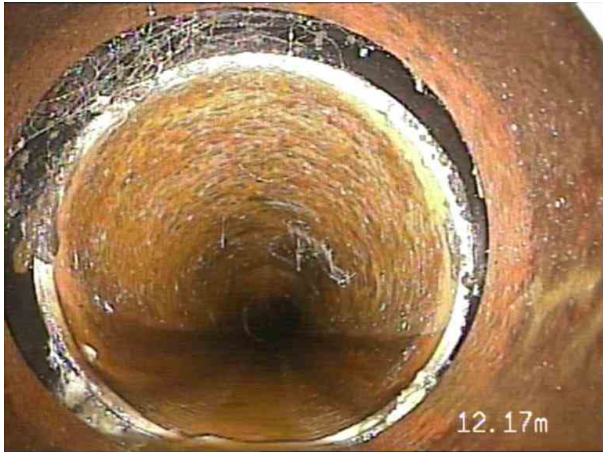
1, 00:01:39, 12.17 m  
Open joint, large

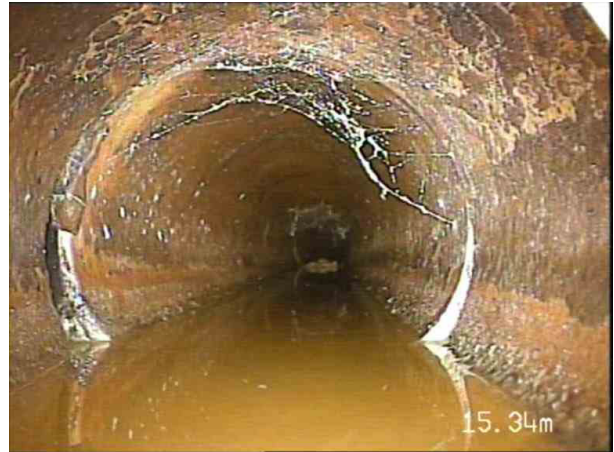
2, 00:02:01, 15.34 m  
Open joint, large

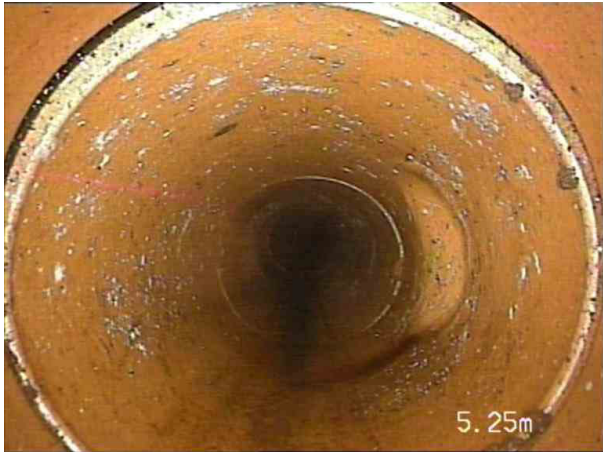
1, 00:00:47, 5.25 m  
Joint displaced, medium

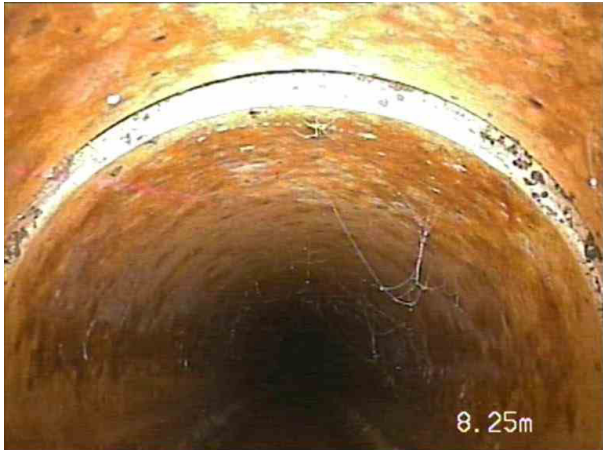
1, 00:01:12, 8.25 m  
Joint displaced, medium

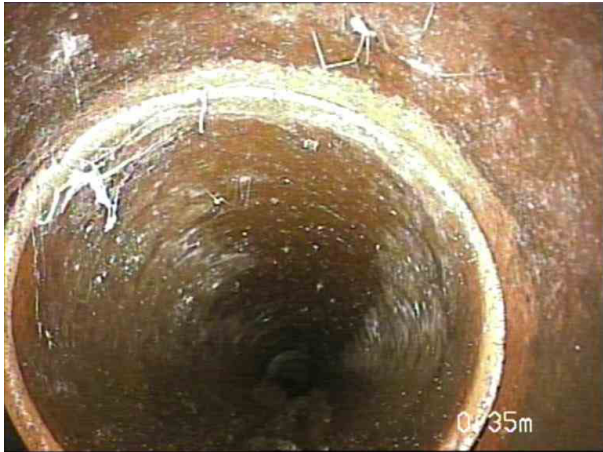
1, 00:00:19, 0.35 m  
Open joint, large

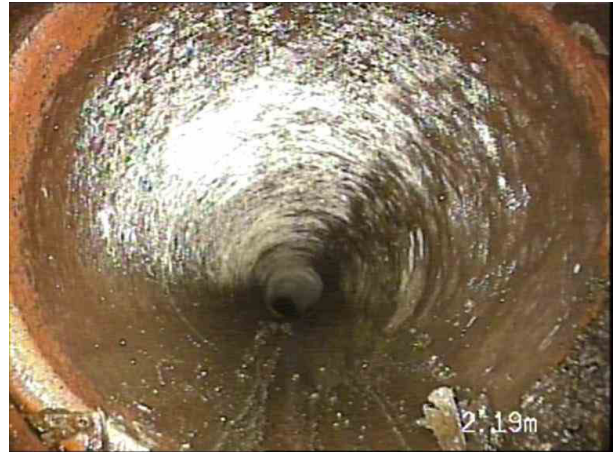
2, 00:00:44, 2.19 m  
Open joint, large

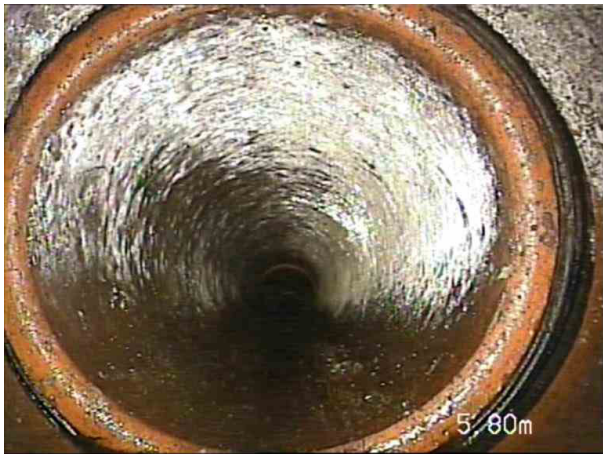
3, 00:01:18, 5.80 m  
Open joint, large

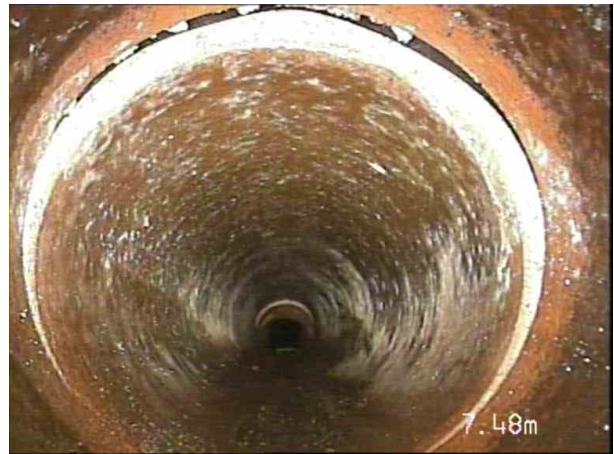
4, 00:01:33, 7.48 m  
Joint displaced, medium

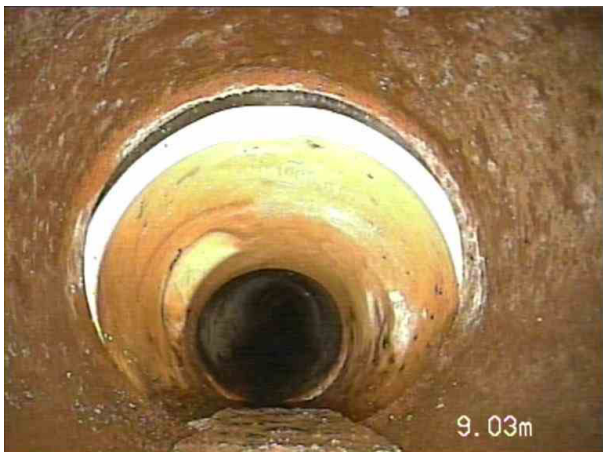
5, 00:01:47, 9.03 m  
Joint displaced, large

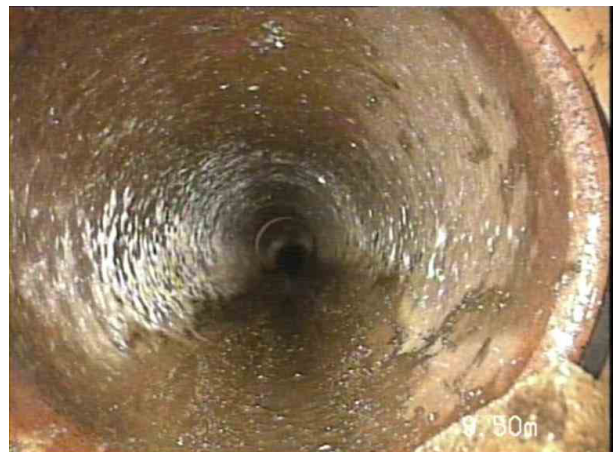
6, 00:02:03, 9.50 m  
Open joint, large

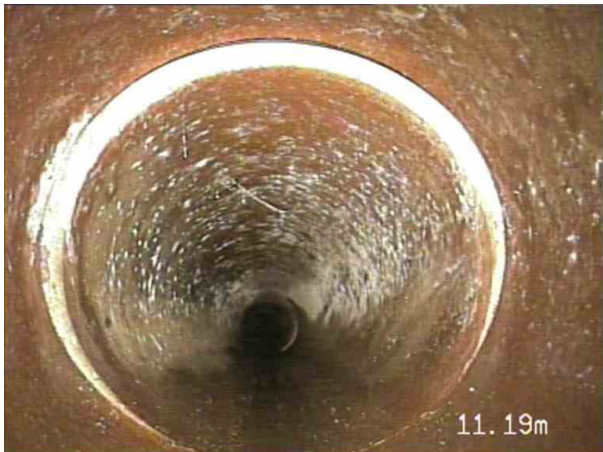
7, 00:02:22, 11.19 m  
Joint displaced, medium

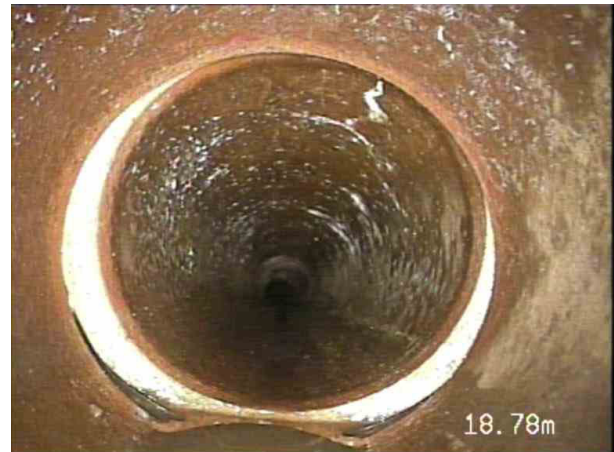
8, 00:03:23, 18.78 m  
Joint displaced, large

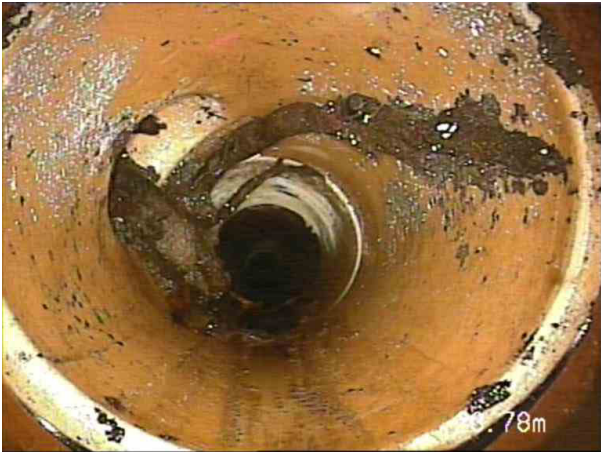
13, 00:04:23, 23.78 m  
Joint displaced, medium

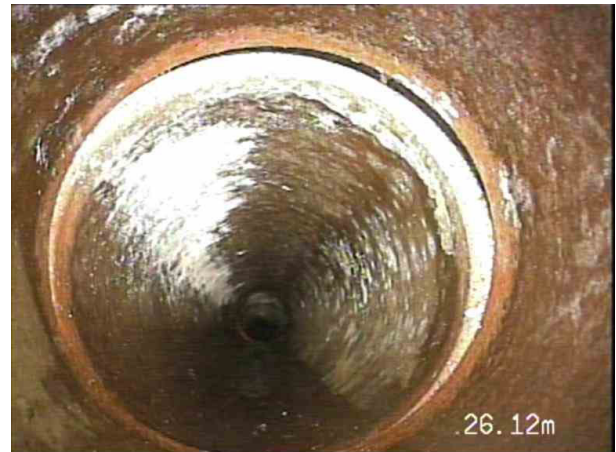
16, 00:04:52, 26.12 m  
Joint displaced, medium

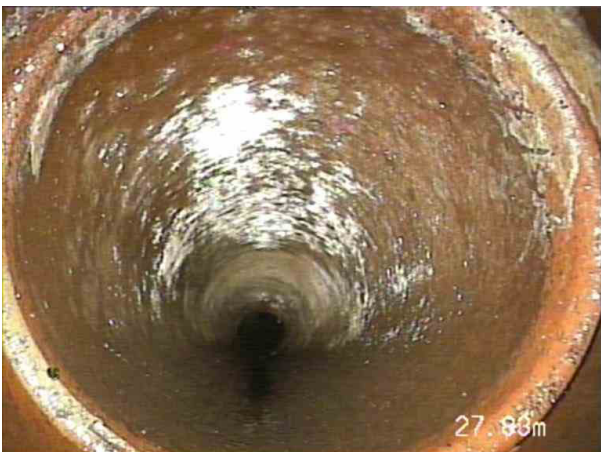
17, 00:05:05, 27.83 m  
Joint displaced, medium

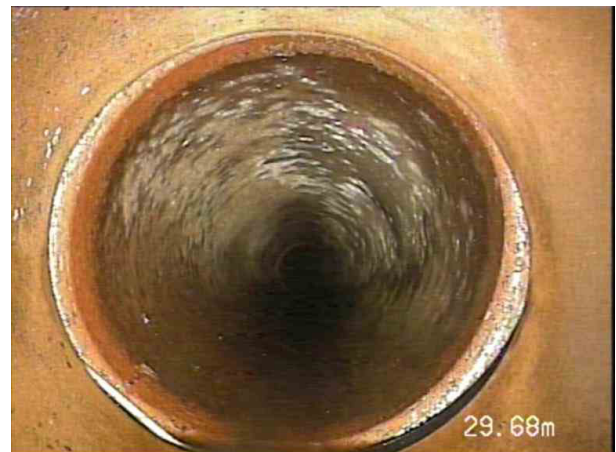
18, 00:05:26, 29.68 m  
Open joint, large

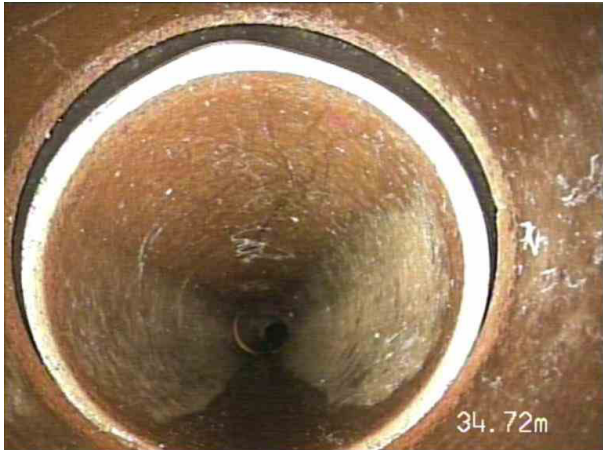
19, 00:05:57, 34.72 m  
Open joint, large

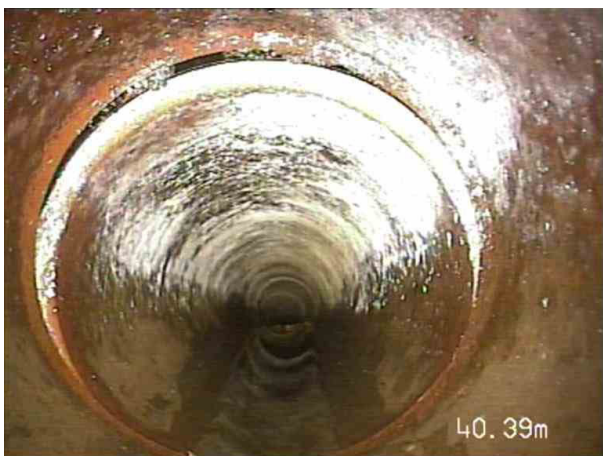
21, 00:06:50, 40.39 m  
Joint displaced, large

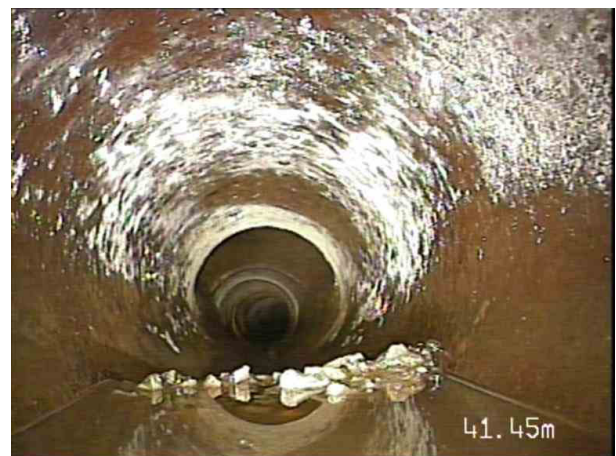
22, 00:07:04, 41.45 m  
Settled deposits, hard or compacted, 10% cross-sectional area loss, CONCRETE

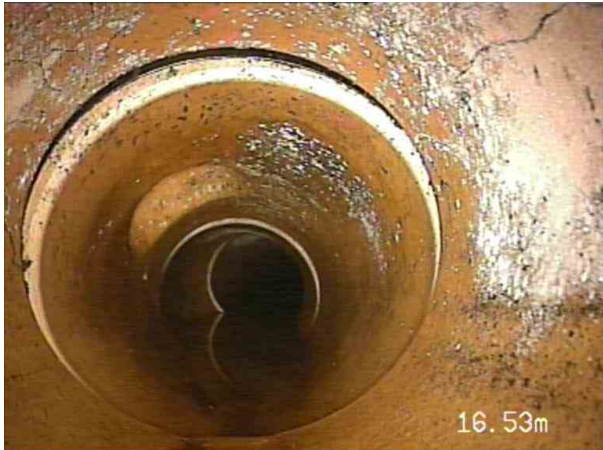
1, 00:02:37, 16.53 m  
Joint displaced, large

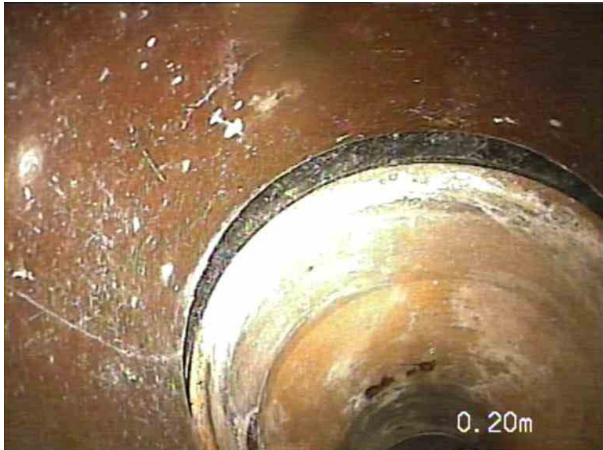
1, 00:00:13, 0.20 m  
Joint displaced, large

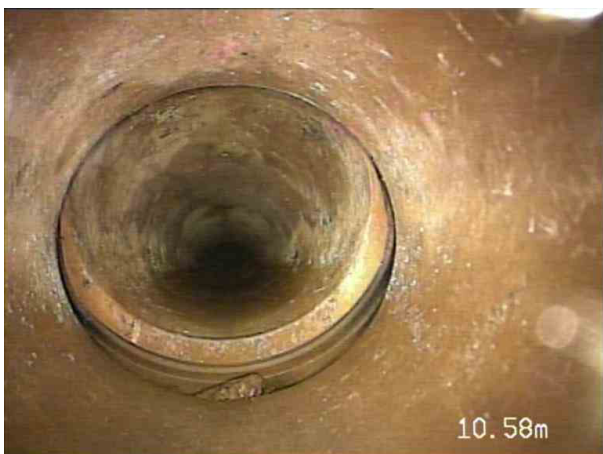
5, 00:01:55, 10.58 m  
Joint displaced, large

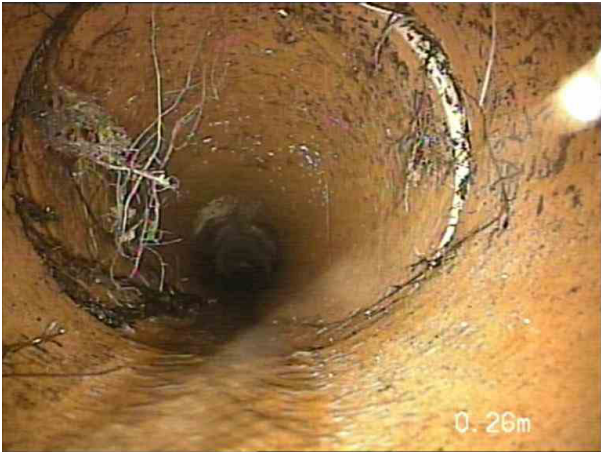
1, 00:00:18, 0.26 m  
Roots, tap at joint

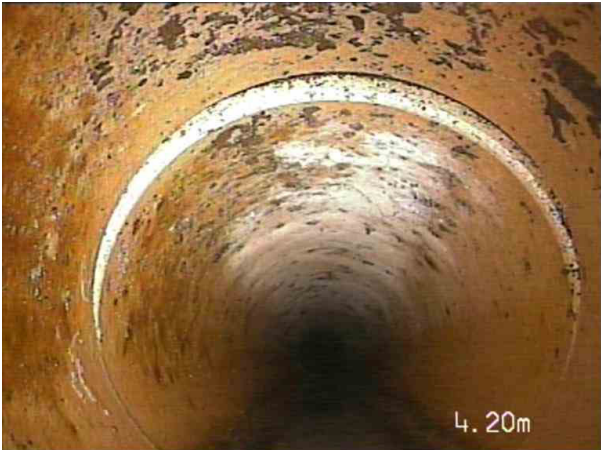
1, 00:00:52, 4.20 m  
Joint displaced, medium

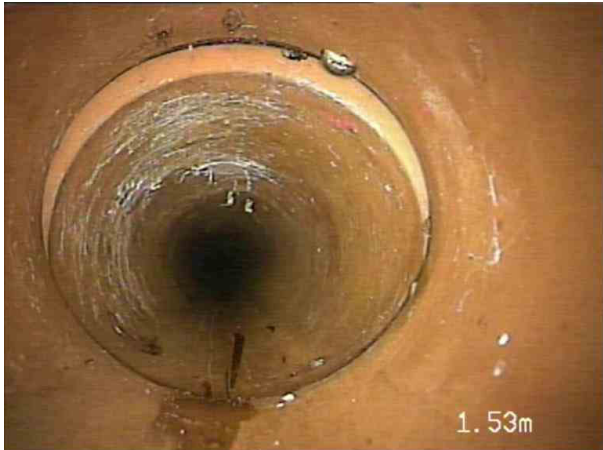
1, 00:00:26, 1.53 m  
Joint displaced, medium

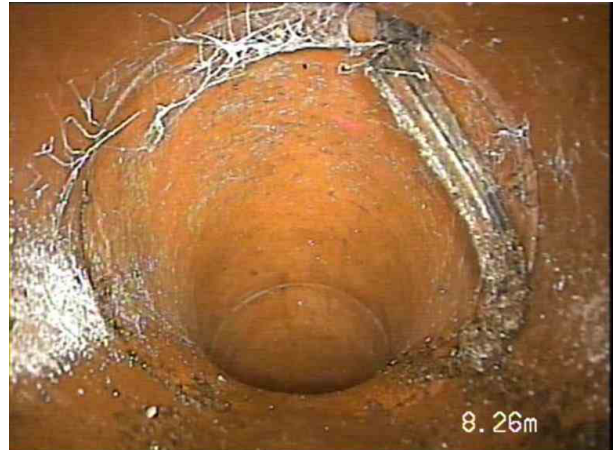
2, 00:01:19, 8.26 m  
Sealing ring intruding from 12 o'clock to 4 o'clock

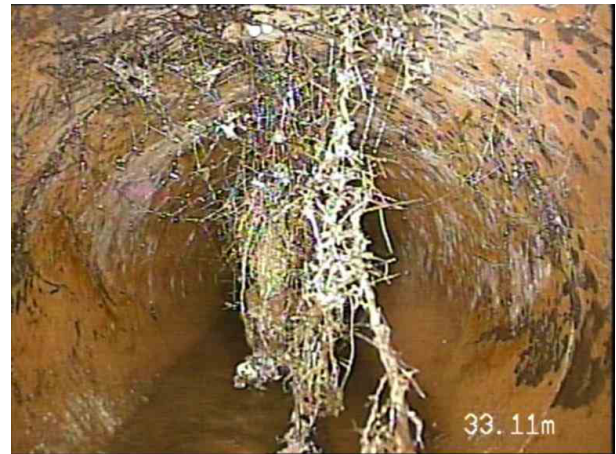
4, 00:04:58, 33.11 m  
Roots, mass at joint, 10% cross-sectional area loss

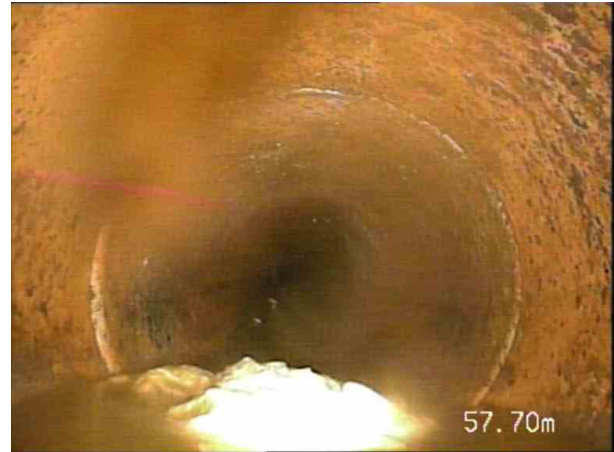
2, 00:11:01, 57.70 m  
Attached deposits, fouling from 5 o'clock to 7 o'clock, 25% cross-sectional area loss

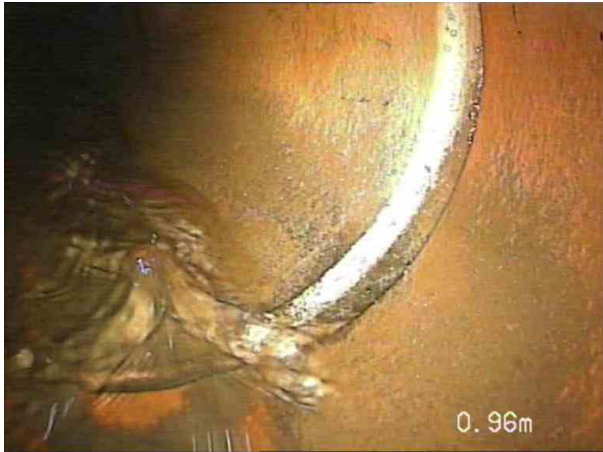
1, 00:00:21, 0.96 m  
Open joint, large

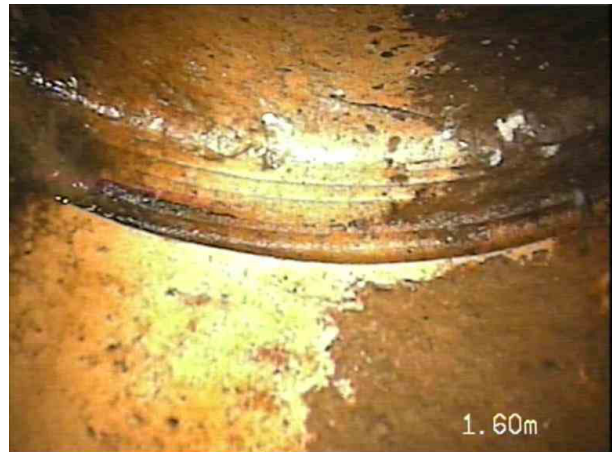
2, 00:00:35, 1.60 m  
Open joint, large
