Site Condition Report

LAND ADJACENT MAELOR FOODS LTD
CROSS LANES
WREXHAM
LL13 0UE

Report Ref. 1572-16 / Final
Revision 1 – 23rd October 2019

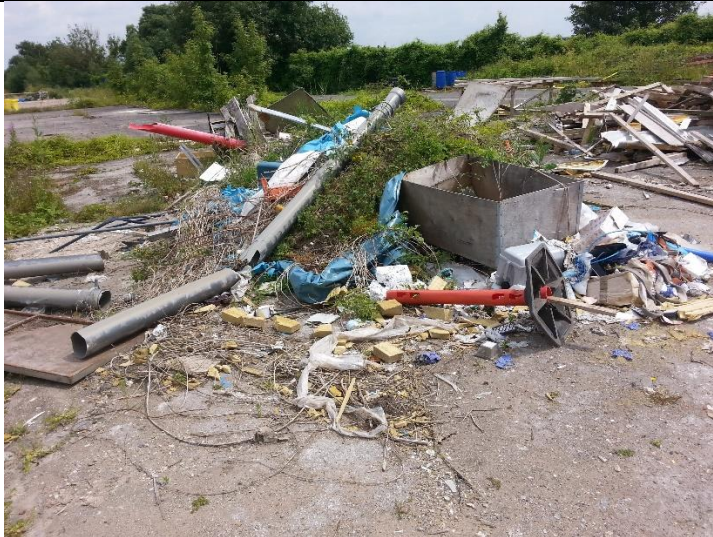
Plate 6. Showing stockpile of waste material facing southeast, near WS3

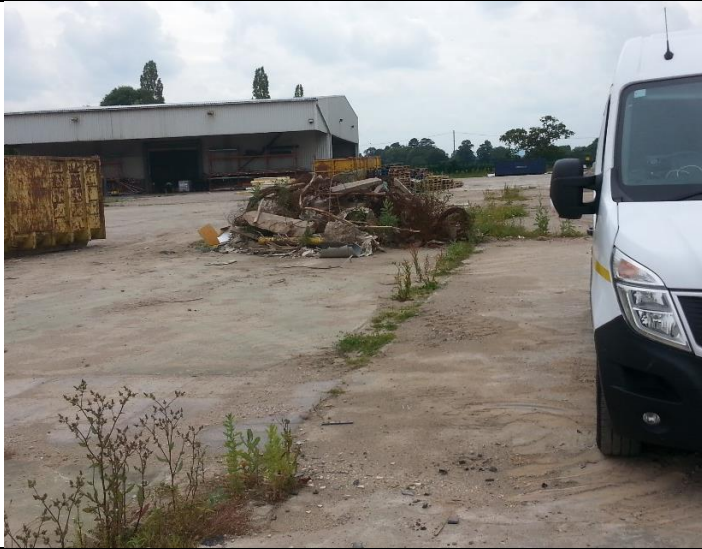
Plate 8. Showing stockpiles of waste material and growth of vegetation facing west, near WS4

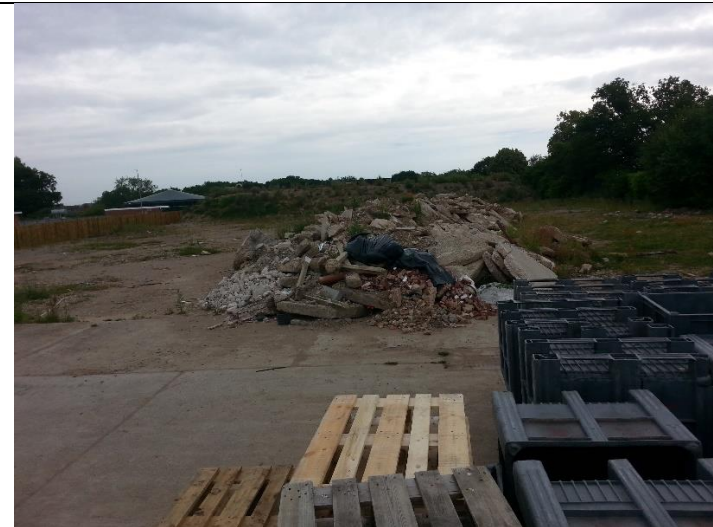
On the eastern part of the site (undeveloped land), a large stockpile was noted comprising clay pipes and broken concrete hardstanding surfaces.

Plate 11. Showing stockpile on eastern portion of the site facing east, near WS5

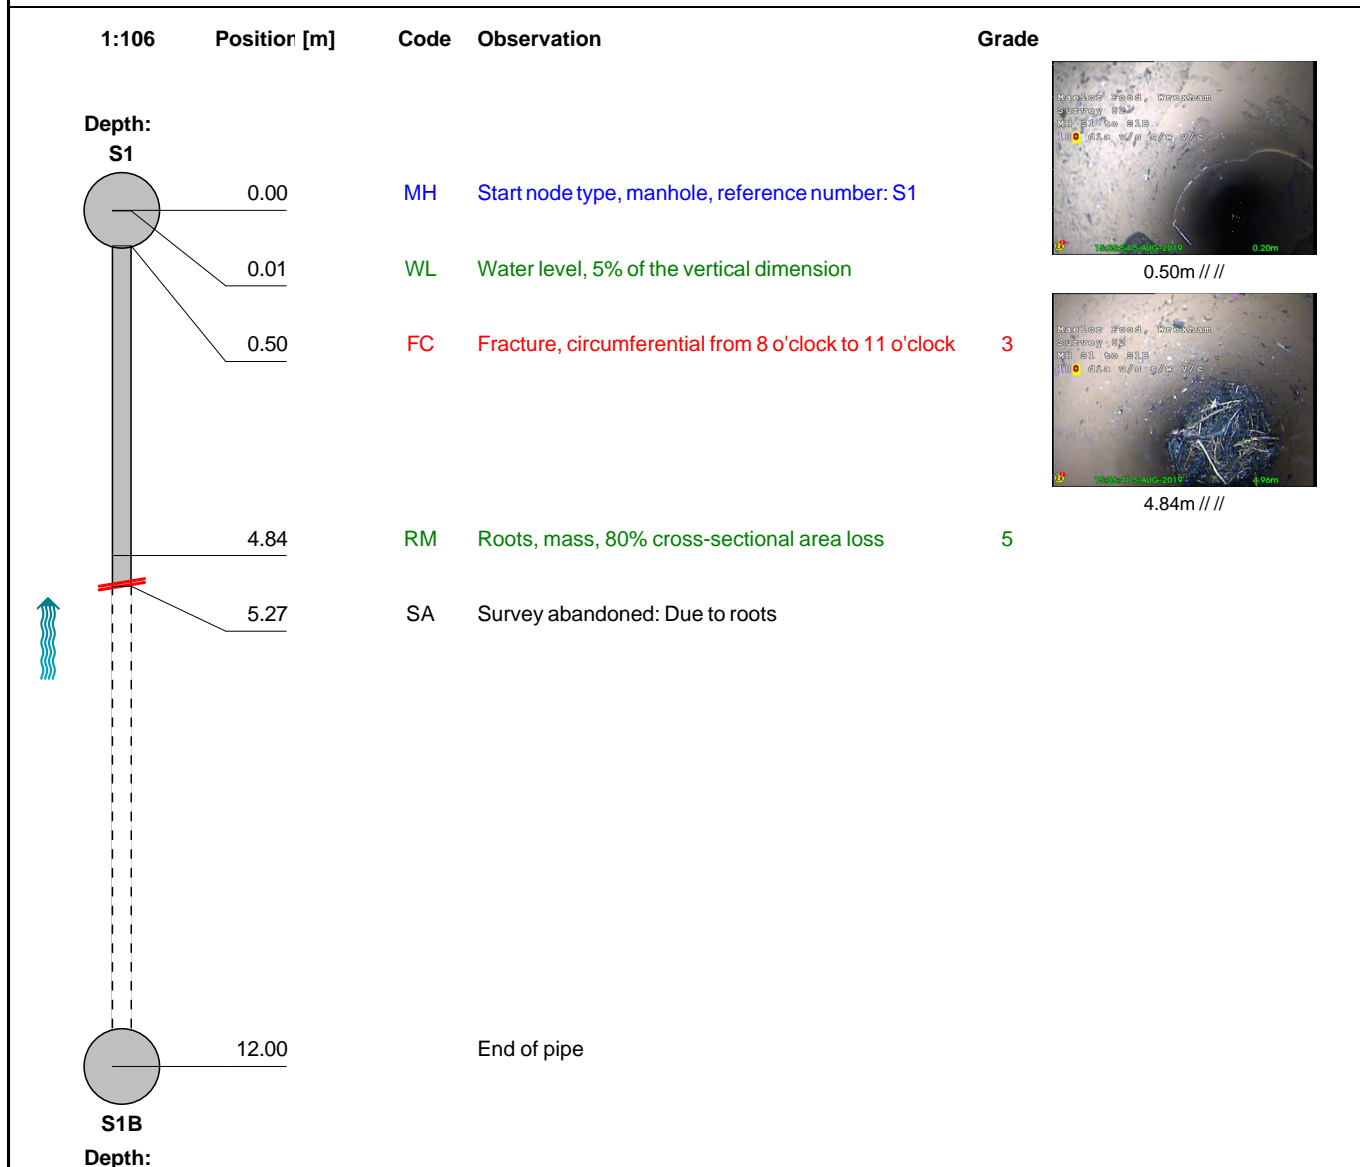
Section Inspection - 8/5/2019 - S1BX

Structural Defects					Construction Features				
Service & Operational Observations					Miscellaneous Features				
STR No. Def	STR Peak	STR Mean	STR Total	STR Grade	SER No. Def	SER Peak	SER Mean	SER Total	SER Grade
1	40.0	3.3	40.0	3.0	1	20.0	1.7	20.0	5.0

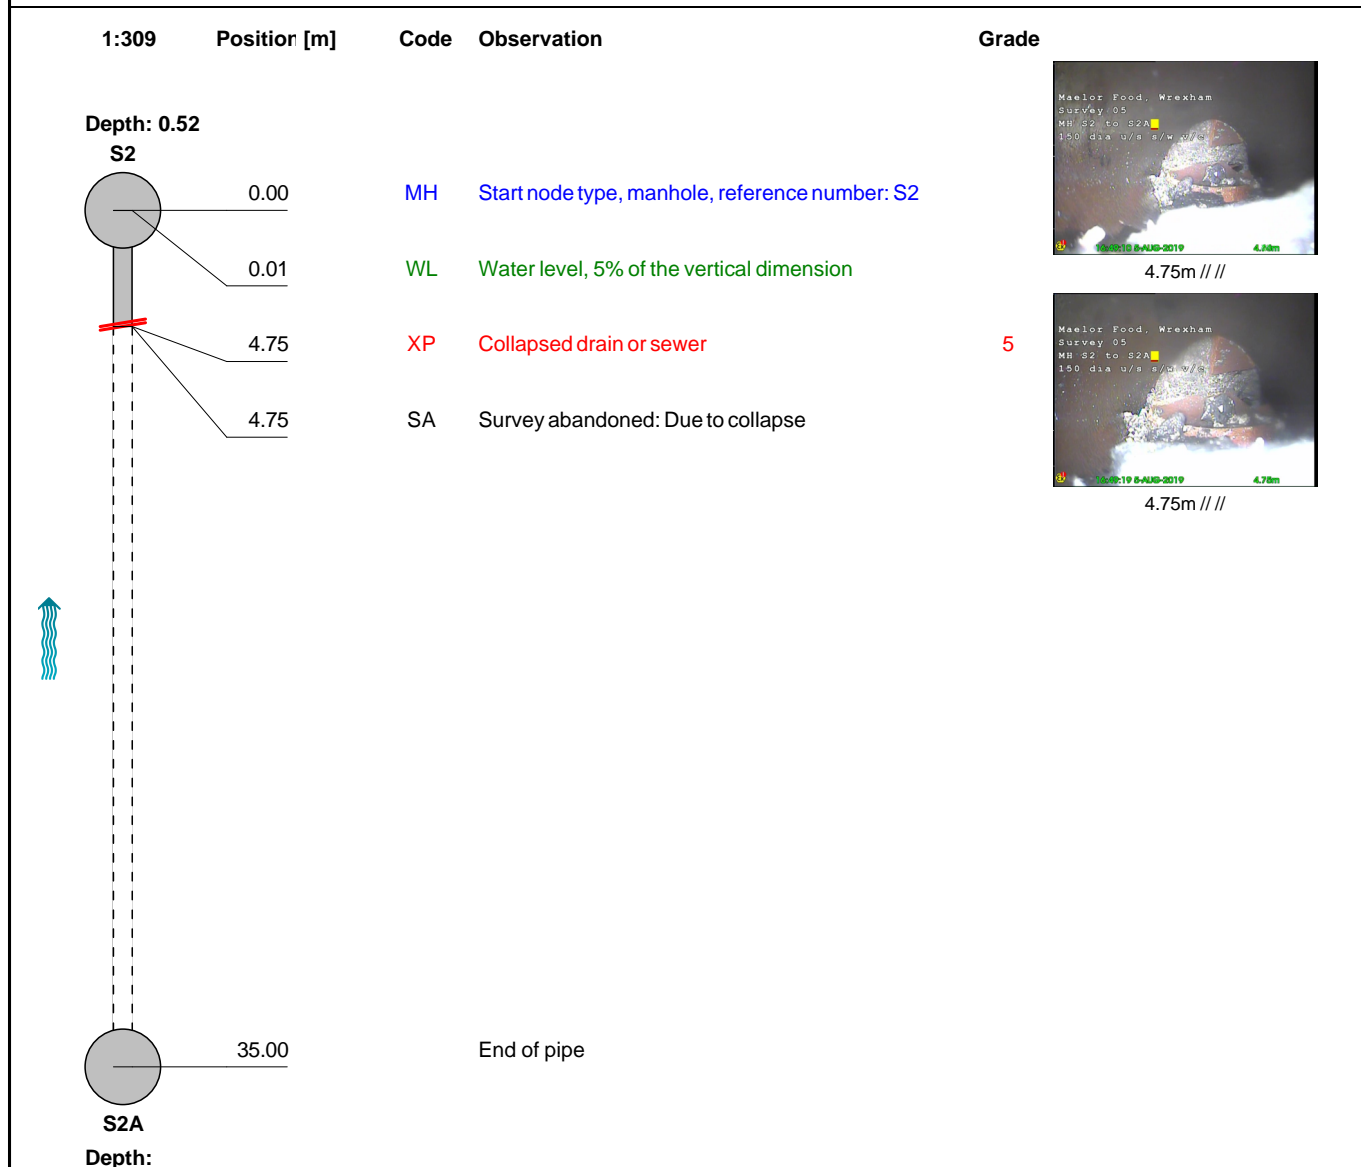
Structural Defects					Construction Features				
Service & Operational Observations					Miscellaneous Features				
STR No. Def	STR Peak	STR Mean	STR Total	STR Grade	SER No. Def	SER Peak	SER Mean	SER Total	SER Grade
1	165.0	4.7	165.0	5.0	0	0.0	0.0	0.0	1.0

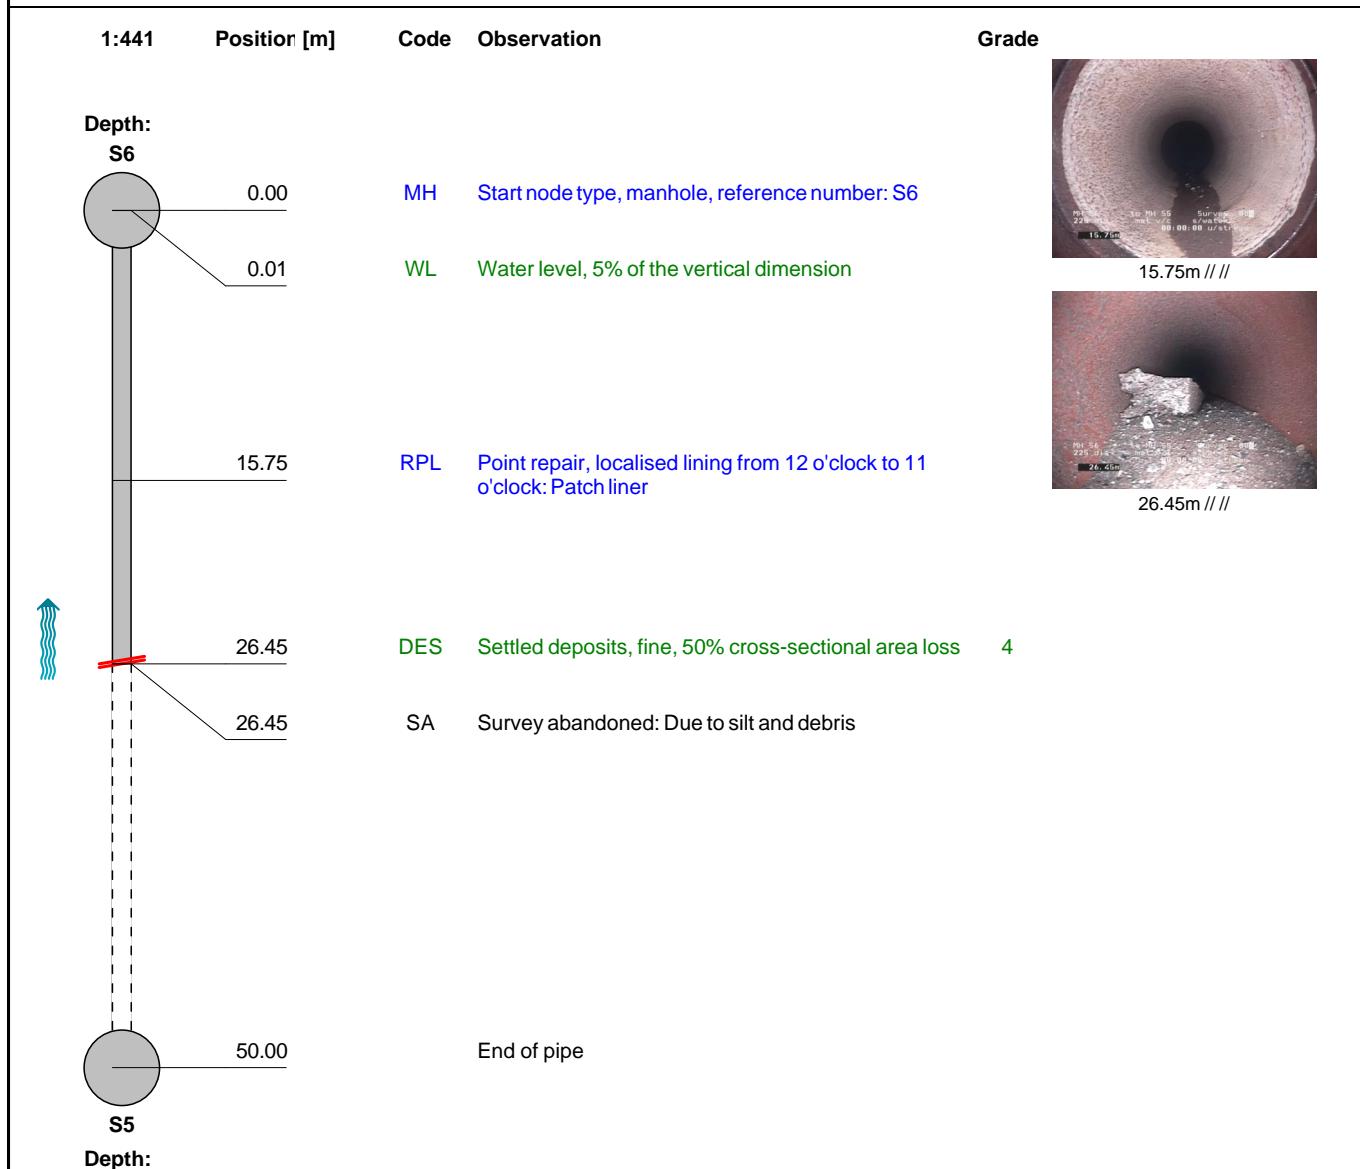
Structural Defects					Construction Features				
Service & Operational Observations					Miscellaneous Features				
STR No. Def	STR Peak	STR Mean	STR Total	STR Grade	SER No. Def	SER Peak	SER Mean	SER Total	SER Grade
0	0.0	0.0	0.0	1.0	1	5.0	0.1	5.0	4.0

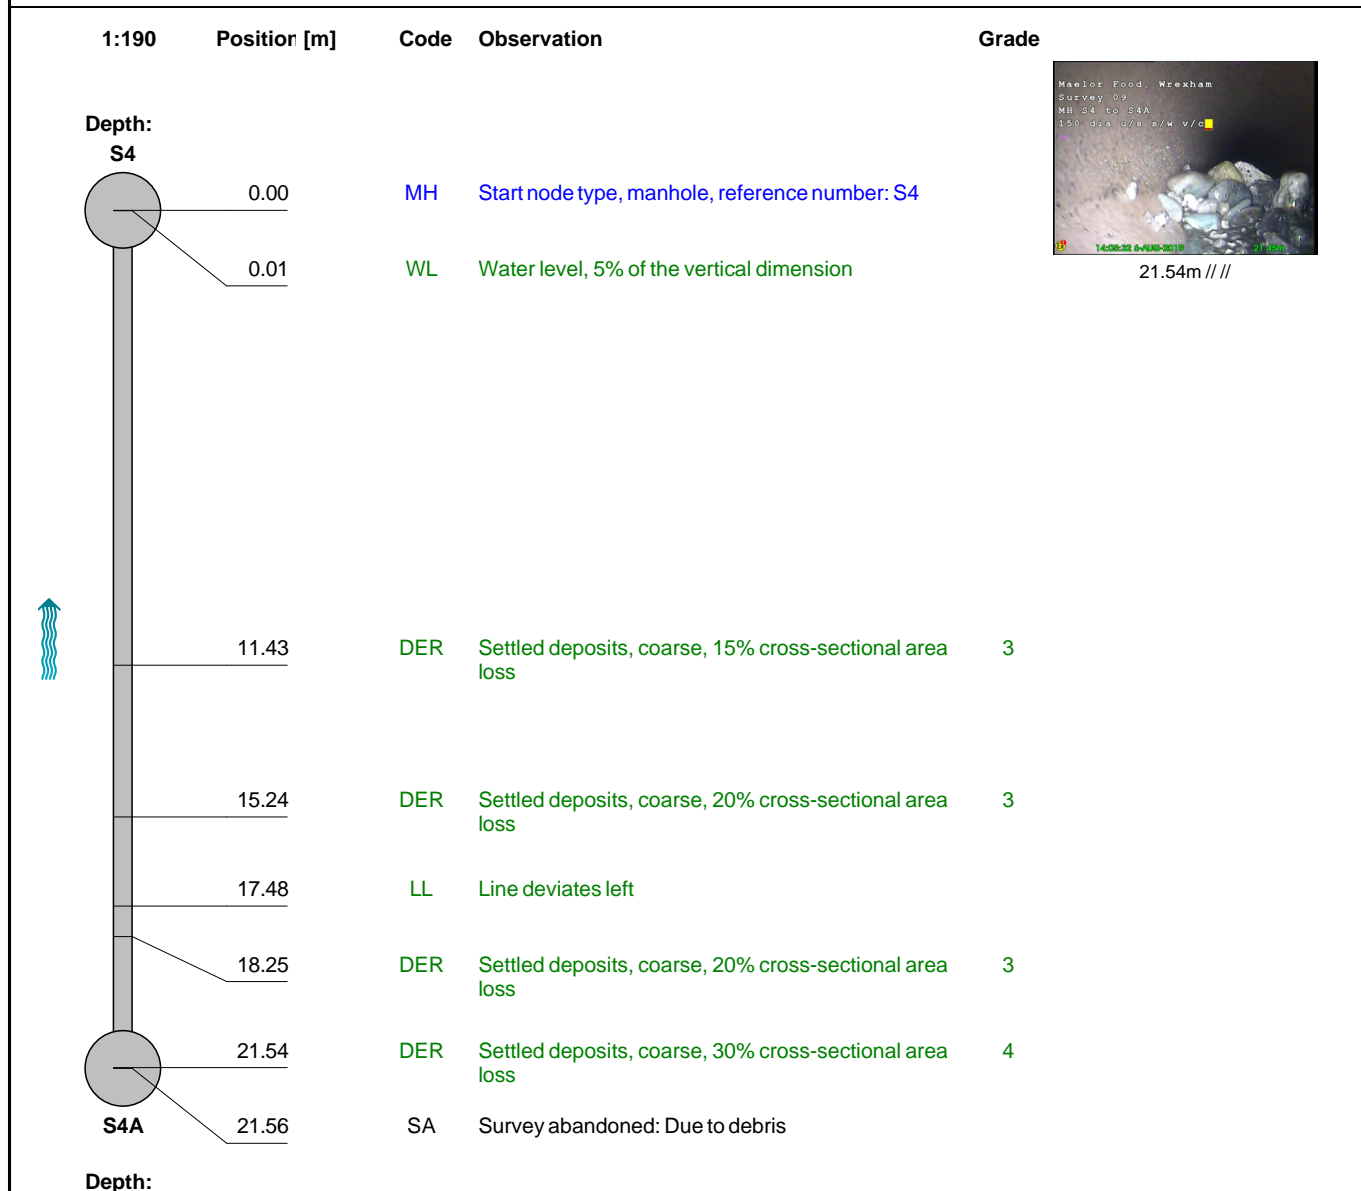
Structural Defects					Construction Features				
Service & Operational Observations					Miscellaneous Features				
STR No. Def	STR Peak	STR Mean	STR Total	STR Grade	SER No. Def	SER Peak	SER Mean	SER Total	SER Grade
0	0.0	0.0	0.0	1.0	4	5.0	0.5	11.0	4.0

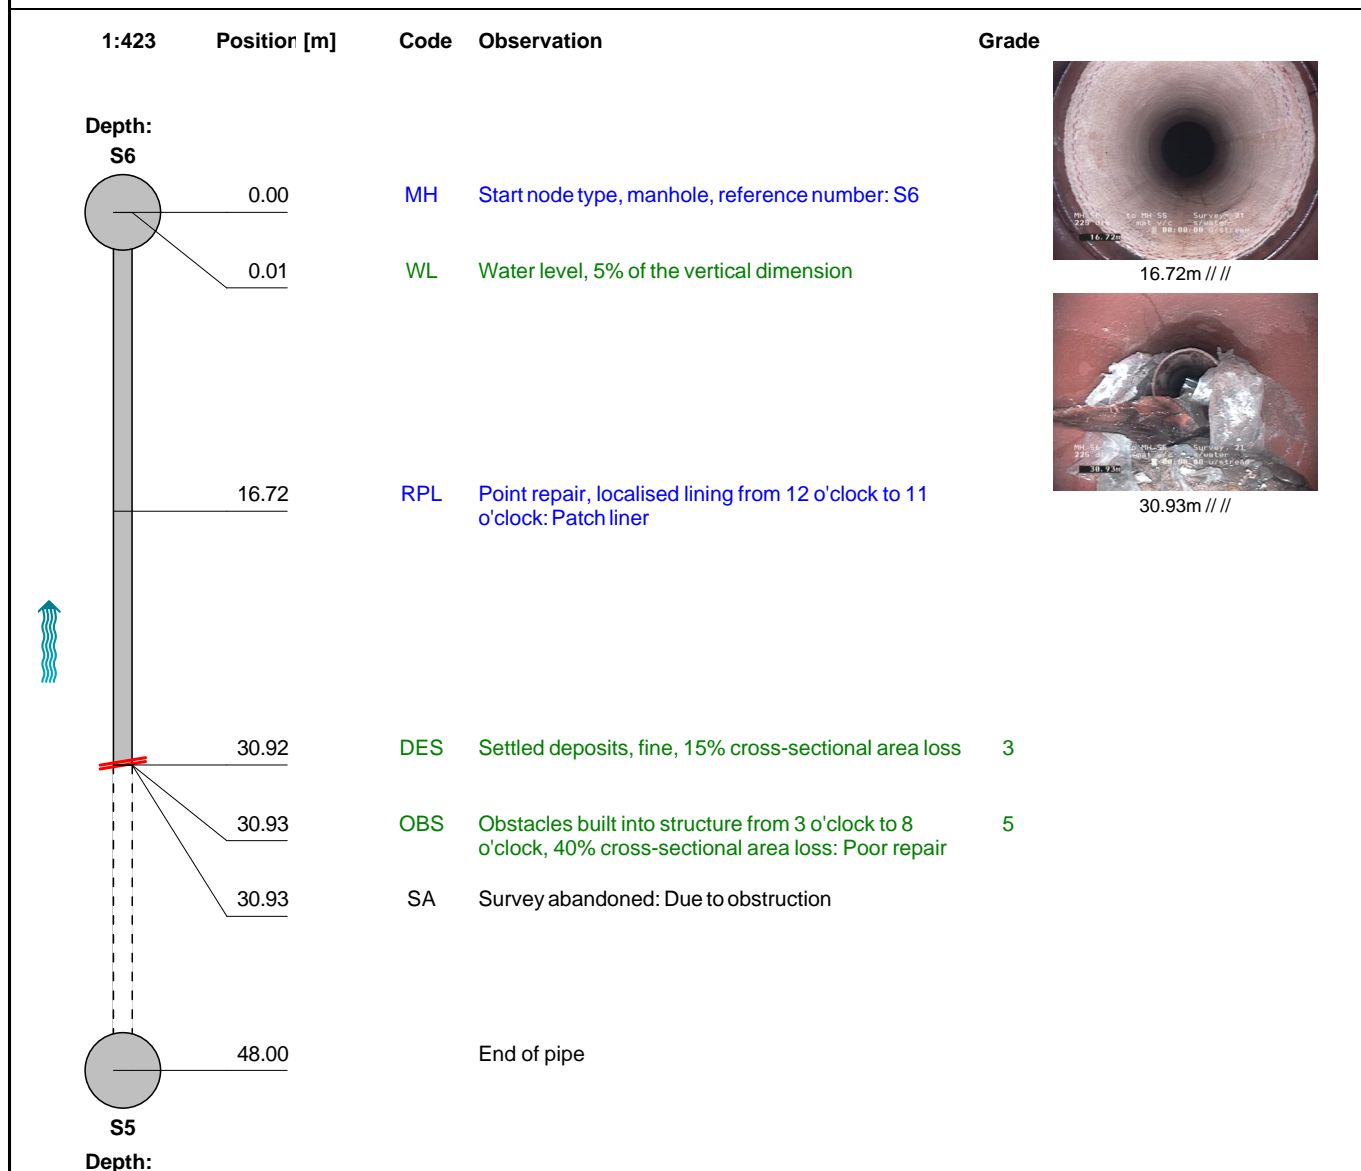
Section Pictures - 8/21/2019 - S5X

S5X_07b4e33c-280a-48a8-8a40-a63b7ba0fc5b_20190831_154800_512.jpg, 16.72m
Point repair, localised lining from 12 o'clock to 11 o'clock

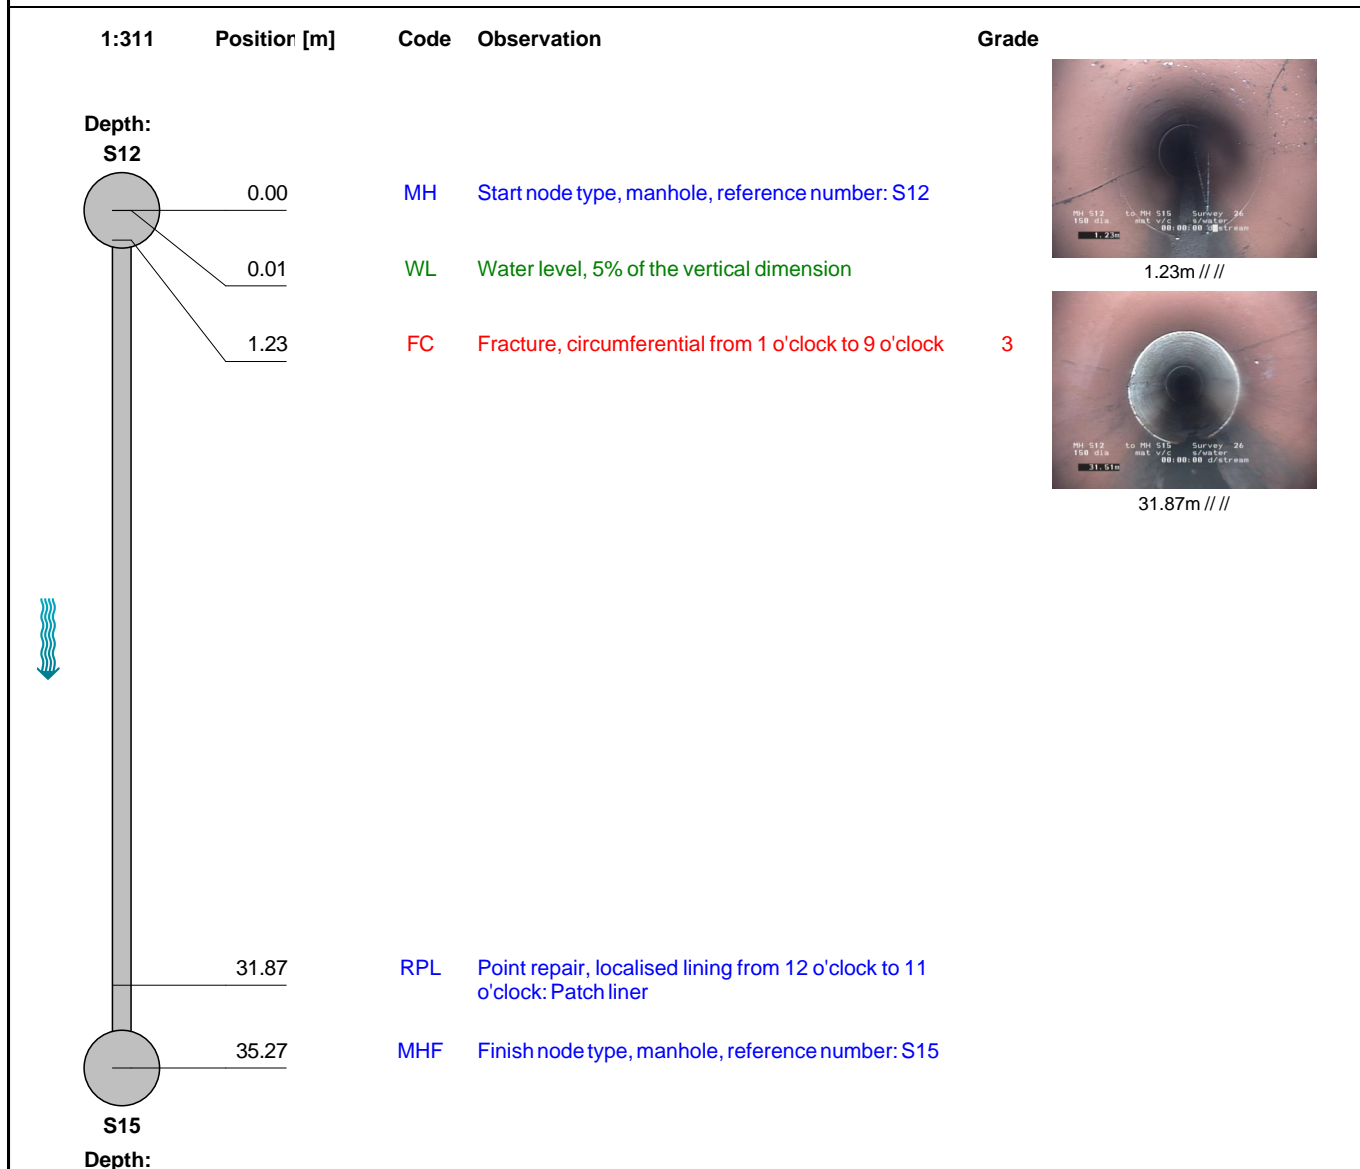
Section Pictures - 8/21/2019 - S12X

S12X_50c434ec-2dba-482b-9d2c-ca77962d7113_20190831_155227_638.jpg, , 1.23m
Fracture, circumferential from 1 o'clock to 9 o'clock

S12X_6b652c16-f3ac-4c81-866a-854d12ce5751_20190831_155341_367.jpg, , 31.87m
Point repair, localised lining from 12 o'clock to 11 o'clock
