**MOSTYN MANUFACTURING SITE**  
**Groundwater Analysis Report**  
**February 2020**

P. J. Bryant. HSES Manager  
18<sup>th</sup> February 2020

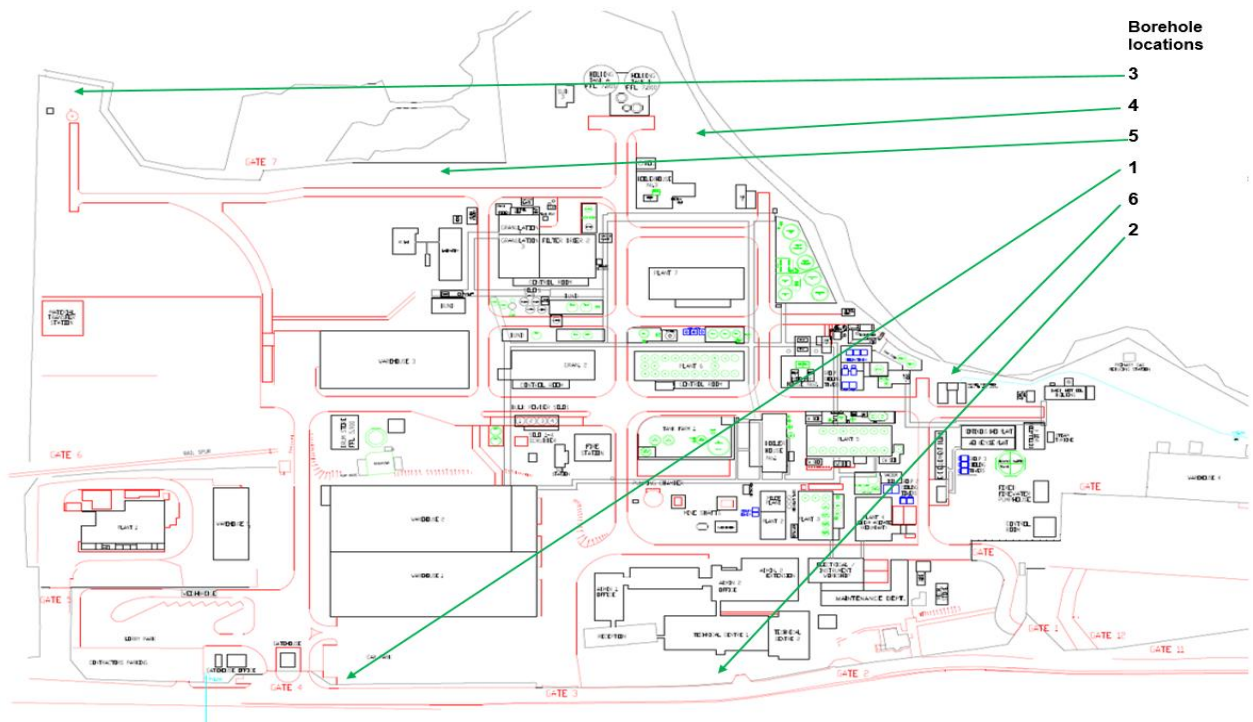
The pH of the groundwater in all six boreholes has remained fairly constant over the last seven years. Changes in the pH can mobilise metals within the surrounding areas but this does not appear to have happened to any extent. In June 2018 there has been a minor increase in the copper levels in borehole 3 (0.8mg/l to 15mg/l) when the pH fell by one unit. However, the high level of copper in borehole 3 in 2016 did not appear to have been affected by any pH change.
