**This form will report compliance with your permit as determined by an NRW officer**

Site	Trostre Works	Permit Ref	BX9471IU
Operator/Permit holder	Tata Steel UK limited		
Regime	Installation		
Date of assessment	13 <sup>th</sup> February 2020		
Assessment type	Inspection		
Parts of the permit assessed	See section 2		
Lead officer's name	Neil Herbert	Accompanied by	Ieuan Davies
Recipient's name/position	Darryl Lewis – Environment & Energy Manager	Date issued	5 <sup>th</sup> May 2020

This visit was arranged primarily to assess progress with the investigations<sup>1</sup> into the effluent flume works and surface water contamination (Surface Water – east system (w2)).

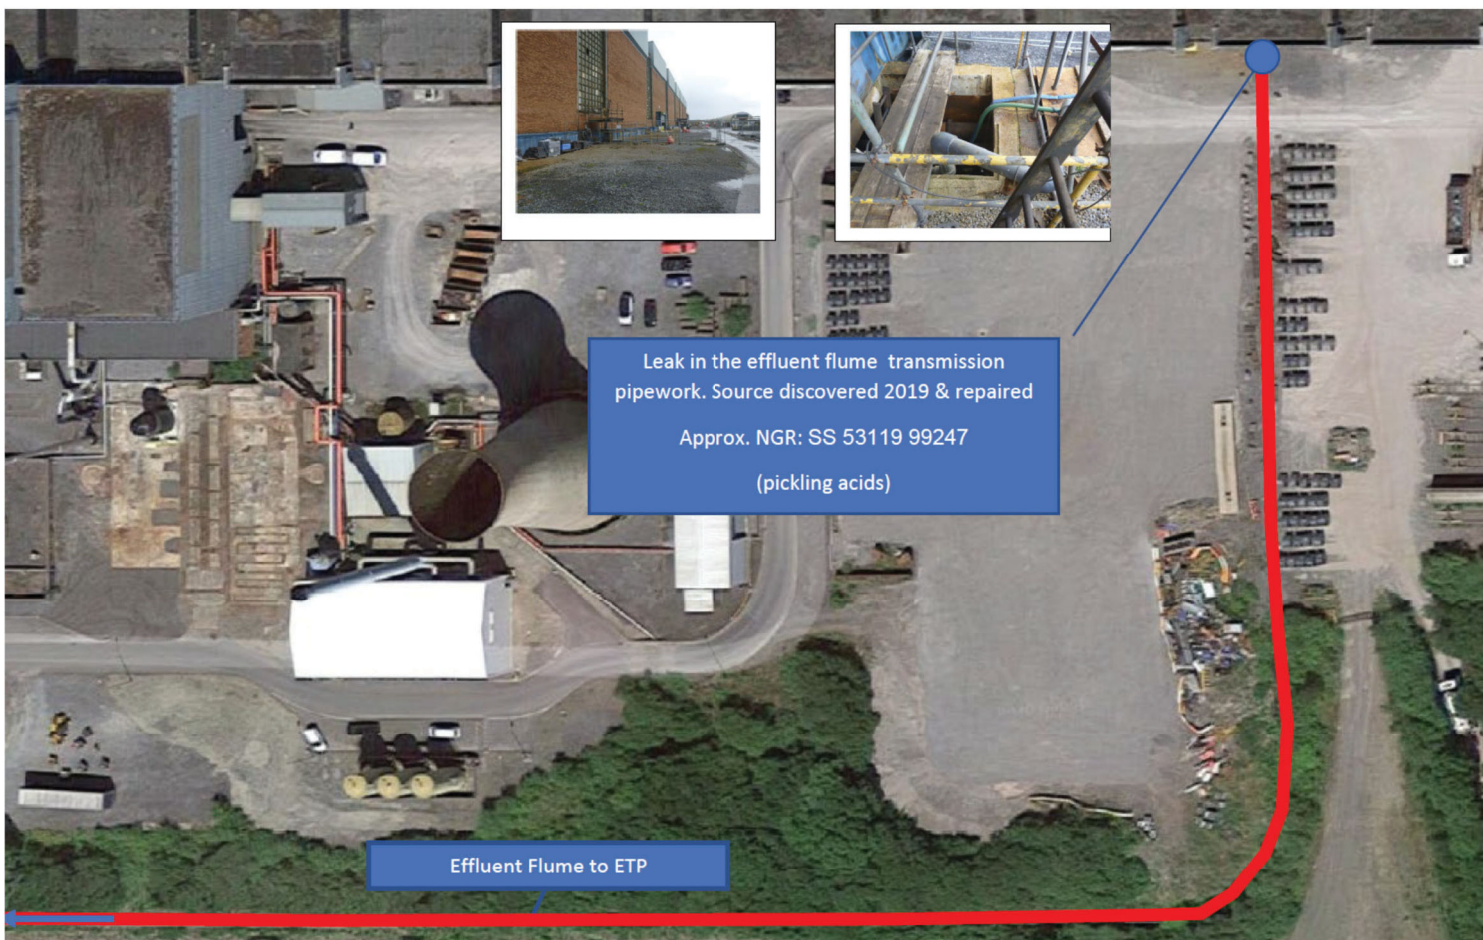
- Effluent Pipe Leak (near BHA)

Since the submission of the 2019 report, TATA's Energy and Environment Department have undertaken investigations into the elevated levels of iron they found near BHA. Additional boreholes were installed during 2019 to assist the investigation. TATA now believe that the source of the contamination has been identified (and rectified). Their investigations revealed a leak in the buried effluent transmission pipe (from the pickling line). The leak was discovered in the pipe as it emerges from the main building and then links up to the buried effluent flume at (approx.) SS 53119 99247. A temporary repair was completed immediately in 2019 and Tata have since started work to undertake a permanent repair, although the work has proven problematic as the structures are encased in thick concrete and space is limited.
