## **MORFA LANDFILL RECHARGE TRENCH**

### **Review of Progress**

*Report Number 2040r1v1d1020*

**October 2020**

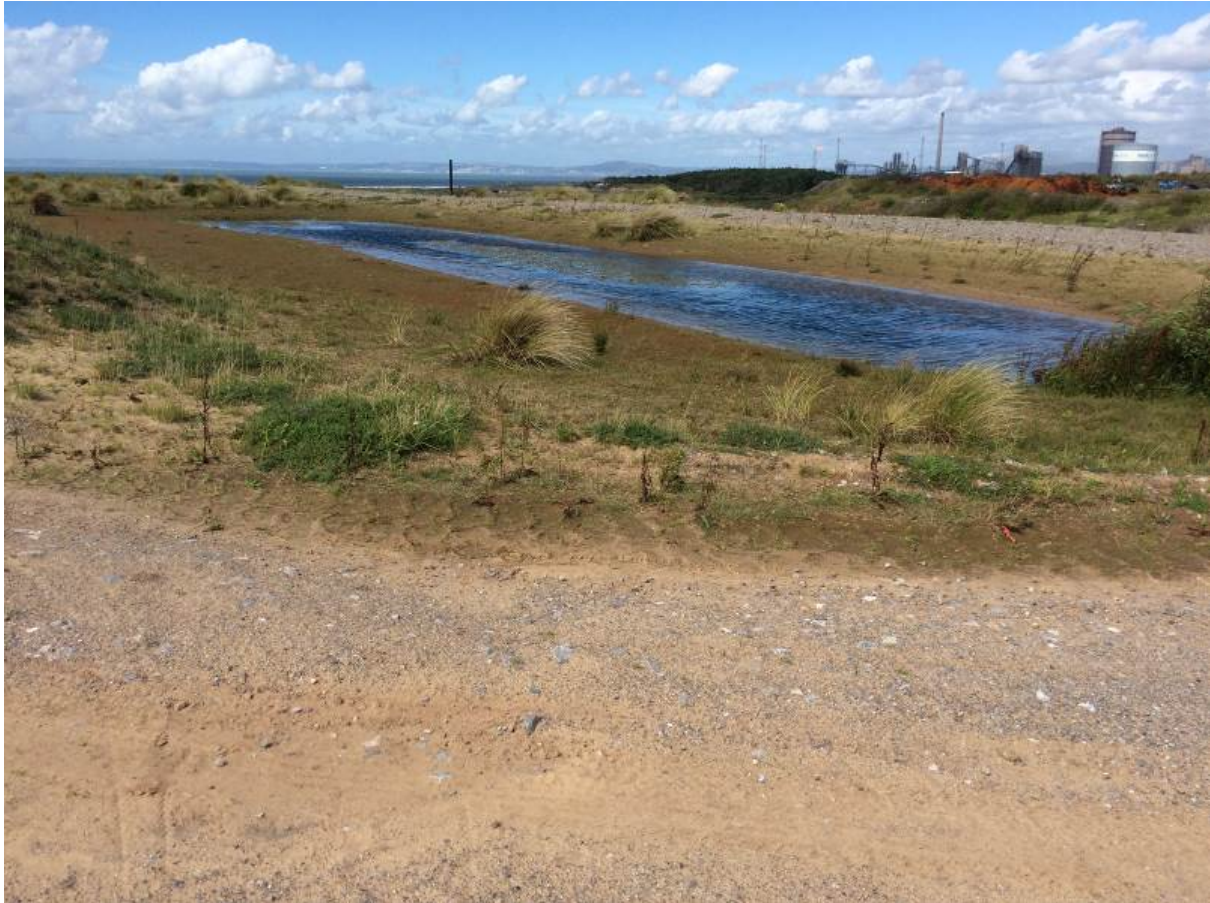
**Plate 4-1 Typical restoration profile on surface of MCL**

Restoration of unlined MCL was completed in phases between 2004 and 2013. The restoration involved the placement of site won dune sand over the plateau and parts of the re-profiled slopes. Below the sand, the restoration scheme involved placement of geomembranes which, in combination, provide gas and surface water management as well as providing barriers to precipitation ingress and gas egress. The sympathetic restoration also involves the placement of sand on top of the geomembranes, creating dune morphology like the surrounding land. Rainwater falling onto the restoration surface infiltrates through the restoration sand layer, encountered the geomembranes and then drains to the ponds shown on Figure 5 and Plate 4-1. The restoration scheme has been complete since 2013 and subject to ongoing maintenance and aftercare.

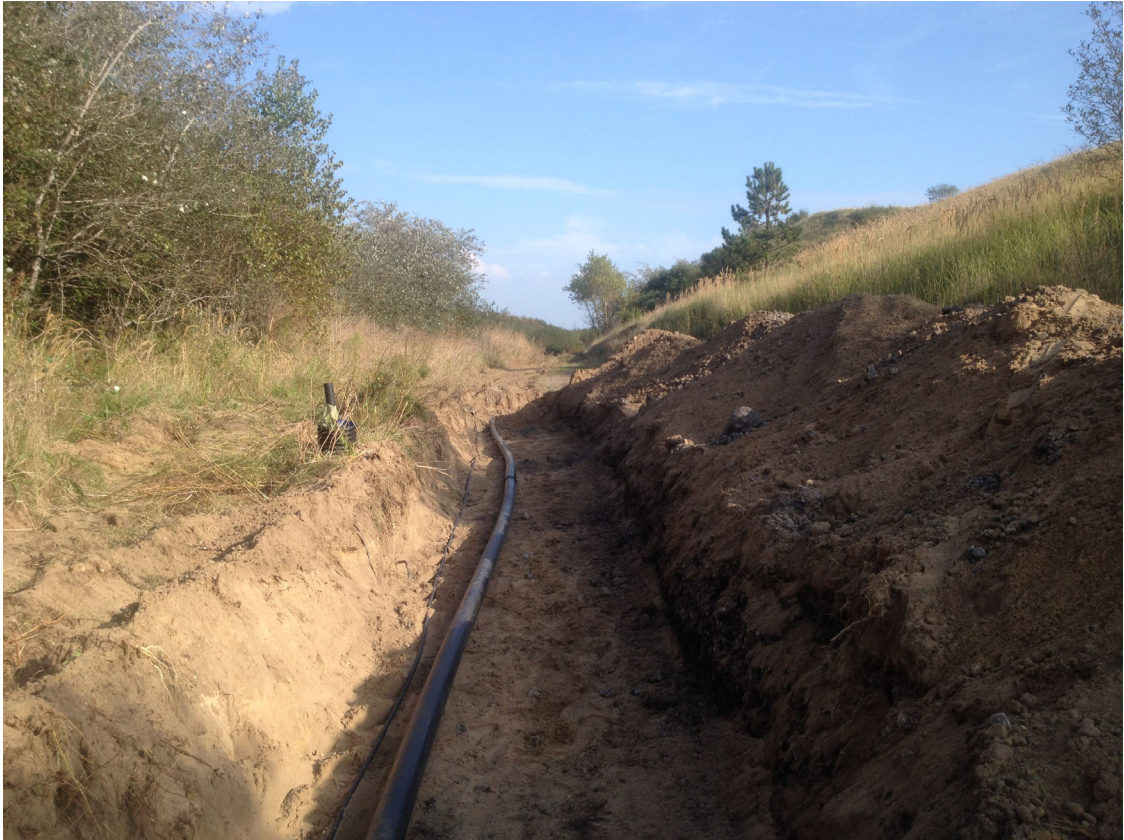
**Plate 4-2 Pipework in trench along toe of MCL**

Recharge trenches A and B were constructed at the toe of the northeastern edge of MCL in August and September 2102. The pipe and cable trenches, pipe and chamber placement together with geomembrane remediation works was completed during November 2014. Photographs of some elements of the work are provided in Plates 4-2 to 4-5.

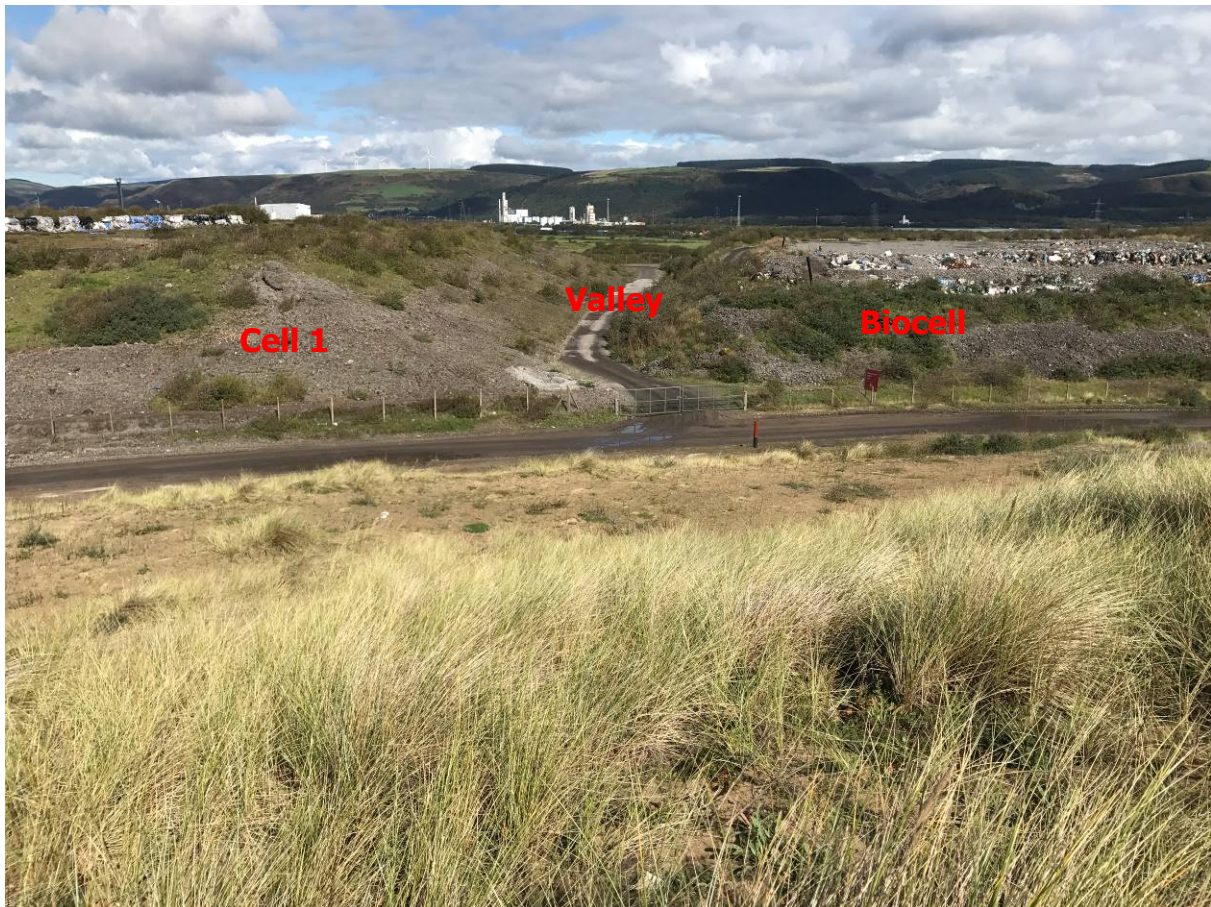
**Plate 4-7 View north towards Non-hazardous Cell 1, valley feature and Biocell**

The existing Biocell is separated from non-hazardous Cell 1 by a deep narrow valley where the opposing south flank of Cell 1 meets the north flank of the Biocell, as shown in Plate 4-7. The approved restoration contours for the landfill, shown in Figure 5, require that this valley is infilled to produce a single elevated landform. To secure additional biodegradable void space, NRW has approved a cut into the upper part of the southern flank of Cell 1 and extension of the biodegradable waste cell lining system into the void to provide sufficient biodegradable waste capacity to 2028. Once the new cell area is available for waste disposal, the completed areas of the Biocell must then be restored by December 2021.
