**MORFA NON-  
HAZARDOUS LANDFILL,  
PORT TALBOT**

**PERMIT BV7311IE**

**2020 Annual Review of  
Environmental  
Monitoring**

*Report Number 2092r1v1d0221*

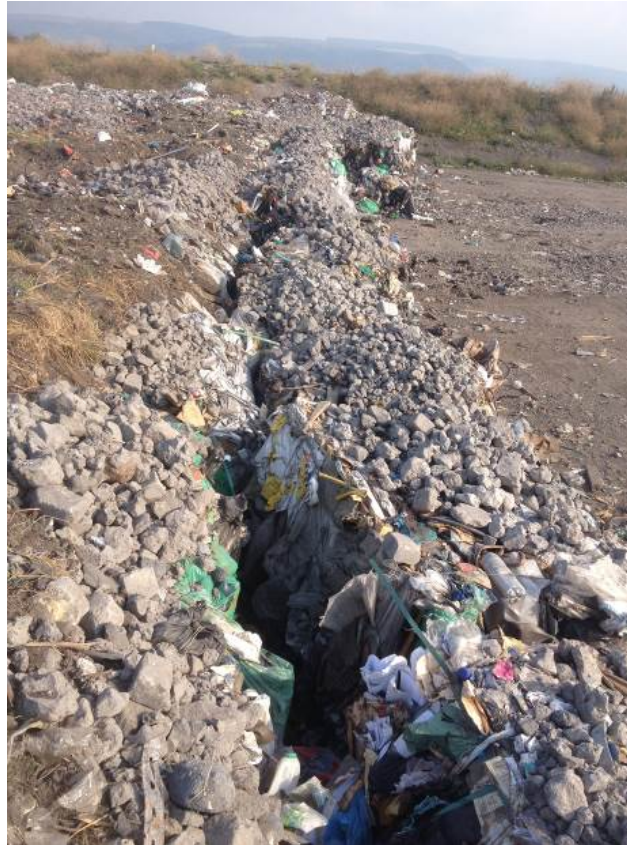
The integrity of the internal gas monitoring wells in bio-cells A and B is inspected monthly. There are no problems with this aspect of the monitoring network although the vents, which are open to the atmosphere, are not designed for monitoring. Consequently, the data gathered to date has been influenced by atmospheric processes and dilution. Some monitoring points in the bio-cell are also difficult / impossible to safely access due to dense growth of buddleia and because the bales are sometimes separated by large gaps. Consequently, not all wells can be routinely safely accessed.

**Plate 4-1 Gaps between bales in bio cell**

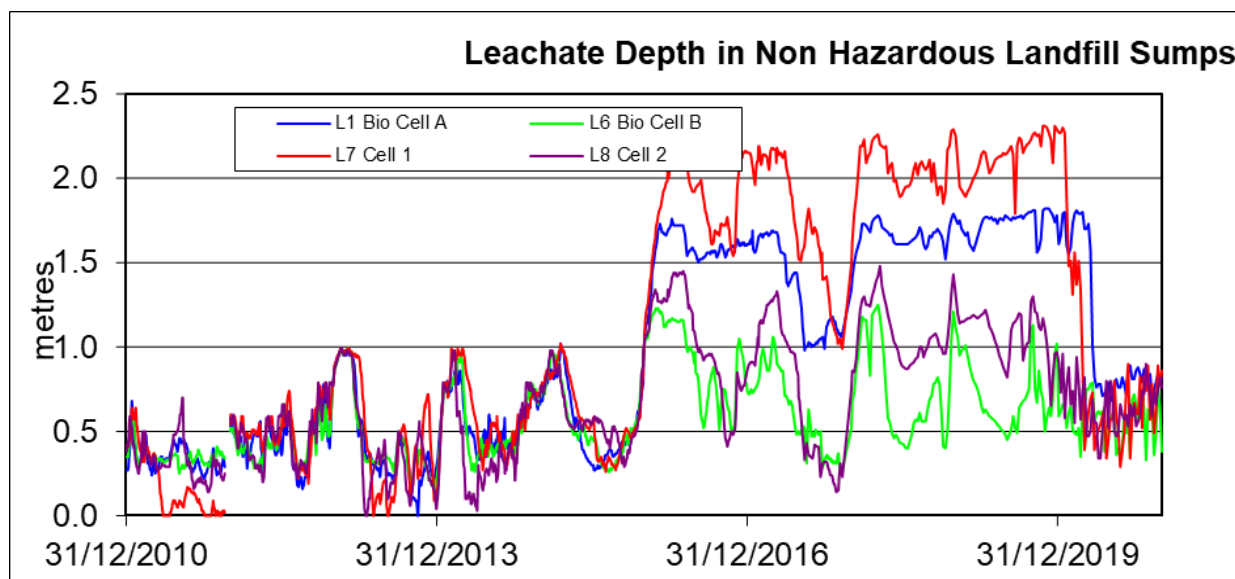
Based on the monitoring results provided by the landfill operator, the variation of leachate levels above the base of the sump is fully illustrated in Appendix 3 and summarised in Chart 8-1. The monitoring reveals that leachate levels exceeded 0.75m above the concrete slab in the winter periods of 2013, 2014 and 2015. Between 2016 and winter 2019, the leachate levels regularly breached the compliance 1.0m level which means that this aspect was not in accordance with the Permit requirements.

**Chart 8-1 Leachate levels**

Since early 2020, the new leachate management system has had a dramatic influence on leachate levels with significant leachate level reductions in all cells. This step change is a direct consequence of the new system enabling the volume of leachate extracted to be significantly increased. This has enabled the landfill to be compliant with the 1.0m leachate level compliance limit set in the Permit.

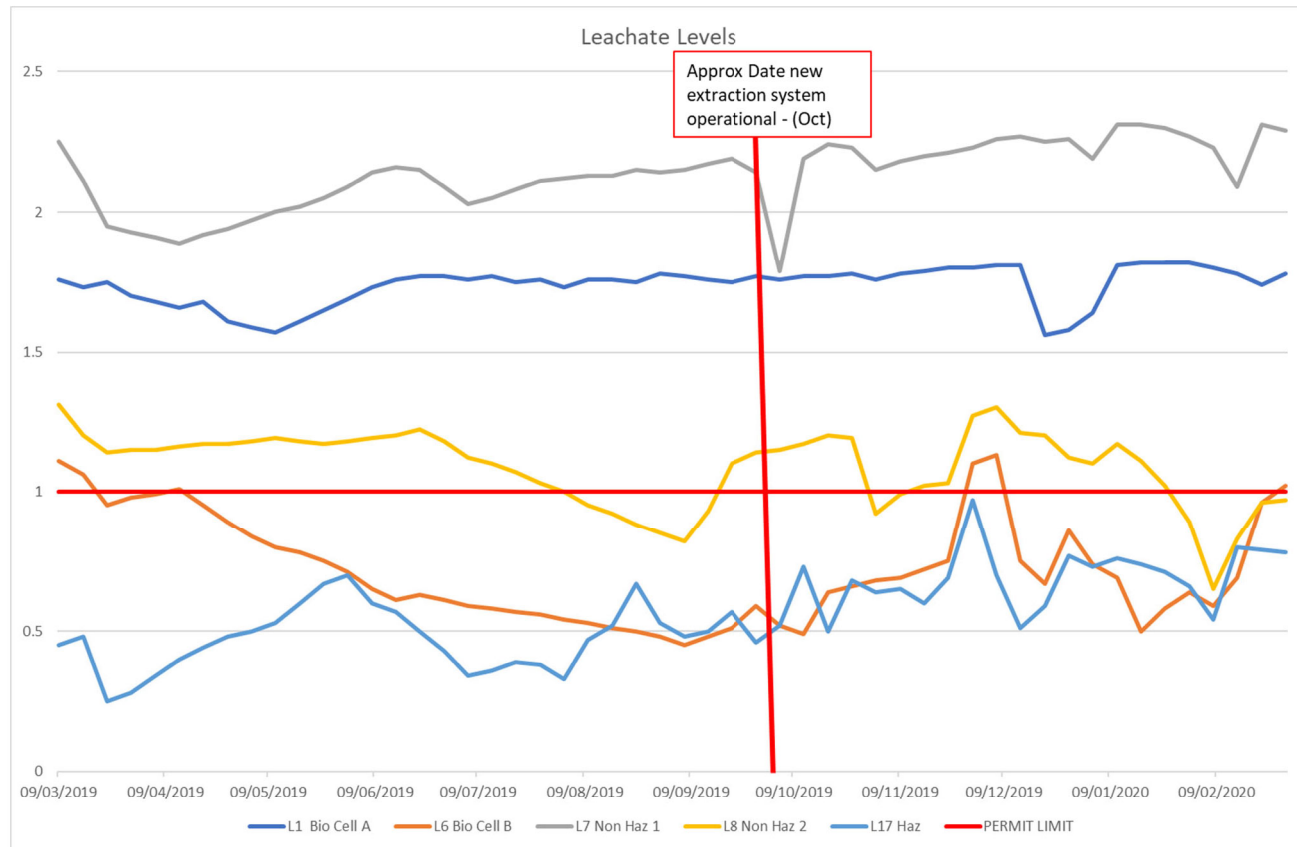
The failure to maintain leachate levels (during the Q4 monitoring period) in accordance with the limits set in the permit are a breach of conditions 2.8.1 and 3.1.2 of your permit. Compliance classification scores (ccs) of 3 will be allocated against the a1 compliance heading. In accordance with ccs scoring guidance the reported permit breaches applicable to these points have been consolidated into **one** score, covering the **Q4** reporting period i.e. one ccs score of 3 will be allocated to the breaches that occurred at these points, over the Oct to Dec (2019) reporting period.

Leachate management comment: The operator have built and commissioned a new leachate extraction system, which we have been informed started operation in early October 2019. It is understood that not all cells are pumped continuously but pumping is on a rotational basis. The following graph shows the leachate levels for 2019 (and early 2020) within the landfill cells, against the compliance limit of 1m.

A recent permit variation also included a new improvement condition requiring the capping of the bio cells – this will need to be completed by Dec 2021. It is expected that a CQA plan for the capping works will be submitted this year. The operator will need to update their leachate level action plan **Action**.

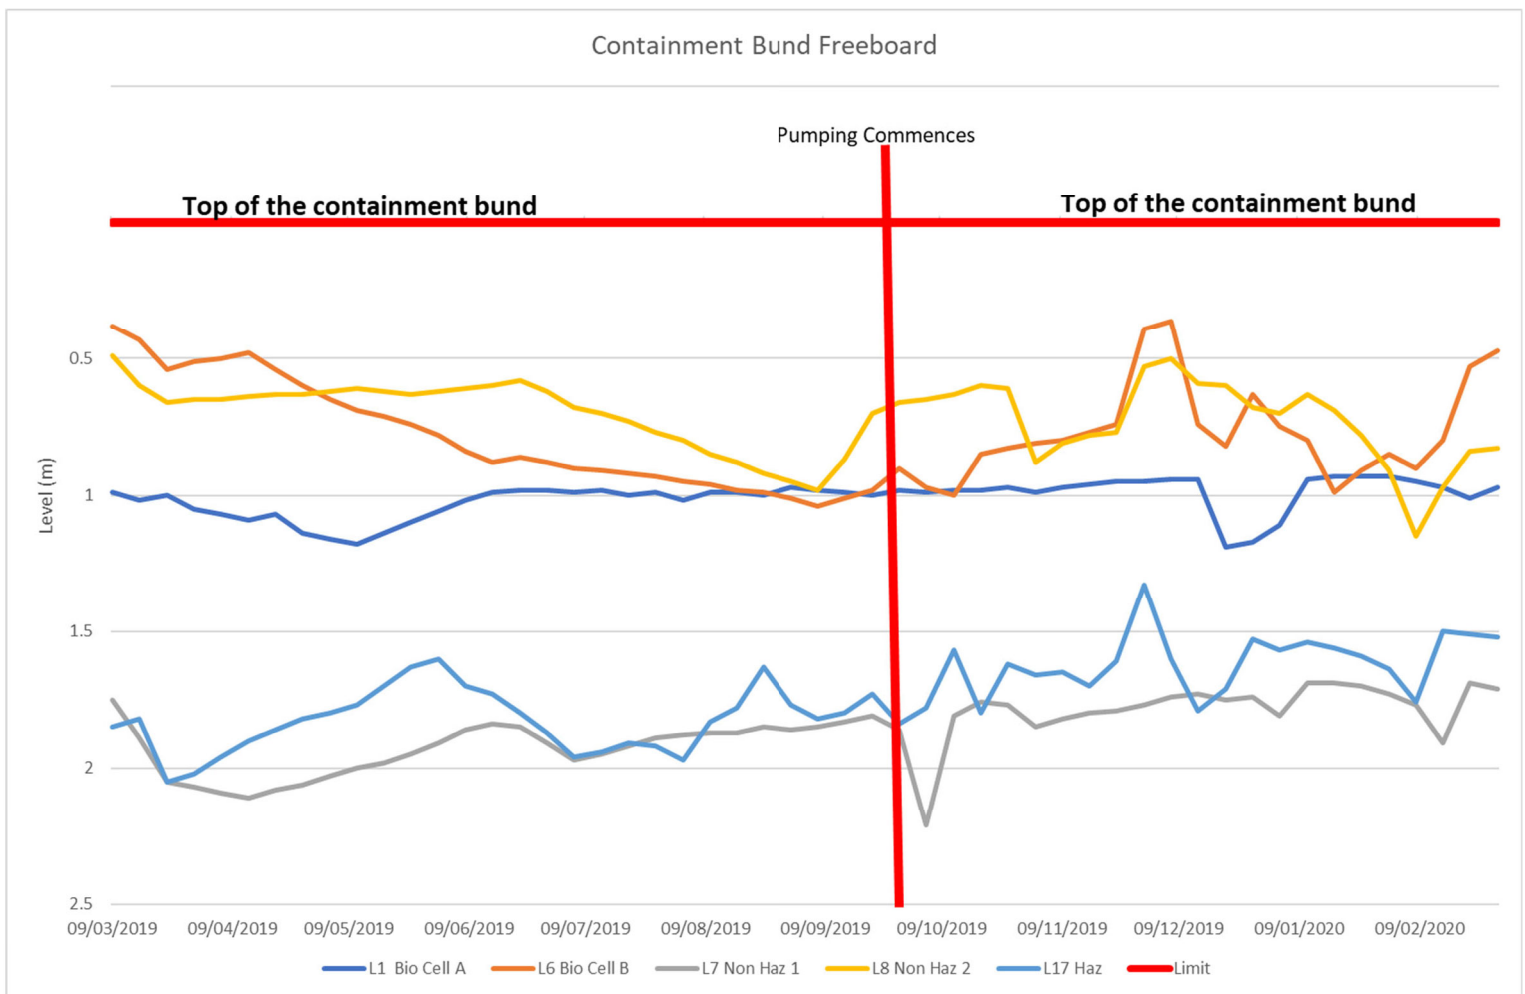
Progress with leachate management control is difficult to assess as the new leachate extraction system only commenced in October 2019 and heavy rainfall over the winter makes an assessment difficult. Based on the data submitted there is no evidence to indicate that the containment bund was over-topped in any of the cells due to elevated leachate levels (see graph below). However, in December the level in bio-cell B was within 36cm of overtopping the containment bund. A smaller spike was also seen in February 2020. It is critical TATA continue to implement their emergency measures to maintain and manage the elevated leachate levels to ensure the containment of leachate. These measures need to be reviewed in light of this winter's experiences to ensure that there is no containment failure whilst the site is attempting to bring the leachate levels back into control. NRW have inserted a new improvement condition into the site's permit that will require the capping of most of the bio-cells to be completed by December 2021. It should be noted that NRW reserve the right to require<sup>5</sup> interim measures (e.g. temporary capping etc.) sooner if there is evidence that the current interim controls are not adequate to maintain leachate containment. The operator need to review and update their leachate level action plan.
