Appendix C: Geomorphology Photo Survey (3rd November 2020)

Table C-1 Geomorphology Photo Survey

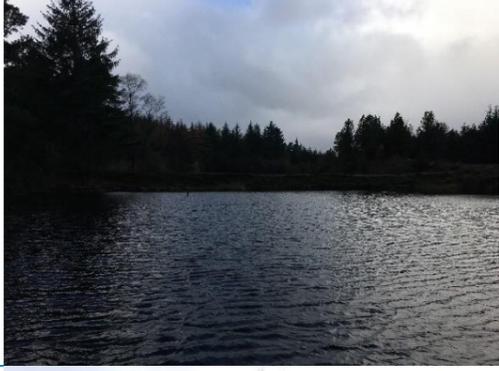
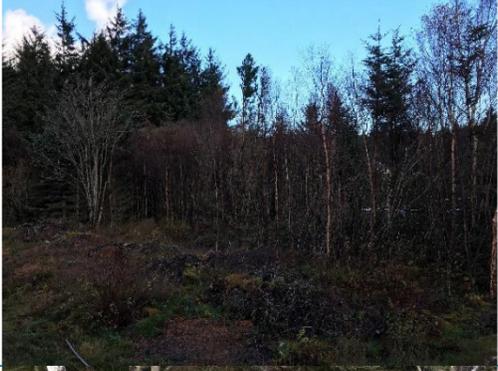
Photo not available

<ul style="list-style-type: none"> • See observations in Location 1.
3 – Pen y Gwaith Reservoir – Temporary Spillway	///lordship.founders.back

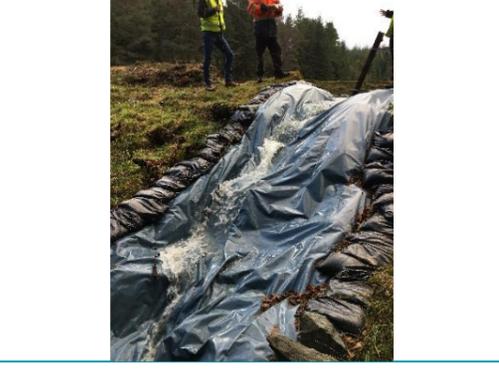
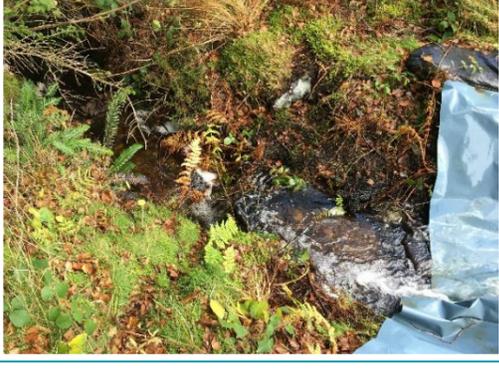
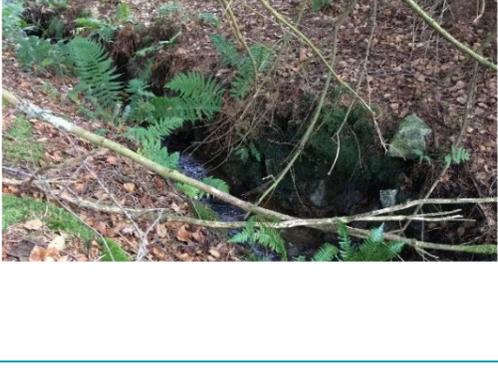
4 - Watercourse – Temporary Spillway	///jetliner.civil.chatted

<ul style="list-style-type: none"> • The temporary spillway erected on the North East Dam appeared in relatively good condition with some minor scour noted at the base of the temporary spillway. • The dam was also vegetated and spongy underfoot in this location.

<ul style="list-style-type: none"> • See observations in Location 3.

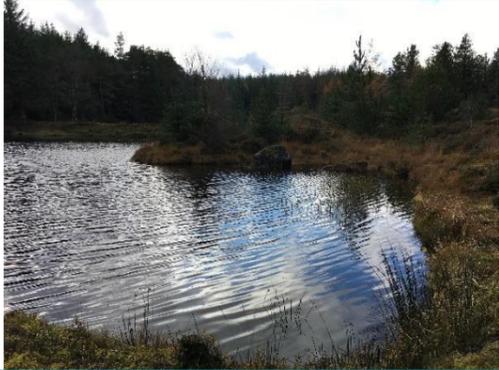
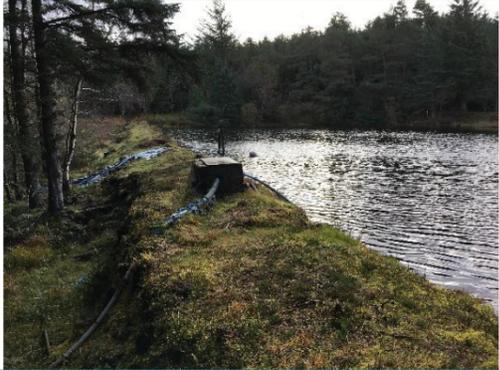
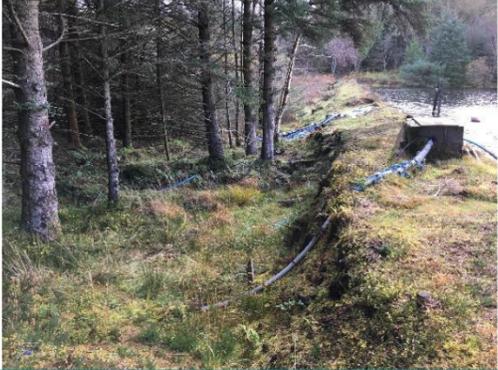
Location and Description	what3words reference	Orientation of Photo			Observations
		Upstream	Cross-Stream	Downstream	
5 – Pen y Gwaith Reservoir – North East Dam	///corrode.looks.throw

<ul style="list-style-type: none"> • See observations in Location 3.
6 – Pen y Gwaith – Embankment B	///mothering.scaffold.declines

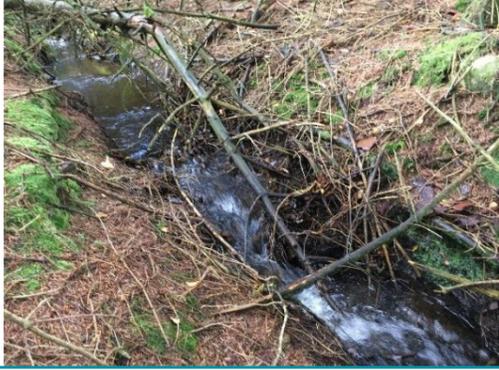
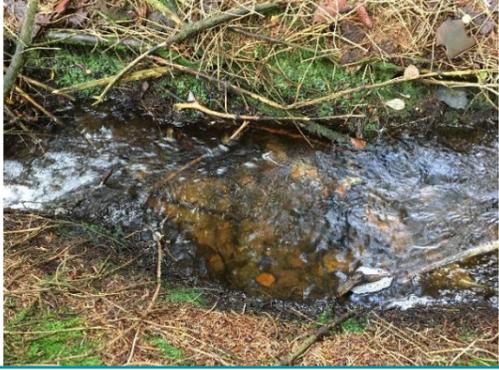
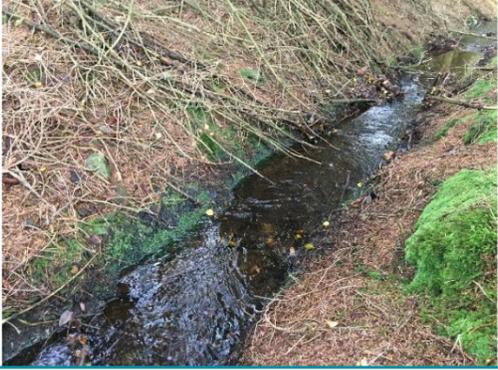
12 – Watercourse – downstream of access track	//pairings.congested.refills

<ul style="list-style-type: none"> • The channel was ~1m wide in this location and appeared incised in comparison to the upper sections of the watercourse. • Channel planform exhibited as unnaturally straight with evidence of bank resectioning and embanked. • Fallen trees encouraging step pool sequences. • Disturbance of the bed suggested the presence of an armoured gravel layer protecting a layer of finer material. • The watercourse was heavily shaded by mature trees and challenging to access through trees.

<ul style="list-style-type: none"> • See observations in Location 11.

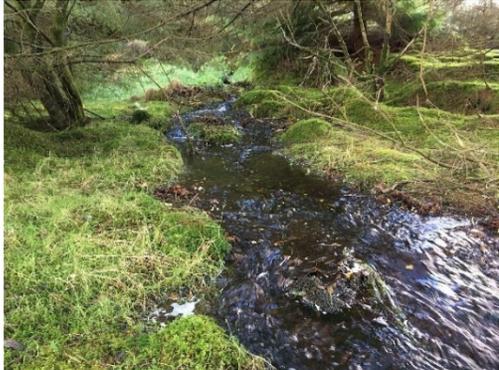
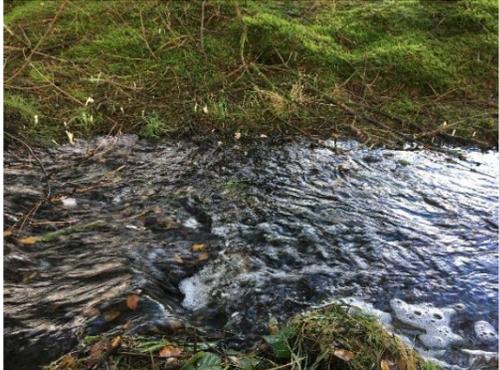
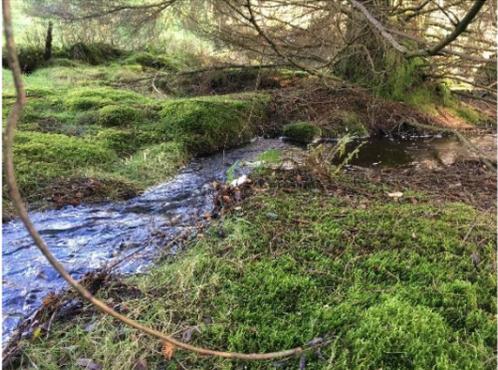
Location and Description	what3words reference	Orientation of Photo			Observations
		Upstream	Cross-Stream	Downstream	
13 – Watercourse – upstream of mine spoil heaps and structure	///rules.ozone.rash

<ul style="list-style-type: none"> The channel widened to ~1.5m at bankfull in this location above a weir structure. The cross-section was wide and shallow with a few small boulders exposed. Evidence of bank modification was less evident in this location. The watercourse was heavily shaded by mature trees and challenging to access through trees.
14 – Watercourse – near mine spoil heaps and weir structure	///agency.squred.gender

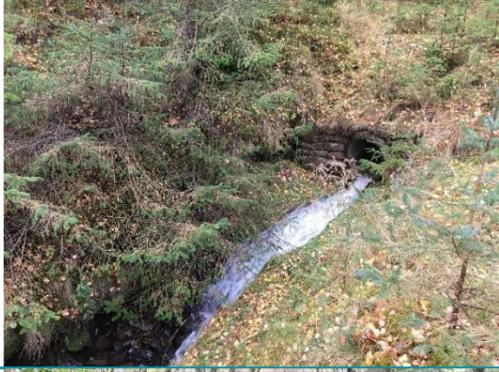
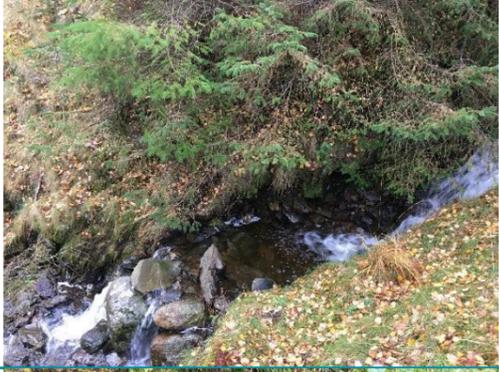
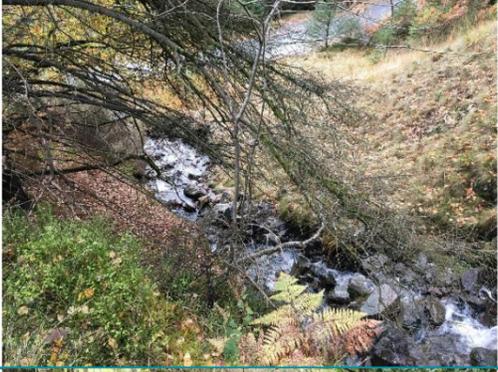
<ul style="list-style-type: none"> See observations for Location 21.
22 - Concrete lined channel	//lined.corporate.flotation
