## Newport Transporter Bridge – ECI Survey Works Report.

## The scope of the ECI Survey works are as follows:

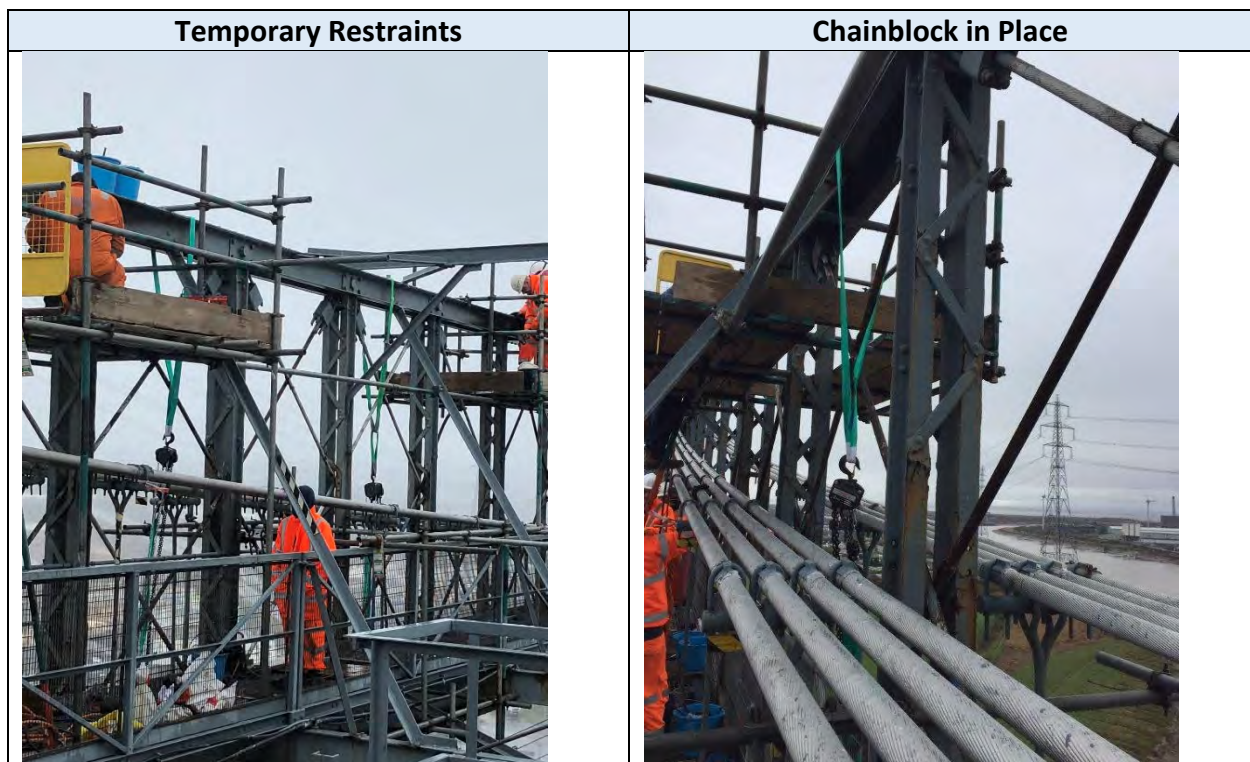
The removal of the existing Diagonal Bracing Cables and associated pins could cause localised effects as the Top and Bottom Chord will naturally want to separate as items are removed.

In order to negate as much of this movement as possible, we installed 4 No. temporary restraints, these were formed from 3t Web Slings slung around the Top and Bottom Chords and tensioned using 2t Chainblocks.

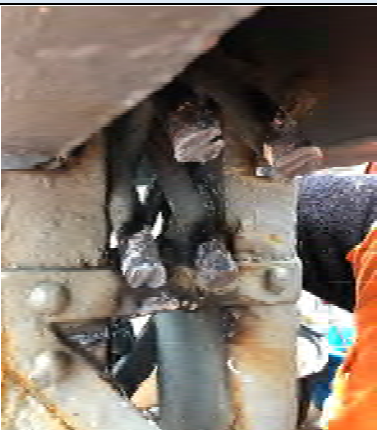
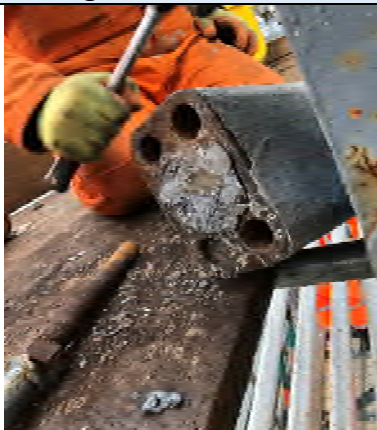
| Released U-Bars | Diagonal Cable Sockets |

The remnants of the U-Bars passing through the Cable Sockets are a lot more difficult to extract, as they appear to have been additionally fixed in place using either lead putty or a resin through the holes. Each Bar was forced out by hammering drifts through the apertures taking care not to damage the cast iron socket.

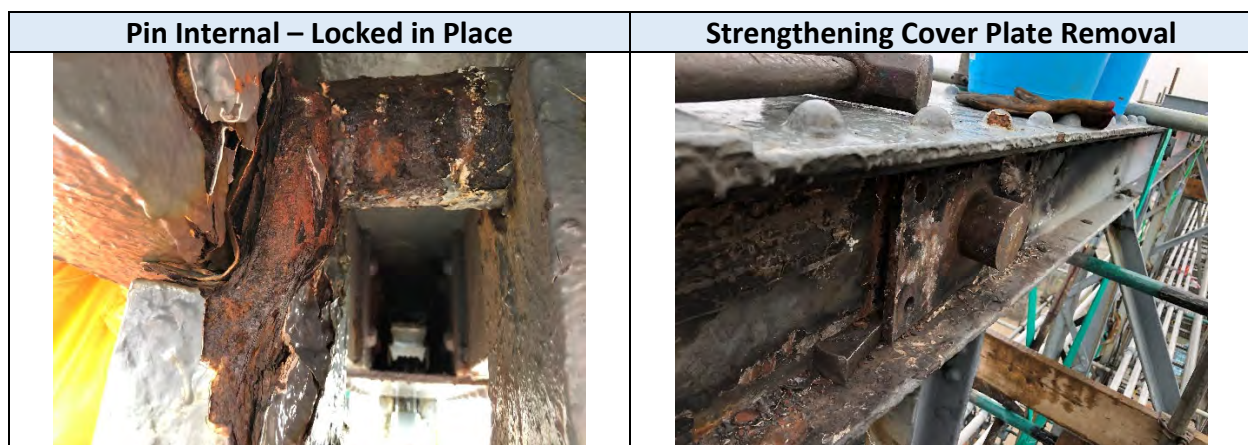
It became apparent through observation that the Vertical Primary Steelwork (VPS44) was transferring all the weight from the Bottom Chord directly onto the Pin Connection and therefore removal of the pin was unattainable without releasing the applied force.

In order to release the weight from the pin, we used a small 10t hydraulic bottle jack to drive the VPS down slightly.

Once we could confirm a nominal movement, we introduced steel wedges between the VPS and the Top Chord to maintain the gap prior to releasing the jack. This removed the applied load from the pin and allowed us to extract this by hammering it through the aperture.

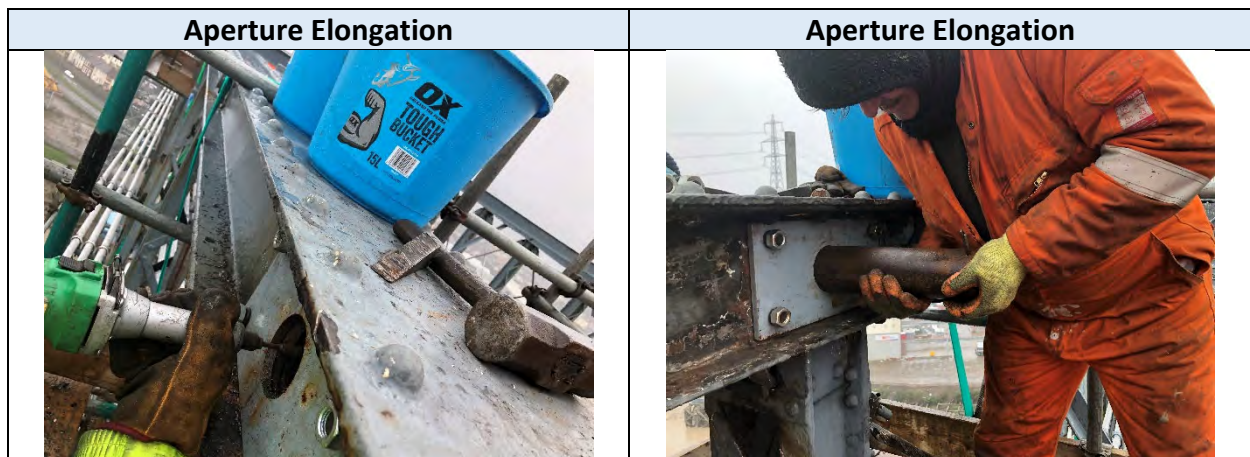
The periphery of the existing aperture was dressed using an acorn grinder to remove any stress fractures, prior to insertion of the new pin, which was easily slid in by hand.

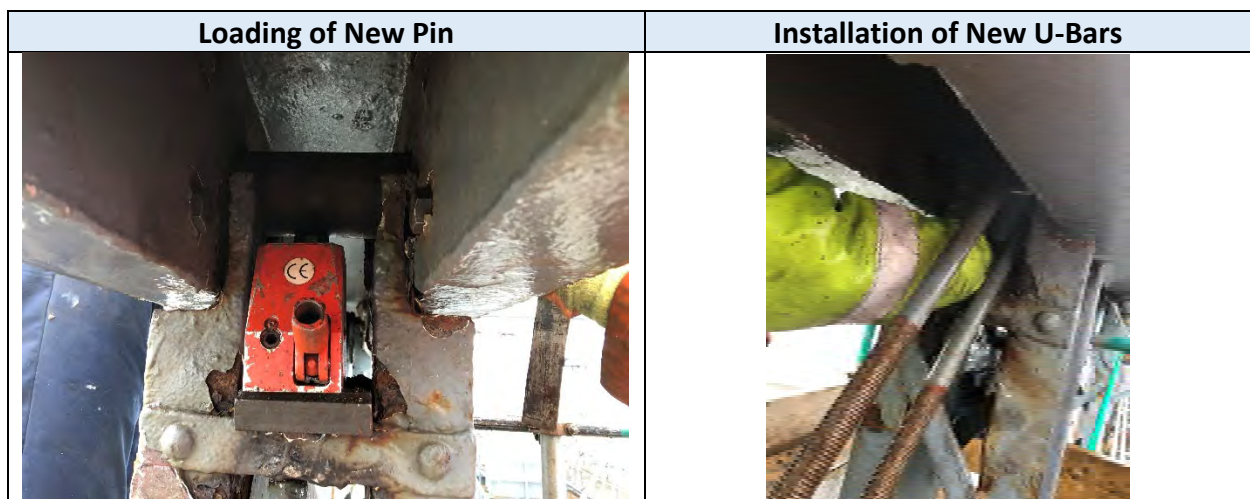
In order to load the pin, we inserted the jack again and pushed down the VPS to allow the removal of the wedges, prior to releasing the jack to load the pin. Once the jack was removed the Pin was secure and unable to be moved (even under force). The Split pins were then inserted and secured in place.

New Pin U-Bars could then be inserted to facilitate reconnection of DB77 and for the replacement of DB78.

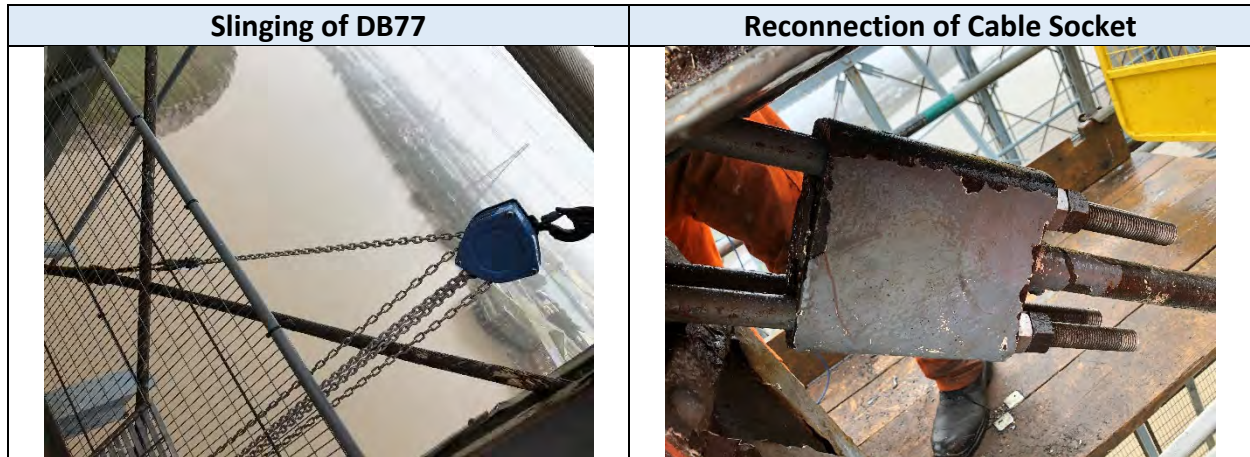
In order to re-connect the existing Diagonal Bracing Cable DB77, we had to install a sling and chain block arrangement, to pull the cable back into position as it had dropped on the lower Cable Socket.

Once retained back in position the new U-Bars could be thread through the Cable Socket and torqued back up.

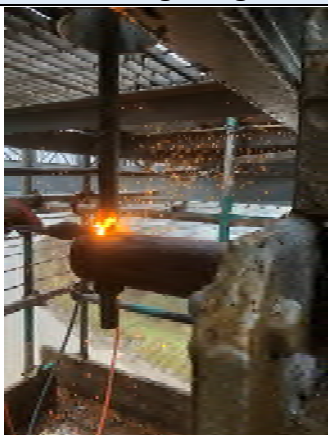
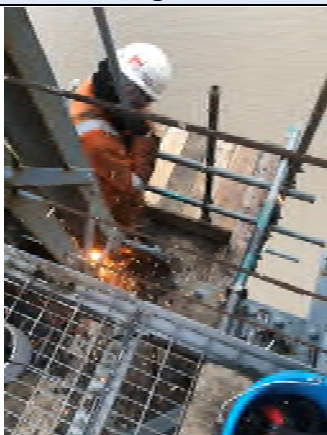
| Releasing Hangars | Burning Out Pin |

Due to the load imposed by the VPS it was apparent there was no means of releasing the Pin without using destructive techniques.

Therefore, the Bottom pin was burned into small sections to allow the small remnants to be forced out of the apertures.

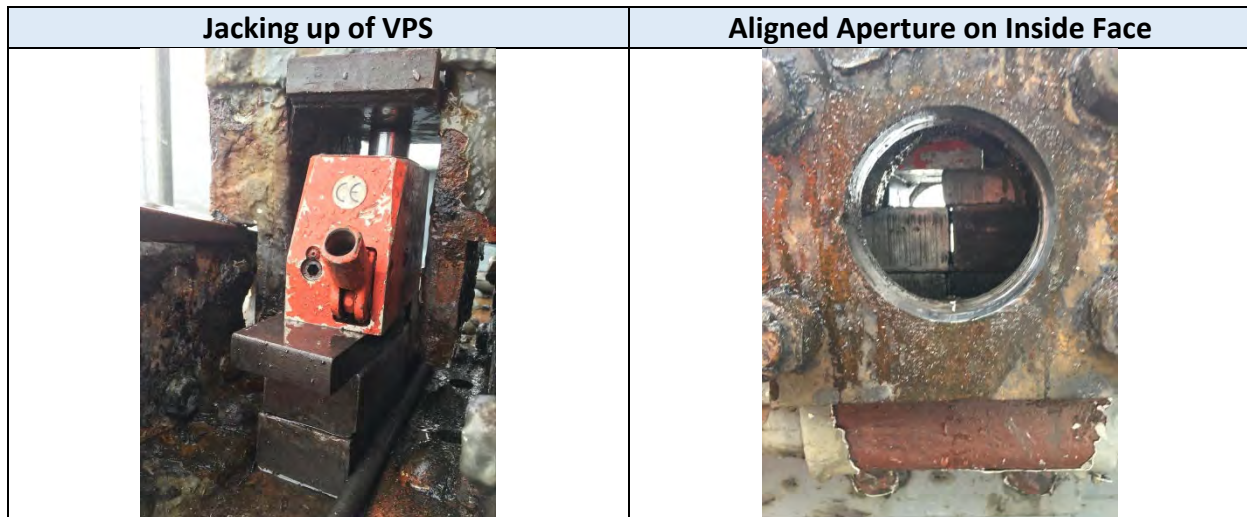
After cleaning the apertures, it became apparent the VPS had dropped slightly and therefore the insertion of the new Pin would not be possible.

Therefore, we used a small 10t hydraulic bottle jack to lift the VPS up slightly to re-align the apertures.
