| <b>Paint Inspection Ltd</b><br>61 High Street<br>Fareham<br>PO16 7BG | | <b>Client</b> | Curtins |
| <b>Project Name</b> | Newport Transporter Bridge | <b>Historical Information</b> | No |

## 1: Survey Details

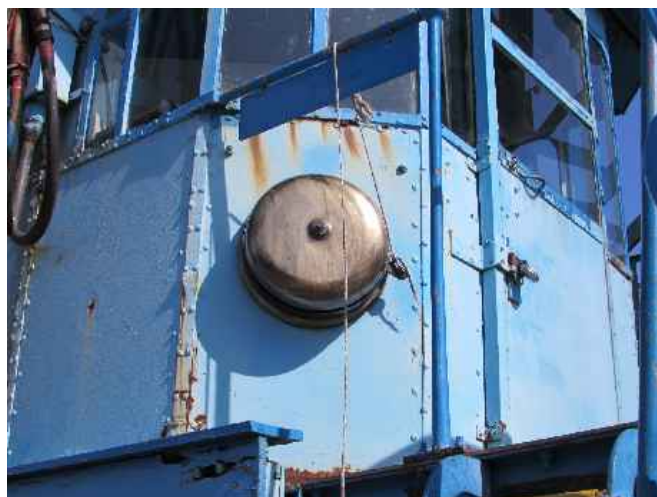
**Gondola Topside**  
Covered seating, deck plate showing coating delamination and flaking.

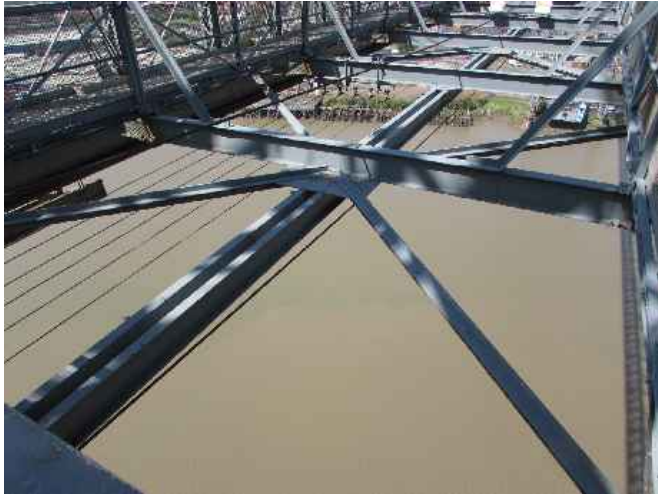
**Main Boom Traveller Steelwork**  
General overview of the Main boom steelwork.

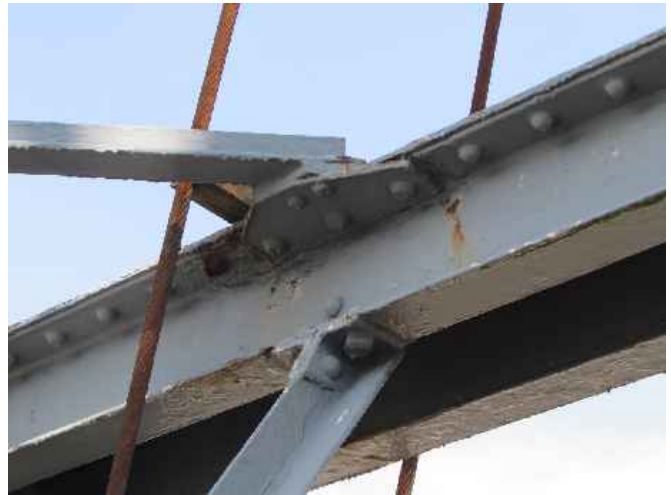
**Main Boom Vertical Steelwork**  
Corrosion and breakdown.

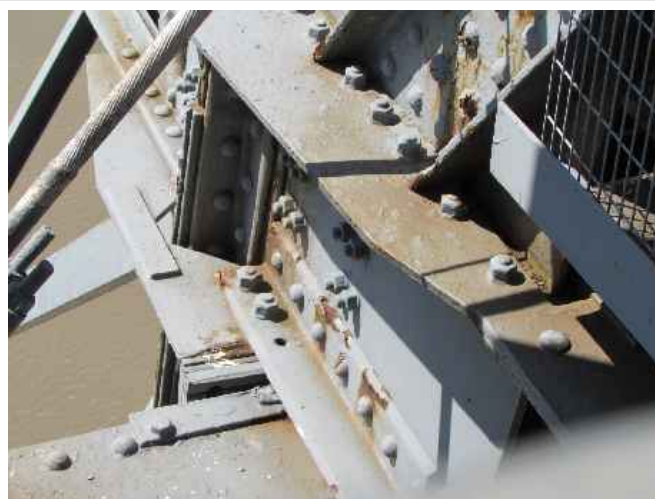
**Main Boom Primary Steelwork**  
Corrosion at interface between steel members.

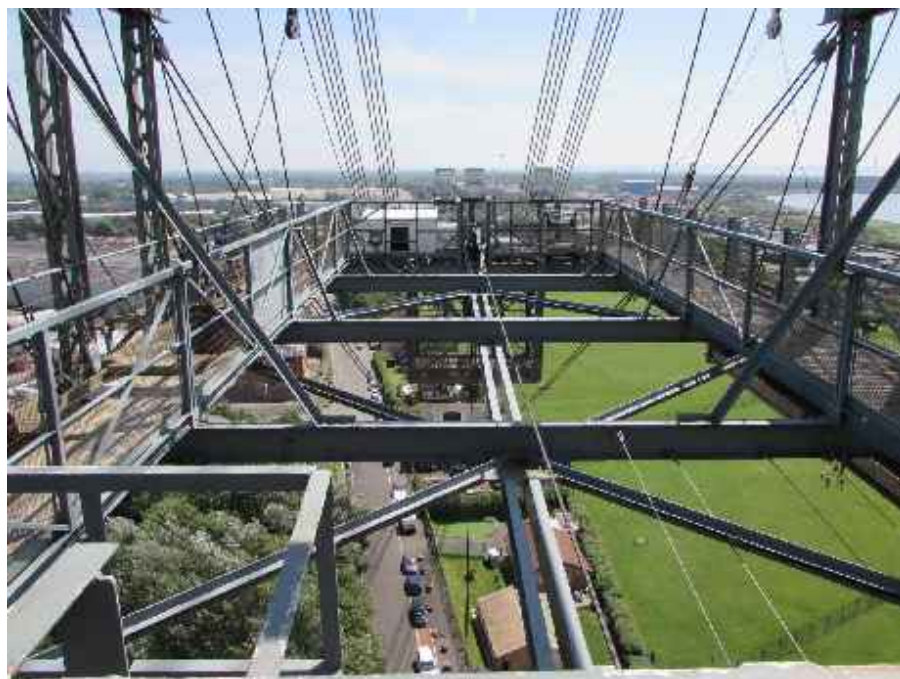
**Main Boom General view**  
*Photo taken: 24-07-2019*

Overall the assessment on corrosion levels to the Main Boom is up to 5% moderate corrosion. The corrosion and breakdown was mainly to edges, corners, fixings. Two paint thickness batches were taken, with average readings of 1143 and 1106microns and upto 5 paint layers identified in the samples taken and analysed. Two adhesion tests were carried out with one on the vertical member given a failure of 40psi and the second test giving a pressure reading of 543psi.

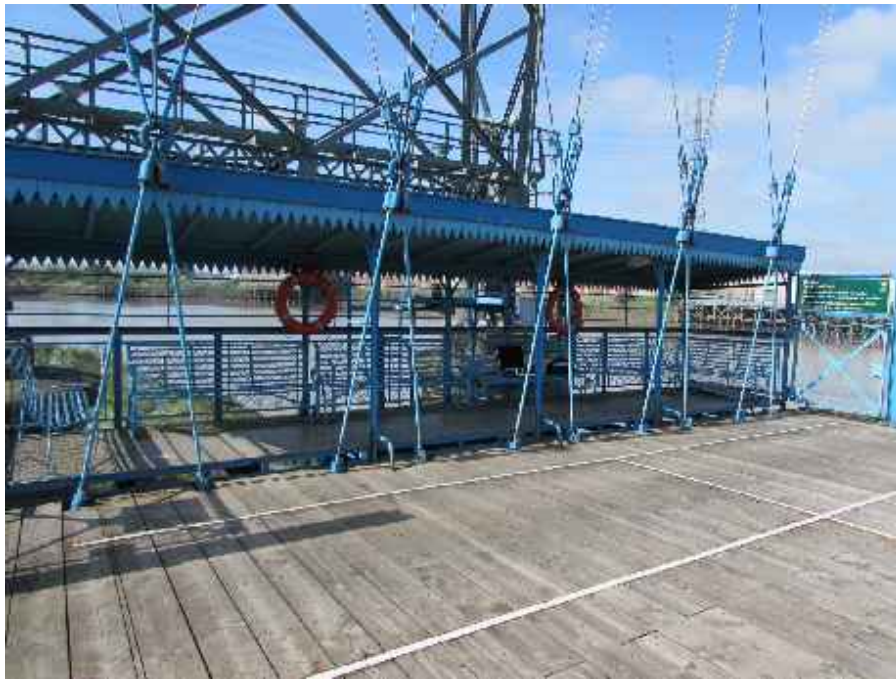
**Gondola Topside General view**  
*Photo taken: 24-07-2019*

The topside lattice steelwork has approx up to 25% corrosion, mainly moderate although heavy in places. The paint film thickness revealed an average of 424microns and up to 5 paint layers were identified in the sample taken and analysed. The adhesion values were good with pressure values of 772psi and 769psi.

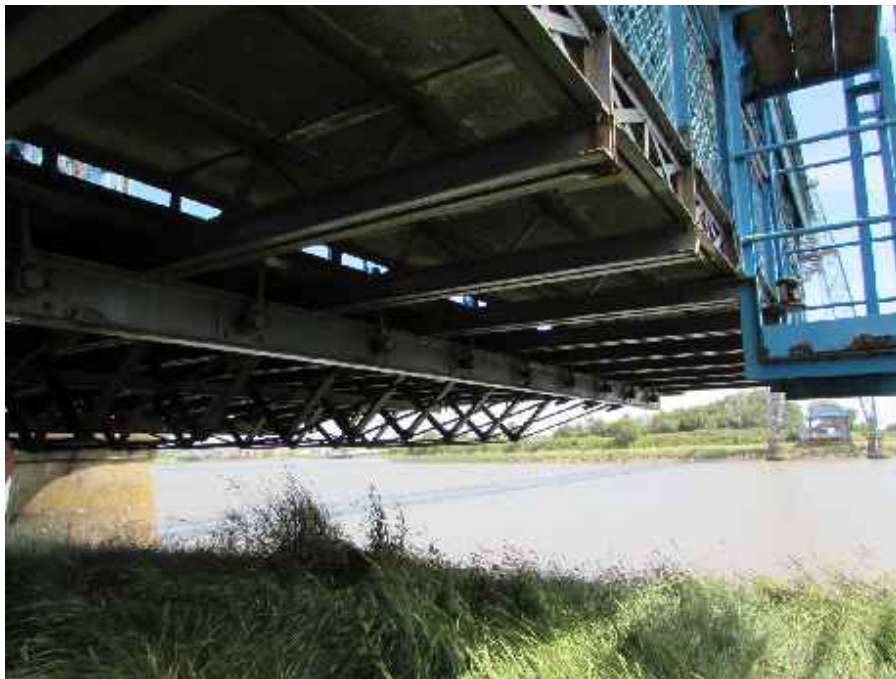
**Gondola Underside General view**  
*Photo taken: 24-07-2019*

The underside primary steelwork is suffering of heavy corrosion up to 50%. No adhesion testing was carried out as our recommendation would be to fully blast clean back to bare steel and repaint. For reference, the paint thickness average is 742microns and up to 5 paint layers were identified in the sample taken and analysed.

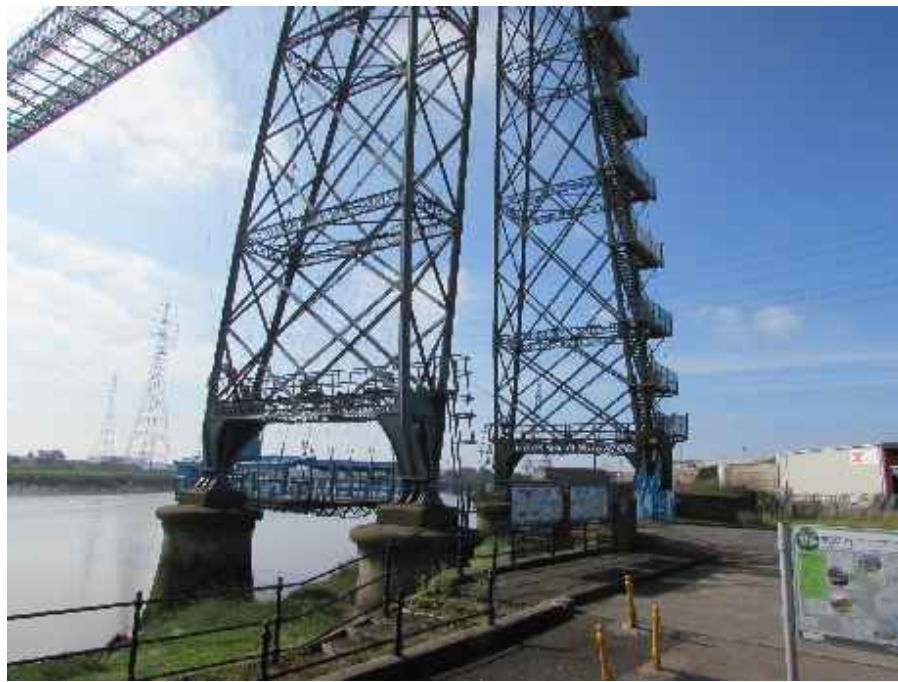
**West Pylon General view**  
*Photo taken: 24-07-2019*

The west pylon was inspected and tested. Overall there is approx 5% moderate corrosion which once again is mainly on the edges, in corners, fixings. It was noted on the west pylon that there is widespread delamination/flaking paint, from the location of inspection it would seem that the top layer(s) is delaminating from the undercoats. The likely cause of failure is from the previous painting programme, where either the surface was not sufficiently cleaned/abraded, paint applied out of specification, or the overcoating times were not adhered to.
