**SOUTH SIDE  
QUEENSWAY WASTE  
MANAGEMENT SITE,  
LLANWERN STEELWORKS**

**2020 Annual Review of  
Environmental  
Monitoring**

*Report Number 2116r2v1d0221*

**February 2021**

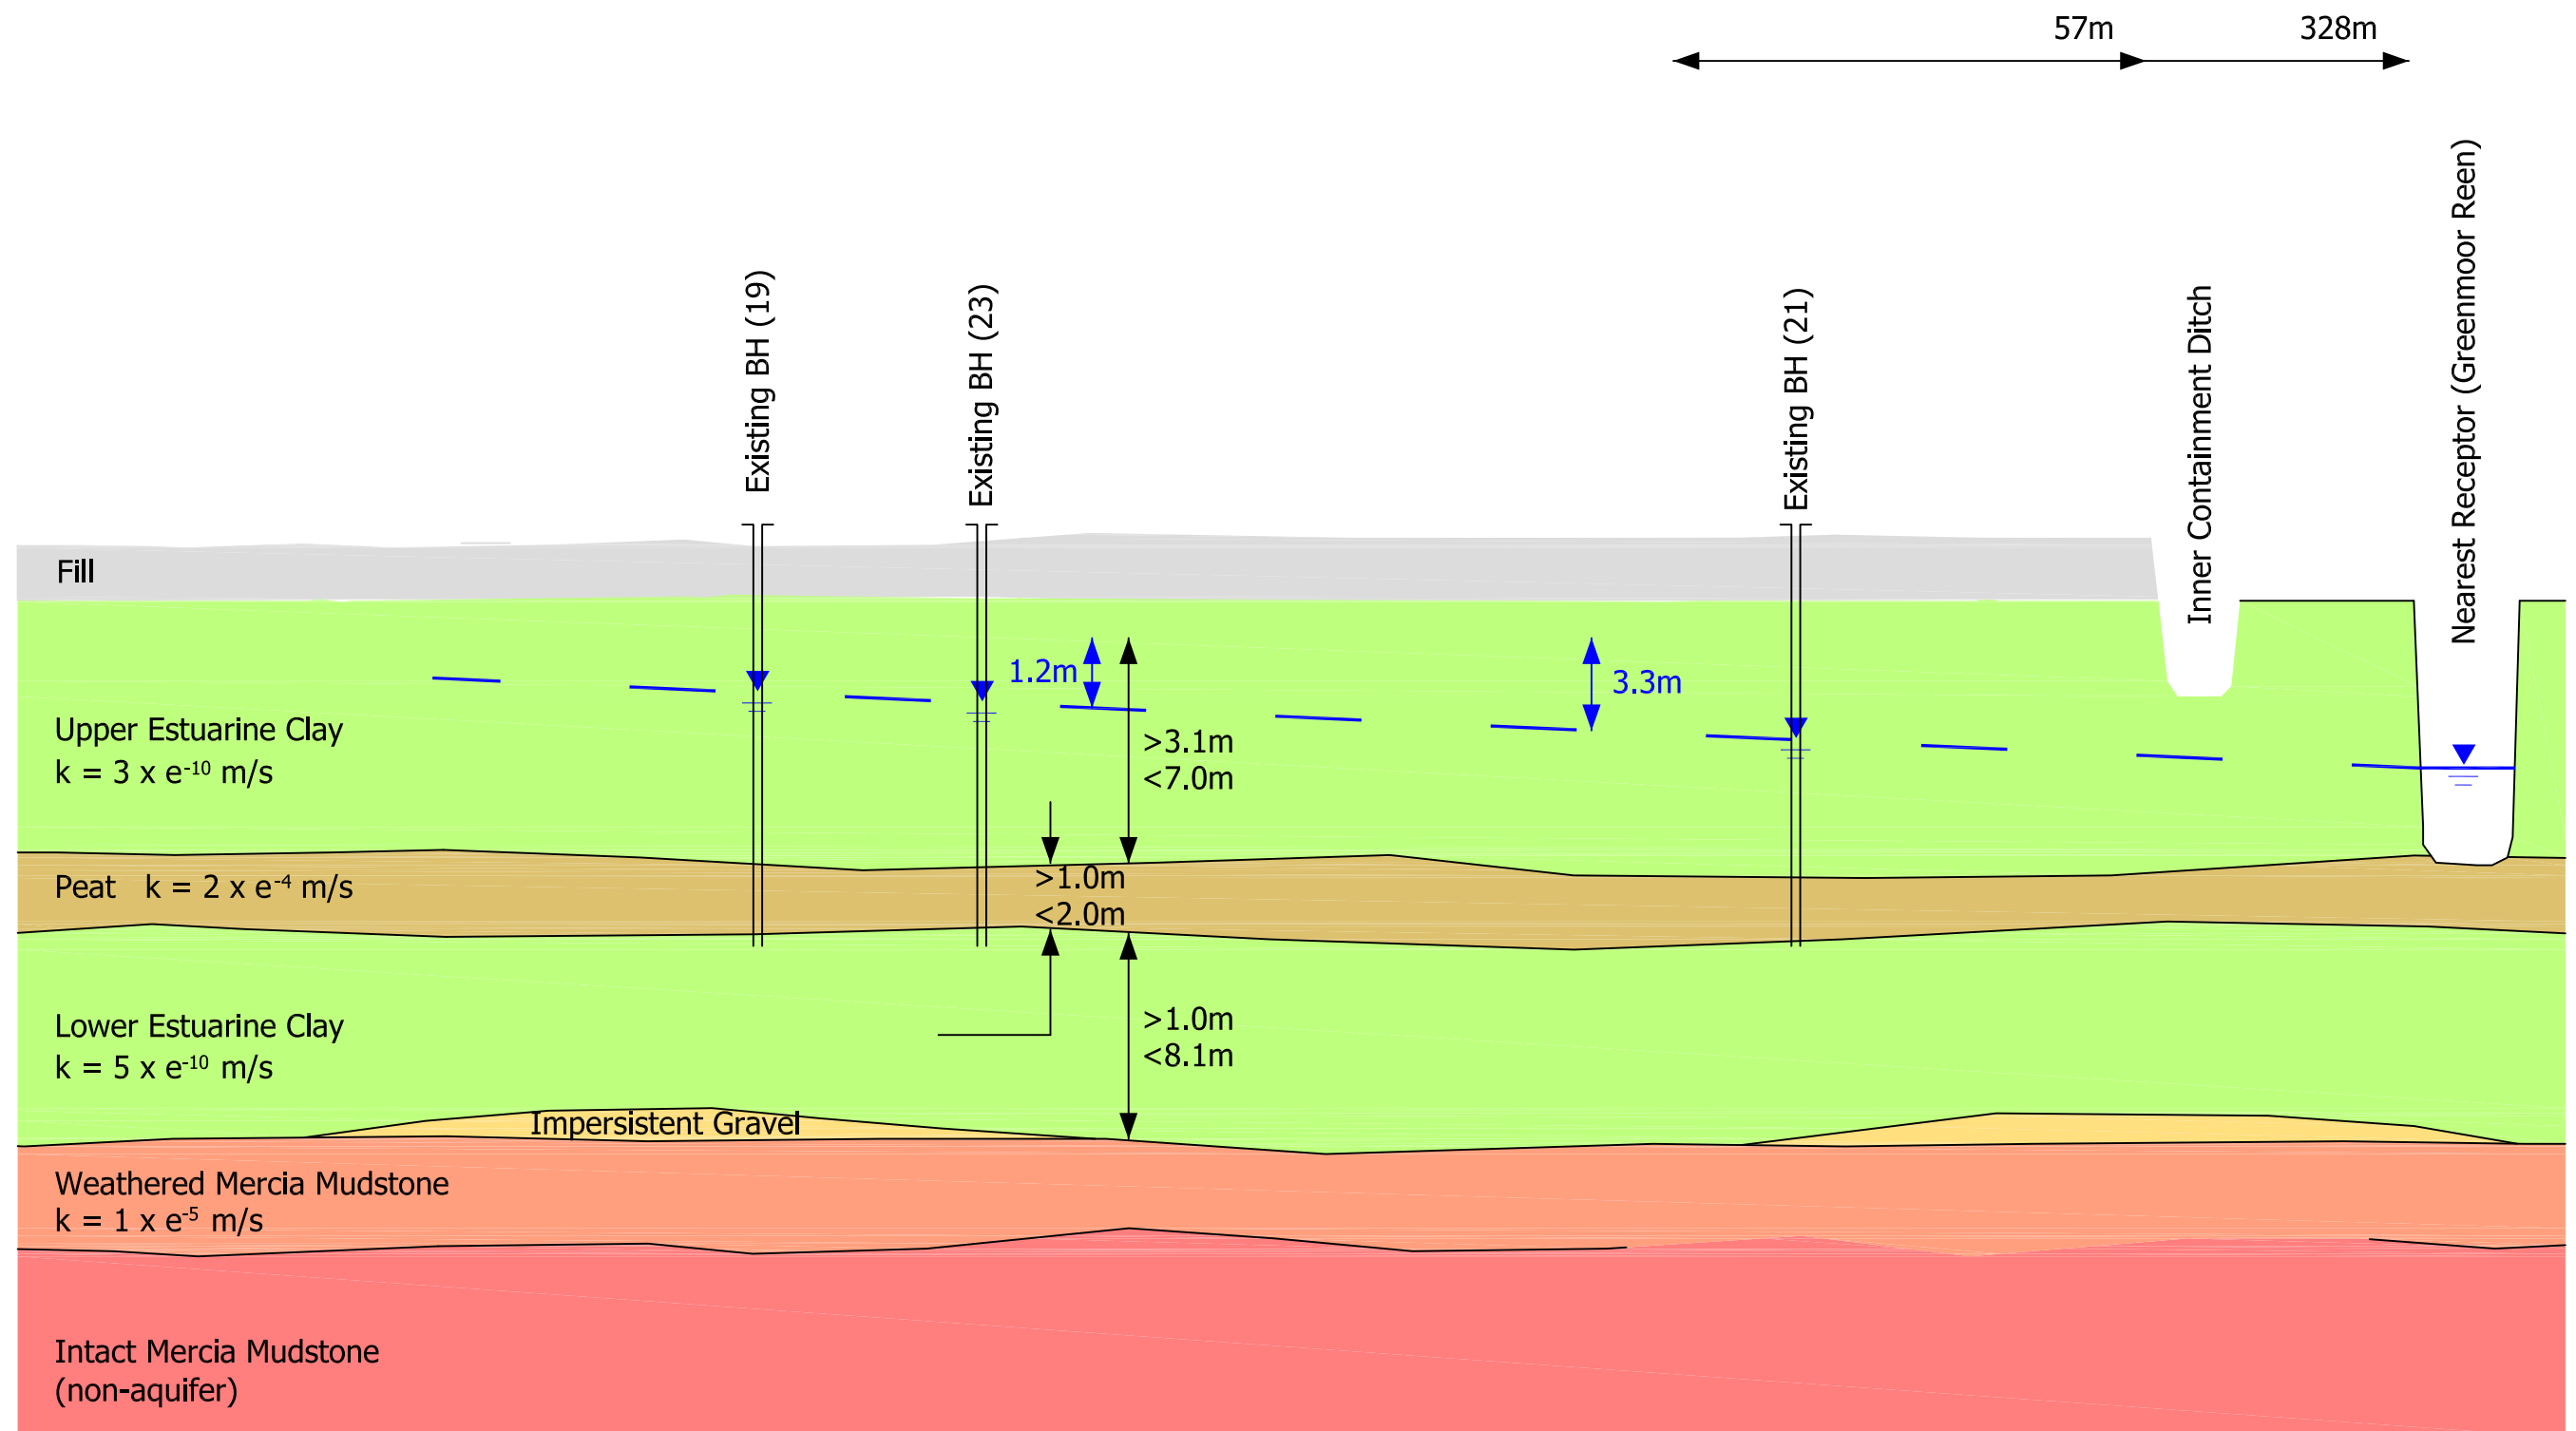
Figure 4 Conceptual Site Model

To enable the risks posed to groundwater and surface water to be evaluated, a conceptual hydrogeological model was developed as part of the closure process. The diagrammatic representation of the model is provided in Figure 4.

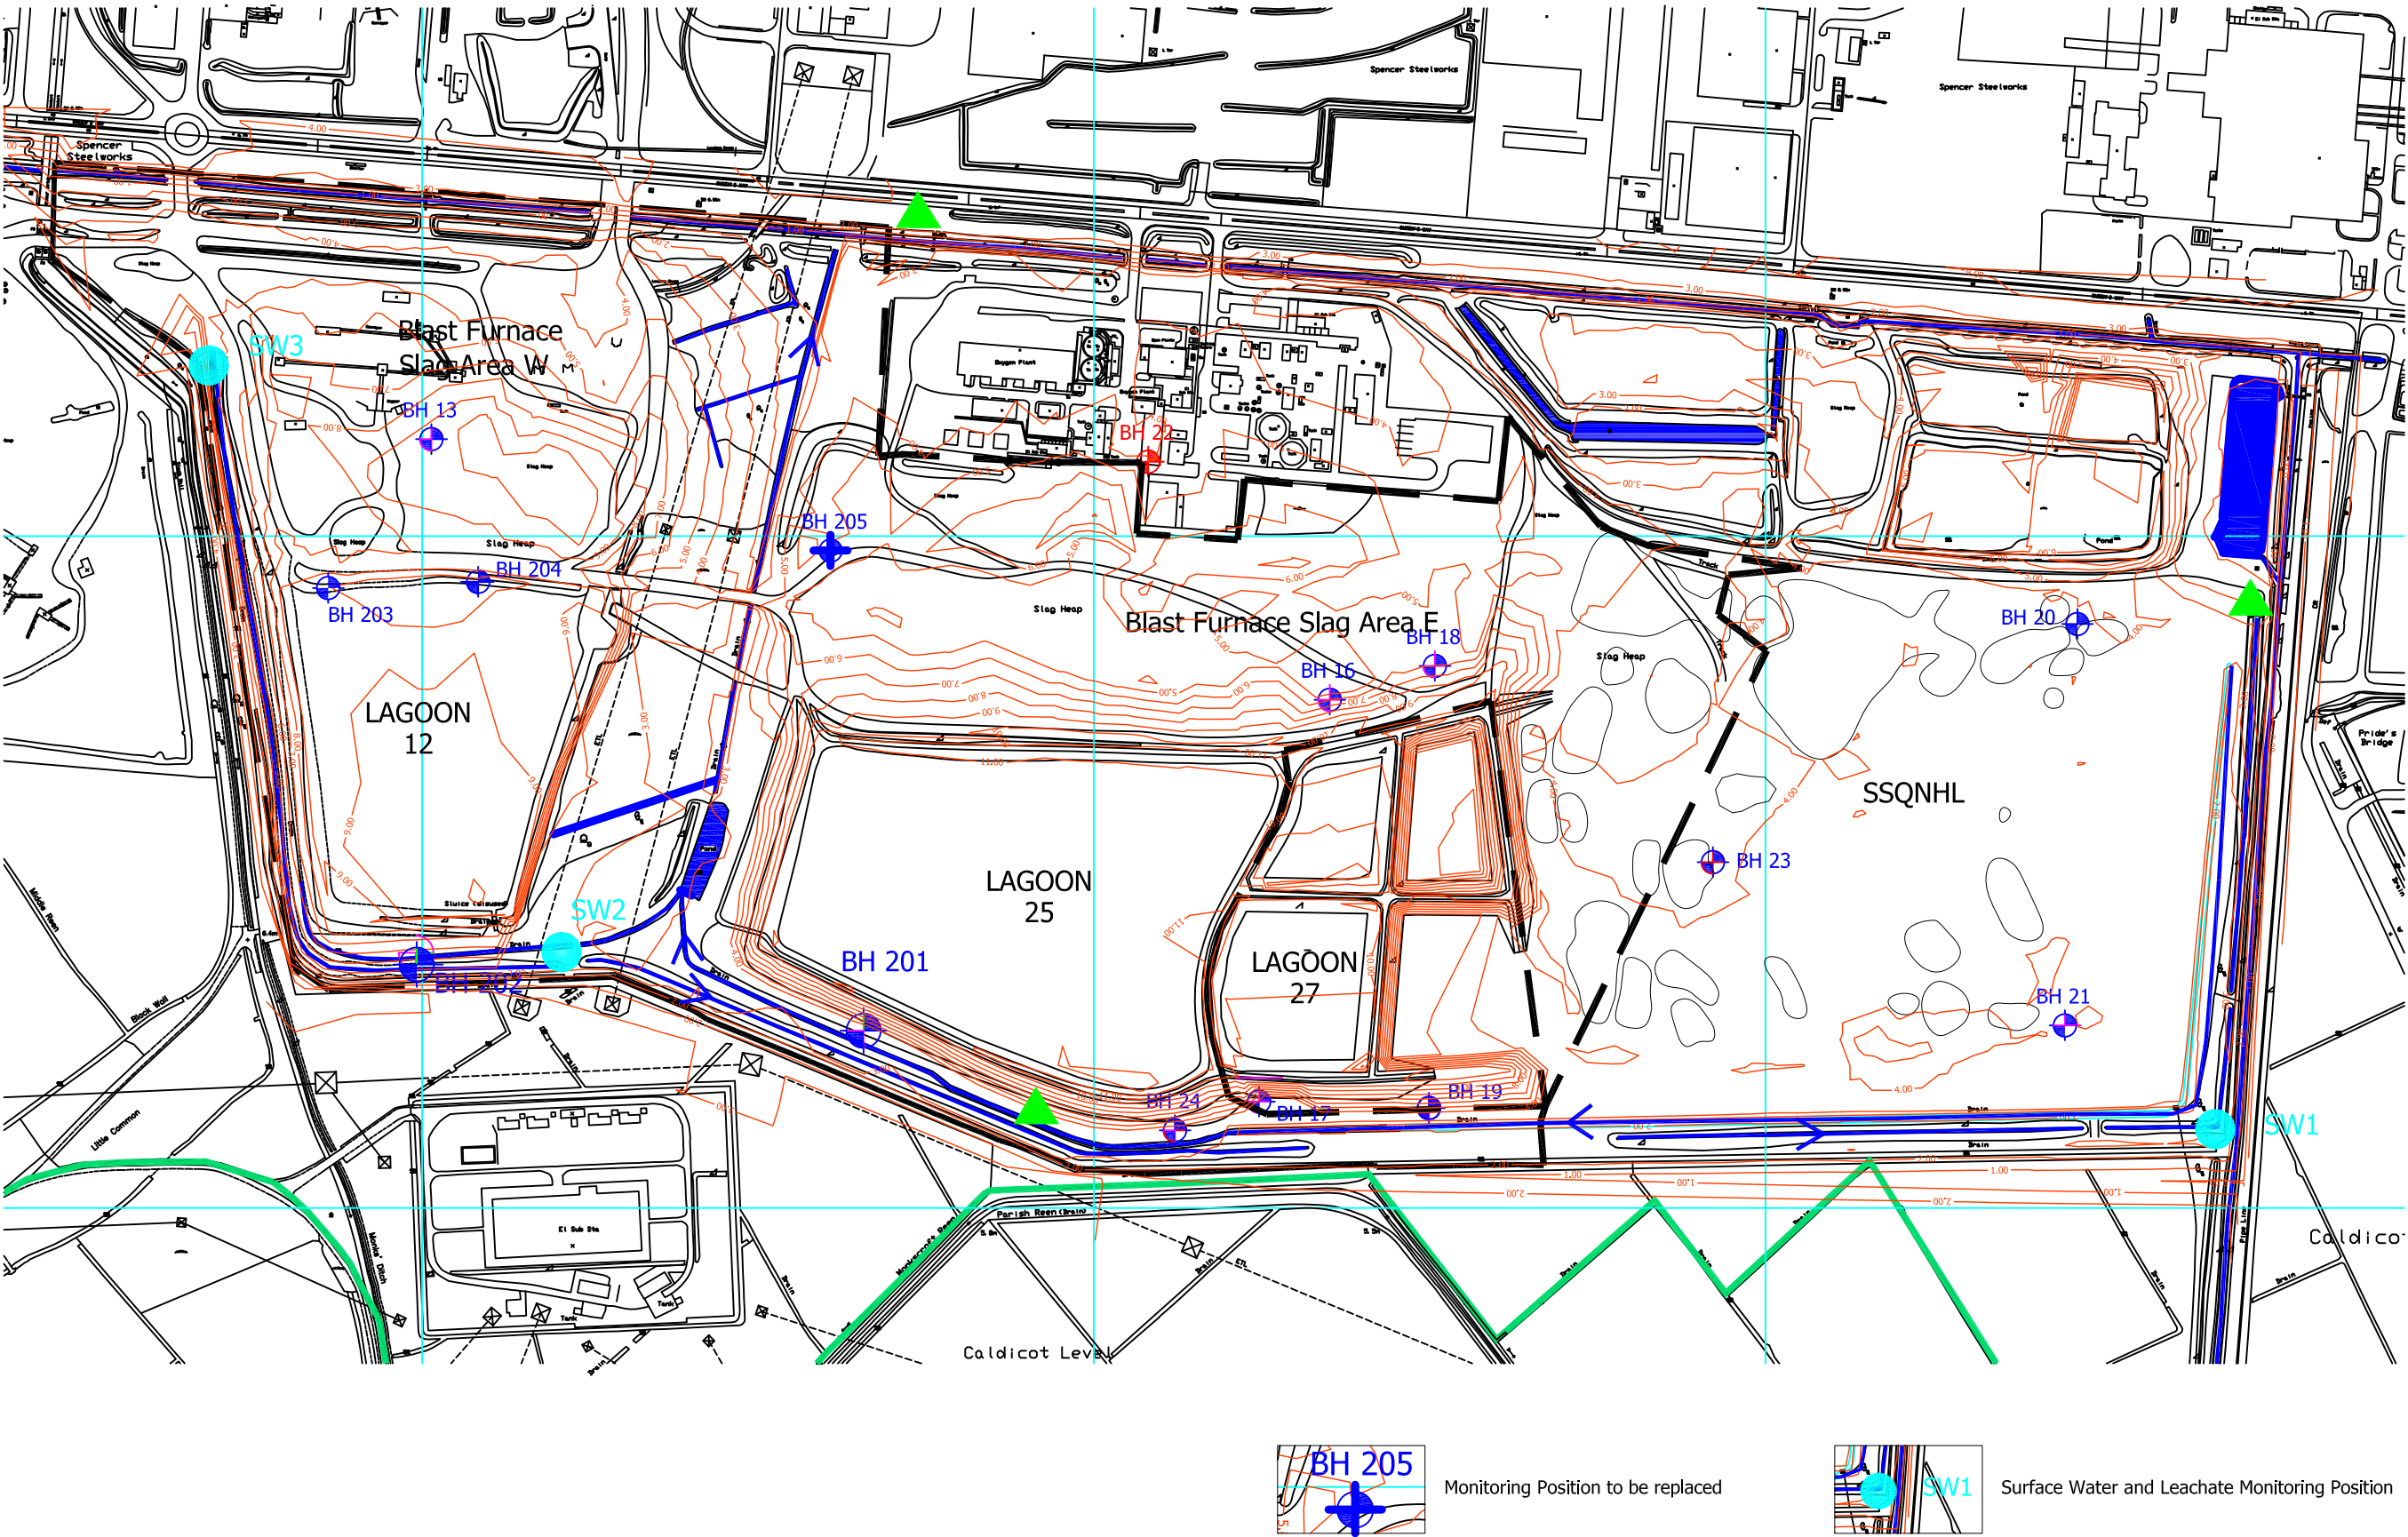
Figure 5 Available Monitoring Network

The current available monitoring network is illustrated in Figure 5.

- Check integrity of the site boundary to ensure members of the public cannot gain access.
- Conduct six monthly walkovers around embankments of Lagoons 12 and 25 to check for leachate breakout.
- Conduct annual walk-over each springtime to look for evidence of shallow translational slips along the embankment of Lagoon 12.
- Improve year-round access to the surface water monitoring positions.
- Locate and expose BH16 and BH18 to assess condition of headworks.
- Manage buddleia growth along the southern boundary as it is limiting access and monitoring.
- Investigate damage to BH24 and take appropriate actions.
