# HV / CHP Fire Investigation Summary

*Saturday 13th March 2021 20:32*

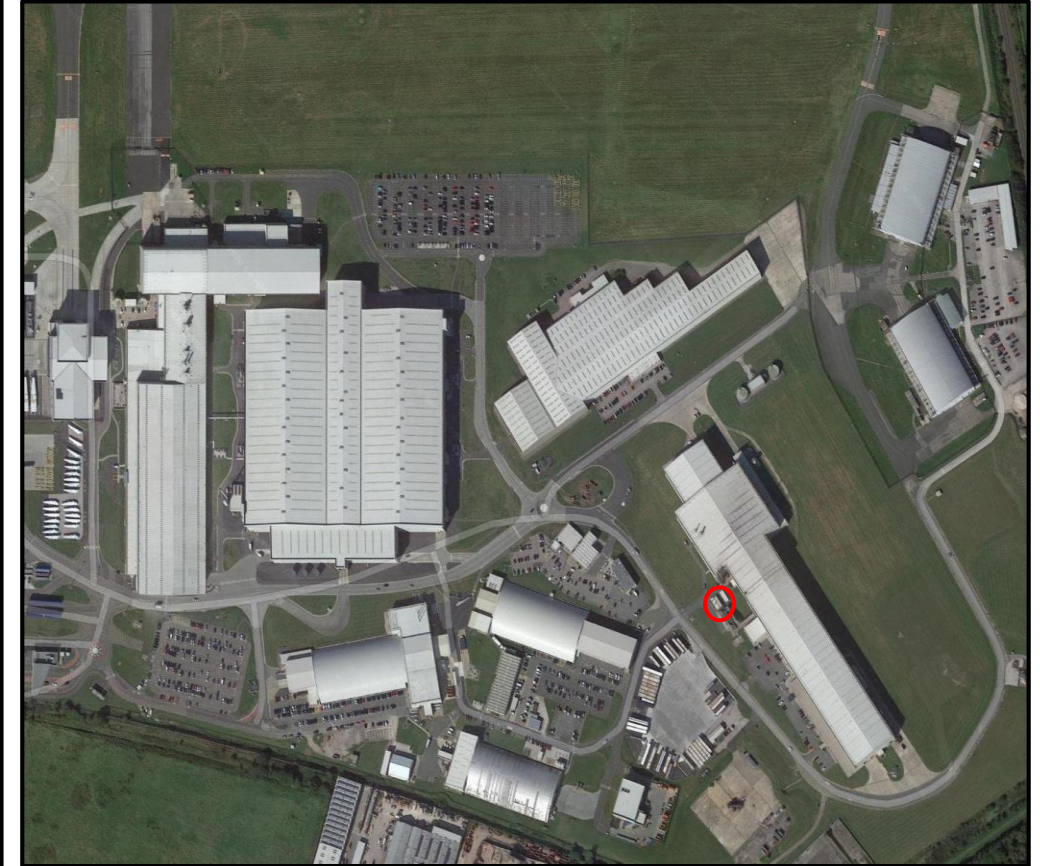
**Location of CHP / HV Switch Panel and Substation 350 at Broughton Site**

- Fire in the SMC HV Switch Room (substation 350) which is connected to the SMC Combined Heat & Power (CHP).
- No persons injured or product damaged through this incident, though the potential for harm was clearly present.
- Significant damage caused to the HV switch room, panels and resistor blocks, which require extensive repairs.
- CHP unit offline, no onsite electricity generation through this unit (cost & environmental impacts).

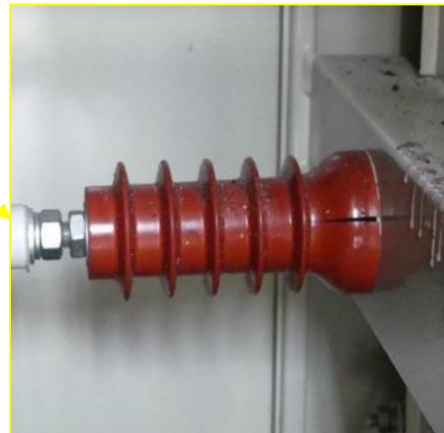
- The fire originated in the HV Switch panel compartments that houses a specific component, **Neutral Earth Resistors (NERs)**
    - *The NERs generate a current to measure the CHP generated electricity and ensure the frequencies match before connecting to the national grid.*

- The brackets of the top NER bank have failed & the top NER bank has fallen on the middle resistor bank.
  - There is a crack in the supporting brackets of the middle resistor bank > believed to have been caused by the incident.

- The protection relays had not been reset before the CHP had been restarted, however the unit would have been trying to synchronise with the grid (done through the NER) and would have failed due to the protection relays being active.

- An extremely excessive number of operations on the circuit breaker have been recorded supporting that the CHP repeatedly tried to connect.
  - This likely overloaded the NER resistor and created excessive heat which could have affected the isolator supports for the resistor.

- Unable to withstand the heat the NER supporting bracket could have failed allowing the upper resistor to fall onto the middle resistor and cause an arc sufficient to initiate the fire.

- Potential modes of failure:
    - a. Design error in restart protection systems
    - b. Process error in restart procedure
