Appendix 2

Bryn Posteg Landfill Audit

18th and 19th April 2018

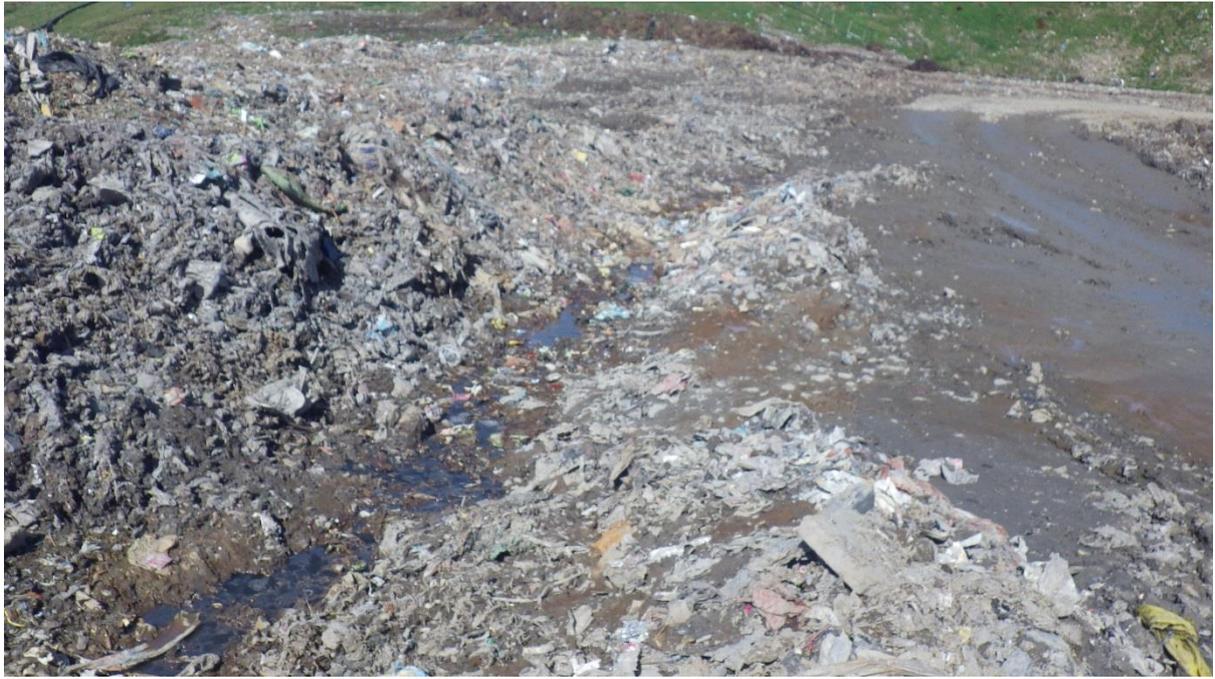
Photograph 8

7	High methane emissions emanating from haul track on Cell 9. Noticed due to bubbling in standing water above the holes. Landfill gas management in this area should be investigated as a matter of urgency.
8	High methane emissions emanating from haul track on Cell 9. Noticed due to bubbling in standing water above the holes. Landfill gas management in this area should be investigated as a matter of urgency.
9	High methane emissions emanating from leachate ditch alongside haul track on Cell 9. Noticed due to bubbling in standing water above the holes. Landfill gas management in this area should be investigated as a matter of urgency.
10	High methane emissions emanating from leachate ditch alongside haul track on Cell 9. Noticed due to bubbling in standing water above the holes. Landfill gas management in this area should be investigated as a matter of urgency.
11	Further work is required to gas collection pipework to improve falls and eliminate low spots where condensate can form and cause slugging effect etc

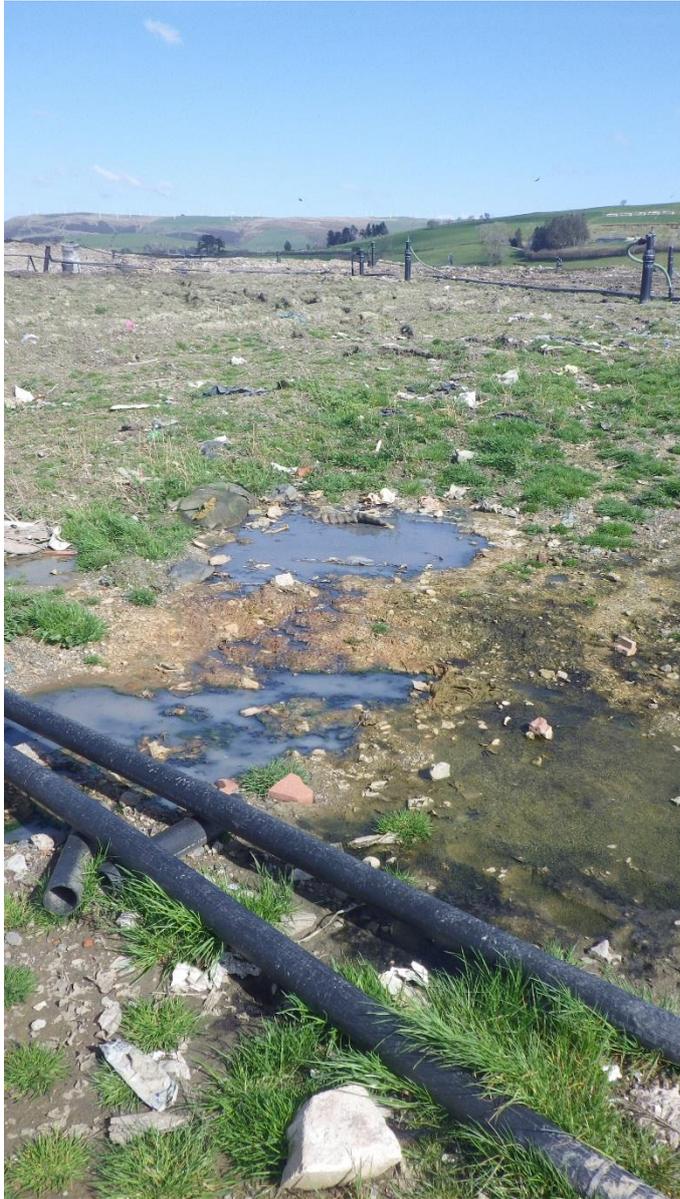
Photograph 14

13	Further work is required to gas collection pipework to improve falls and eliminate low spots where condensate can form and cause slugging effect etc
14	Further work is required to gas collection pipework to improve falls and eliminate low spots where condensate can form and cause slugging effect etc
15	Further work is required to gas collection pipework to improve falls and eliminate low spots where condensate can form and cause slugging effect etc
16	Example of one of these inaccessible high leachate towers where high methane readings were also noted around the base.
17	An area that needs de-watering urgently and gas extraction infrastructure improved considering all appropriate health and safety measures.
18	An area that needs de-watering urgently and gas extraction infrastructure improved considering all appropriate health and safety measures.
19	A hole in the flank demonstrating methane forcing its way out under pressure and readings as high as 21.9% was noted in the (south west corner of cell 9D)

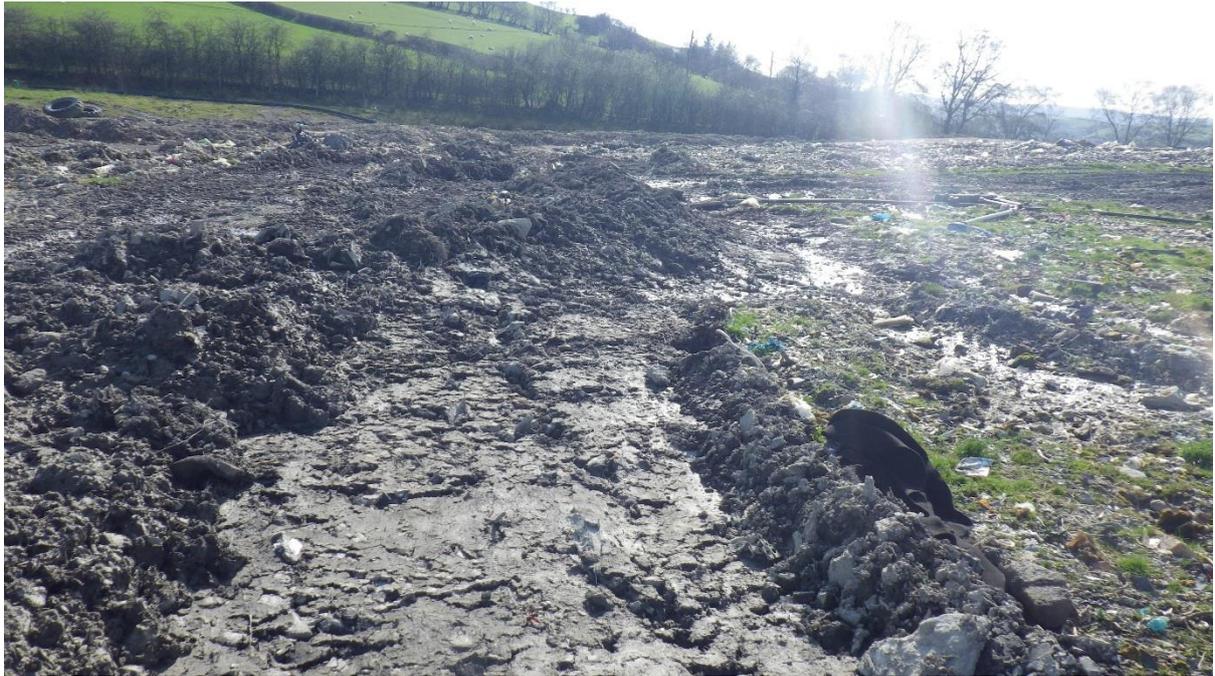
Photograph 21

20	A hole in the flank demonstrating methane forcing its way out under pressure and readings as high as 21.9% was noted in the (south west corner of cell 9D)
21	A trench been excavated by the operator to contain contaminated water that had been previously noted by officer to be pooling at the top of Phase 9DA and been running down the capping on the southern flank, to the haul road
22	A trench been excavated by the operator to contain contaminated water that had been previously noted by officer to be pooling at the top of Phase 9DA and been running down the capping on the southern flank, to the haul road
23	Well bunged and not properly sealed. Well head should be replaced with sealed screw top well head
24	Bailing tool left permanently in well. Unable to seal due to rope attached to bailing tool.
25	Rock placed on top of well- Replace with well casing and lid fit for purpose
26	Unable to sample due to broken valve
