## HANSON CEMENT WORKS - PADESWOOD LANDFILL SITE

# Landfill Closure Report

**Report Number** 1419741.501/A.0

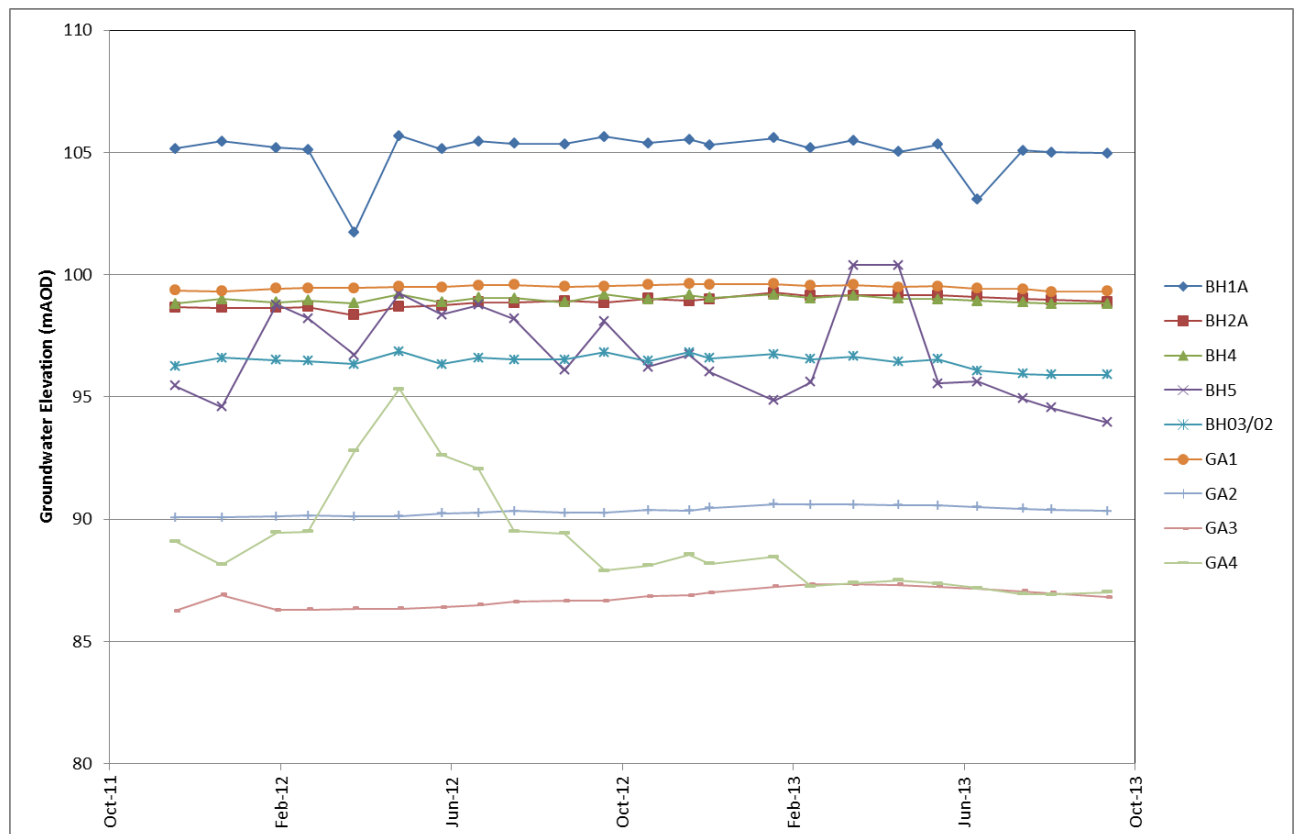
Figure 1: Drift Groundwater Elevation Hydrograph

Groundwater hydrographs from the monitoring boreholes BH1A, BH2A, BH03/02, BH4, BH5, GA1, GA2, GA3 and GA4 covering a period of 2 years are presented in Figure 1 below. From the data presented it is identified that there are no discernable trends in the data with the exception of BH5 and GA4. The variation in groundwater elevation in BH5 appears to be seasonal with insufficient water present to enable sampling during the drier part of the season. The elevation of groundwater in GA4 peaked during the winter of 2011/2012 but declined during 2012 and has been consistent with the elevation of groundwater in GA3 since. It is unclear what the cause for elevated groundwater heads at this time was.

There is approximately a 20 m range in the elevation of groundwater observed within the Drift deposits. This observation is consistent with the interpretation of the conceptual model reproduced above whereby rather than there being a steep consistent hydraulic gradient across the Site, the groundwater present in the Drift is perched in isolated lenses of more permeable deposits separated by less permeable clay deposits. The presence of perched water in the Drift is dependent on the presence of a lens of more permeable material and the presence of infiltration whether from precipitation, leakage of leachate or proximity to the adjacent watercourse. The composition of the water present within these lenses will be indicative of the infiltration source or the unsaturated pathway that the infiltration has followed.

- The elevation of groundwater at GA1 is broadly co-incident with an interpolation of the elevation of the bed of the adjacent watercourse. From Figure 1 the elevation of groundwater in GA1 is observed to be relatively constant at between 99.31 and 99.63 mAOD, this elevation is also broadly co-incident with the elevation of the base of the overlying Madeground. It is proposed that infiltration either through the landfill or through the Made Ground between the Site and GA1 is collecting on the surface of the underlying boulder clay. It is also proposed that borehole GA1 is acting as a sump for this perched water;
- Boreholes BH4, BH5 (seasonally) and BH03/02 have elevations of groundwater above or co-incident with the bed of the adjacent watercourse indicating that there is the potential for perched groundwater at these locations to discharge to the watercourse; and

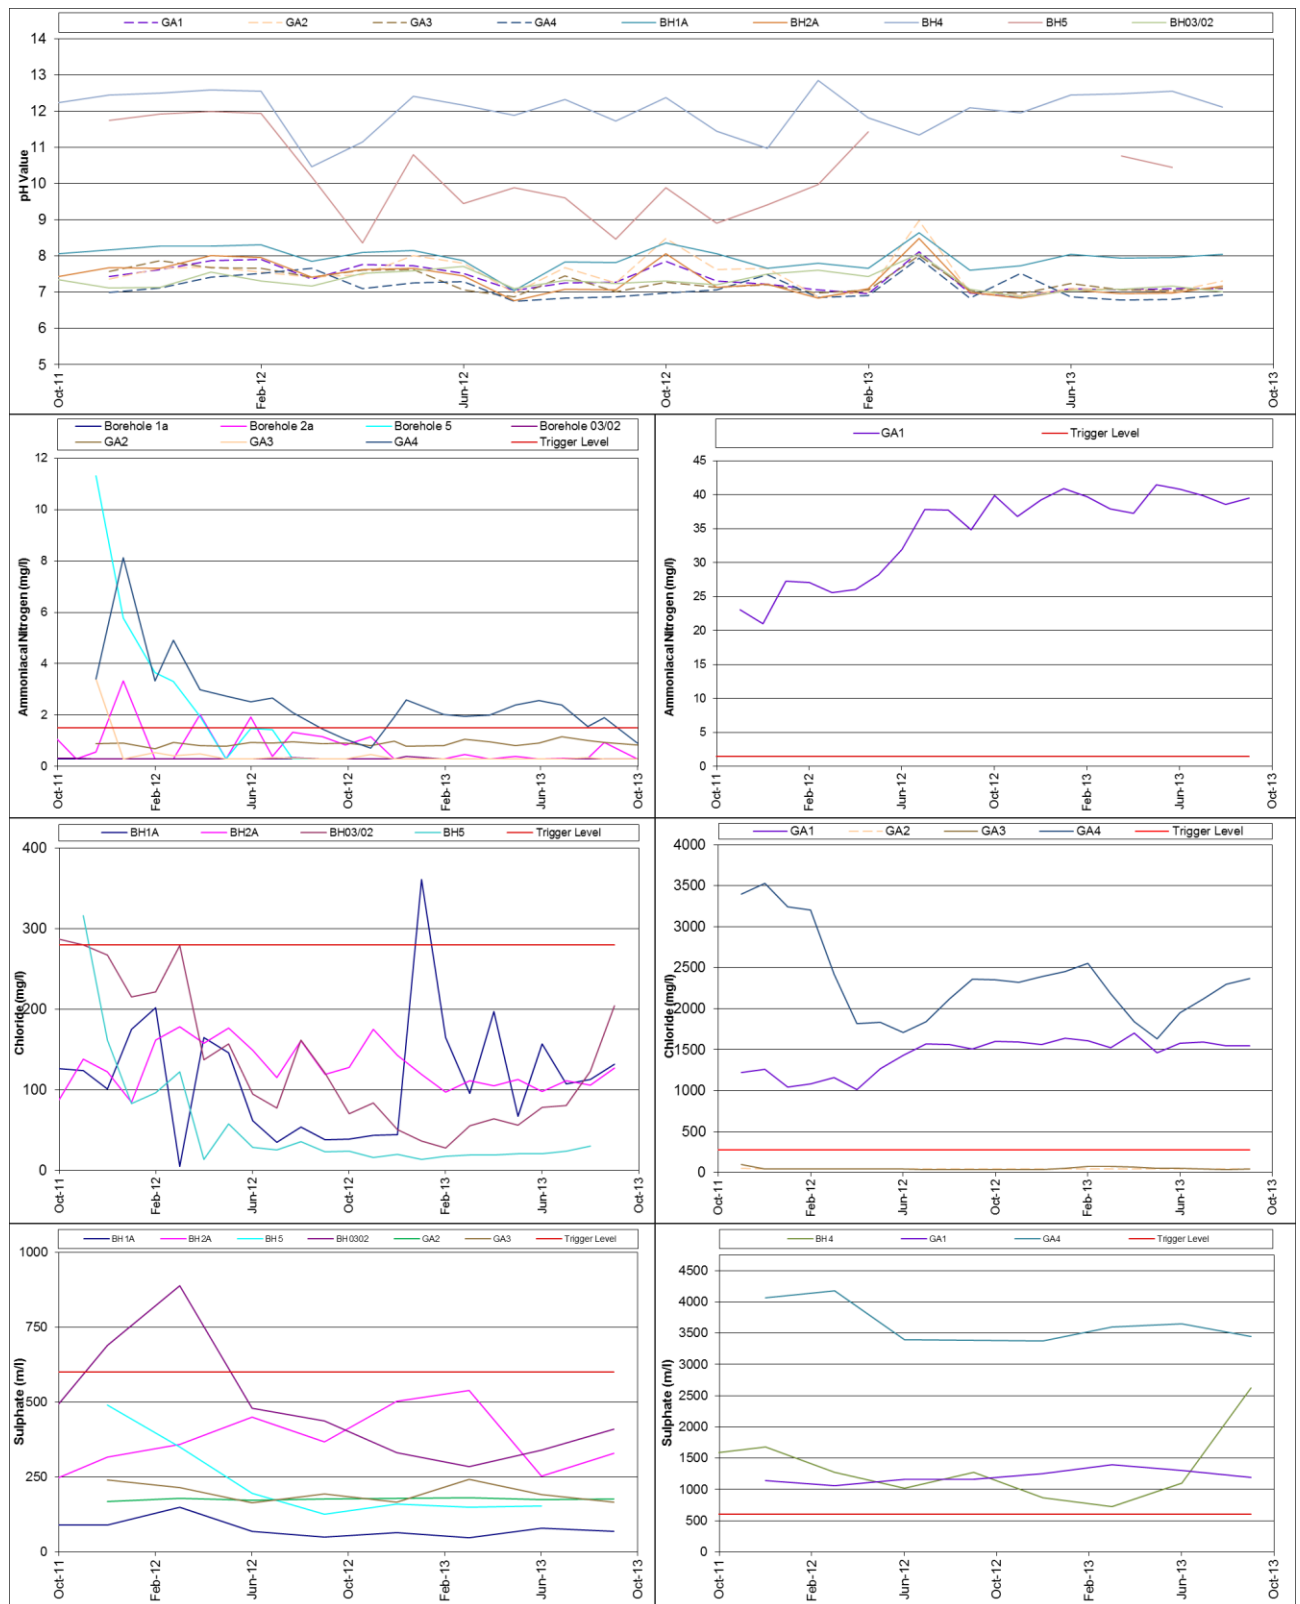
Figure 2: Time-Series Graphs of Compliance Substances

- Ammoniacal nitrogen: Ammoniacal nitrogen has been identified in the leachate source term. Elevated concentrations of ammoniacal nitrogen have been identified in GA4 and BH5 in the past; however, a long-term declining trend in the concentration of ammoniacal nitrogen is identified at these locations. The concentration of ammoniacal nitrogen is elevated up to a maximum of 38.9 mg/l in samples from GA1, as identified above it is considered likely that GA1 is acting as a sump to collect infiltration collecting on the top of the Drift, Boulder Clay deposits and that this infiltration may have passed through source areas comprising the adjacent landfill or Madeground between the landfill and GA1; and

- Concentrations of sulphate and chloride have routinely been elevated above the respective interim Trigger Levels in GA1 and GA4. The presence of a number of compliance substances at elevated concentrations indicates that GA1 and GA4 are influenced by leachate or by infiltration that has passed through unsaturated waste either inside or outside of the capped area and collected within the perched lenses of water monitored by these installations.

Based on the interpretation of water levels with respect to the conceptual model it is identified that the presence of perched water on the interface between the Drift and the Coal Measures is expected and that the presence of substances also present in the leachate is also expected. Water levels in GA2, GA3 and GA4 conform to this Conceptual Site Model and as they are below the elevation of the bed of the adjacent
