**MORFA TIP CLOSED  
LANDFILL,  
PORT TALBOT**

**PERMIT EPR/AP3292LT**

**2021 Annual Review  
of Environmental  
Monitoring Results**

*Report Number 2192r1v1d0222*

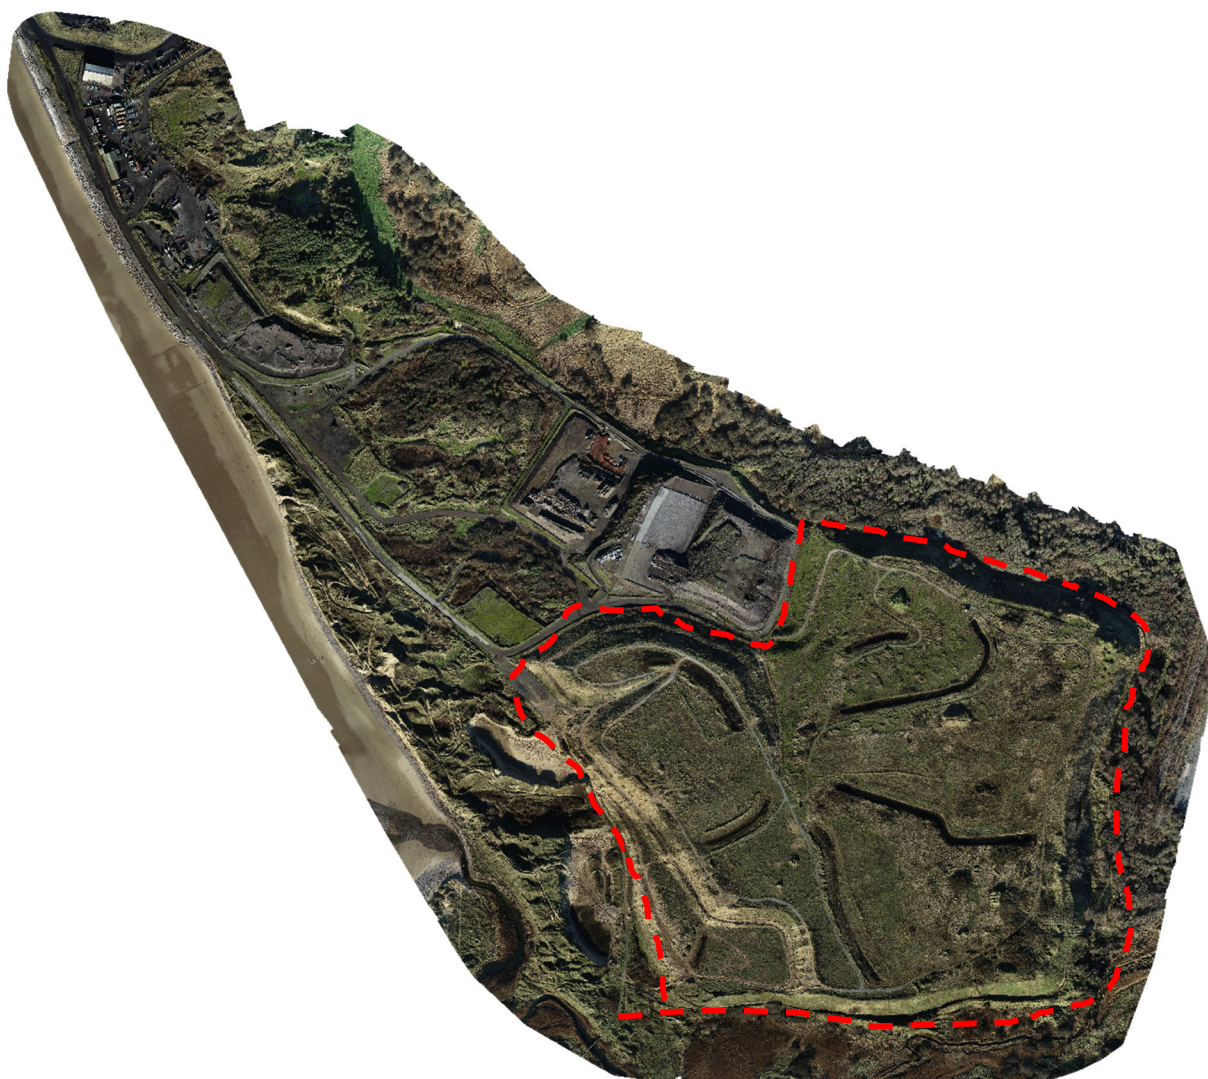
**Plate 2-2 2022 Aerial photograph of Morfa Site with MCL boundary dashed red**

Since completion, several elements of the restoration system have been damaged by direct and determined vandalism, indirect action caused by trespassers on scramblers and wind action, as shown in Plate 2-2. The wind turbine intended to power the recharge trench penstocks has been severely damaged and where capping membranes have been exposed by wind action, these have been subsequently punctured by the passage of scramblers. Geotechnology is aware that Tata is reviewing boundary security at the site and maintenance of the cap. These aspects are routinely discussed by the Technical Working party overseeing management of the site that includes NRW.
