**EAST WASTE  
MANAGEMENT SITE,  
LLANWERN STEELWORKS**

**PERMIT EAWML/30003**

**2018 Annual Review of  
Environmental  
Monitoring**

*Report Number 1785r1v1d0219*

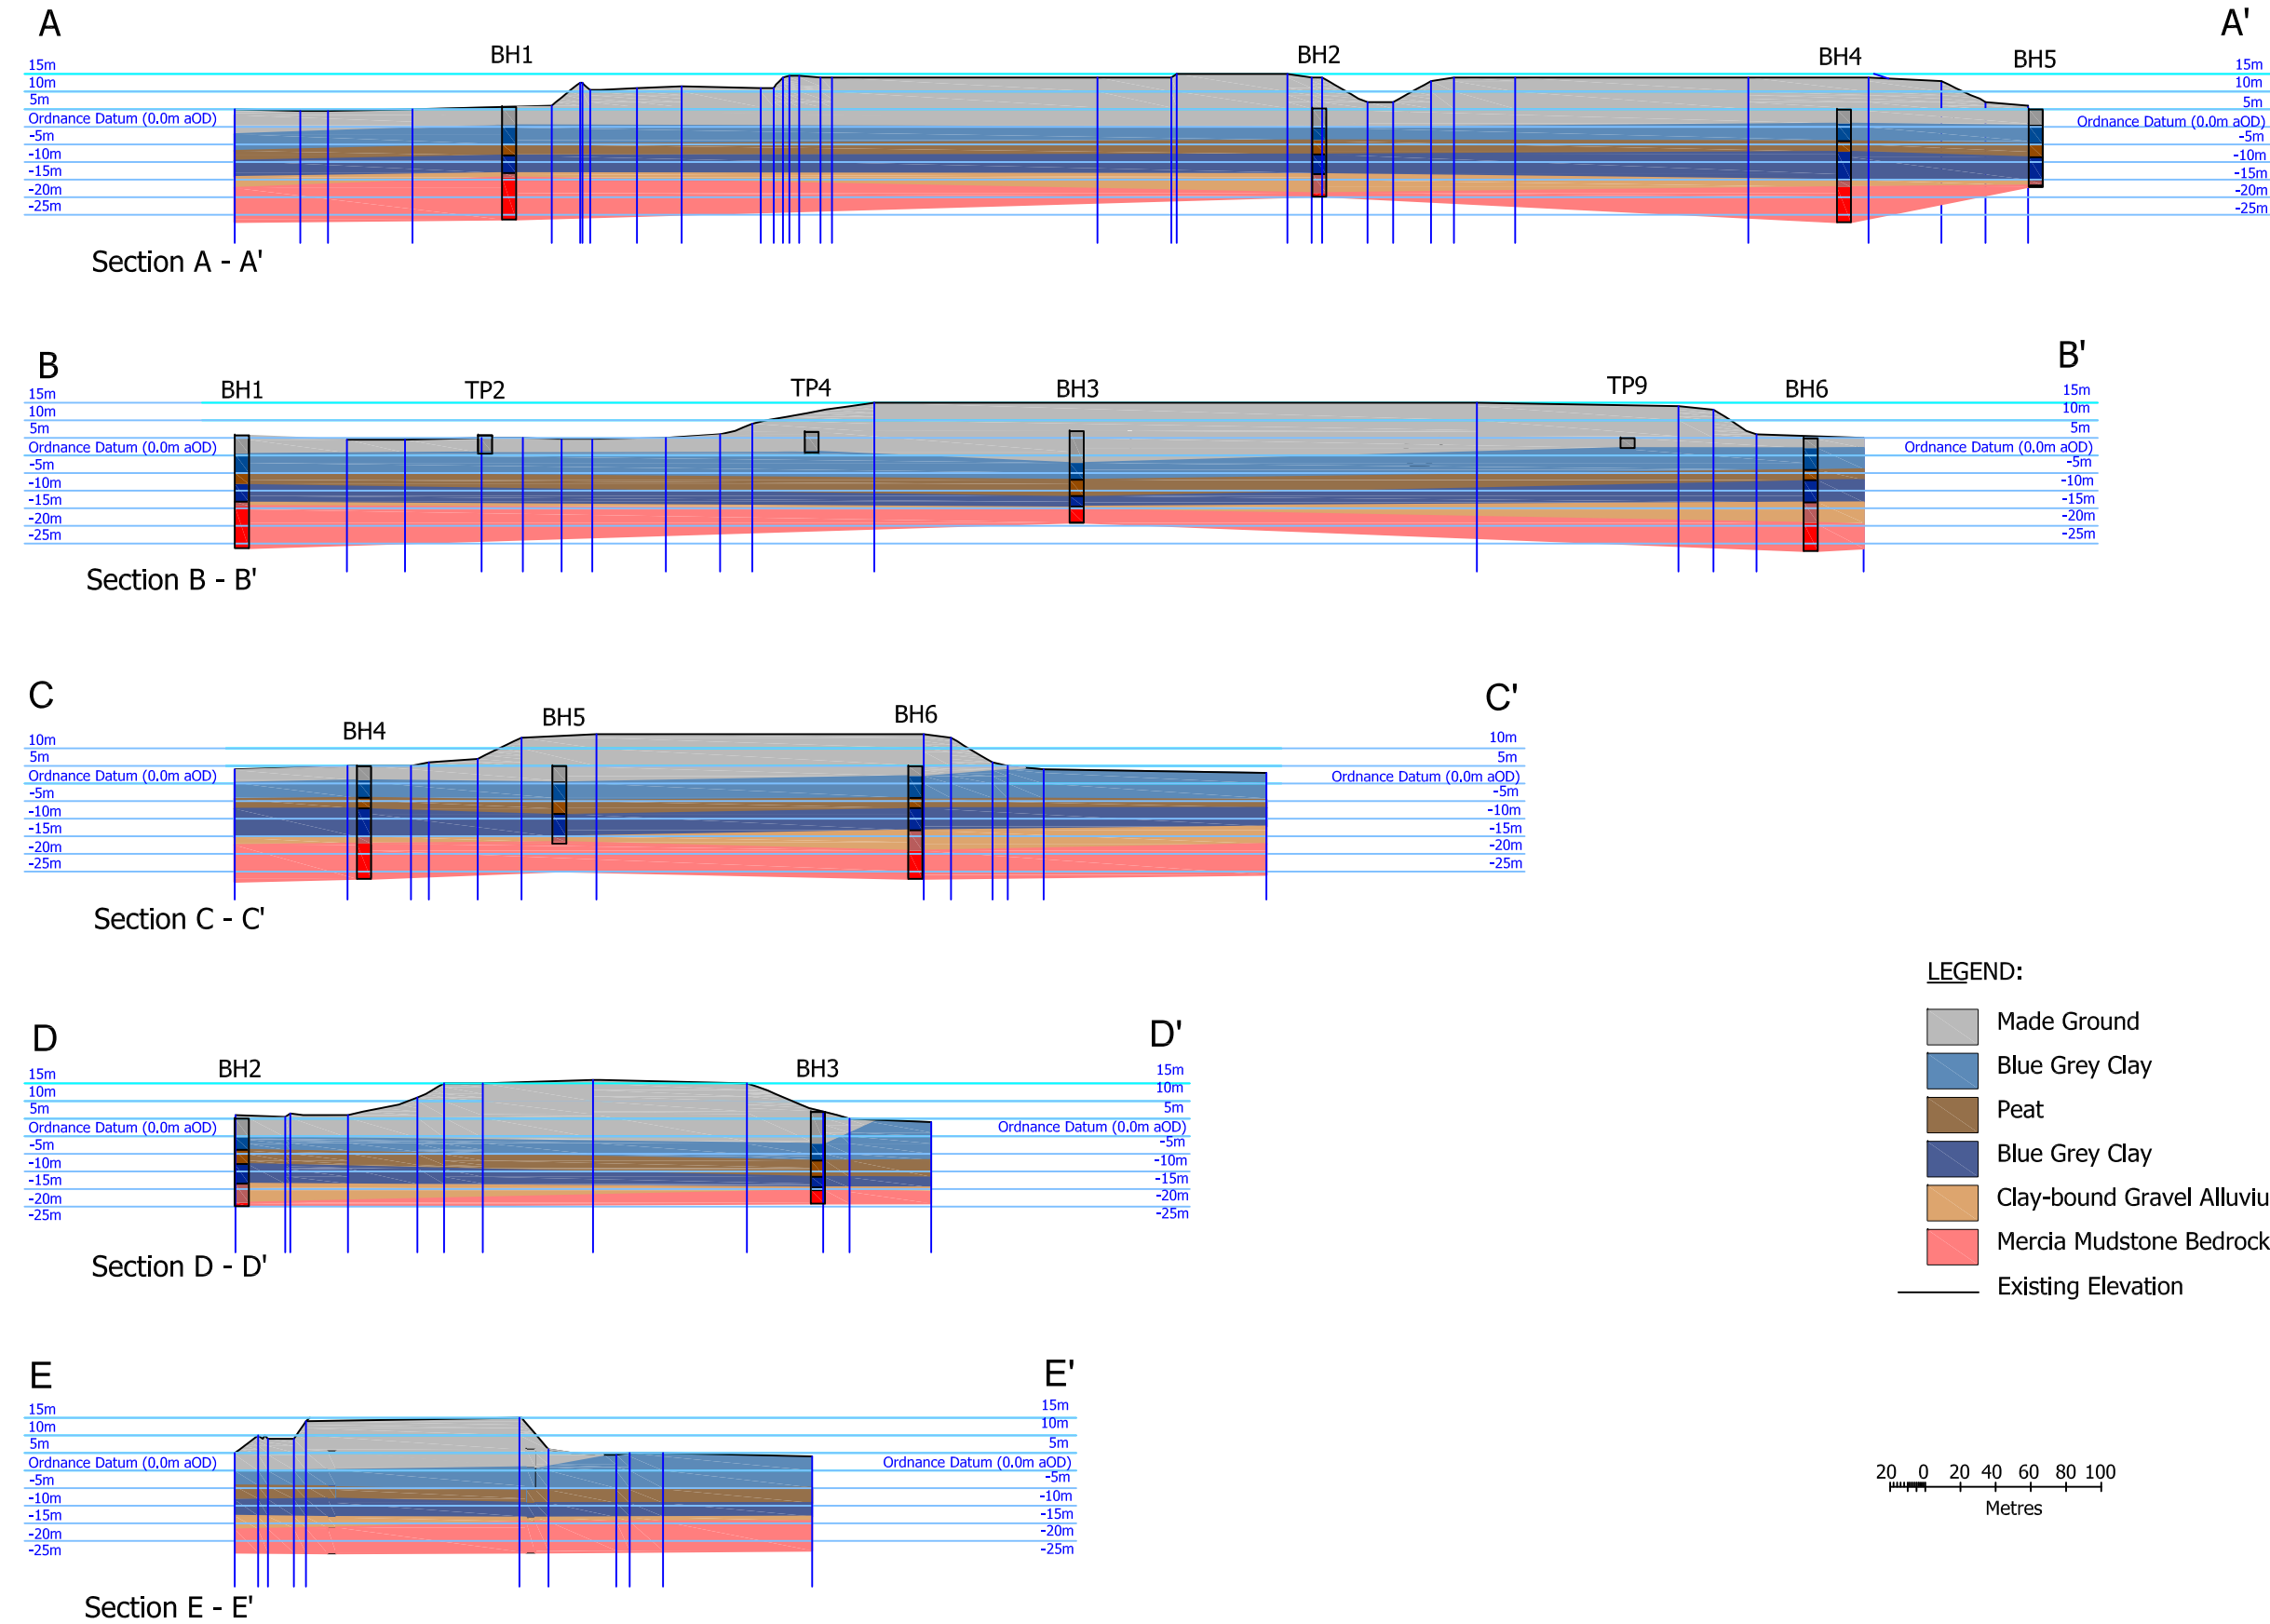
Figure 5 Geological Cross Sections

An examination of the cross sections in Figure 5 and the conceptual hydrogeological model in Figure 7 shows that the fill materials have been placed into a shallow excavation in the clay. This is consistent with historical information which indicates that the site was previously used for water settlement lagoons. The lagoons were dug and embankments constructed around them to contain the water. When the lagoons were decommissioned, they were backfilled with steel slag wastes and thus the water body in the made ground is contained by the clay materials.

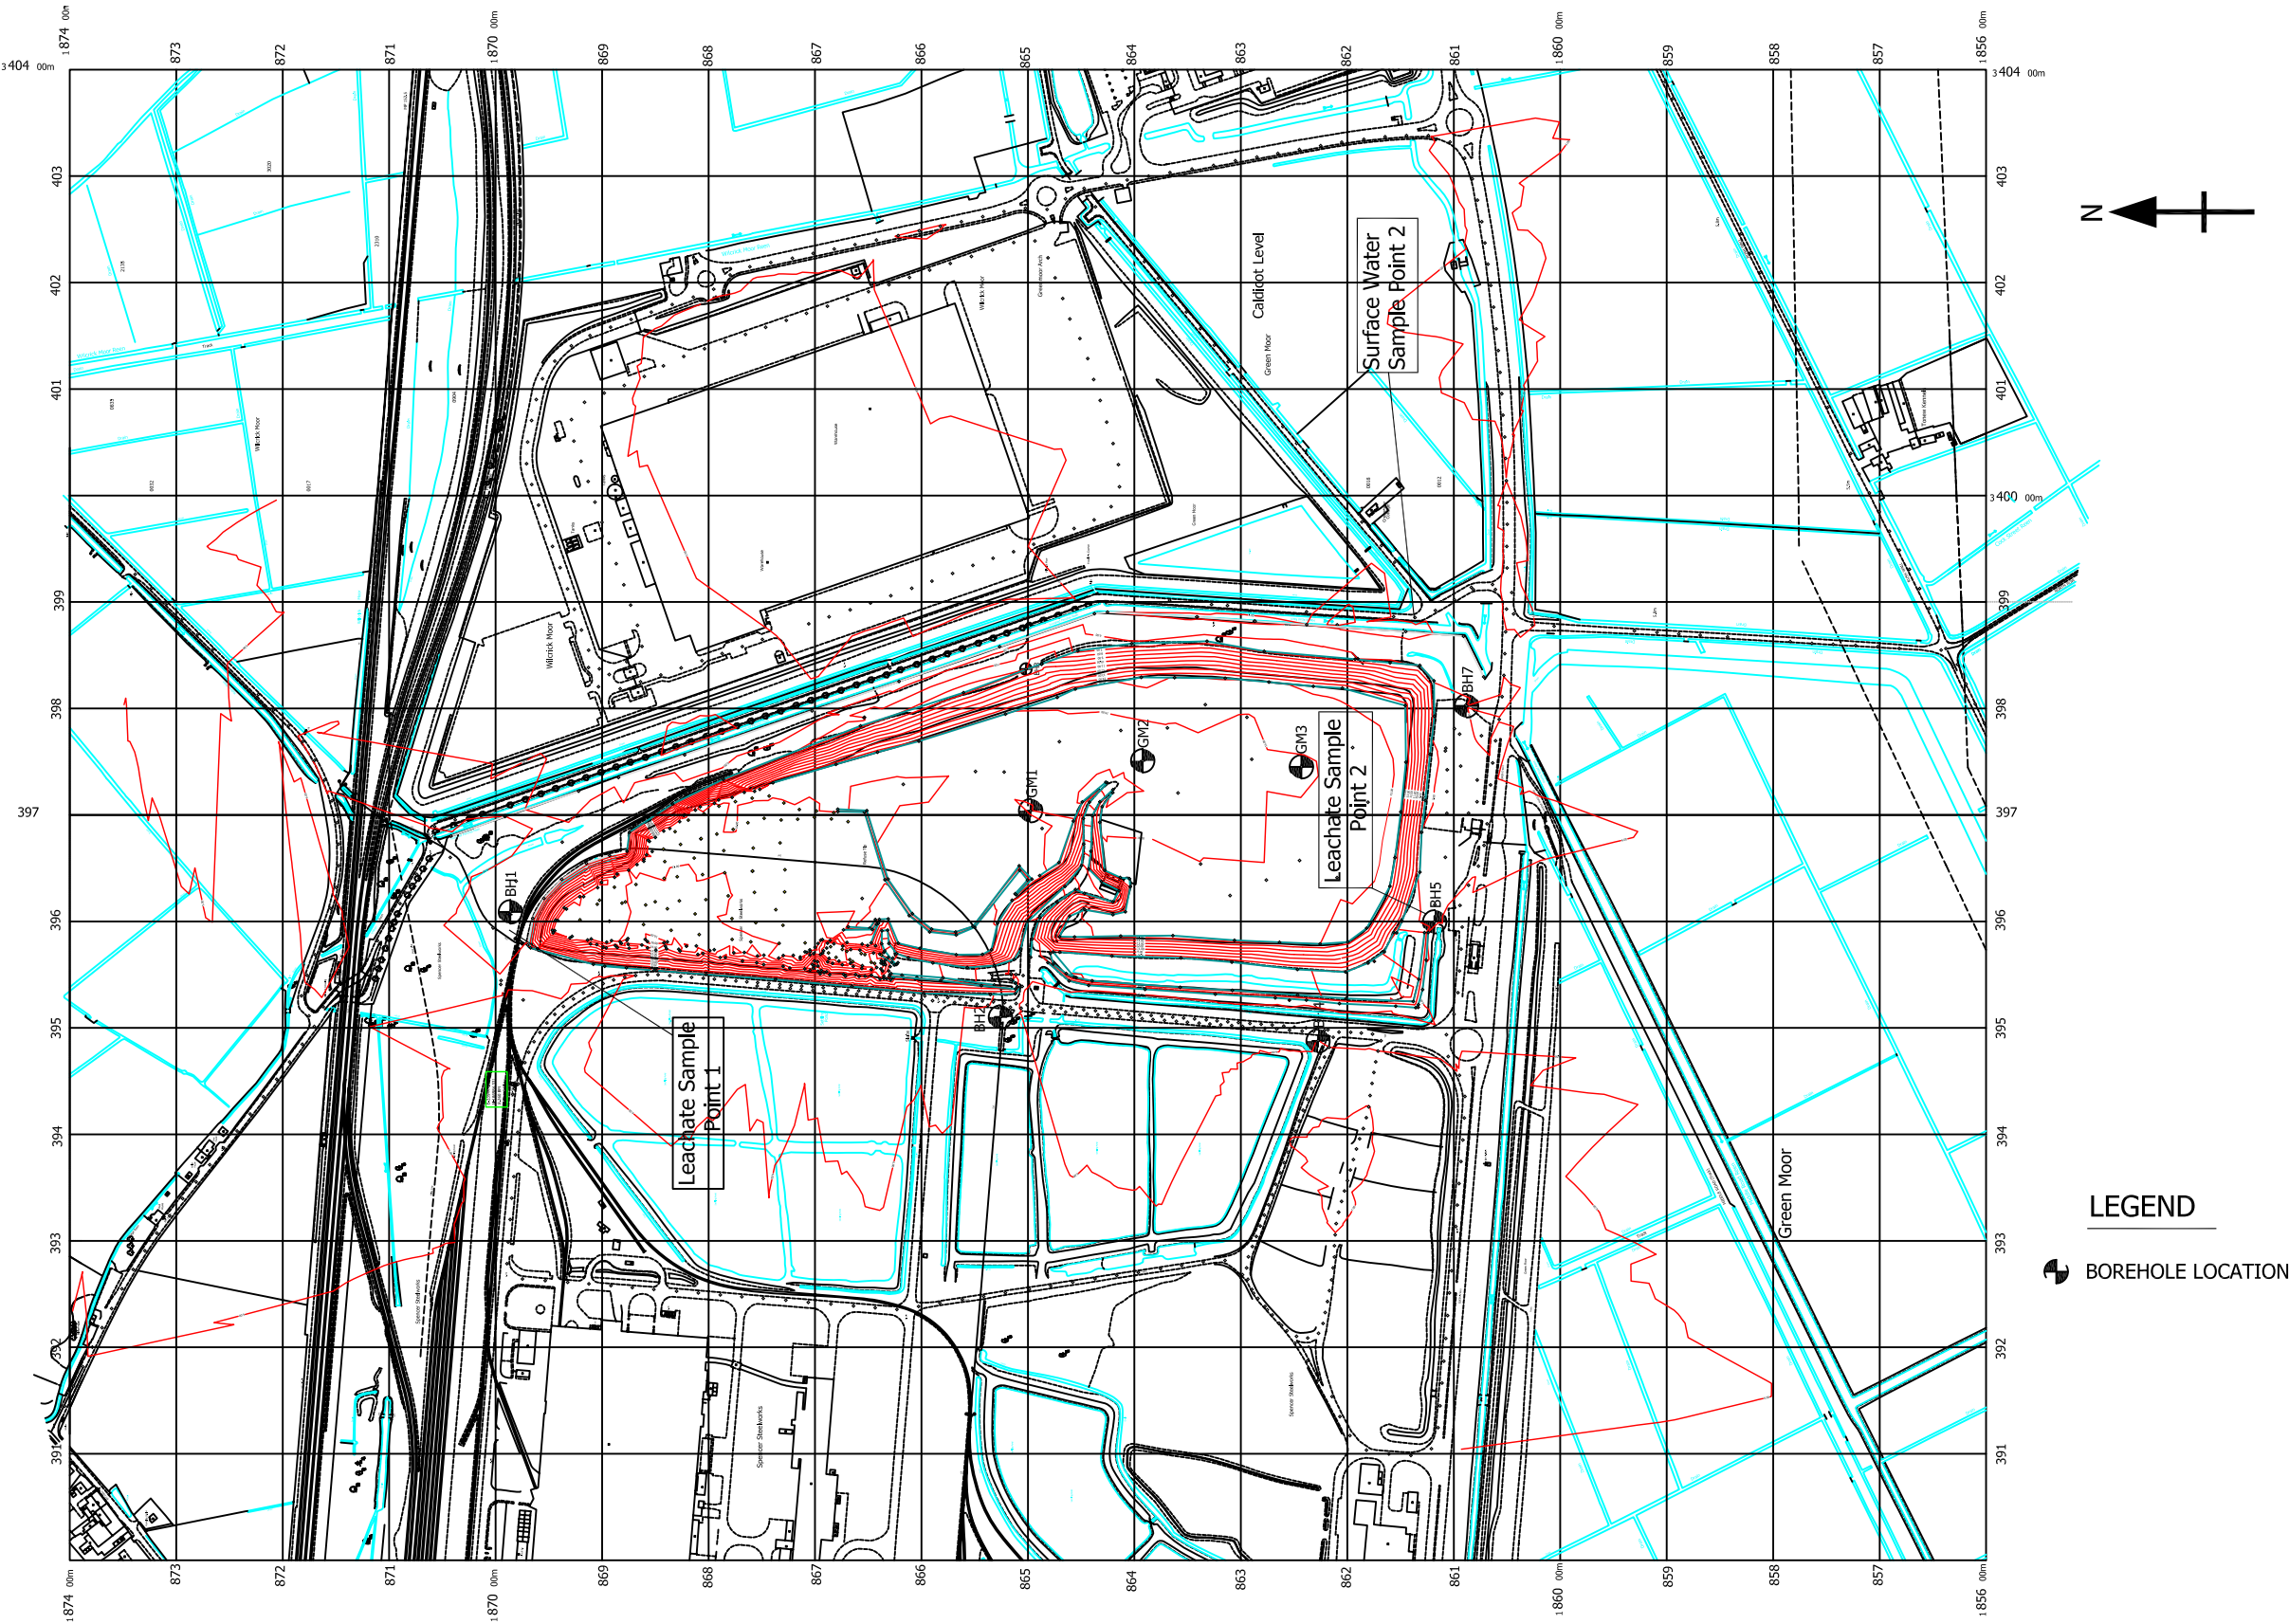
Figure 6 Available Monitoring Newtownk

Since 2016, samples have started to be collected from the leachate collection ditches at positions EL1 and EL2, as shown on Figure 6.

Leachate monitoring currently comprises a walkover survey of the landfill edge, to examine for the presence of any leachate breakout and sampling from the perimeter ditches at positions EL1 and EL2, as shown on Figure 6.

The monitoring positions available (BH's 1 to 7) are shown on Figure 6. All positions are currently inspected quarterly to ensure that they provide suitable monitoring infrastructure.

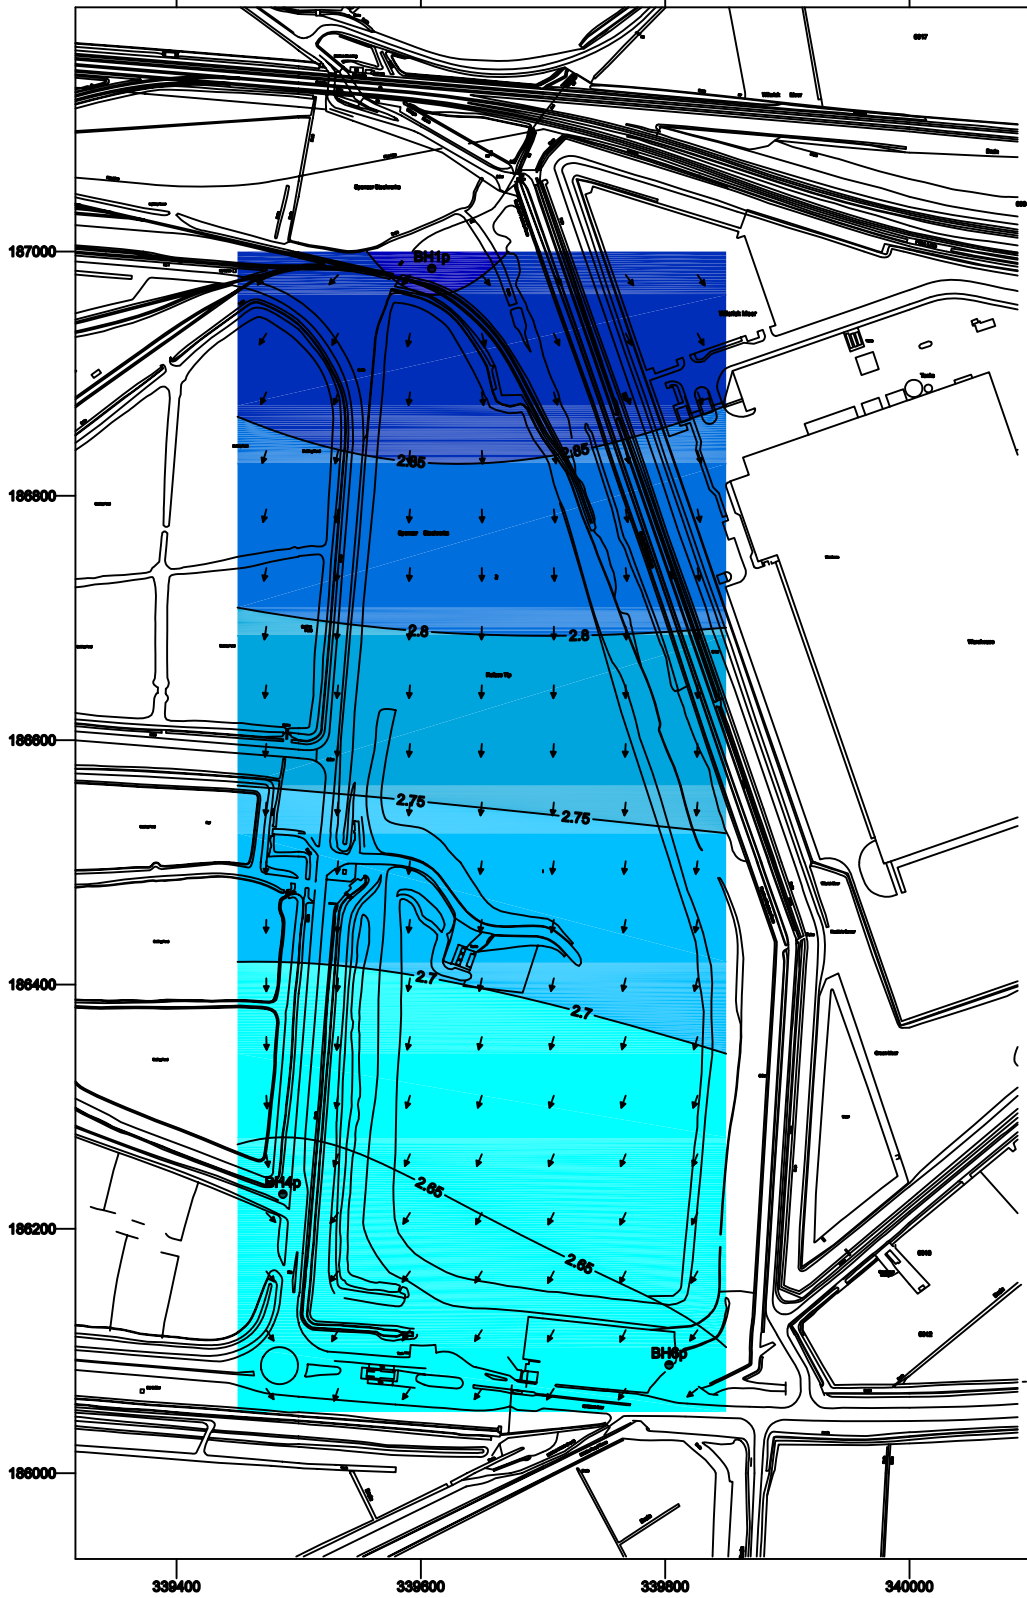
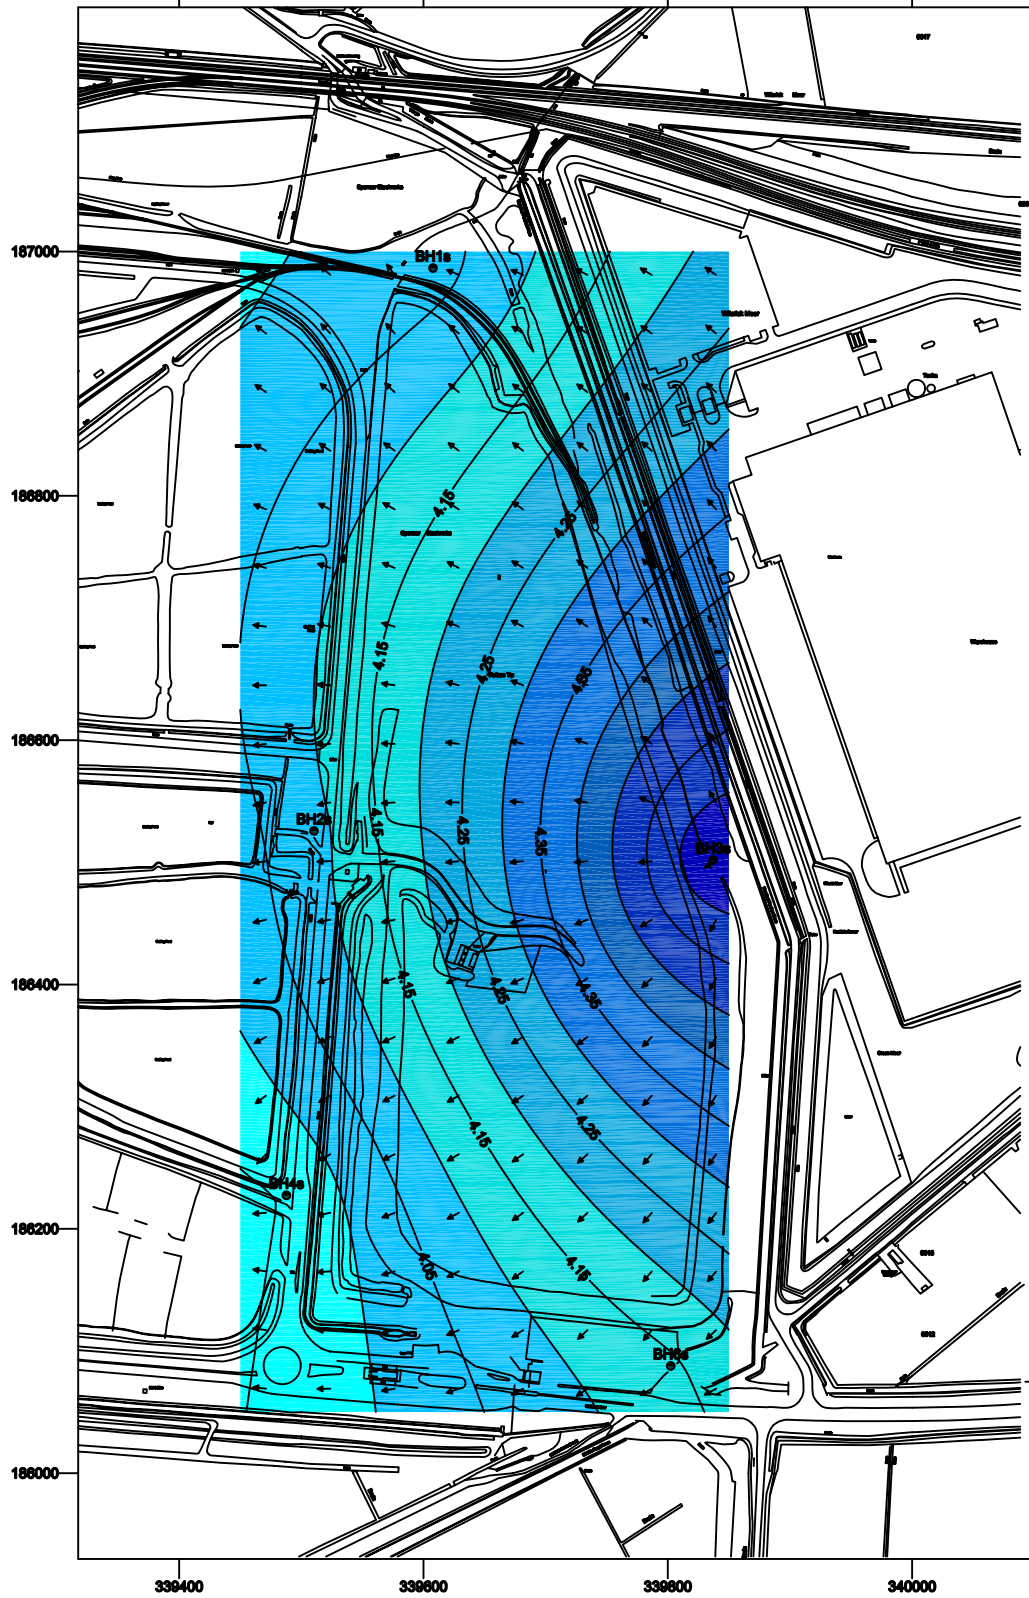
### Figure 8 Historical Groundwater Levels

Groundwater flow in the shallow fill has been historically examined by contouring the piezometric surface, as shown using historical data in Figure 8. The levels, based upon 6 boreholes and 5 trial pits, reduce in elevation from east to west and from centre to north and south. This is not unexpected. A surface water drain, transmitting water from nearby parts of the plant follows the western edge of the landfill at a level controlled by a weir at Drain 10. This water, destined for the works effluent treatment plant is considered to act as a fixed head in the fill materials, controlling the rise of groundwater above this level. This mechanism, therefore, also provides an opportunity for groundwater lowering by reducing the fixed head.

The water flowing in the fill is recharged by infiltration through the waste mass. This is considered to be leachate formed as a result of precipitation, infiltration and subsequent mounding within the waste mass. With the head distribution and flow pattern shown on Figure 8 there is no lateral recharge and therefore, the fill through which the leachate flows could reasonably be considered to be the leachate drainage blanket.

Groundwater flow in the Mercia Mudstone aquifer has been previously established by drilling three piezometers into the rock and measuring the piezometric head. The groundwater levels are sub-artesian and are confined by the lower clay layer. Upon piercing the lower clay and the clayey basal layer, groundwater was seen to rise to 2.9m AOD in the north of the site to 2.6m AOD in the south. Consequently, a very shallow groundwater gradient from north to south was previously detected, as shown on Figure 8.

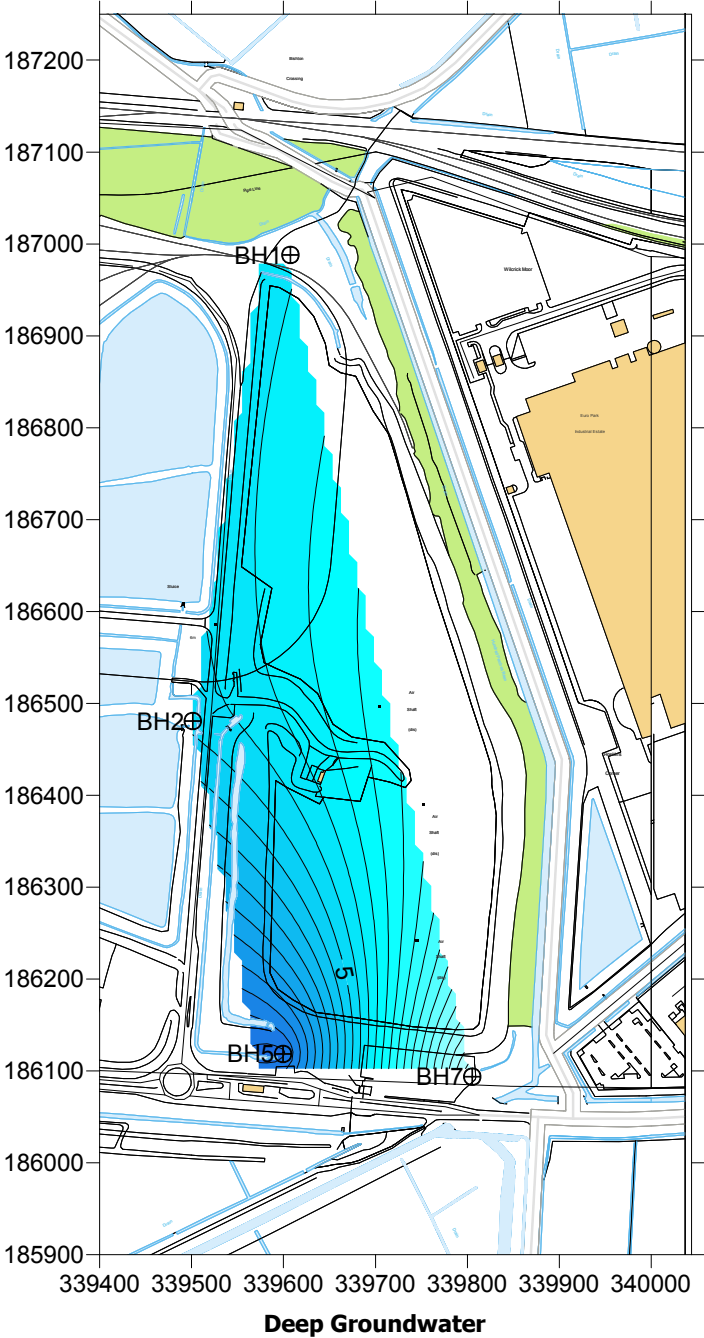
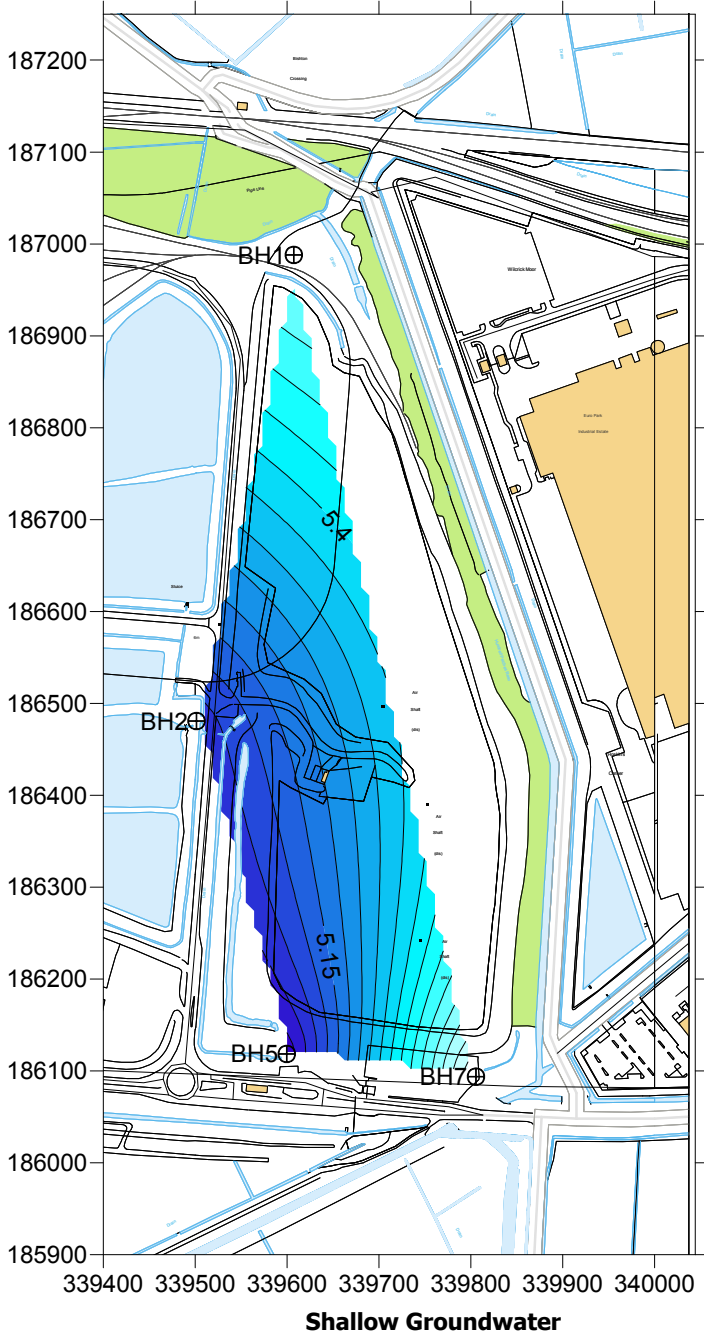
Figure 9 Recent Groundwater Elevations (mAOD)

Based on available monitoring data from the last few years it would appear that the hydraulic gradients are shallow and sometimes lowest in the east at BH3 in both the shallow and deep aquifers (see Figures 9 and 10). Interestingly, in September 2017, the reverse was true in the deep aquifer. An outbreak of leachate has been observed on the eastern side of the site (just south of BH3) and this would appear to be coincident with the low point in the system. Tata is closely monitoring this position and has already informed NRW (who has also visited the site). A temporary bund to protect the adjacent reed has been constructed.
