**EAST WASTE  
MANAGEMENT SITE,  
LLANWERN STEELWORKS**

**PERMIT EAWML/30003**

**2016 Annual Review of  
Environmental  
Monitoring**

*Report Number 1555r1v1d0117*

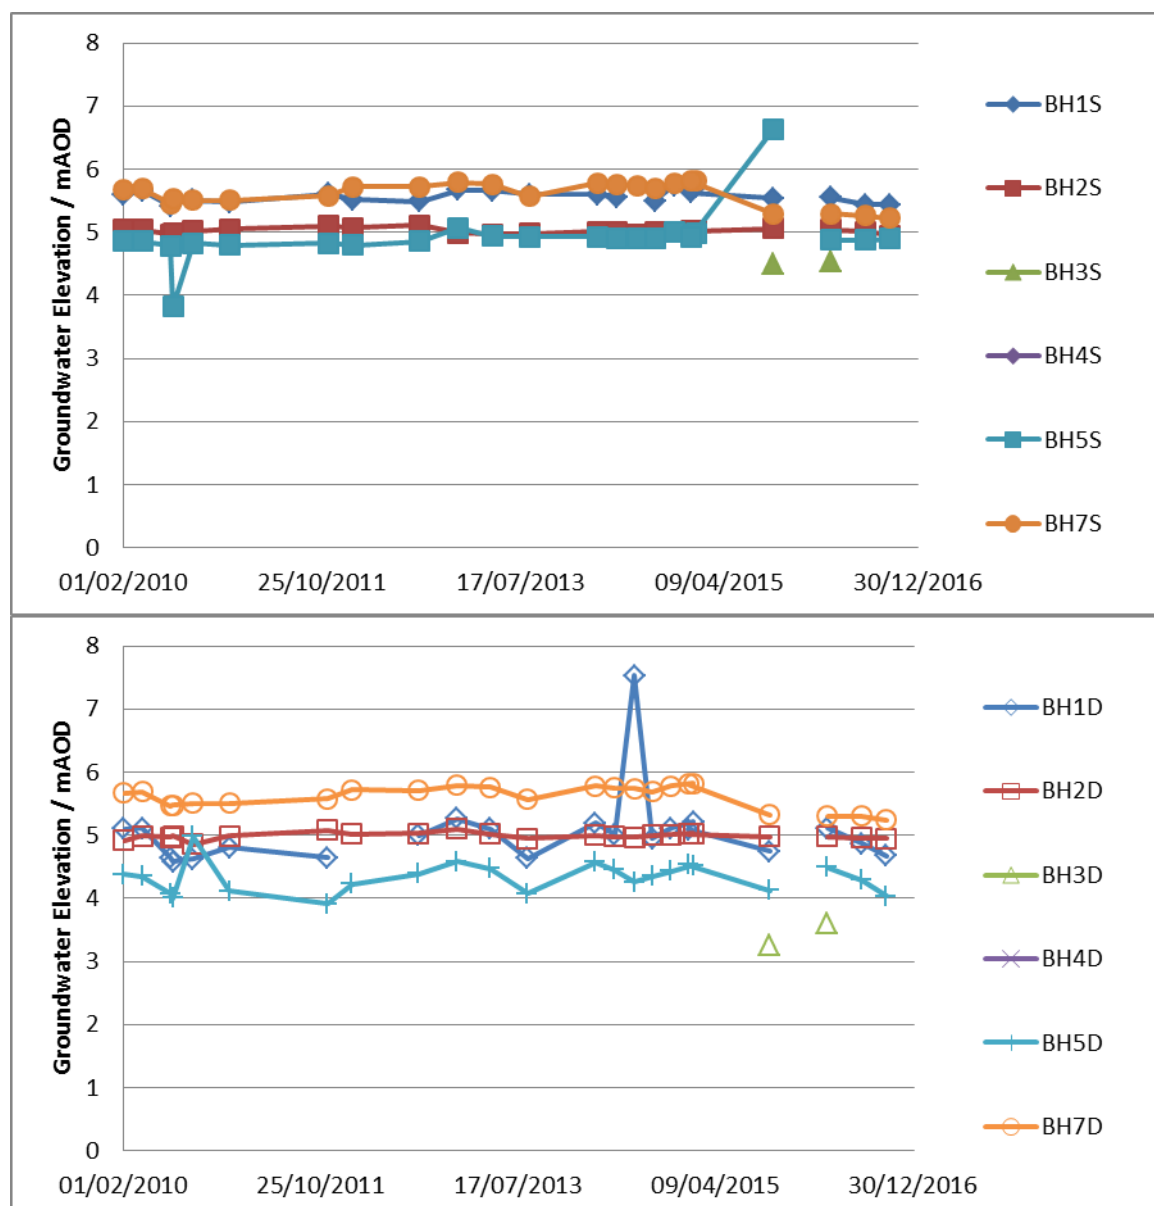
Historic groundwater monitoring data (although incomplete) has indicated that head loss, and therefore water movement, has been predominantly from the east to the west. With the benefit of more recent data from BH3 (when accessible through dense vegetation) the scenario is a little more complicated as the latest data suggests groundwater elevation is lowest in the east at BH3 in both the shallow and deep aquifers (see Figure 9). Interestingly, an outbreak of leachate has been observed on the eastern side of the site (just south of BH3). Tata is closely monitoring this position and has already informed NRW (who has also visited the site) and constructed a temporary bund to protect the adjacent reën. As more data continues to be gathered, now that the monitoring boreholes are more readily accessible, this situation will continue to be closely evaluated.

Groundwater levels and flow patterns are likely to change as the site is progressively capped. Time series plots of current groundwater levels are included below and in Appendix 1.

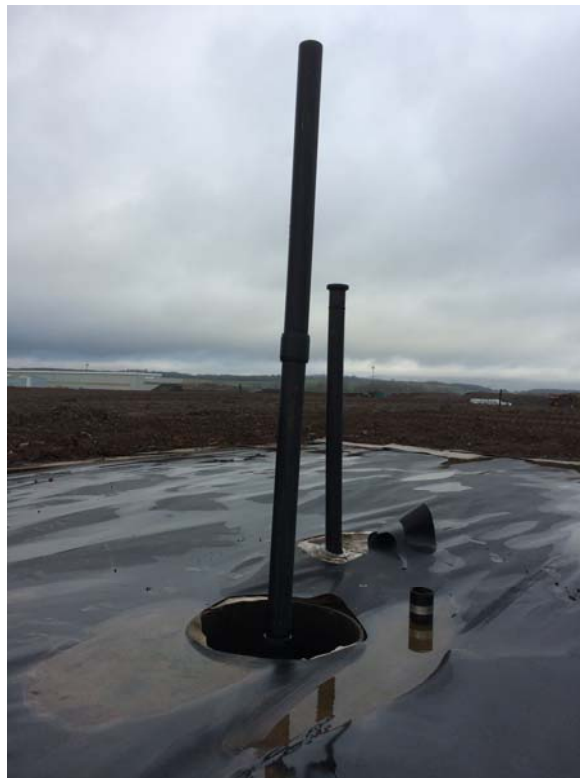
Plate 4. Construction of Gas Vents through Capping Systems

The gas wells will continue to be monitored as the restoration works progress. During this process the gas wells are being connected to the capping systems, as shown in Plate 4. However, as the gas is still free to vent to the atmosphere, only when the site is fully capped can a more representative assessment be made.
