Tata Steel Strip Products UK Port Talbot Steelworks Environmental Improvement

Quarterly On-site Ambient PM₁₀ Monitoring Report for Quarter 2 2014

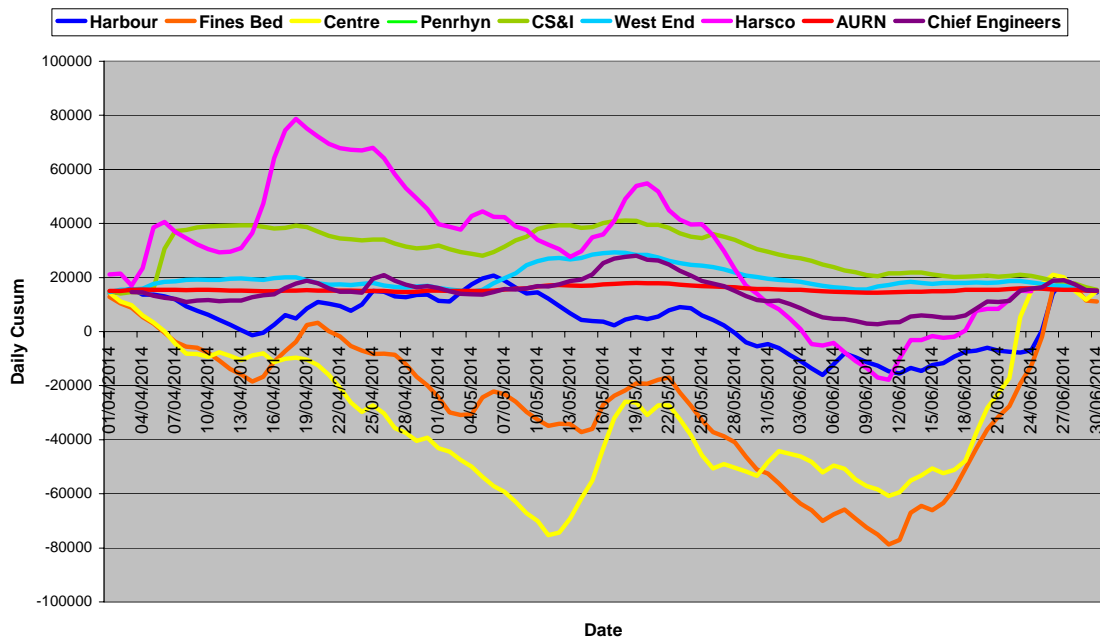
Figure B – Daily cusums for the Harsco, Centre, CS&I, Fines Bed, Chief Engineers, West End and Harbour TOPAS monitors from 1st April to 30th June 2014

Monitored PM₁₀ concentration data trends for the Harsco, Centre, CS&I, Fines Bed, Chief Engineers, West End and Harbour monitors are presented as daily cusum plots in Figure B.

After a small decrease between 2nd and 3rd April, the trend for the Harsco monitor increases steeply until 6th April. This is followed by a gradual decrease in the trend until 12th April, again followed by a steep increase until 18th April. The cusum plot then generally decreases until 13th May except for two small peaks on 25th April and 5th May. The general decrease does not coincide with the two near miss days recorded at the AURN monitor on 9th May and 10th May. The plot once again steeply increases until 20th May, followed by a steep decrease until 11th June. This is prior to a gradual increase in the trend until the monitor was removed for calibration on 25th June. No breach or near miss days were recorded during the increases observed in the cusum trend between 3rd and 6th April, 13th and 18th April, 13th and 20th May or 11th and 25th June.

The Centre monitor cusum trend decreases steeply until 8th April and is followed by a series of shallow peaks and troughs until 19th April. The trend then decreases steeply once again until 11th May, which does not coincide with the two near miss days recorded at the AURN monitor on 9th and 10th April. The plot then increases sharply until 19th May followed by a small decrease and then a small increase until 22nd May. The plot decreases steeply until 26th May prior to a series of small peaks and troughs, which are followed by a steep increase in the trend between 17th June and 27th June. The trend decreases slightly for the final time until 29th June and then increases until the end of the quarter.

Despite the Harsco monitor and the Centre monitor being located in reasonably close proximity to each other, the cusum trends do not at first appear to be very similar. However, similarities can be seen in that both monitor cusum trends show steep increases in May and June. Therefore, it is likely that the incidents potentially affecting the Harsco monitor may have also corresponded with increases in the cusum trend for the Centre monitor.

The CS&I monitor is located in reasonably close proximity to both the Harsco and Centre monitors. The CS&I cusum trend is very stable until 5th April but then increases very steeply until 7th April. The trend is fairly stable again until 19th April but is followed by a gradual decrease until 5th May. The trend generally and gradually increases again until 18th May, which coincides with the two near miss days recorded at the AURN on 9th and 10th May. This increase is followed by a steeper general decrease until 10th June and a more gradual decrease until the end of the quarter.

As the CS&I monitor cusum trend shows increases at similar times as those for the Harsco and Centre monitors, it is likely that the incidents potentially affecting these monitors also affected the CS&I monitor at times when increases were not seen in the AURN cusum plot. However, the CS&I monitor cusum trend started to increase on May 5th, which was just prior to the increases in the Harsco (May 13th) and Centre (May 11th) monitor trends. During the period from 5th to 13th May, several EIFs were issued for incidents that likely impacted on the monitor causing the increases seen on the cusum trend including; BF4 casthouse emissions, ferrous stockhouse emissions and dust emissions from the GCI plant. It may be possible that the incidents during this period impacted on the AURN monitor during the near miss days that occurred on 9th and 10th May. In all cases, immediate actions were taken to mitigate emissions.

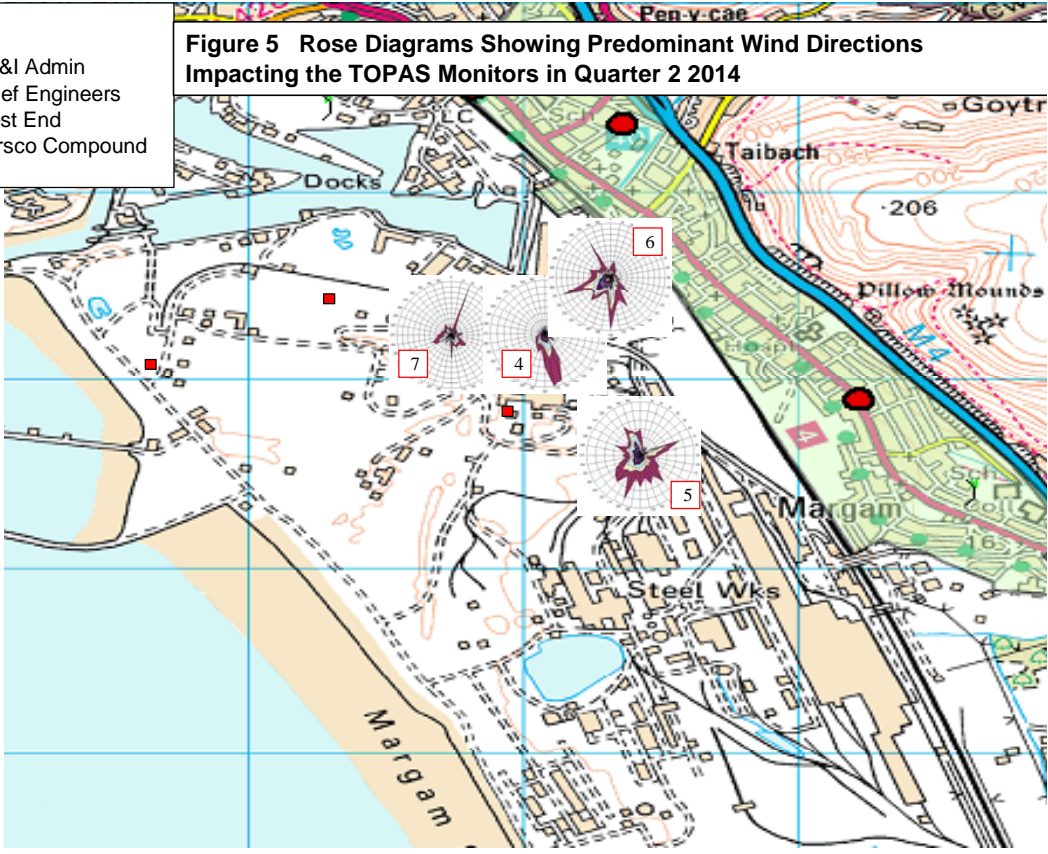
- Key**
- 4 – CS&I Admin
 - 5 – Chief Engineers
 - 6 – West End
 - 7 – Harsco Compound

Figure 5 Rose Diagrams Showing Predominant Wind Directions Impacting the TOPAS Monitors in Quarter 2 2014

Rose diagrams for data from all of the Tata owned monitors (and one monitor owned by Harsco) are presented as Figures 4 and 5 in Appendix A. The rose diagrams illustrate the predominant wind directions that impact each monitor with PM₁₀. If wind data is not available from a monitor (see Table B), then data has been substituted from the Margam AURN monitor wind vane. Also, wind data from the AURN monitor was used for the West End monitor because the data was inconsistent with wind vanes on other monitors. Maintenance was carried out on the West End wind vane during Q2 but the issue could not be resolved. Therefore, the wind vane will be replaced during Q3 2014. Potential sources of PM₁₀ that may impact the site monitors are discussed below. The potential sources discussed are not necessarily the same as those that impact the monitors located in the town.
