## Tata Steel Strip Products UK Port Talbot Steelworks

### Quarterly On-site Ambient PM<sub>10</sub> Monitoring Report for Quarter 3 2014

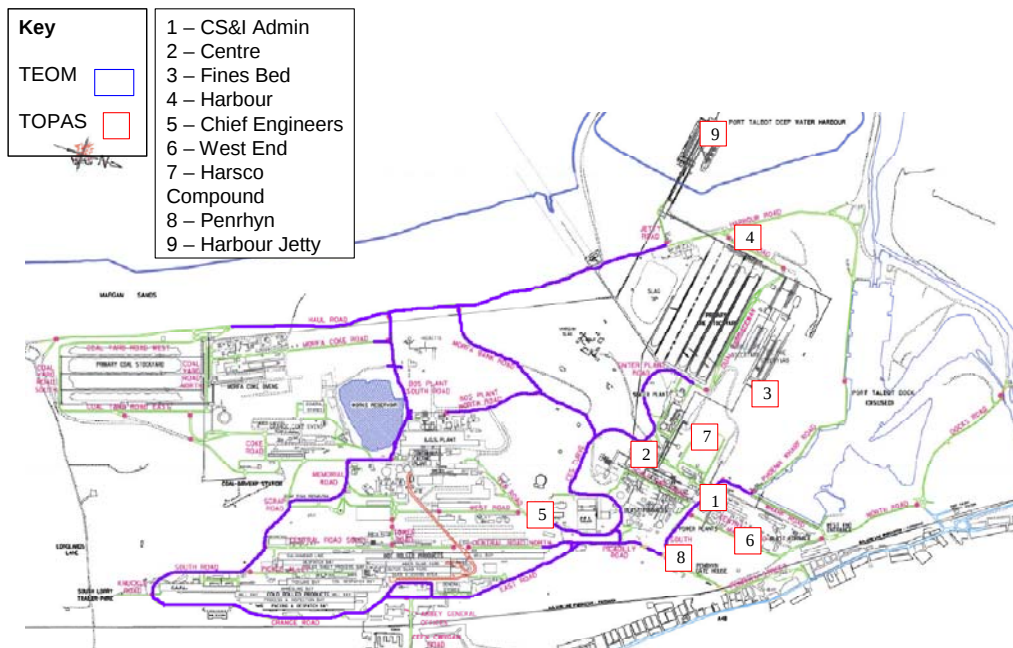
**Figure 2 Future On Site Monitoring Network (Tata Steel Monitors\*) as Planned in March 2014**

\*with the exception monitor no.7 which is owned by Harsco

Since the October 2010 response to Improvement Condition 9.8, the locations of monitors in the monitoring network have changed. The current locations of the monitors are illustrated in Figure 1 in Appendix A. Figure 2 shows the latest revision of the monitor network as reviewed in March 2014.

The review of the monitor network carried out in March 2014 also concluded that the TOPAS monitor replacing a failed TEOM unit at the Beach would be deployed at a new location on the unloader jetty rather than at the original Beach location. The new unloader jetty monitor was deployed in Q3 2014.
