# Tata Steel Strip Products UK Port Talbot Steelworks Environmental Improvement

## Quarterly On-site Ambient PM<sub>10</sub> Monitoring Report for Quarter 1 2014

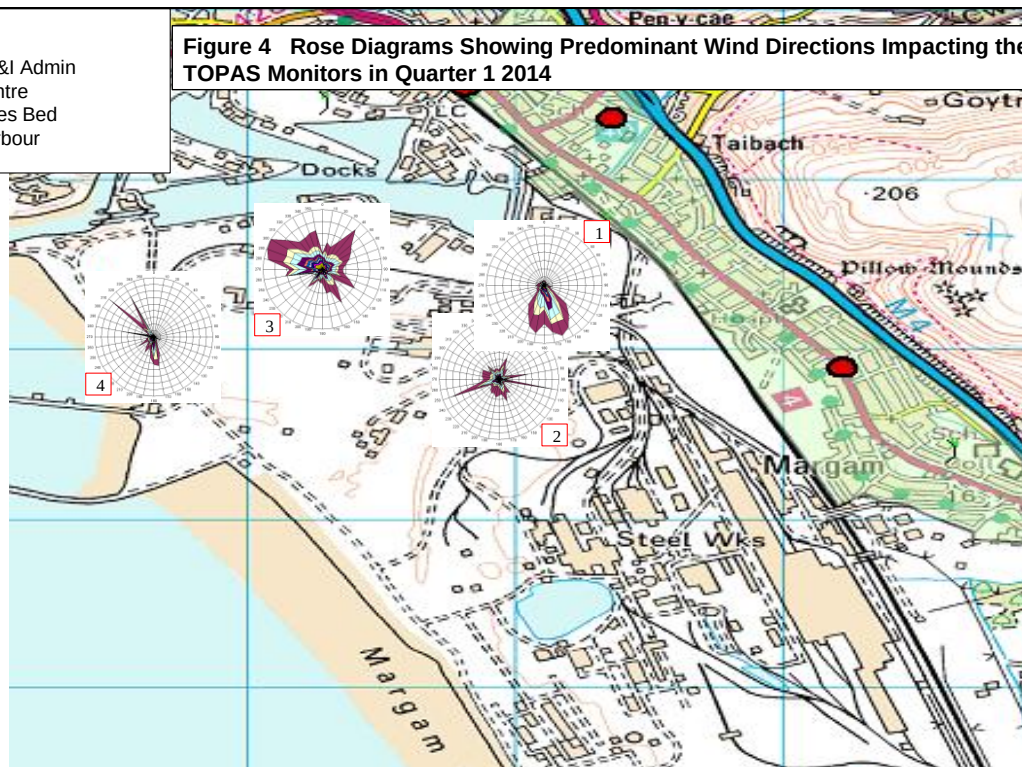
- Key**
- 1 – CS&I Admin
  - 2 – Centre
  - 3 – Fines Bed
  - 4 – Harbour

**Figure 4 Rose Diagrams Showing Predominant Wind Directions Impacting the TOPAS Monitors in Quarter 1 2014**

Rose diagrams for data from all of the Tata owned monitors (and one monitor owned by Harsco) are presented as Figures 4 and 5 in Appendix A. The rose diagrams illustrate the predominant wind directions that impact each monitor with PM<sub>10</sub>. If wind data is not available from a monitor (see Table B), then data has been substituted from the Margam AURN monitor wind vane. Also, data wind from the AURN monitor was used for the West End monitor because the data was inconsistent with wind vanes on other monitors. Maintenance will be carried out on the West End wind vane in order to rectify these issues. Potential sources of PM<sub>10</sub> that may impact the site monitors are discussed below. The potential sources discussed are not necessarily the same as those that impact the monitors located in the town.
