**PROPOSED COMMERCIAL DEVELOPMENT  
MABEY HOUSE, NEW HOUSE PARK, CHEPSTOW**

**PHASE TWO GEO-ENVIRONMENTAL AND  
GEOTECHNICAL ASSESSMENT**

Document Ref. 6283b.02.2582

Date: July 2016

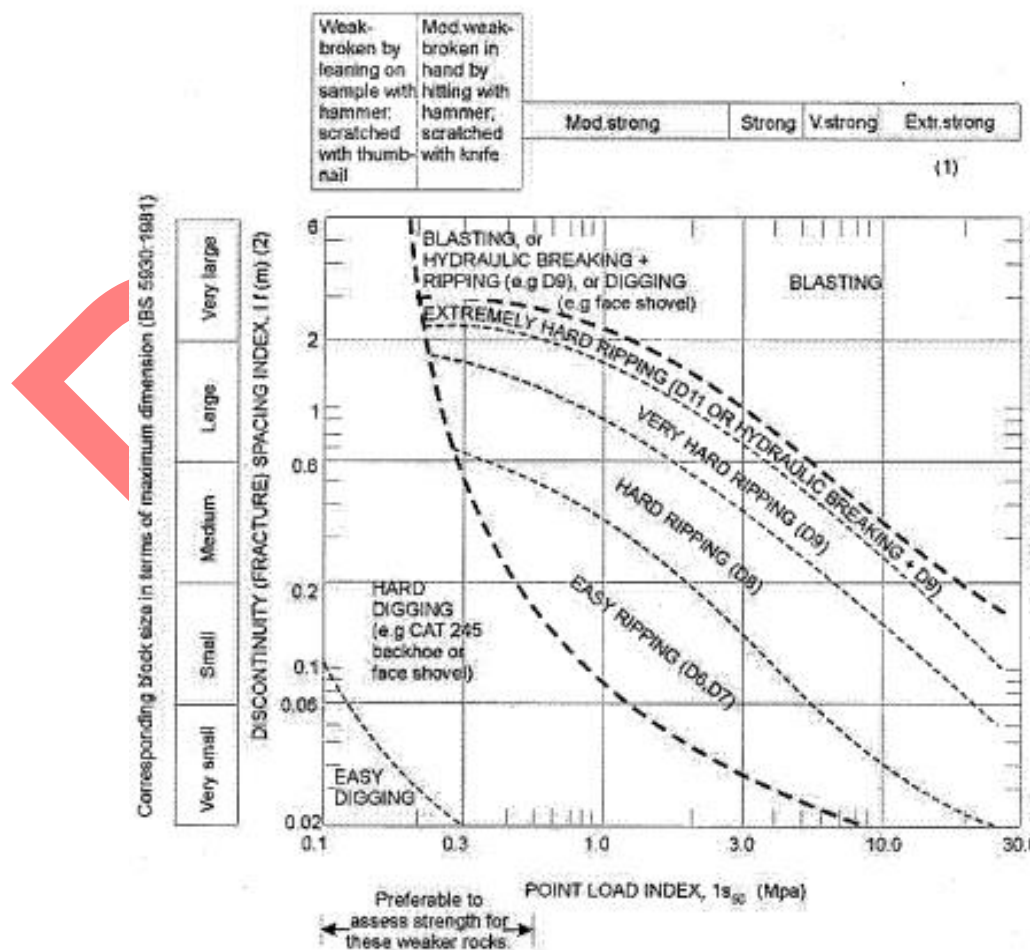
Insert 1: Excavatability (rippability) of rocks (Pettifer and Fookes, 1994)

Based on the point load test results presented in Appendix G and using the relationships developed by Pettifer and Fookes (1994) presented in Insert 1 below, the rippability of the underlying bedrock can be determined.

Excavatability graph (Pettifer and Fookes 1994)

Below are the results of the Point Load tests to determine the Mpa value for use with the above chart. This is used in conjunction with the fracture spacing identified in the rotary core drill hole. The recovered core samples identified a generally weak strength mudstone, becoming moderate with depth. Bands of weathered 'non intact' Mudstone were also identified.

In addition to the above, the fracture spacing index identified in the recovered core samples showed a range from non-intact to 0.25 I<sub>f</sub>(m). With the determined point load index results ranging from 0.02 to 0.06 I<sub>s(50)</sub> and based on the relationships developed by Pettifer and Fookes, the weathered Mercia Mudstone underling the proposed maintenance/construction pit would be determined as 'Easy Digging' to 'Hard Digging' and an excavator such a CAT 245 (or equivalent) would be able to excavate the rock, based on the information obtained and the ground conditions observed.
